## **PRELIMINARY ECOLOGICAL APPRAISAL (BATS) AT 10 COURTENAY DRIVE EMMER GREEN**

**Prepared for:  
Mr C Cox  
10 Courtenay Drive  
Emmer Green  
RG4 8XH**

**17 July 2023**

**Ref: SPH/NP/PEA-23/04.07**

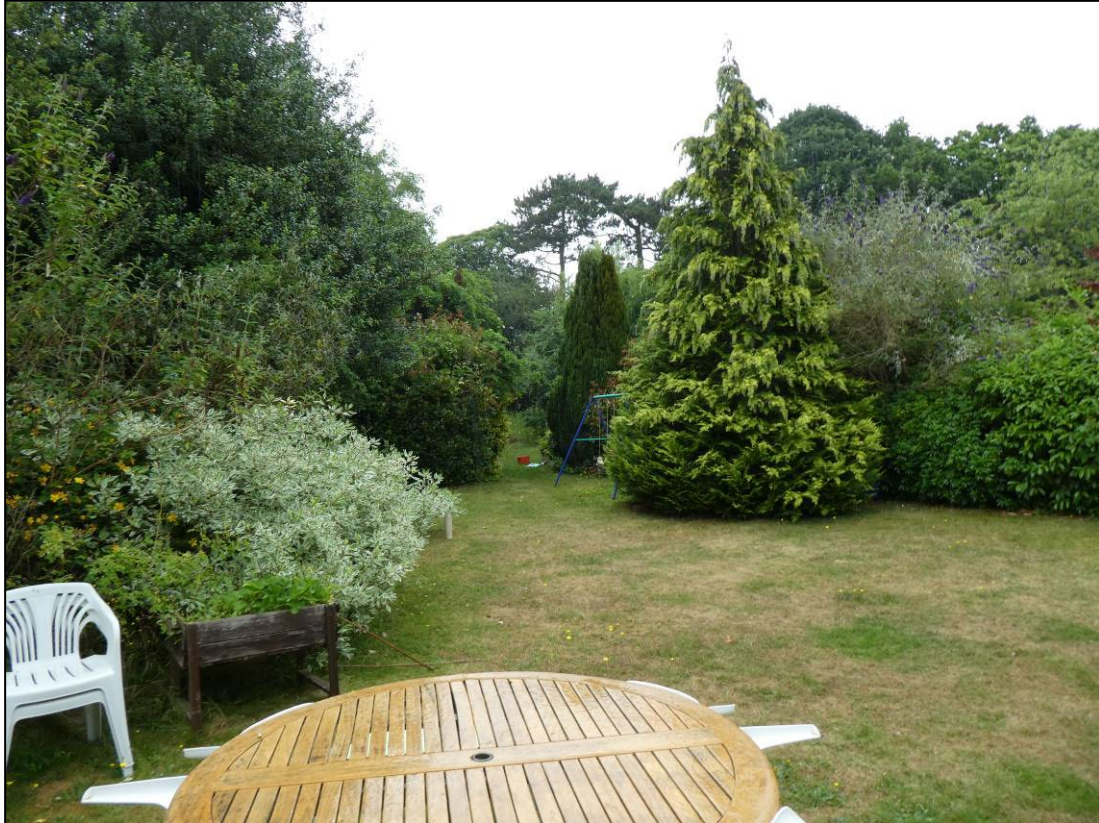
The application site comprises a detached, brick-built property with an integral garage. The remainder of the site comprises a concrete driveway, and a rear garden, which is mainly laid to lawn, with some trees, hedgerows and shrubs throughout, see Figure 4 below. The site itself offers good foraging and commuting habitat for bats.

Figure 3. Rear garden. 10 Courtenay Drive, Emmer Green. 04.07.23

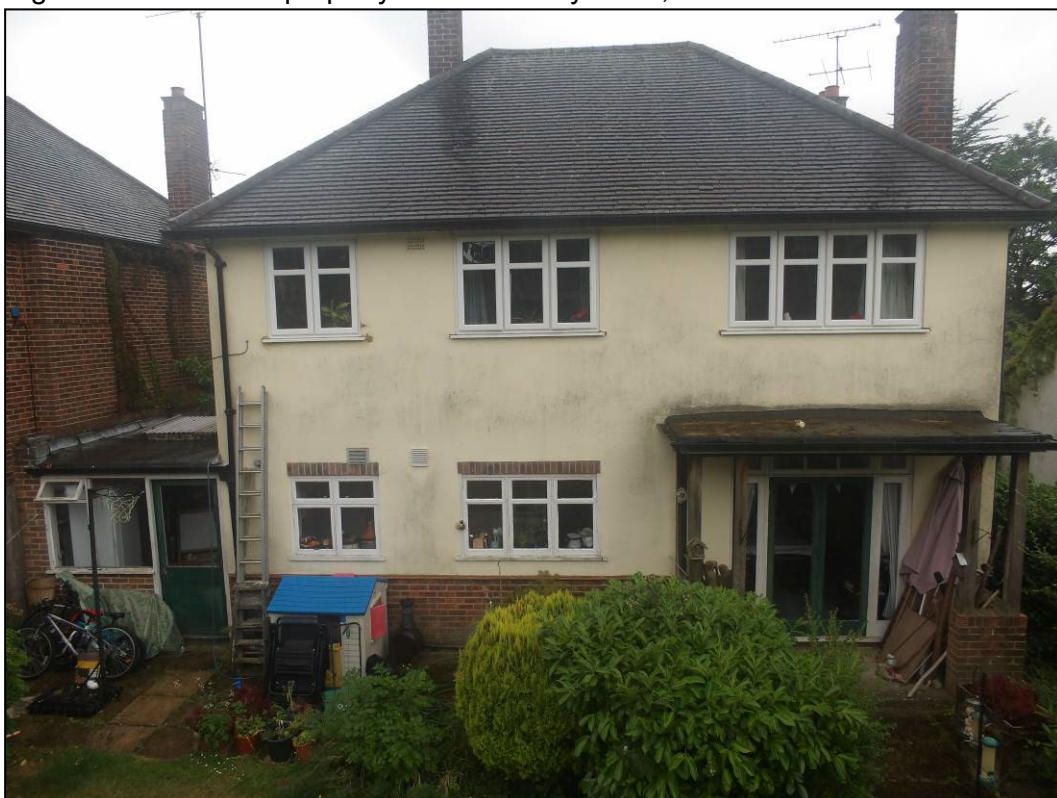
Figure 4. Rear of the property. 10 Courtenay Drive, Emmer Green. 04.07.23

The property is a detached, brick-built building, that is rendered and painted and is in a good condition externally, see Figure 4 below. The roof of the property is pitched and covered in close fitting tiles, none of which are missing or broken, see Figure 5 on page 9. The ridge tiles are all tightly fitted with no gaps in which bats could utilise for roosting and the hip tiles are all well cemented and have no gaps in which crevice dwelling bats could use for roosting, see Figure 6 on page 9. The lead flashing around the chimney is all tightly fitted to the roof tiles and provided no gaps in which roosting bats could exploit (see Figure 7 on page 10) and the soffits and fascia's are all tightly fitted to the walls and had no cracks or splits which could be utilised by roosting bats, see Figure 8 on page 10. There is a single storey side extension to the property, see Figure 9 on page 11. The roof of the extension is flat and covered in bitumen and a small section of corrugated plastic, all of which is tightly fitted with no rips or tears in which roosting bats could exploit externally, or enter the building to roost, see Figure 10 on page 11.

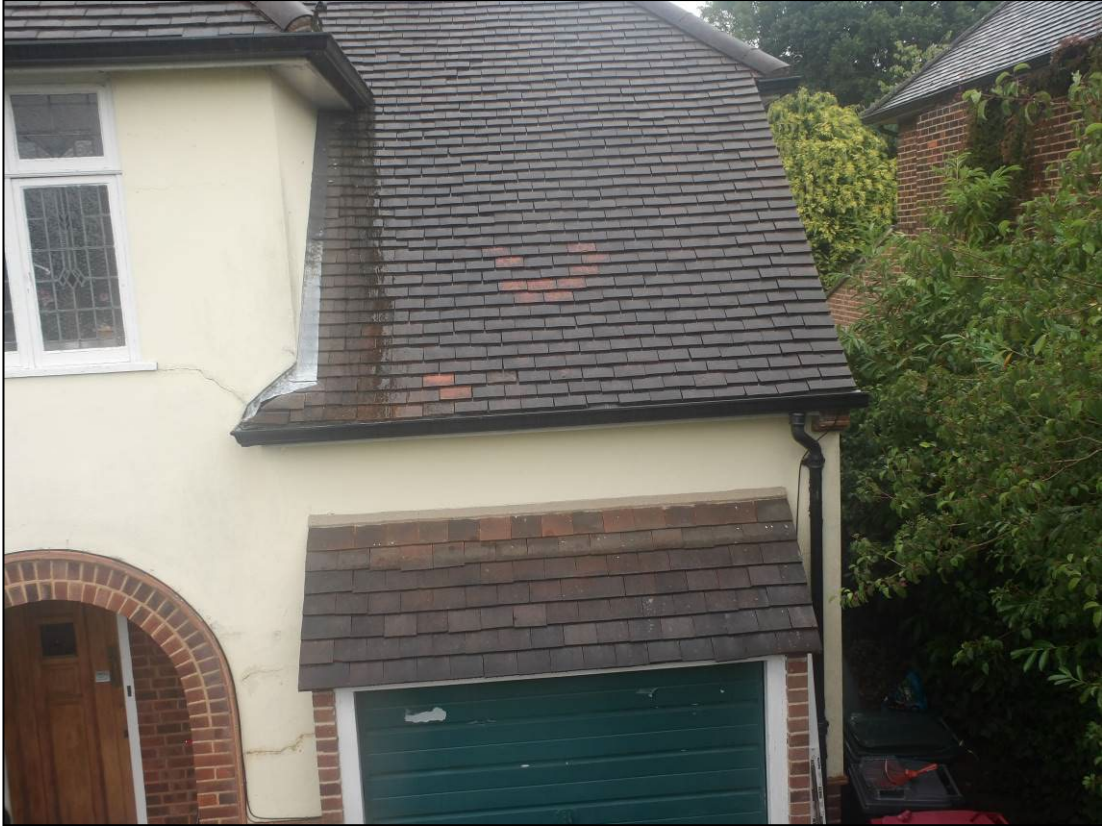
Figure 11. Integral garage. 10 Courtenay Drive, Emmer Green. 04.07.23

The integral garage was also inspected externally, see Figure 11 on page 12. The sloped section of the garage roof is covered in close fitted tiles, none of which are missing or broken, see Figure 12 on page 12.
