85 Cressingham Road  
Reading  
Berkshire  
RG2 7RX

# Preliminary Bat Roost Assessment

*Report prepared by Conor Watson ACIEEM; reviewed by John Wenman MCIEEM*  
Ref: R3528/a

**September 2023**

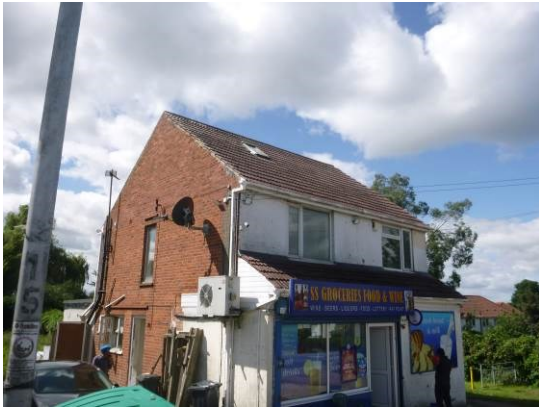
1. Front of property viewed from northeast.

- 4.2.1** The detached property was of brick cavity wall construction with a pitched roof; it had a single-storey shop frontage and a single-storey rear extension (**Photographs 1 & 2**).

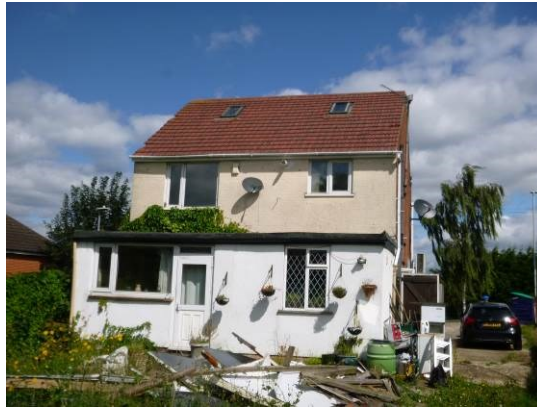
2. Rear of property viewed from south.

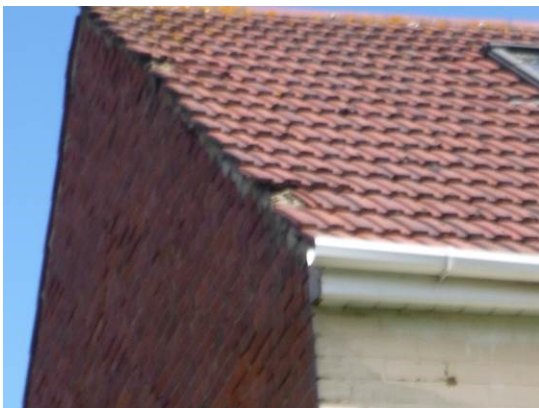
- 4.2.2** The pitched roof was covered with interlocking roof tiles that were flat and intact except for a couple of missing verge tiles at the western gable, but cement blocked any potential bat ingress/egress (**Photograph 3; Target note 1**). The ridge tiles were securely mortared, and the gable verge mortar was all intact (**Photographs 4 & 5; Target notes 2 & 3**). The uPVC soffits were intact and tight at the eaves (**Photograph 6; Target note 4**). A hole with a plastic pipe insert in the western gable wall was closely inspected and showed no signs of bat occupation (**Photograph 7; Target note 5**).

3. Couple of missing verge tiles (rear elevation).

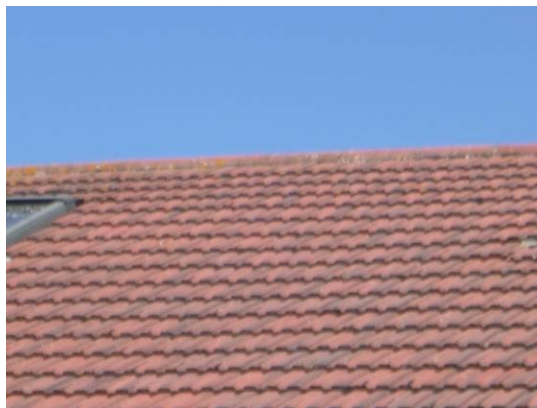
4. Securely mortared ridge tiles (rear elevation).

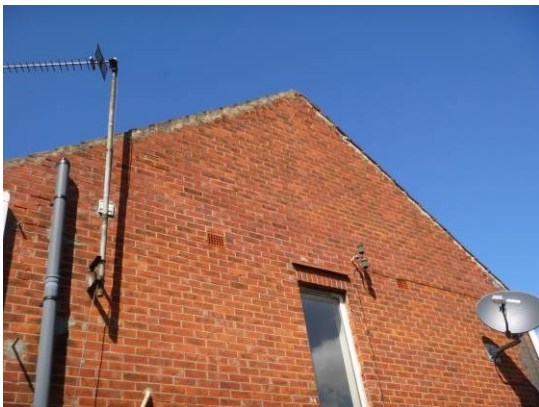
5. Intact verge mortar (east elevation).

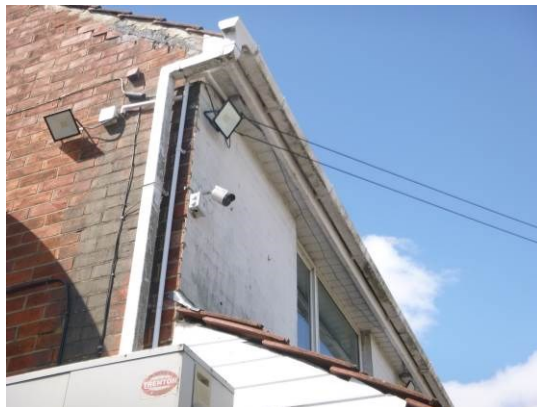
6. Intact and tight uPVC soffits (front elevation).

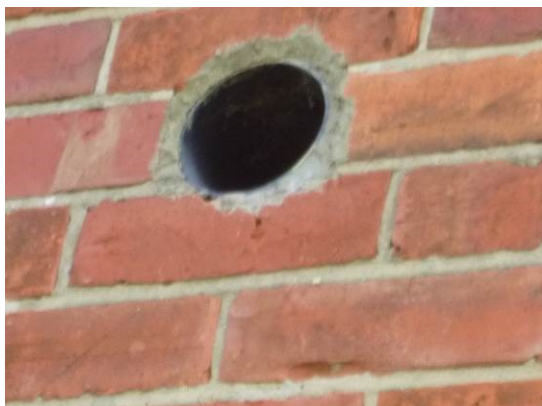
**5.1.2** Overall, the property lacked external features that could provide potential roosting sites for crevice-dwelling bats, such as the pipistrelle (*Pipistrellus* spp.) and/or small *Myotis* species. There were a few low-level features – i.e. a hole with a plastic pipe insert in the gable wall and slight gaps beneath verge tiles and lead flashing on the side of the shop frontage of very limited suitability – that were closely inspected and showed no signs of bat occupation (droppings, staining etc.).

**7. Hole with pipe insert in gable wall (west elevation).**

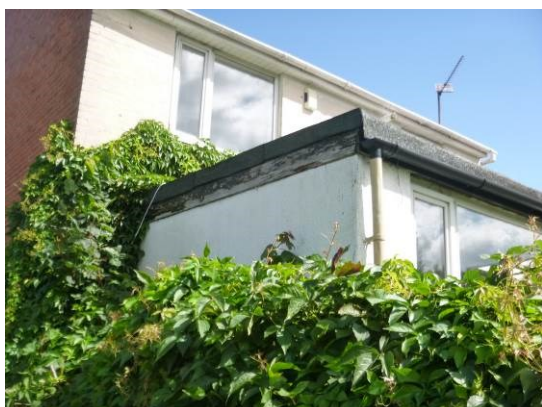
- 4.2.3** The shop frontage had a sloping roof covered with interlocking roof tiles that were flat and intact; there were slight gaps beneath verge tiles and lead flashing, but these were closely inspected and showed no signs of bat occupation (**Photograph 8; Target note 6**). The rear extension had a flat bituminous roof with timber fascias which were flush to the walls (**Photograph 9; Target note 7**).

**9. Bituminous flat roof and flush timber fascias on rear extension (rear elevation).**

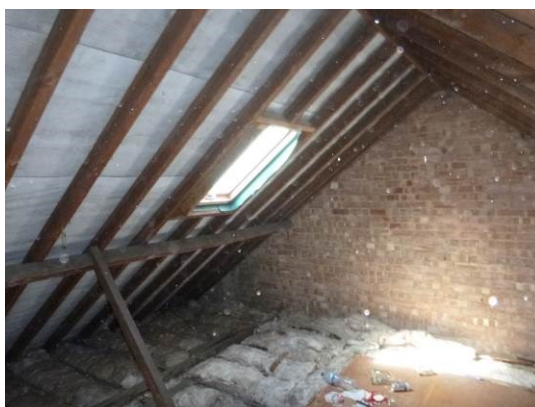
- 4.3.1** The roof void covered the two-storey footprint of the property and was accessible via a first floor loft hatch. The void had an approximate floor-to-ridge height of 2.5 metres, was of 'cut and pitch' roof construction and had three roof lights (**Photograph 10**). The roof was lined with intact non-bitumen coated breathable roofing membrane and the ridge beam was lightly cobwebbed, which can indicate an absence of recent void-dwelling bat activity (**Photograph 11; Target notes 8 & 9**).

**10. Roof void.**

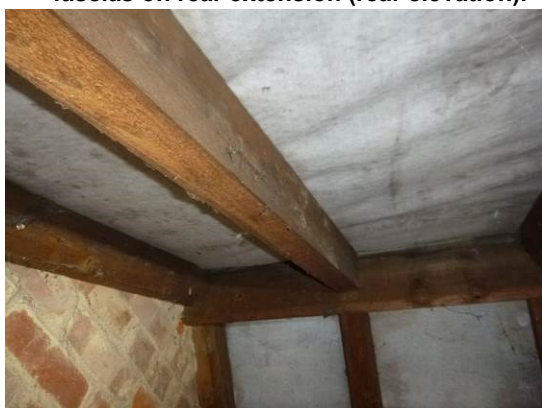
**11. Breathable roofing membrane and lightly cobwebbed ridge (roof void).**

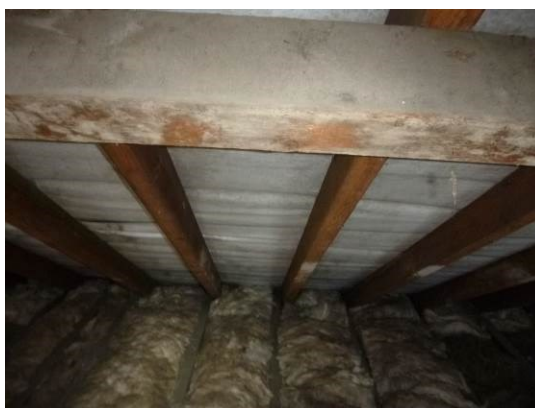
The floor had a new layer of fibreglass insulation above an older layer; the eaves were filled with fibreglass insulation (**Photograph 12; Target note 10**). The gable ends were of brick construction and featured gaps behind the end roof rafters; these were closely inspected and showed no signs of use by roosting bats (**Photograph 13; Target note 11**).

**12. Eaves filled with fibreglass insulation (roof void).**

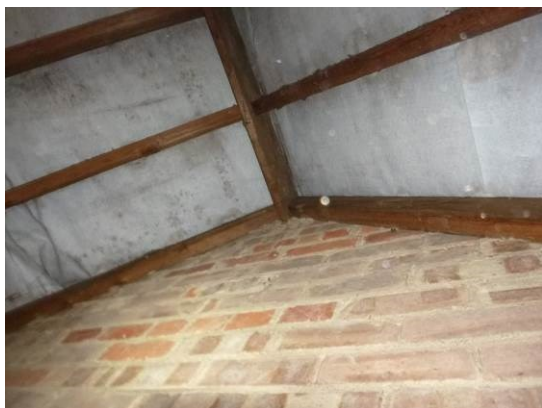
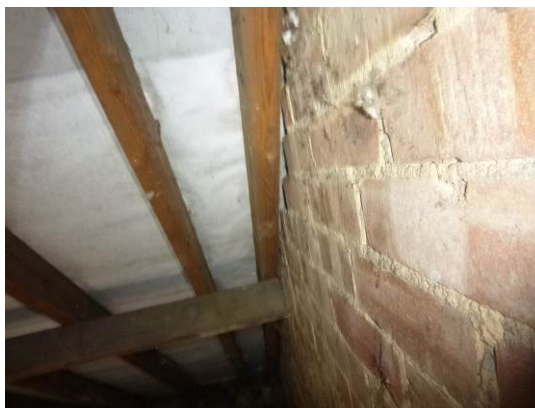
**13. Gaps behind rafters at gable end (roof void).**

**14. Gaps behind rafters at gable end (roof void).**

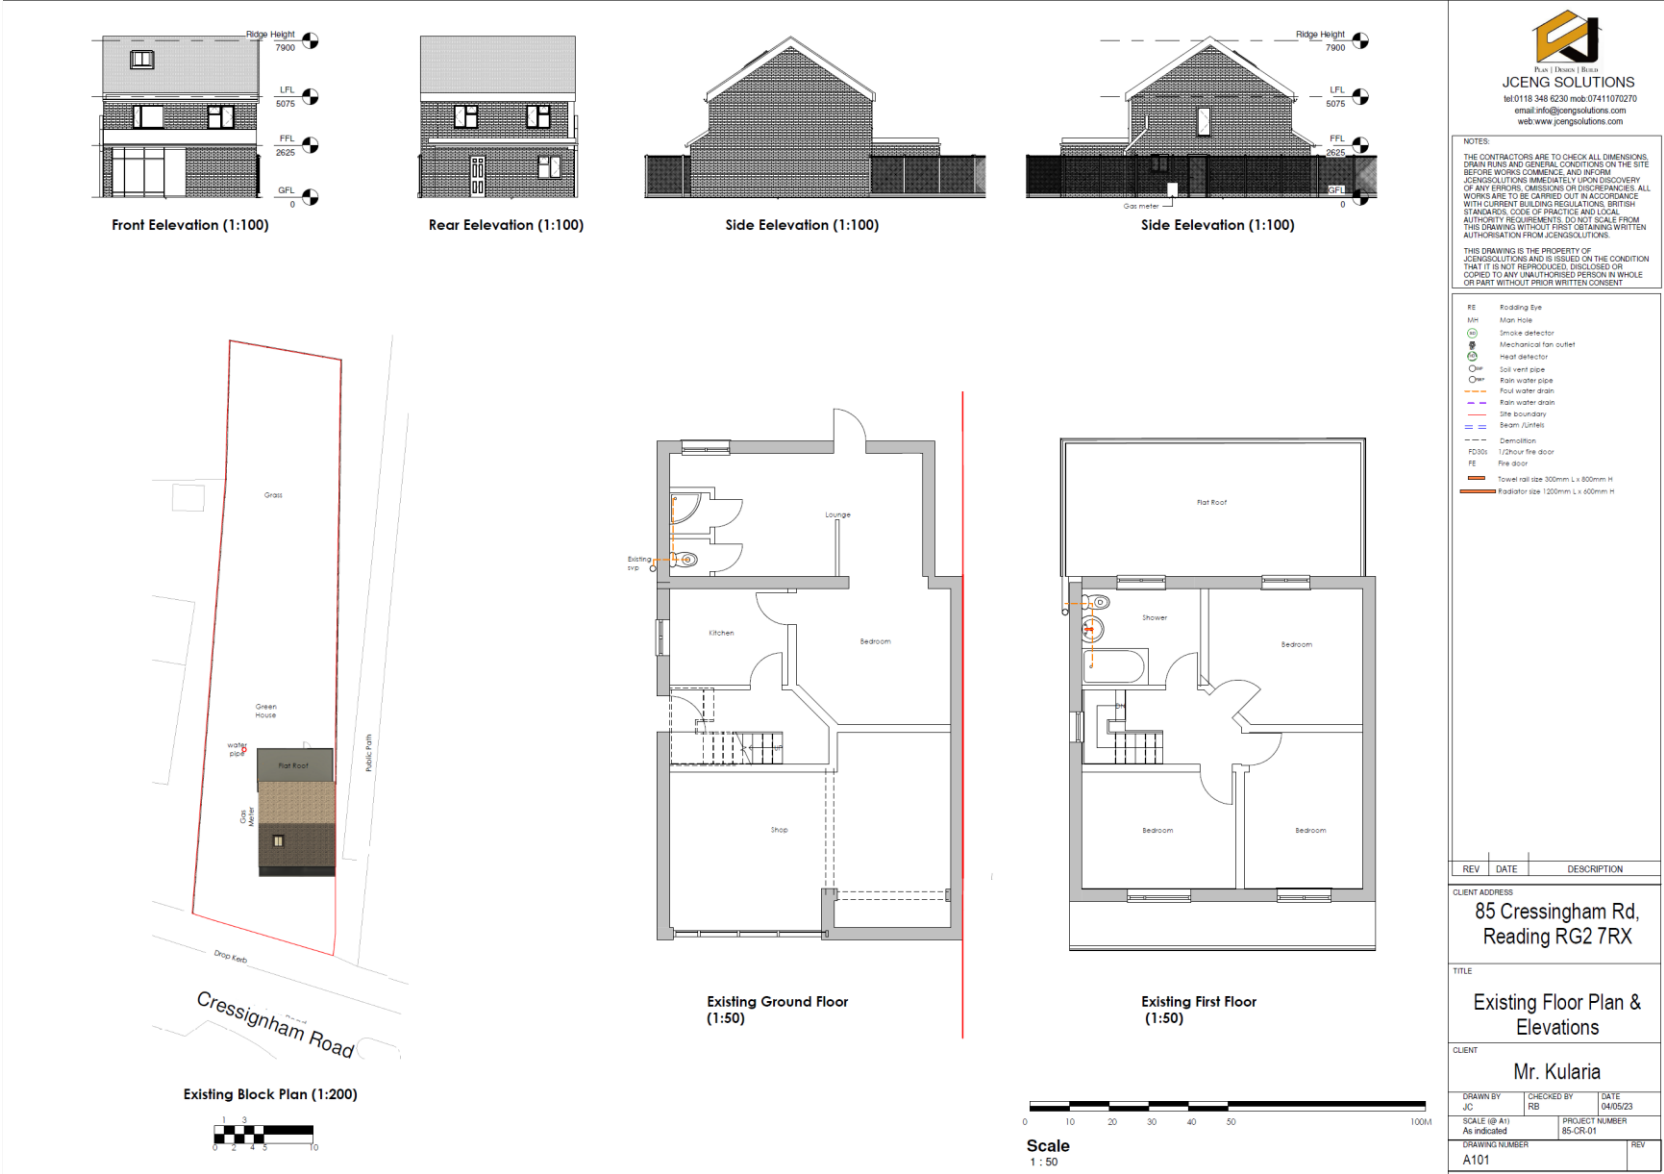
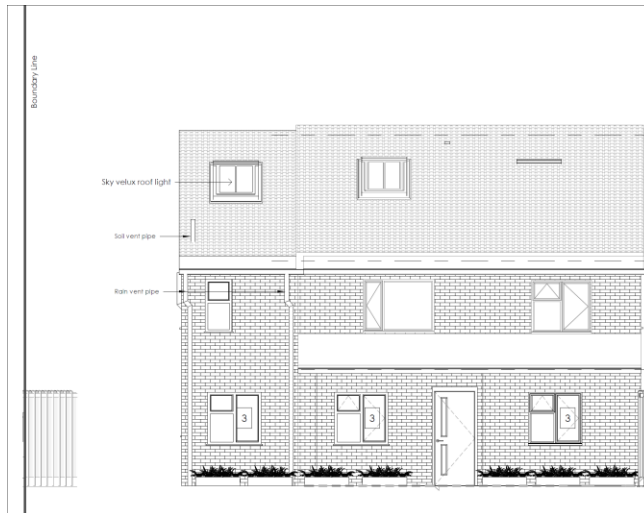
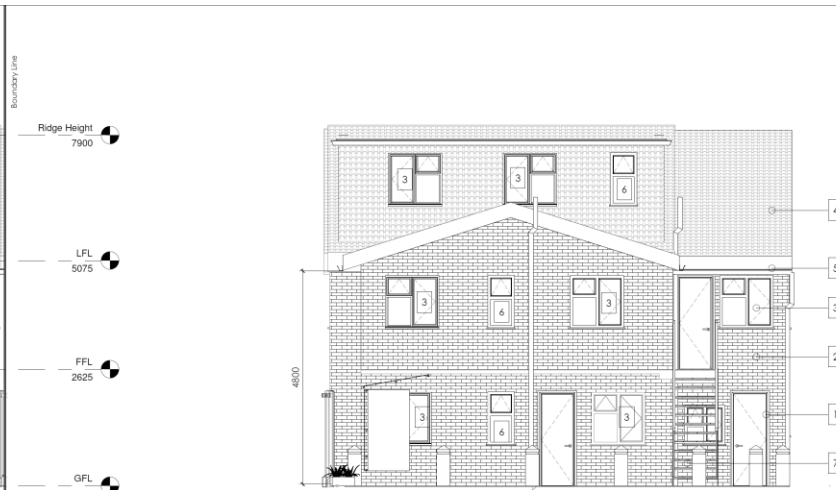
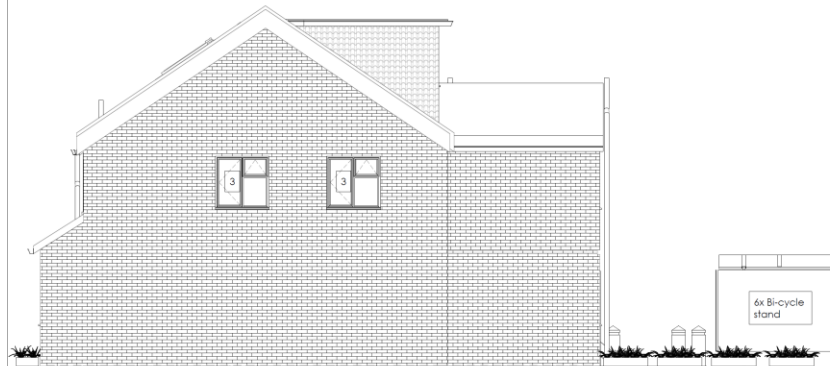
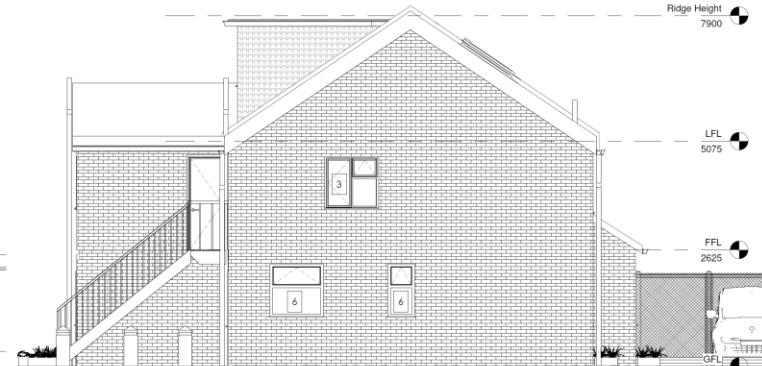
APPENDIX 3 – EXISTING AND PROPOSED ELEVATIONS

**5.2.1** The planning proposals seek consent for two storey side and rear extensions and associated changes to the roof including the installation of dormers (refer to existing and proposed elevations in **Appendix 3**). The survey findings demonstrate that these proposed works are highly unlikely to result in the damage or destruction of a bat roost or lead to the disturbance of bats occupying roosts. Therefore, a European Protected Species (EPS) mitigation licence would not be required to allow the works to proceed lawfully.
