# Preliminary Geo-Environmental Risk Assessment

Logicor Park Reading, Rose Kiln Court

Presented to: Redwood (Light Industrial) Propco Sarl

Delta-Simons Project No: 91193.557185

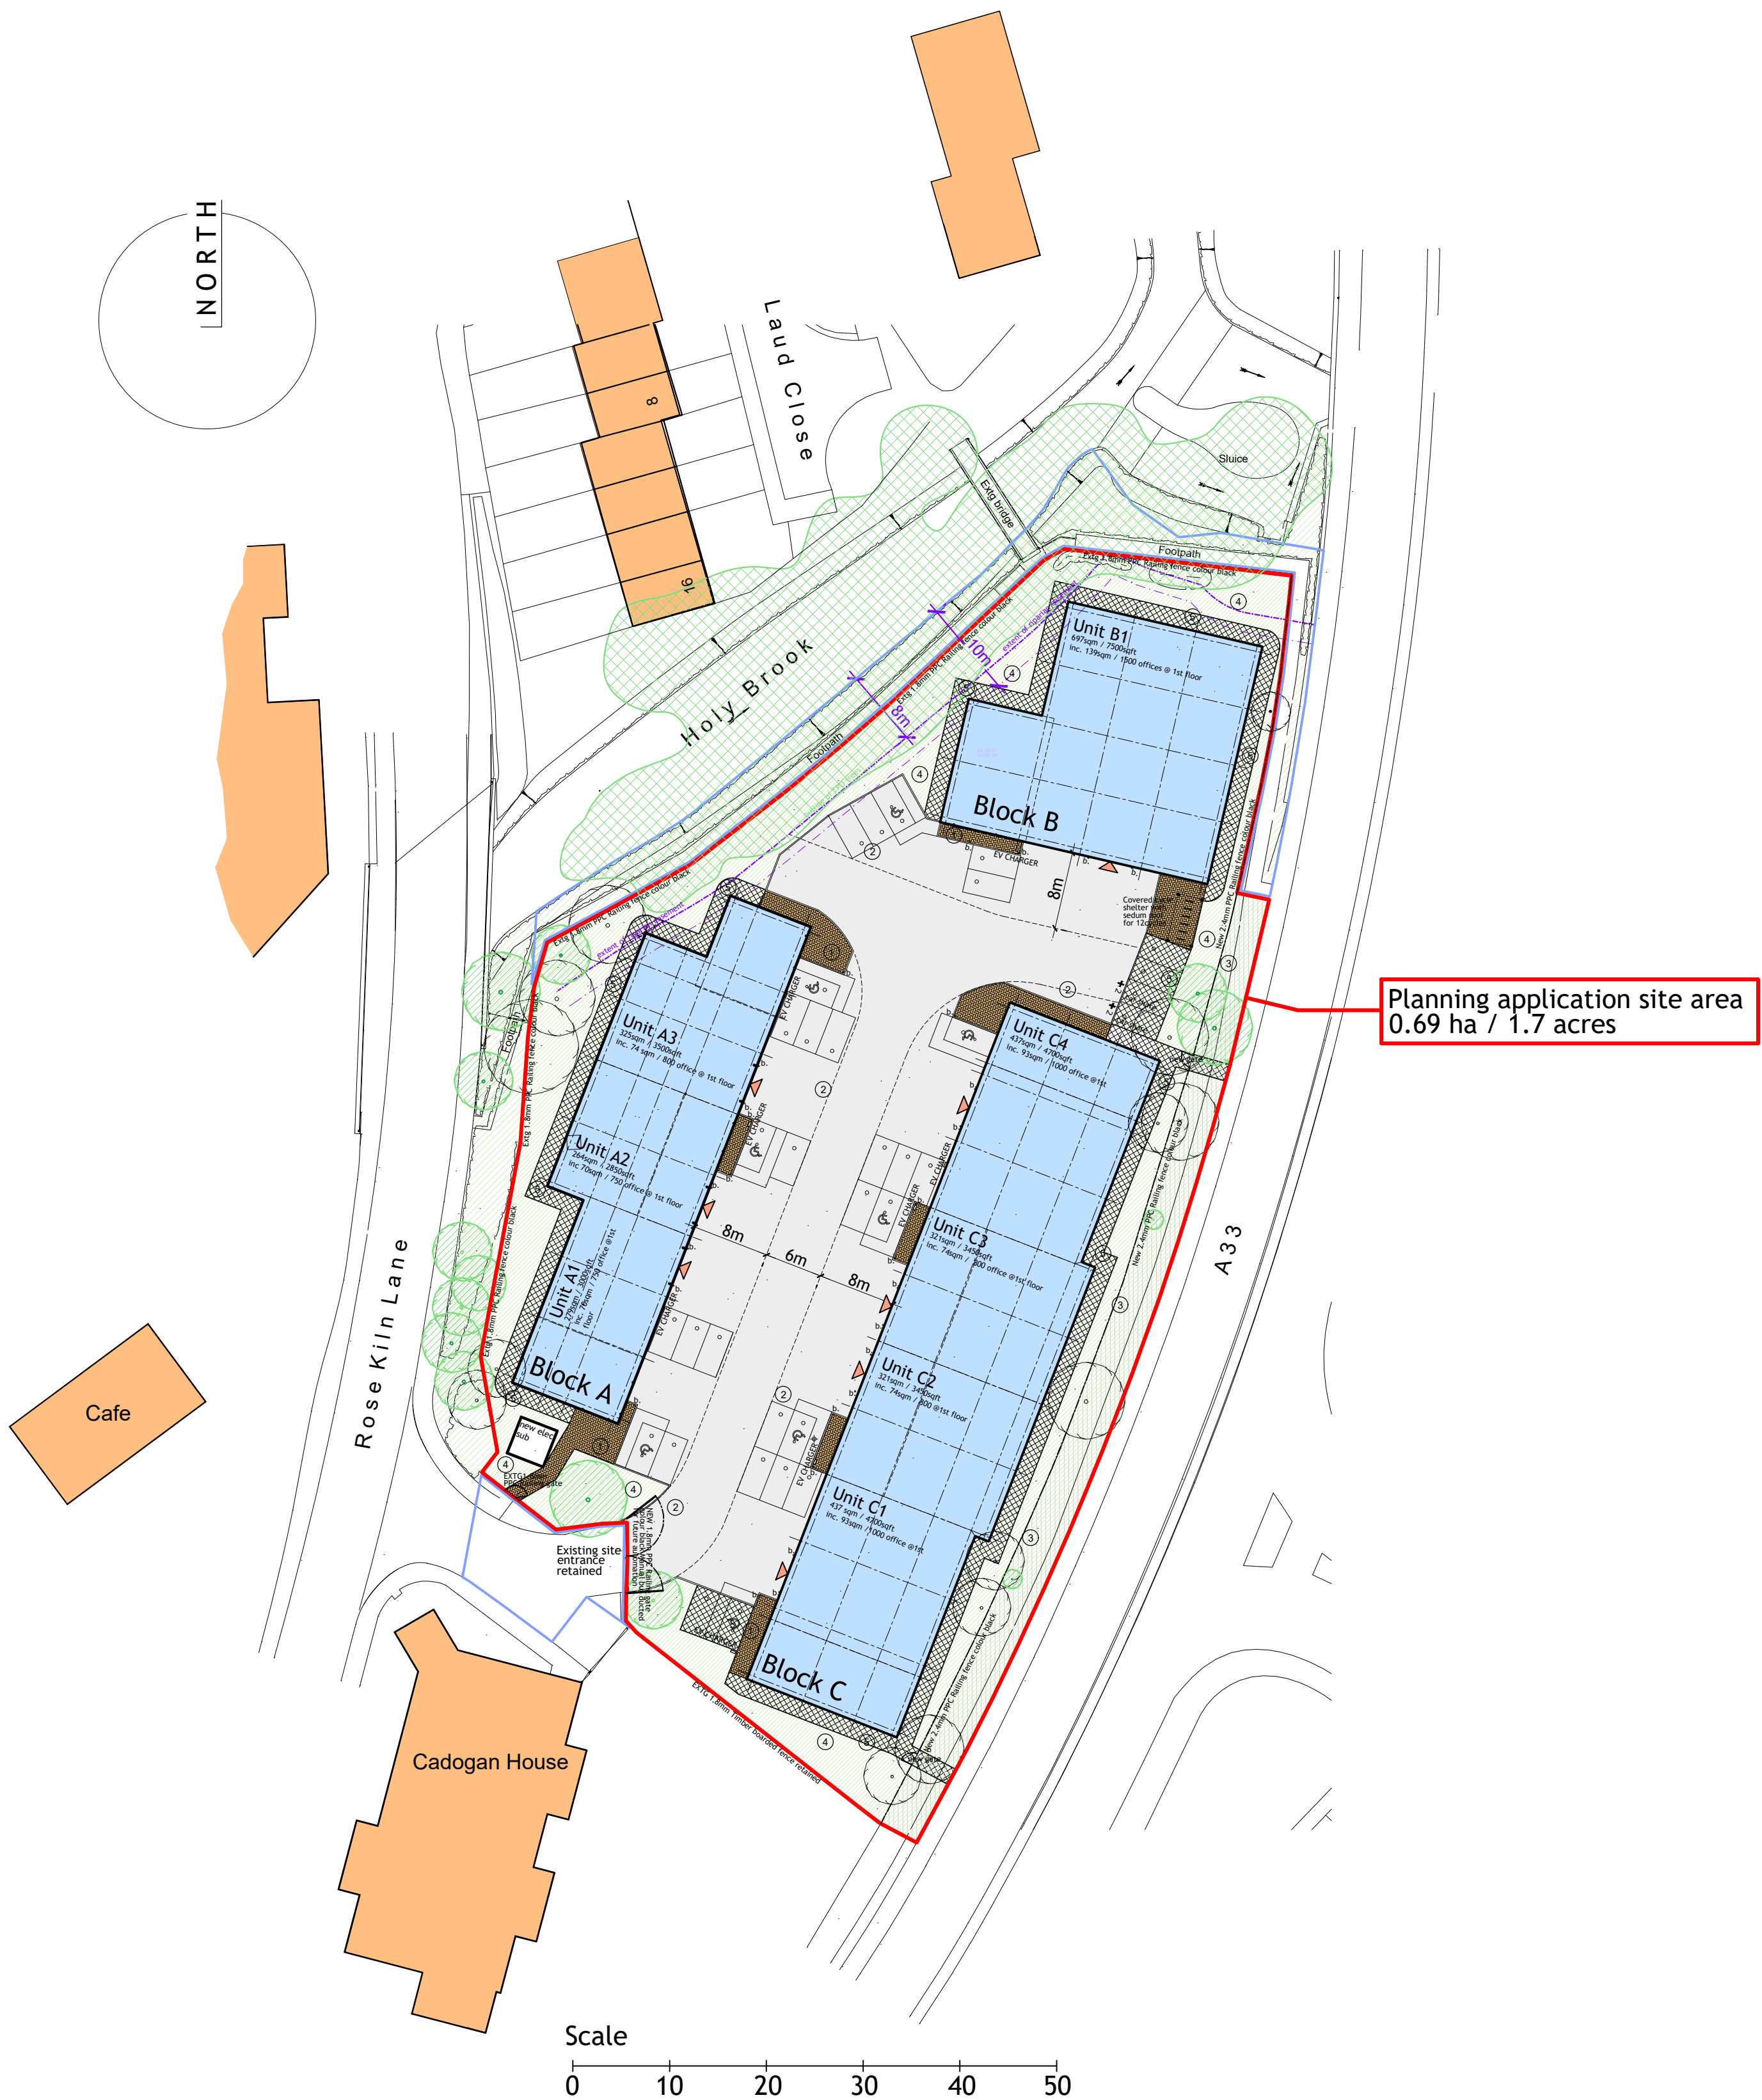
## Drawing 1 - Proposed Development Plan

The Site is proposed to be predominantly covered in buildings and hardstanding with areas of soft landscaping surrounding the peripheries of the buildings and car parking areas. A Proposed Development Plan is included as Drawing 1.

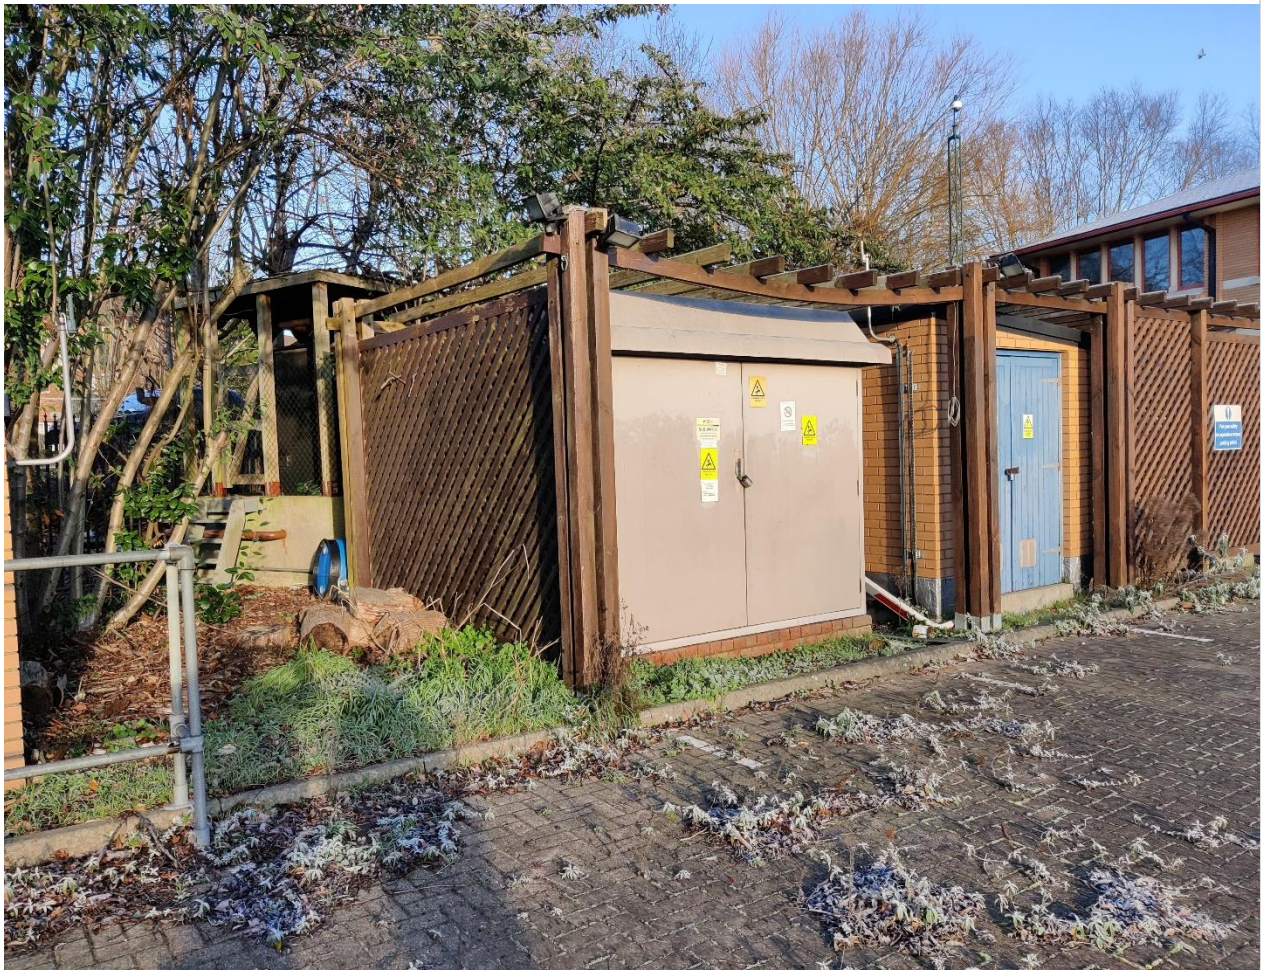
**Plate 1 - Electrical substation and above ground storage tank (AST) on western portion of the Site.**

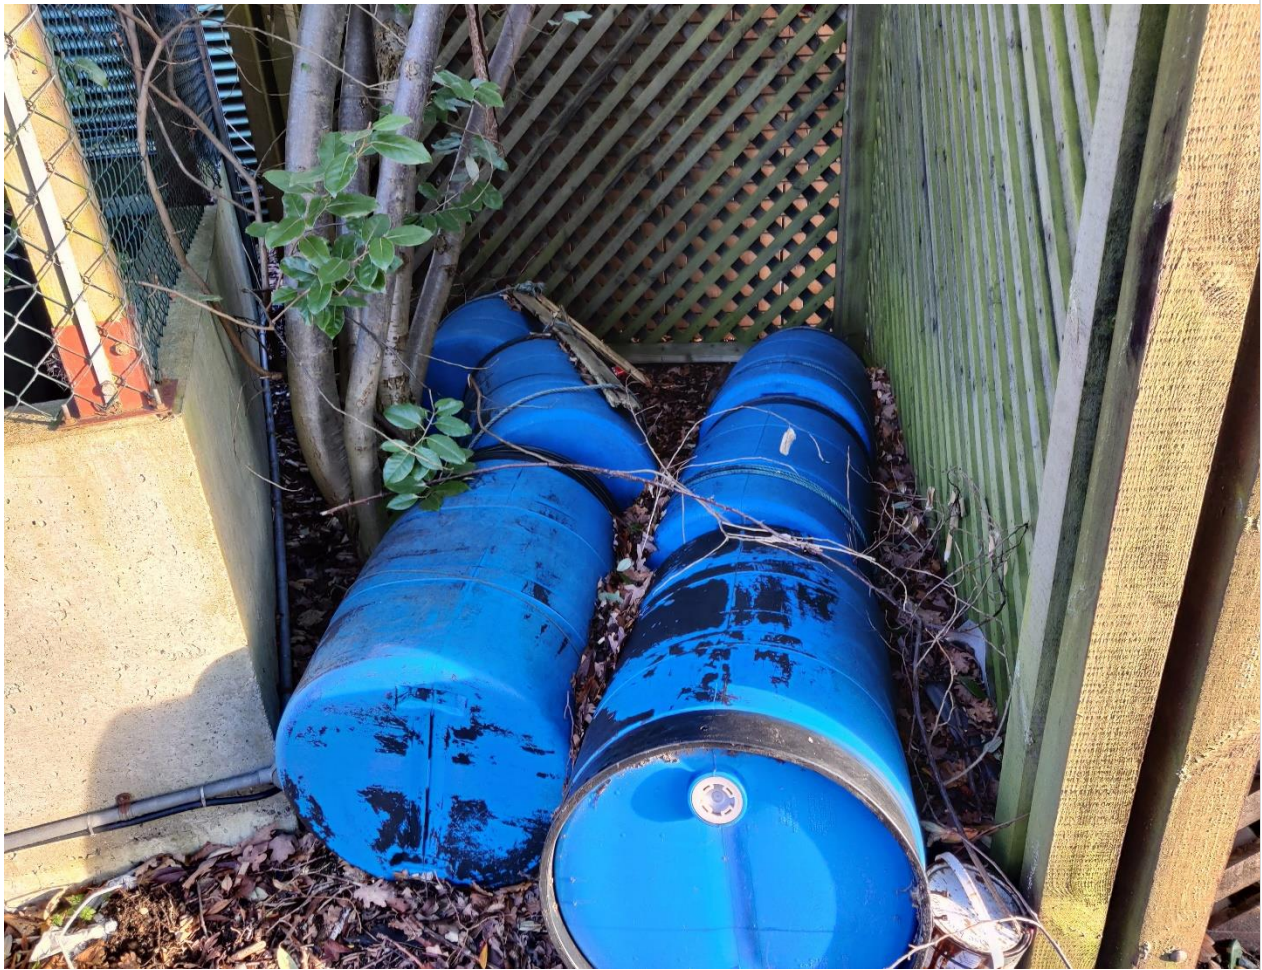
**Plate 2 - Empty drums adjacent the AST.**

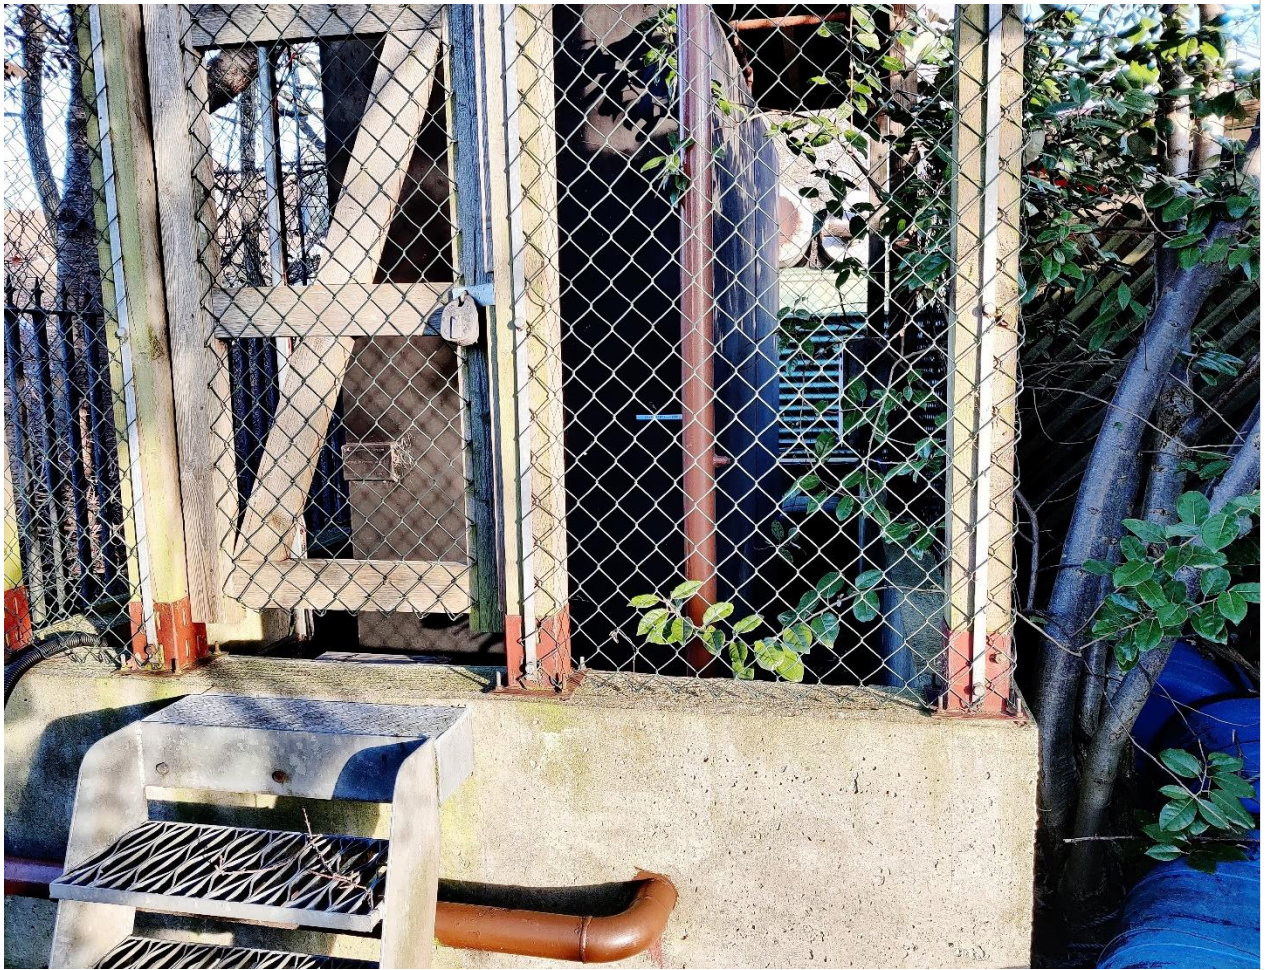
**Plate 3 - Steel banded AST within concrete and wooden building.**

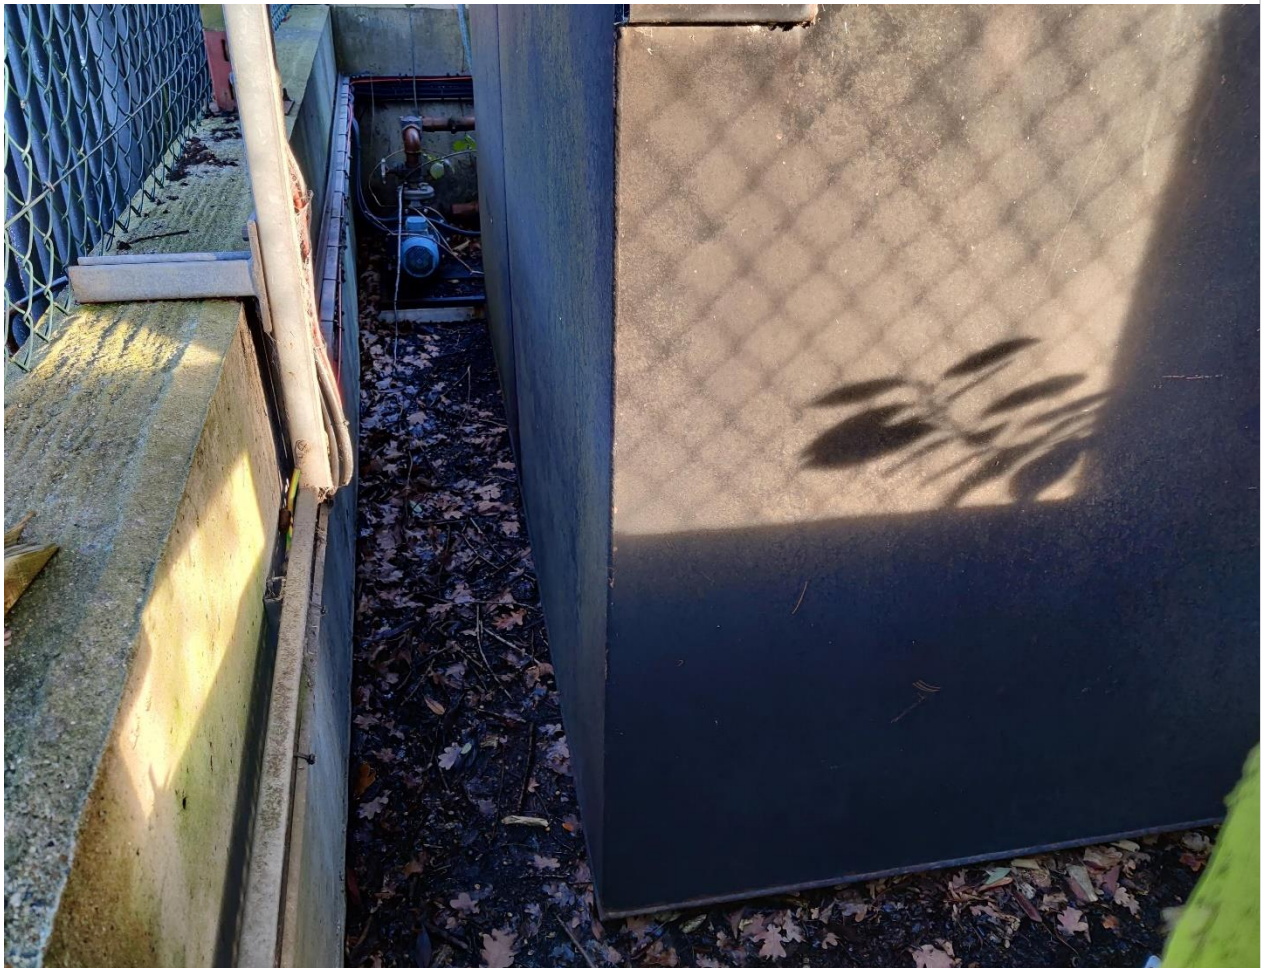
**Plate 4 - Inside AST cage, pump noted at rear of the cage and no evidence of spillages.**

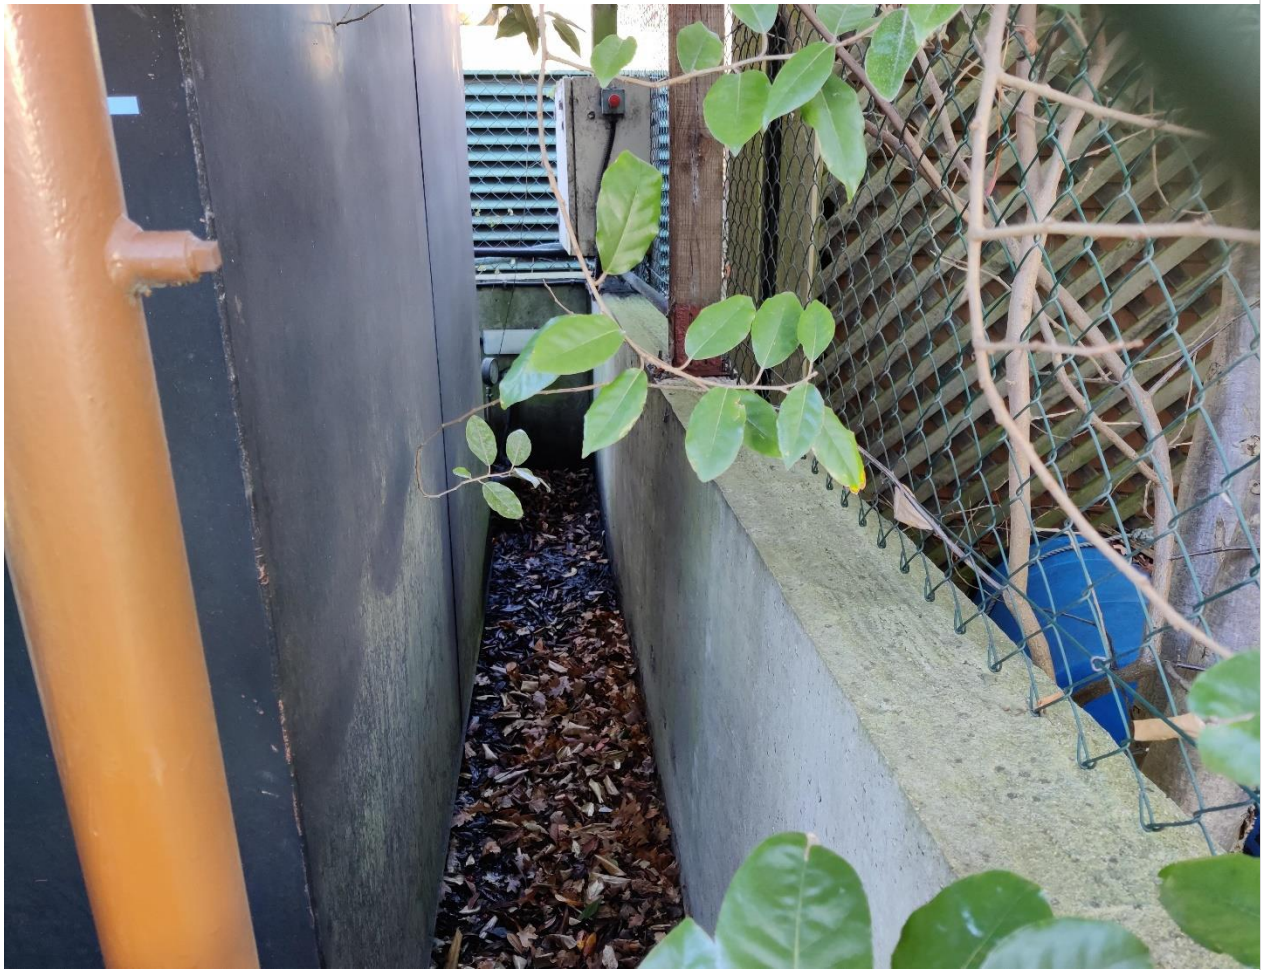
**Plate 5 - Inside AST cage, gauge noted associated with the tank. Water noted on the floor.**

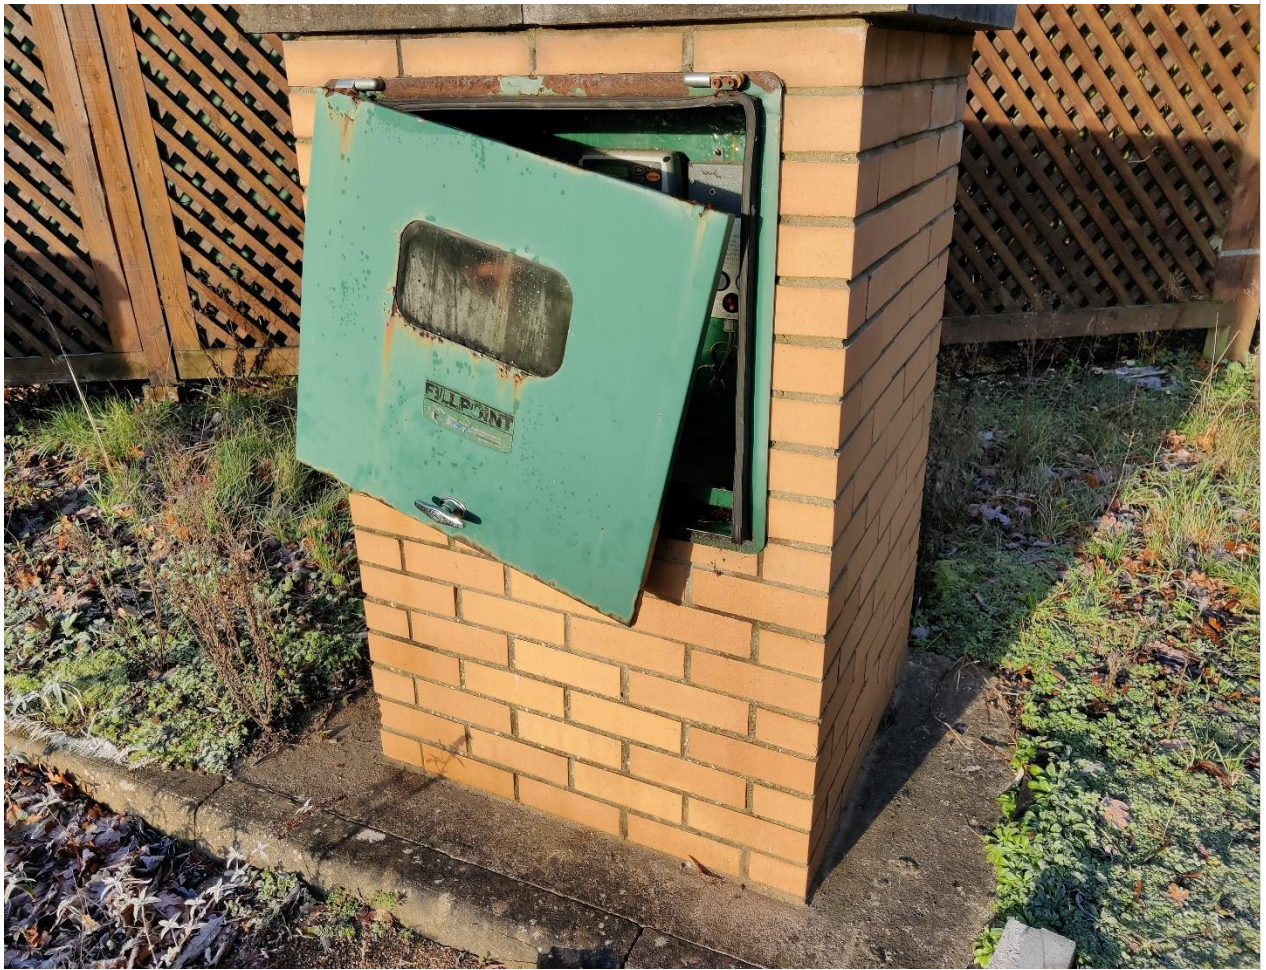
**Plate 6 - Filling point.**

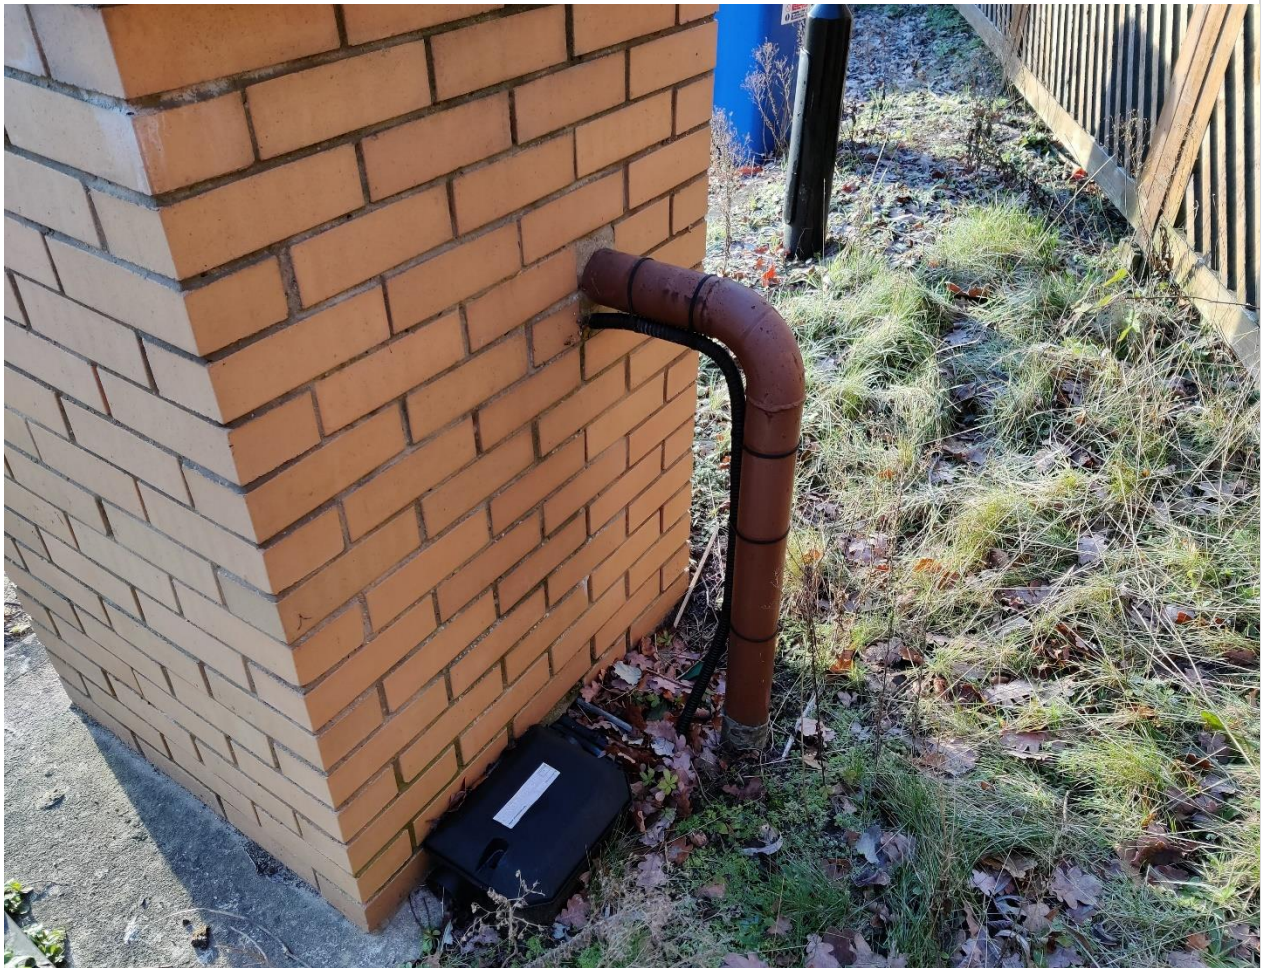
**Plate 7 - Pipe/ducting on the back of the filling point going underground.**
