**FORMER GEORGE AND DRAGON, BATH ROAD, READING, RG30 2HA**

**HERITAGE STATEMENT & BUILDING RECORDING**

**MARCH 2023**

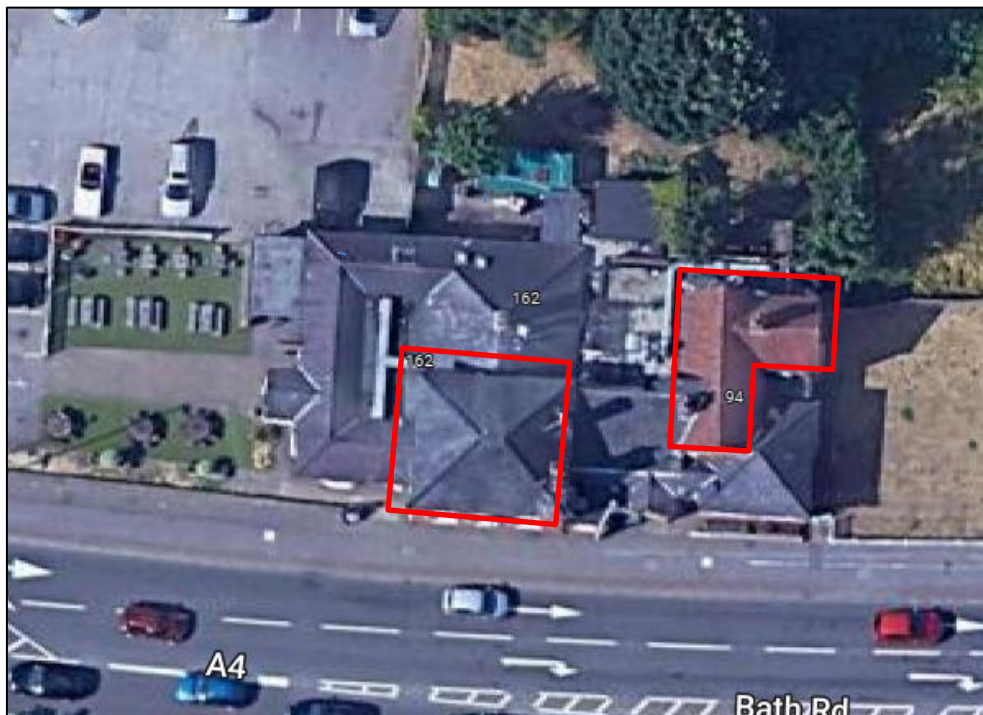
*Plate A – Building Description Site Plan*

- 3.1.5 For the purposes of the assessment of significance and the building recording, the sections of the building which are the focus of the works are identified in red on Plate A below and are referred to within this report as the 'main building' and the 'L Shape building'. Later additions which adjoin the two buildings are discussed where relevant for context.

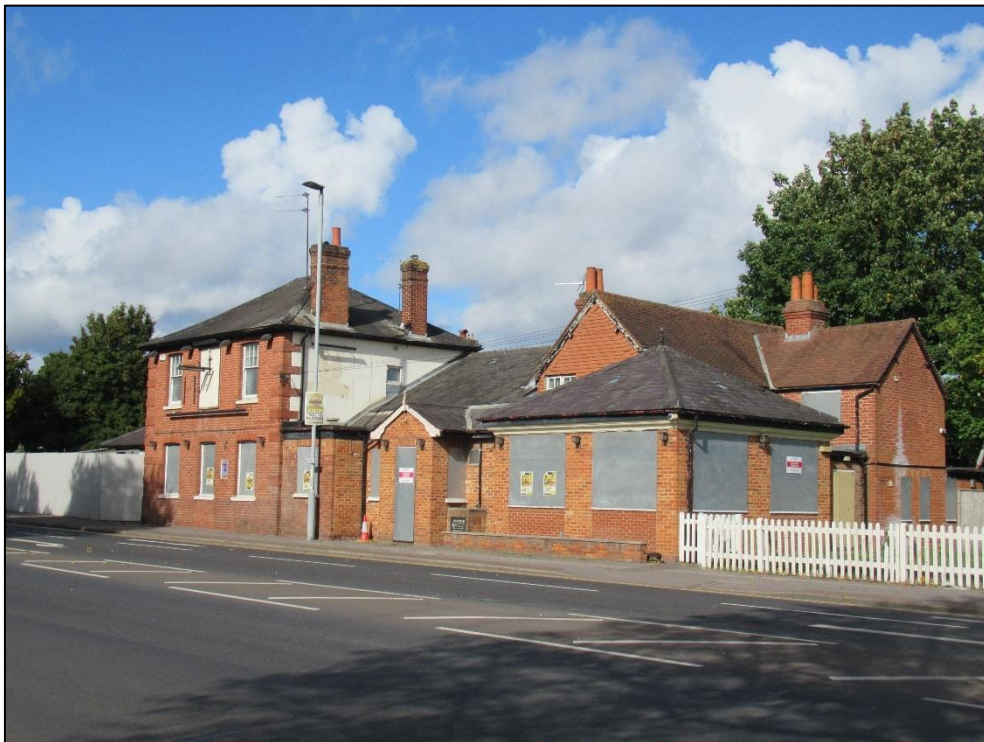
*Plate B – South and east elevations*

- 4.2.12 The first floor of the gabled south elevation of the L shape building is visible above the single storey addition. The elevation is gabled and finished with hung red clay tiles with painted timber bargeboards and exposed purlin feet. A window opening is present positioned off centre to the west and retains a modern timber casement window with side opening and top opening casements. A red brick end chimney stack with corbelled upper courses and two red terracotta pots is present to the west side of the roof projecting through the later, two storey mono-pitch addition. The first-floor south elevation of the short east projecting arm of the L shape building is visible in oblique views of the main south frontage. This elevation displays red brick walls of a similar rich red colour to the main building and a matching Flemish bond brick pattern. A window opening pierces the elevation centrally and contains a modern, timber casement window. The ground of the elevation is abutted by flat roof addition which connects the ground floor to the north elevation of single storey, pyramidal roof addition.

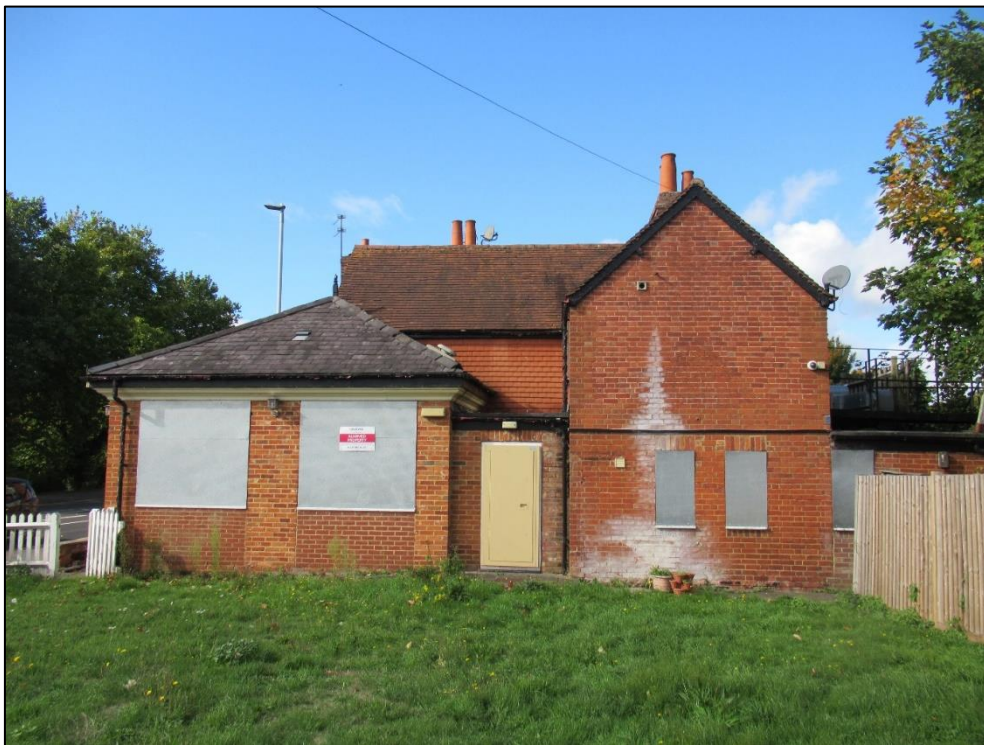
*Plate C – East elevation*

- 4.2.17 The east elevation of the main building is obscured to ground floor level by the later mono-pitch addition which connects the main building to the L shape building. The first floor displays a painted render finish with a small and contains a small, rectangular window opening positioned centrally within the elevation (Plate 15). The opening contains a modern timber window with opaque glazing indicating to the opening serving a bathroom.
- 4.2.18 Two red brick end chimney stacks with corbelled upper stages are present to the east side of the roof. The southern retains a single red terracotta chimney pot. The north stack is smaller in size and of a darker coloured brick to the south stack suggesting it may have been rebuilt.

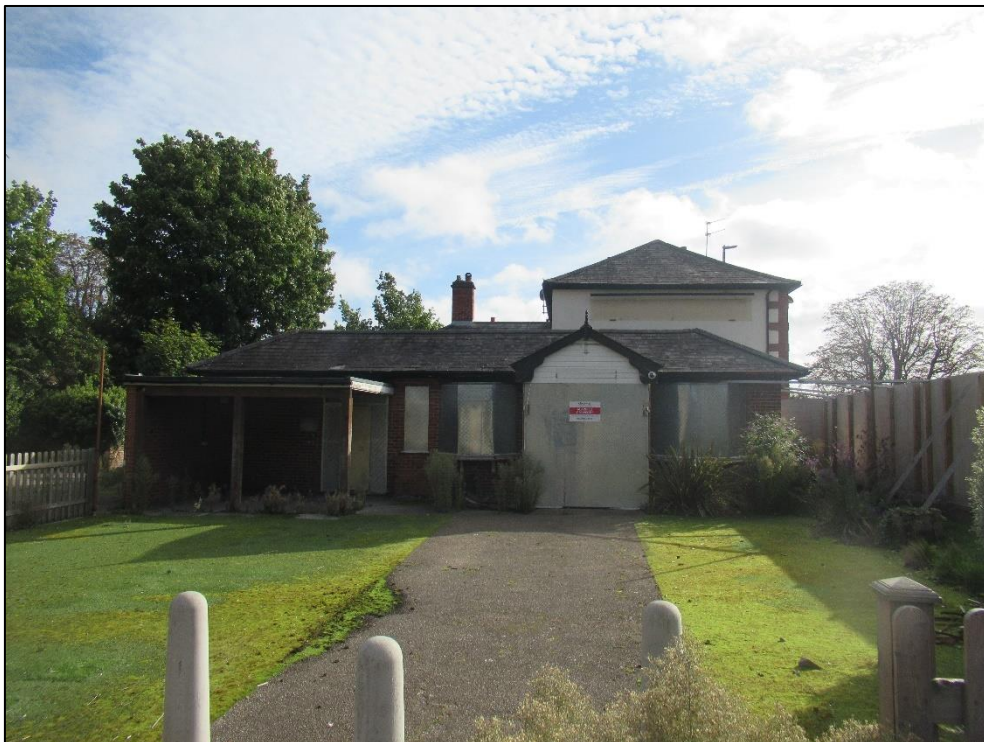
*Plate D – West elevation*

- 4.2.21 The first-floor west elevation of the main building has a painted render finish. A through light and discolouration to the render identify where external signage has previously been sited and since removed following the closure of the pub.

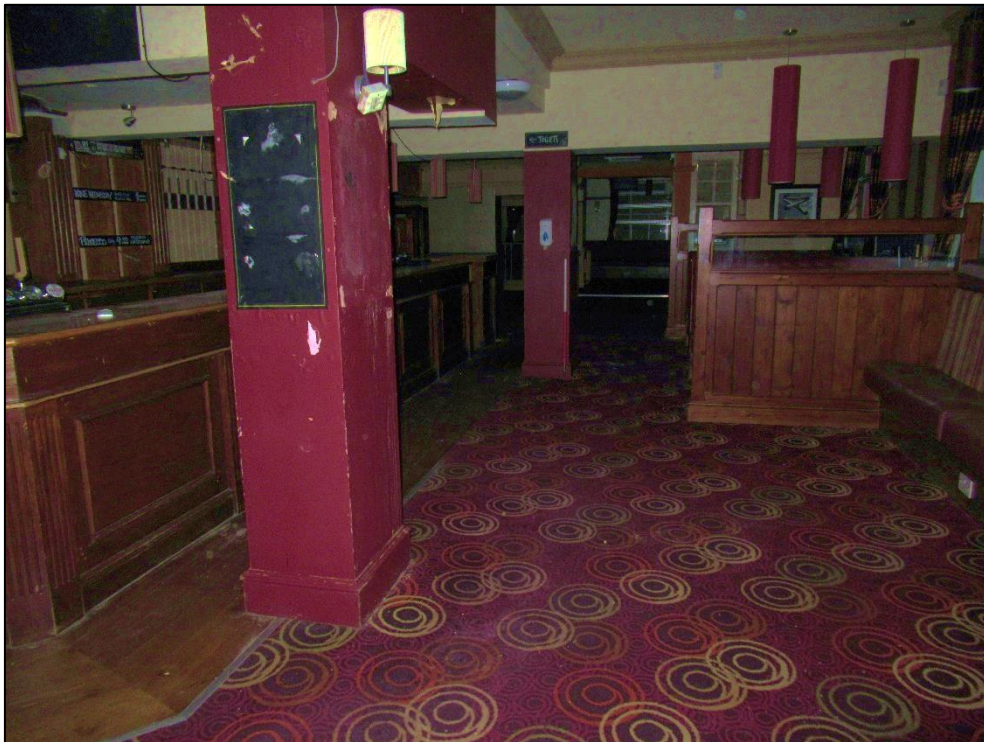
*Plate F – View east through the ground floor of the main building*

and the L shape building (Plates 34 – 36 and 41, 44 and 47). Encased steel beams to the ceiling extending between retained sections of original external wall offer some evidence as to earlier divisions although due to the extent of change this is not readily discernible in the extant arrangement.

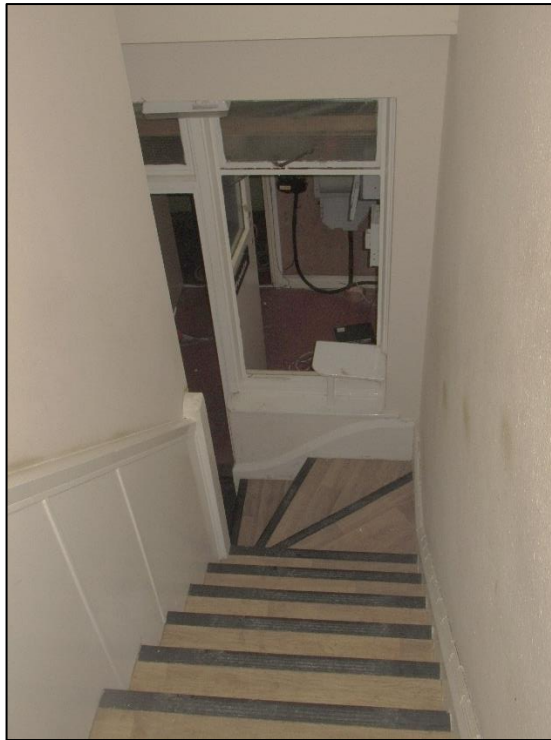
*Plate G – Internal Partition to the staircase*

- 4.3.11 Access to the first-floor accommodation is provided through a small room most recently used as an office. The room is located to the north of the main building and is accessed via a corridor which leads to the WC facilities (Plate 62). The winder staircase is enclosed from the office by a partition wall with retains glazed side panel and fanlight (Plates 64 to 66). The partition is aligned with the original east external wall of the main building and indicates the original extent of the east wall of the mid-20<sup>th</sup> century single addition to the north elevation. The balustrade and newel post of the staircase are partially set within the adjacent partition wall, suggesting the partition is in part a later insertion and that the hallway at the bottom of stairs was previously larger likely extending into the area now occupied by the female WC facilities.

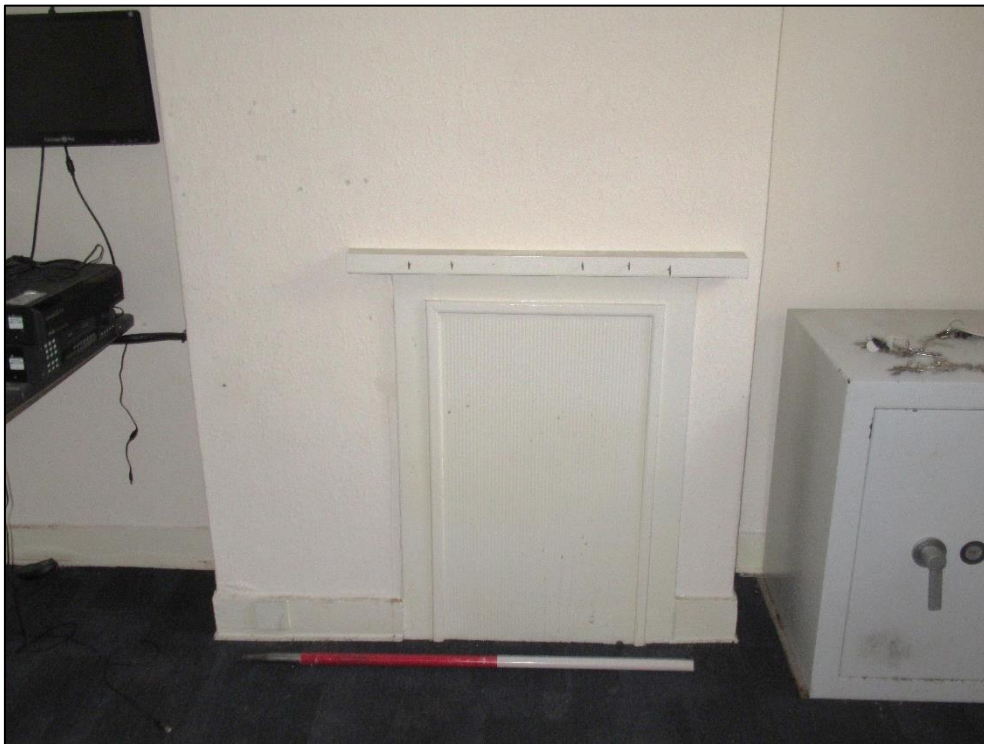
*Plate H – Fireplace and chimney breast to the northwest first floor room of the main building*

- 4.3.13 There are three rooms and a small store cupboard directly accessed from the landing area. The room to the northwest retains a simple fire surround, which is set off centre within a centrally positioned chimney breast (Plate 82). The surround is plain in detail of early 20<sup>th</sup> century character (Plate 83). To the northwest corner of the north elevation is a modern casement window; the position of the window in the wall suggests that the sill height has been raised possibly when the rear hip roof addition was added to the north elevation in the mid-20<sup>th</sup> century. A cupboard is present to the northeast corner of the room (Plate 84). No other features of interest remain to the room.

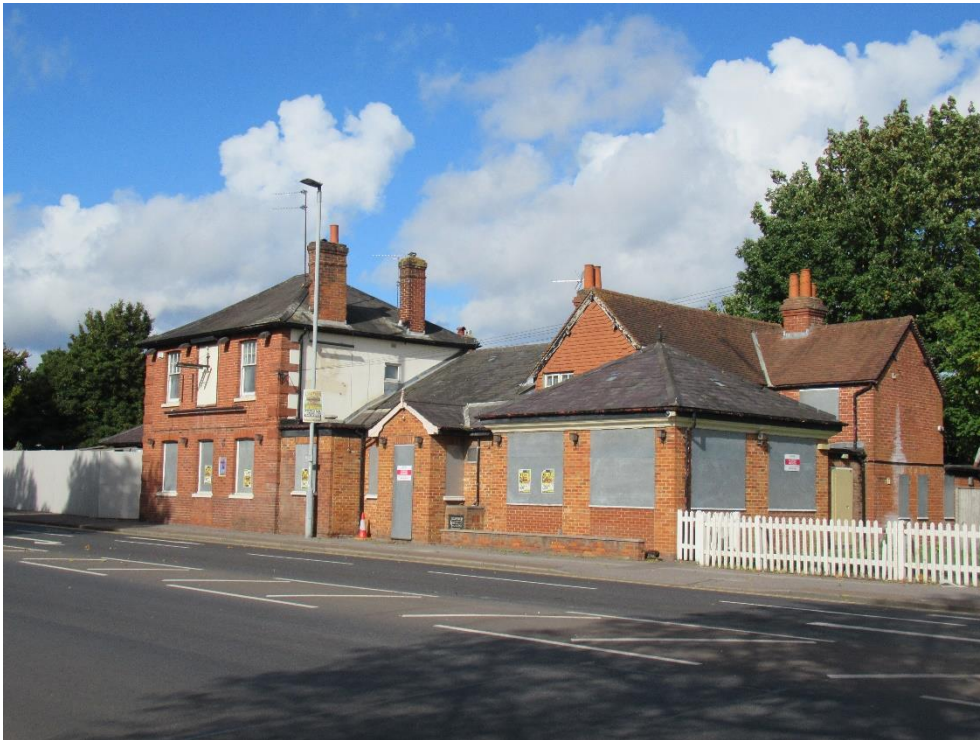
Plate 1 – South and east elevation viewed from Bath Road

- 3.1.6 The extant building complex comprises of the main building, the L shape building and a series of two-storey and single storey extensions which have resulted in a large, multi-phase building complex (Appendix 3, Plate 1).

- 4.2.1 The building from the exterior presents as a large, multi-phase building predominantly of red brickwork construction with a mix of slate tile, red clay tile and flat roof coverings (Plate 1). The main building and the L shape building extend to two storeys in height with a range of later, single storey additions also present. The building occupies a large, rectangular type footprint positioned off centre to the east within the wider Site. The principal frontage faces south onto Bath Road and is set directly adjacent to the rear edge of the footway.

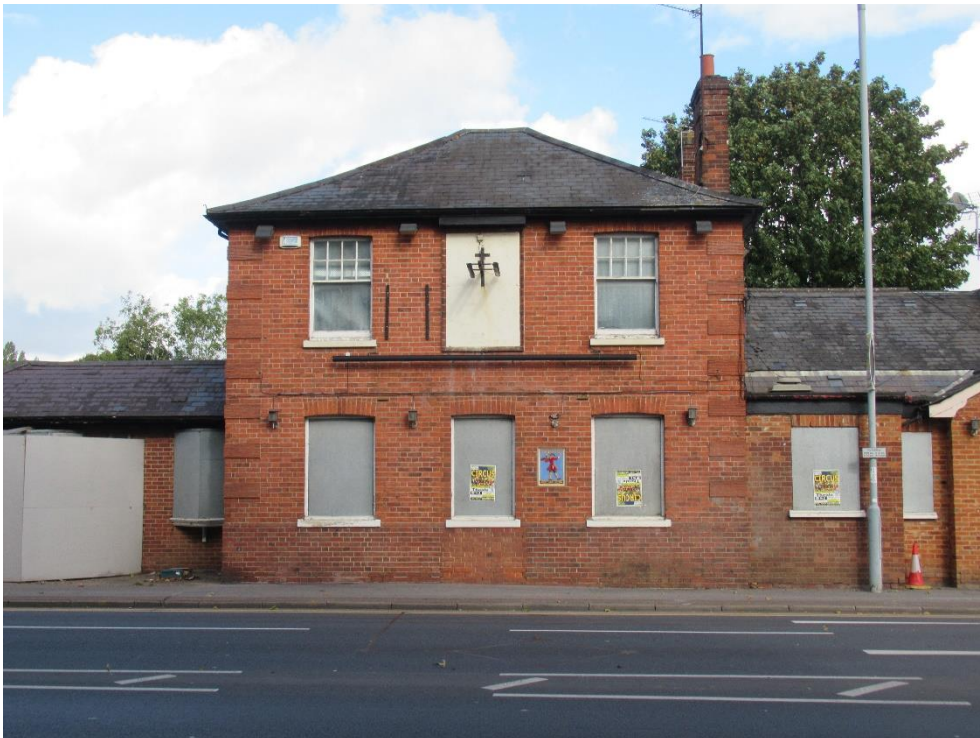
Plate 2 – South elevation of the main building

- 4.2.2 The south elevation as a whole presents a multi-phase, red-brick elevation which directly abuts the rear edge of the adjacent footway.
- 4.2.3 The south elevation of the main building is of rich coloured red brick construction laid in a Flemish bond pattern (Plates 2 and 3). The east and west corners of the elevation are detailed with slim, red brick tile quoins which are three brick courses in height and which are laid at five brick course intervals (Plate 6). A deep red brick plinth is present with a slight canted edge running level with the ground floor window sills.
- 4.2.4 The elevation extends to two storeys in height with a slate tile covered hip roof which has slightly oversailing eaves. The hip ridges are finished with butt jointed, slate coloured ridge tiles.

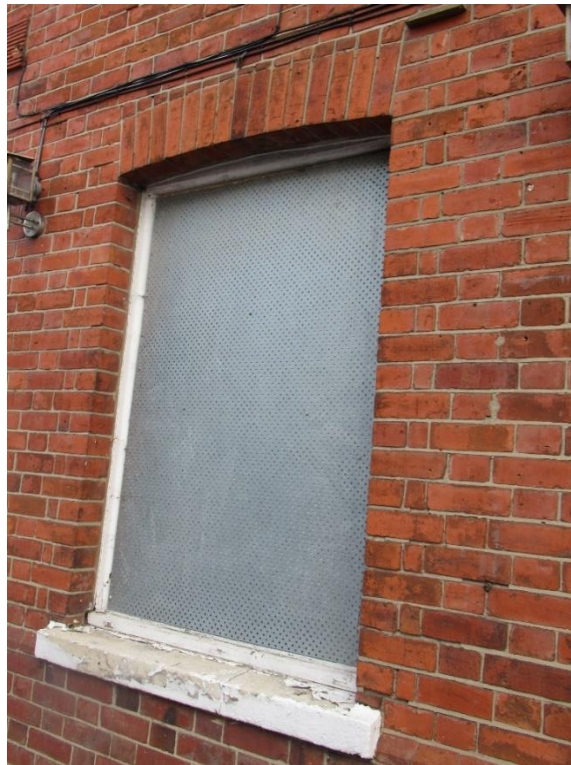
Plate 5 – Typical window head and sill detail to the window openings on the south elevation of the main building

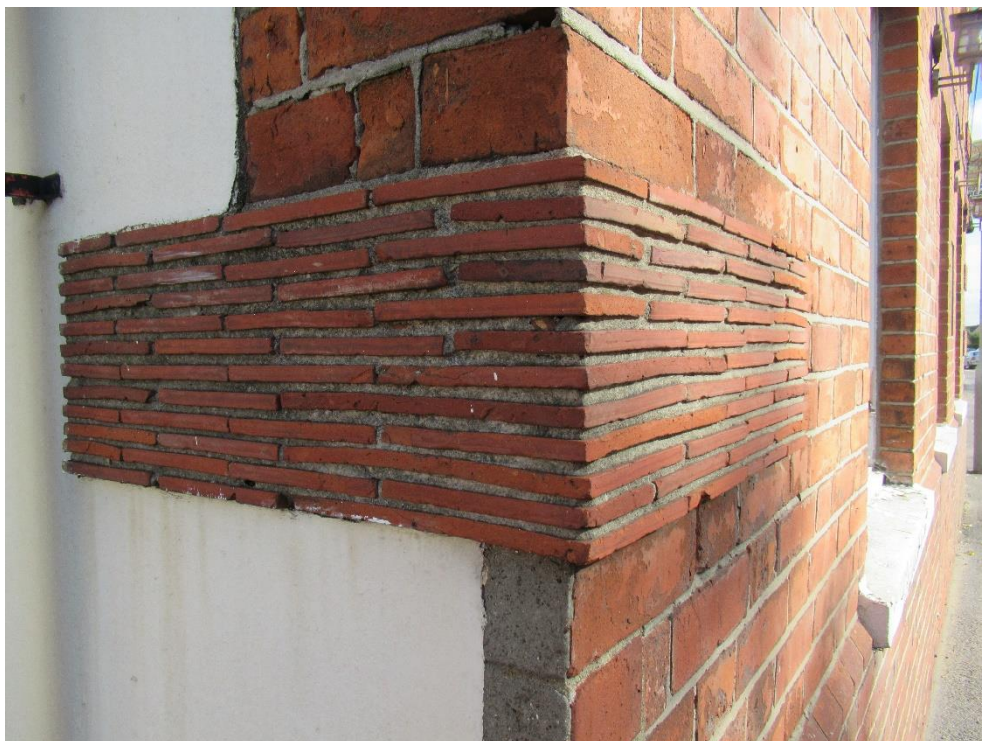
Plate 6 – Quoin detail present to the east and west corners of the south elevation of the main building

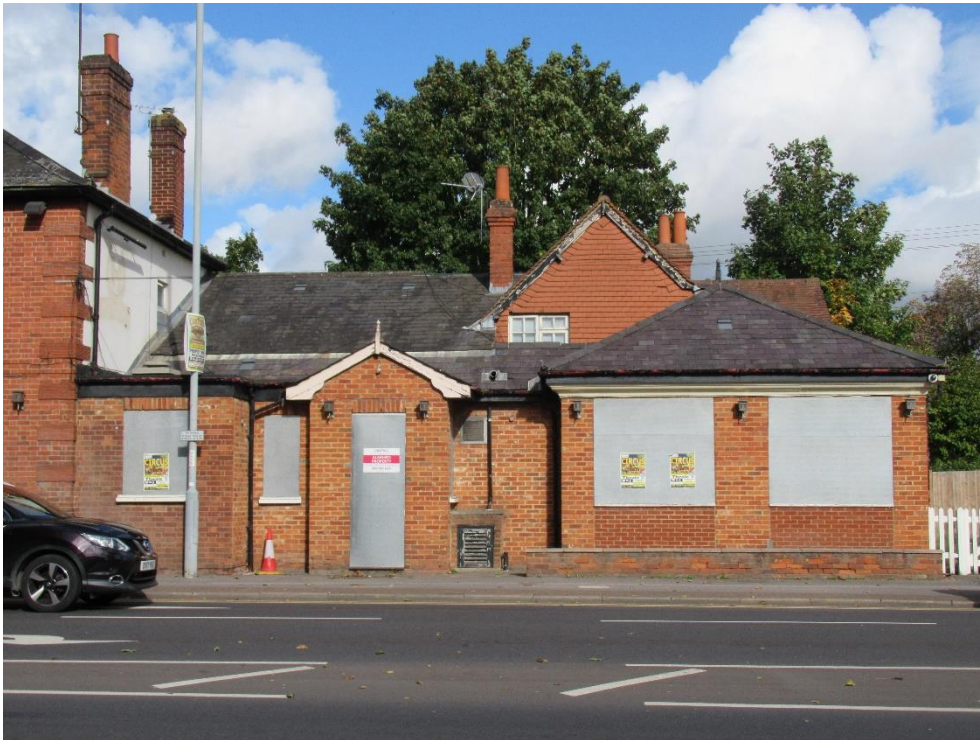
Plate 7 – Additions to the east of the main building; gabled form of the first floor of the L shape building visible to right of centre

- 4.2.9 To the east, the main building is adjoined by a series of extensions which range from two storey to single storey in scale and which vary in roof form (Plate 7). To the south, abutting the footway are a series of single storey additions. Directly abutting the east elevation of the main building is a small, square addition of red brick work laid in a Flemish bond pattern with a flat roof covering with concealed timber window set under a brick wedge lintel and with painted stone sills (Plate 8). A joint visible to the brickwork of the east elevation of this small addition suggests it has partially been rebuilt. Set back from this flat roof addition is a porch addition. The porch displays red brick work laid in a stretcher bond pattern which evidences that the porch and the flat roof addition are not contemporary and form to separate phases of extension. The

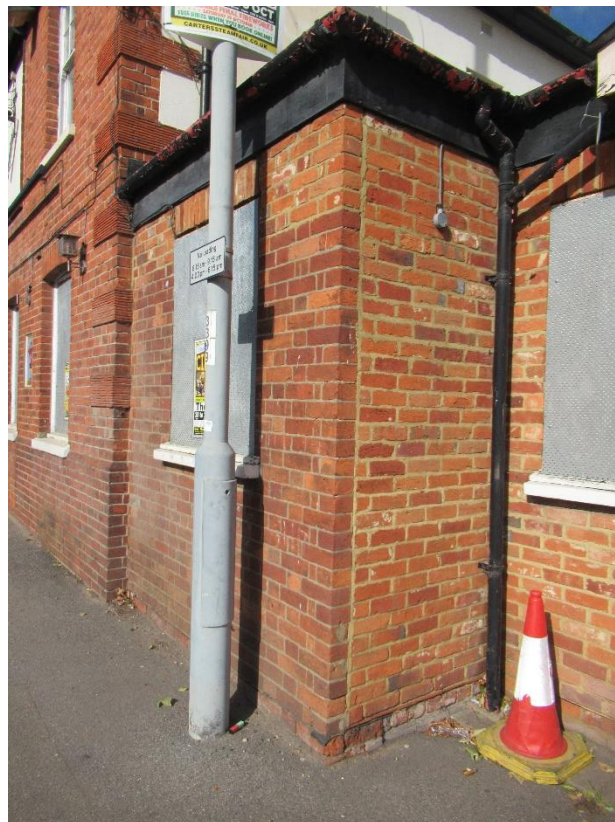
Plate 8 – LateE flat, roof single storey addition to the east

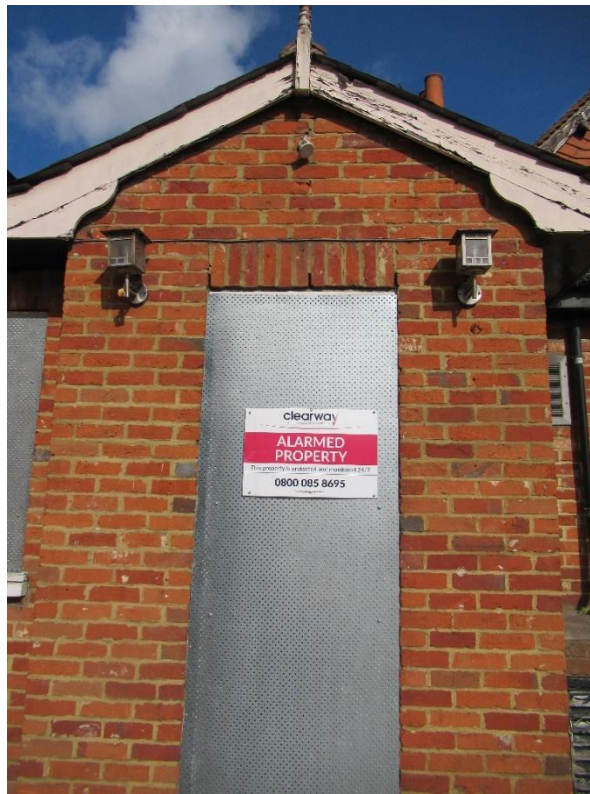
Plate 9 - Gabled porch addition to the east facing onto Bath Road

externally boarded-up entrance is defined by an advanced gable with timber bargeboards and finial (Plate 9). The door opening is centrally positioned with solid course header detail. Flanking the porch to the west is a small window opening with timber window and solid course head and painted sill. To the east return of the gabled porch is matching small window opening with a timber window frame and solid course head and painted sill. These additions increase in scale in a northwards direction, where a single storey lean-to slate tile roof has been altered to adjoin a steeper mono-pitch slate roof which rises to two-storeys in scale and which adjoins the east side elevation of the main building and the west side elevation of the L shape building (Plate 7).

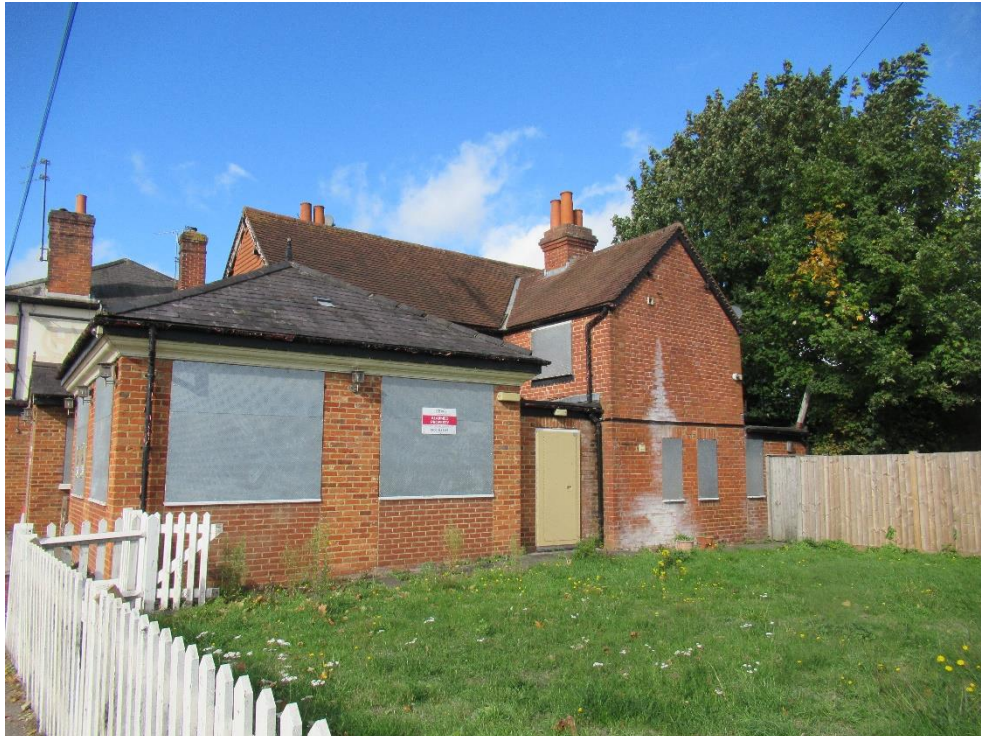
Plate 10 – East elevation

- 4.2.10 To the east again is a further single storey addition which has been constructed directly in front of, and which has encapsulated, the ground floor of the south elevation of the L shape building. The connecting roof between the porch and the east addition is mono-pitch and partly obscures a first-floor window opening to the L shape building. The single storey addition is set back slightly from the rear edge of the highway behind a section of low, red brick wall. The addition has a slate tile covered pyramidal roof which is set on deep moulded eaves (Plate 10). The summit of the roof is decorated with a timber finial.

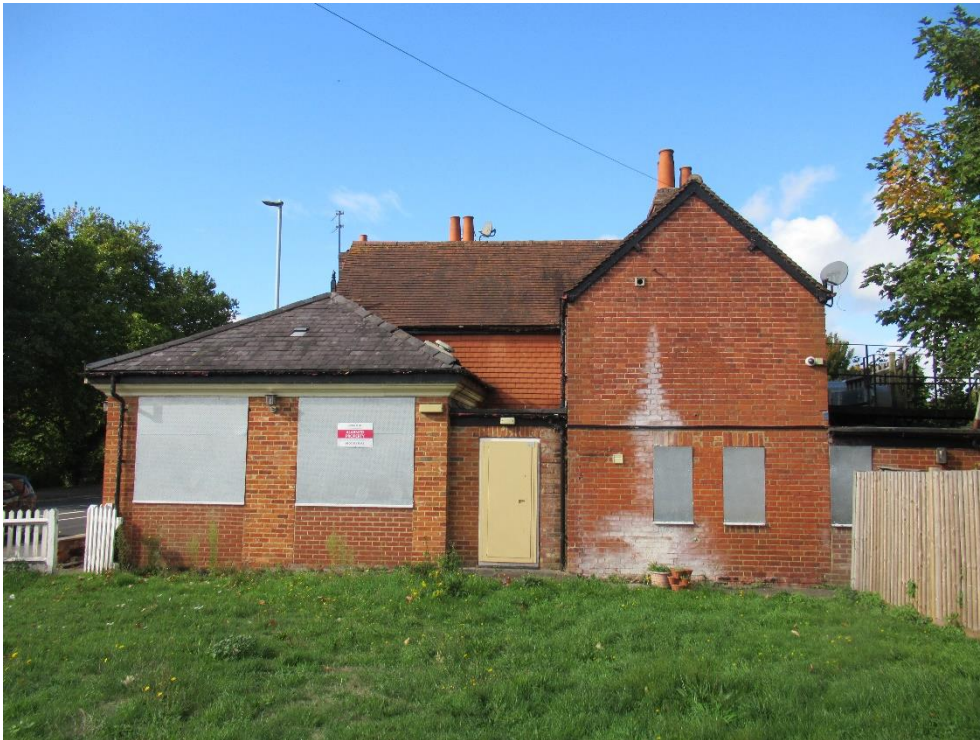
Plate 11 – East elevation

- 4.2.14 The multi-phase nature of the building is expressed by the east elevation and comprises of the pyramidal, single storey addition, and a flat roof link addition which services as a rear porch retaining a door opening set under a solider course head (Plate 11). The east elevation of flat pyramidal roof addition display the same pattern and detail of fenestration as that on the south elevation (Plate 12).

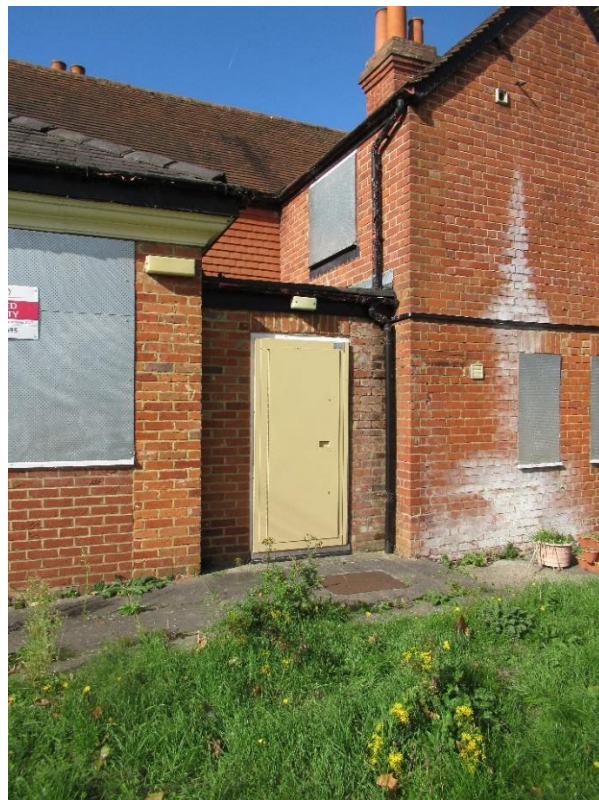
Plate 14 – Part south and west elevation of the L shape building with infill addition to the ground floor

- 4.2.16 Hung, red clay tiles are visible to the east elevation longer arm of the L shape building above the later addition (Plate 14).

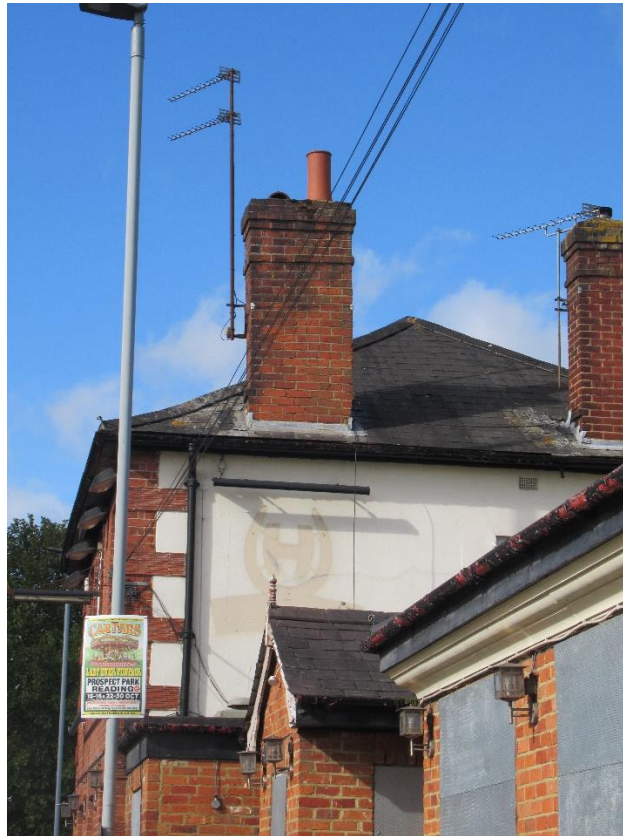
Plate 15 – First floor east elevation of the main building

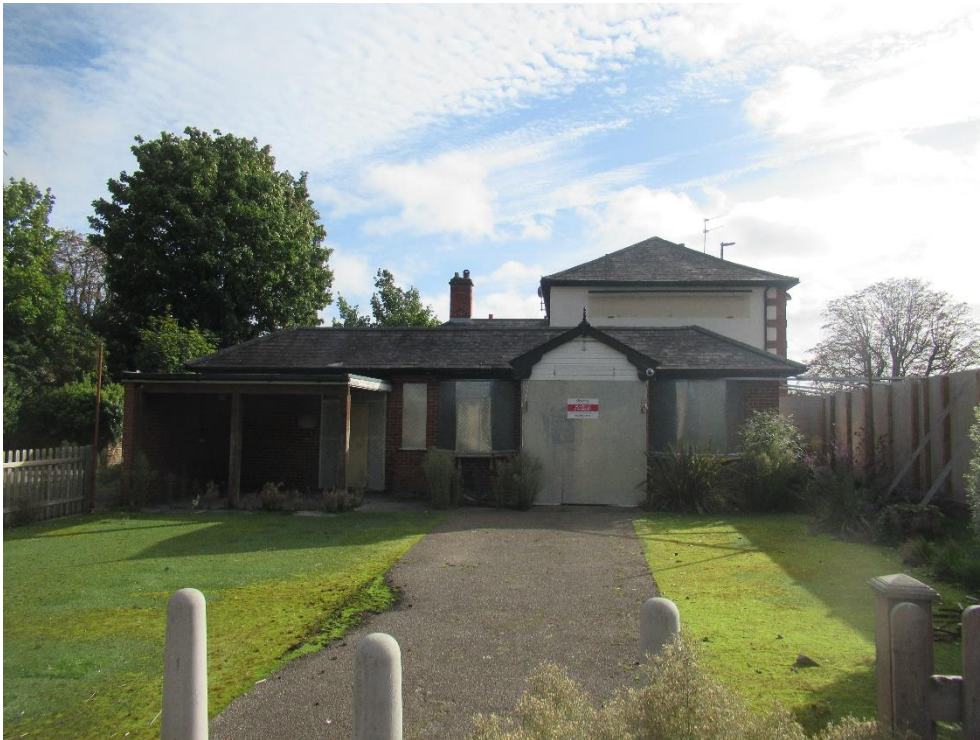
Plate 17 – West elevation

- 4.2.19 The west elevation fronts a small external seating area enclosed from the carpark area by picket fencing to the west and north and a low red brick boundary wall to south (Plate 17).
- 4.2.20 The elevation consists of a later single storey hip-roof addition which adjoins and which obscures the ground floor elevation of the main building. Historic mapping from the 1962 suggests that the extant addition replaces a previous, smaller addition depicted to the west elevation. The addition is set back slightly from the south frontage of the main building and extends north into the site well beyond the original extent of the north elevation of the main building. A smoking shelter has been added

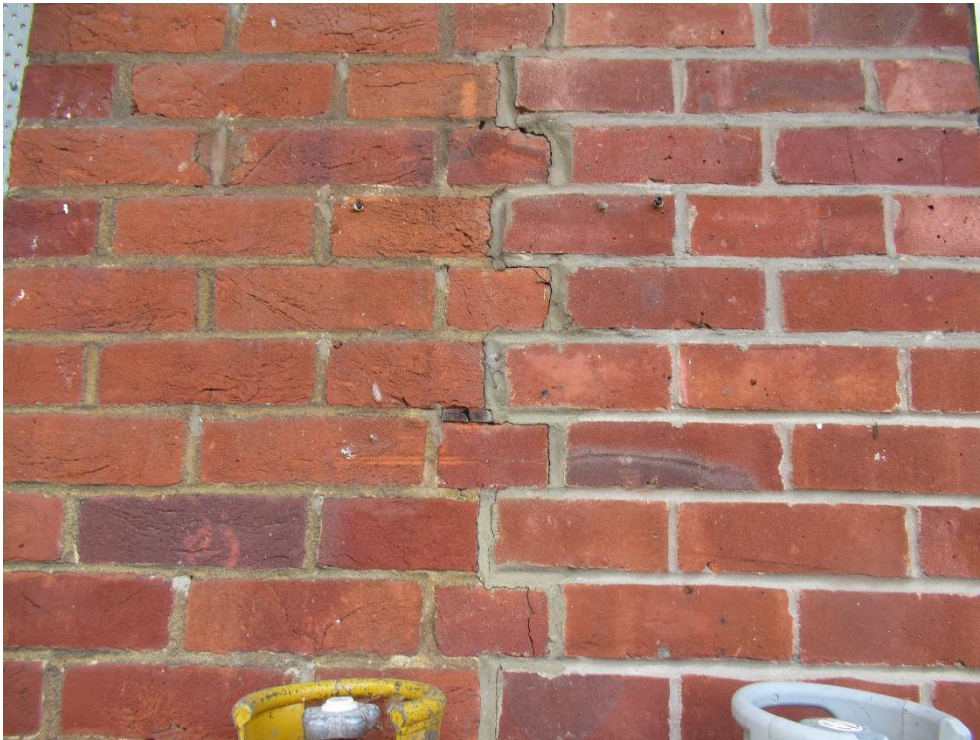
Plate 21 - Joint in brickwork visible on the north elevation between the mid-20<sup>th</sup> century addition to the north and later 20<sup>th</sup> century addition to the northwest corner and west

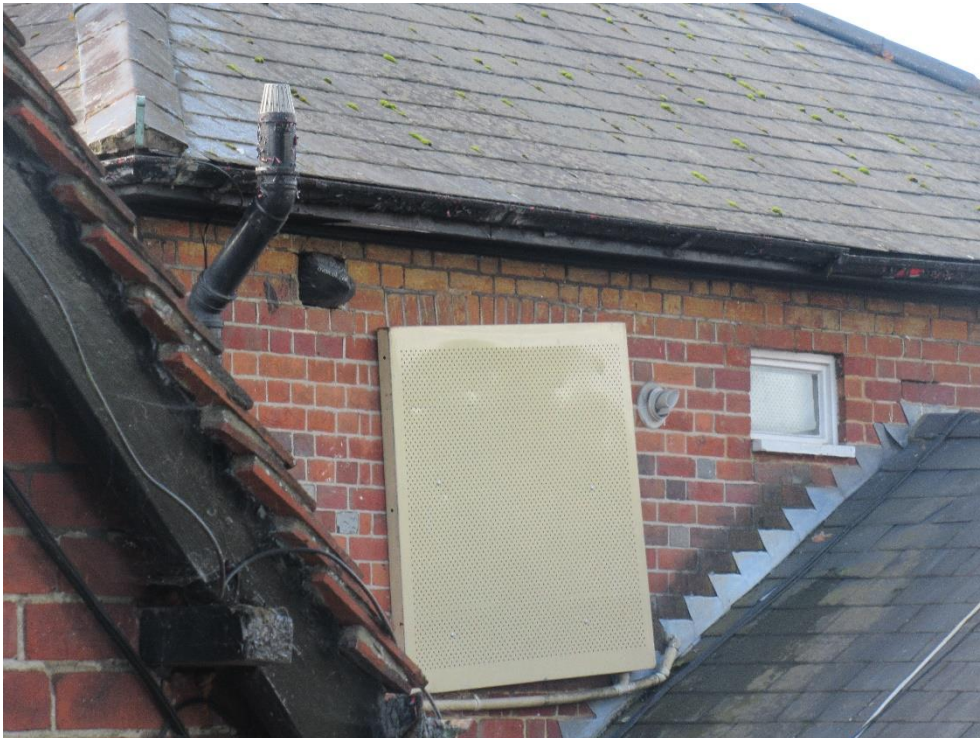
Plate 24 – North elevation of the main building showing infilled opening and change to the brickwork to the upper courses

- 4.2.30 Just below the eaves level, the uppermost two courses of brickwork are of a lighter, orange colour and have been pointed in a darker mortar. This may be indicative that the roof has been raised at some point or that the upper courses have been rebuilt as part of previous repairs to the roof. A small window opening with modern window has been inserted to the east of the centre of the elevation (Plate 24 and E below).

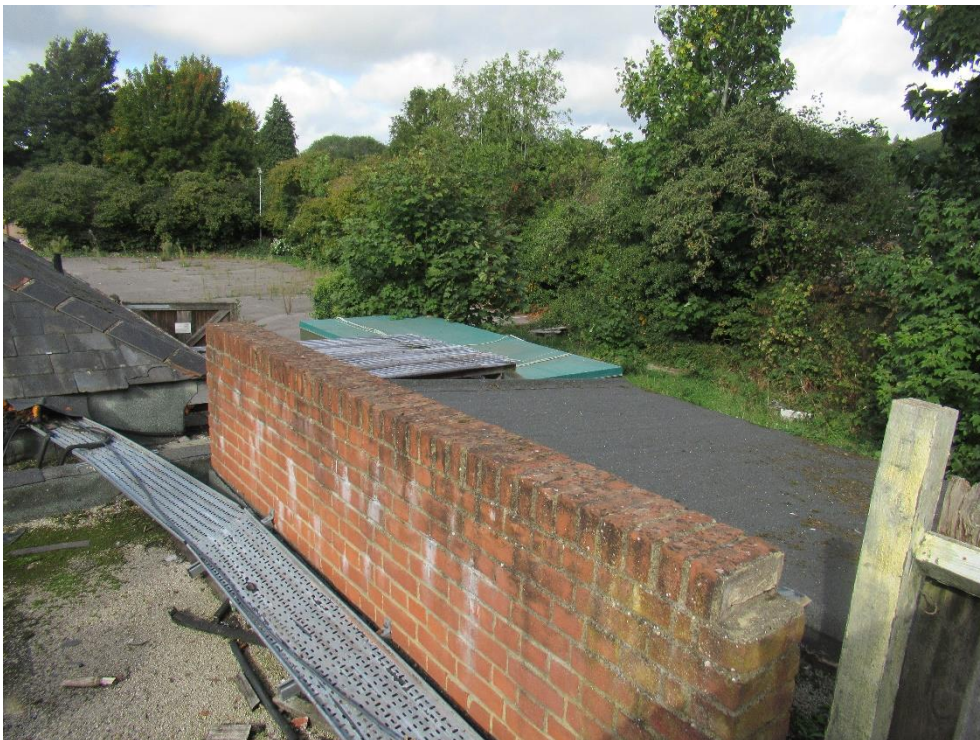
Plate 26 - Brick parapet between a later flat roof addition to the north and the flat, felt covered roof of the garage addition

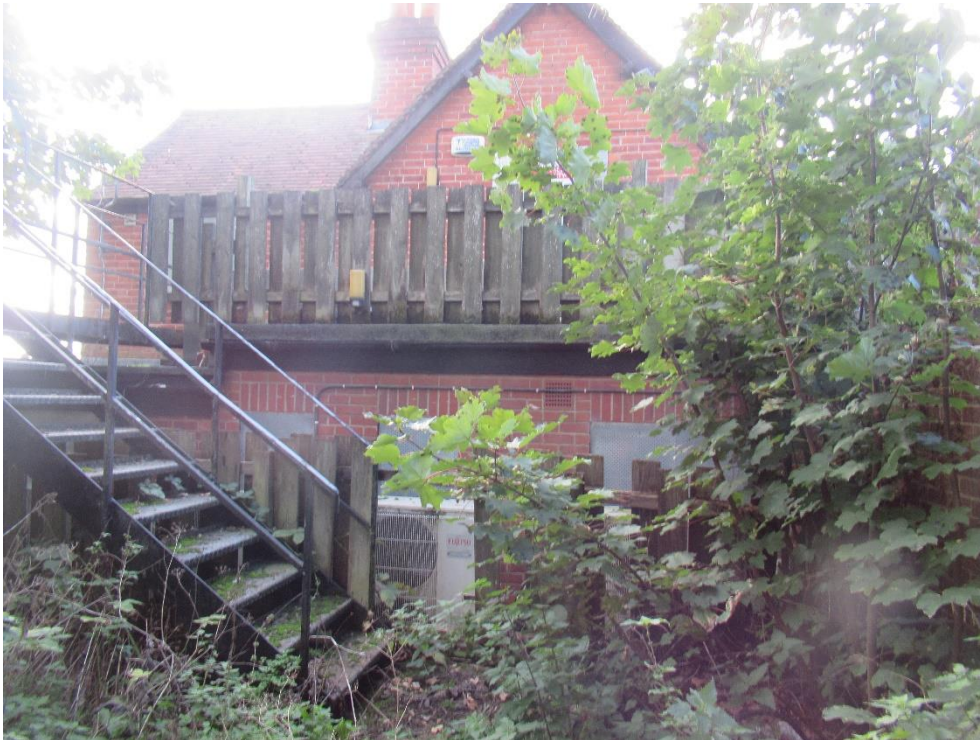
Plate 29 -North elevation showing later addition to the L shape building

- 4.2.24 The ground floor elevation has been extended with flat roof additions is of red brickwork laid in a stretcher bond pattern (Plates 29 and 30). An external metal stair provides access to the flat roof and the first-floor door opening within the north gable end of the L shape building. A series of small window openings with brick soldier course heads are present, which overlook a small timber-fence enclosed yard area that contains AC units.
