## PRELIMINARY BAT ROOST AND BREEDING BIRD APPRAISAL

126 BLANDFORD ROAD, READING  
RG2 7JJ

Date: 9<sup>th</sup> May 2023

Client: Kris Navaratnam

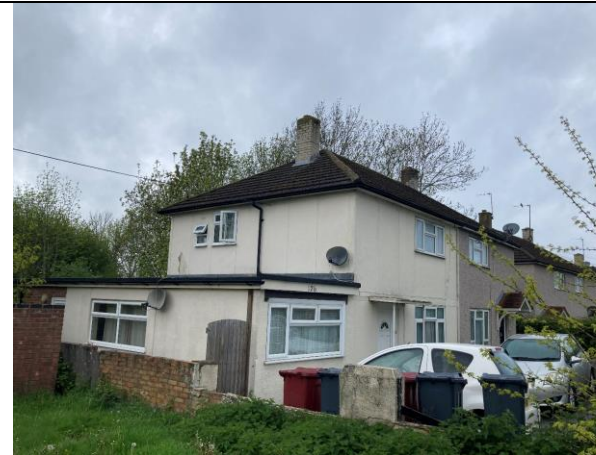
3.1.1 The building was a semi-detached, double-storey structure that appeared to have perhaps been built during the mid-twentieth century and was constructed of concrete. The house had a hipped roof clad with concrete interlocking roof tiles. Generally, the roof appeared to be in good condition; all tiles, lead flashing and soffits were well-sealed and showed no PRFs.

| Photo 1 East elevation | Photo 2 Sealed roof |

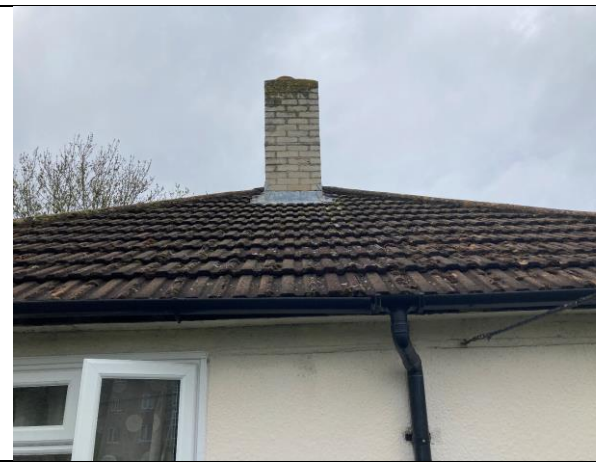
3.1.4 Inside the roof void it was found that the roof was lined with bitumen felt and the loft floor insulated. Some cobwebbing was present at the hip junction, however generally the roof was cobweb free, and this was considered to be due to the well—sealed nature of the roof rather than caused by animal movements. The loft floor was clean except for a layer of dust, and no evidence of bats or breeding birds was present.

| Photo 3 Sealed roof | Photo 4 Light cobwebbing at hip junction |

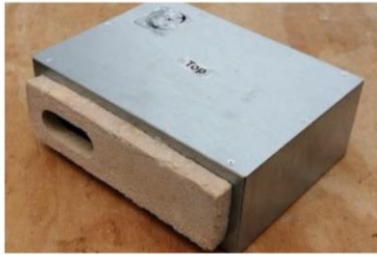
Brick Slip Facing 100mm Cavity

4.4 It is recommended that 3 x integral swift bricks are included in the proposed extension at the north east eaves and fitted to the manufacturer's instructions. This will help ensure

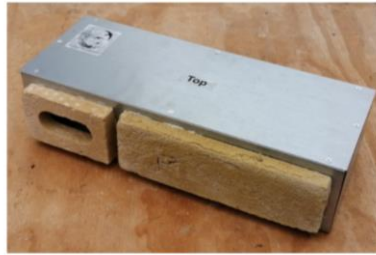
Brick Slip Facing 50mm Cavity
