# 2.6 Site Analysis

## **DESIGN DEVELOPMENT**

# 3.1 Pre-Application Advice

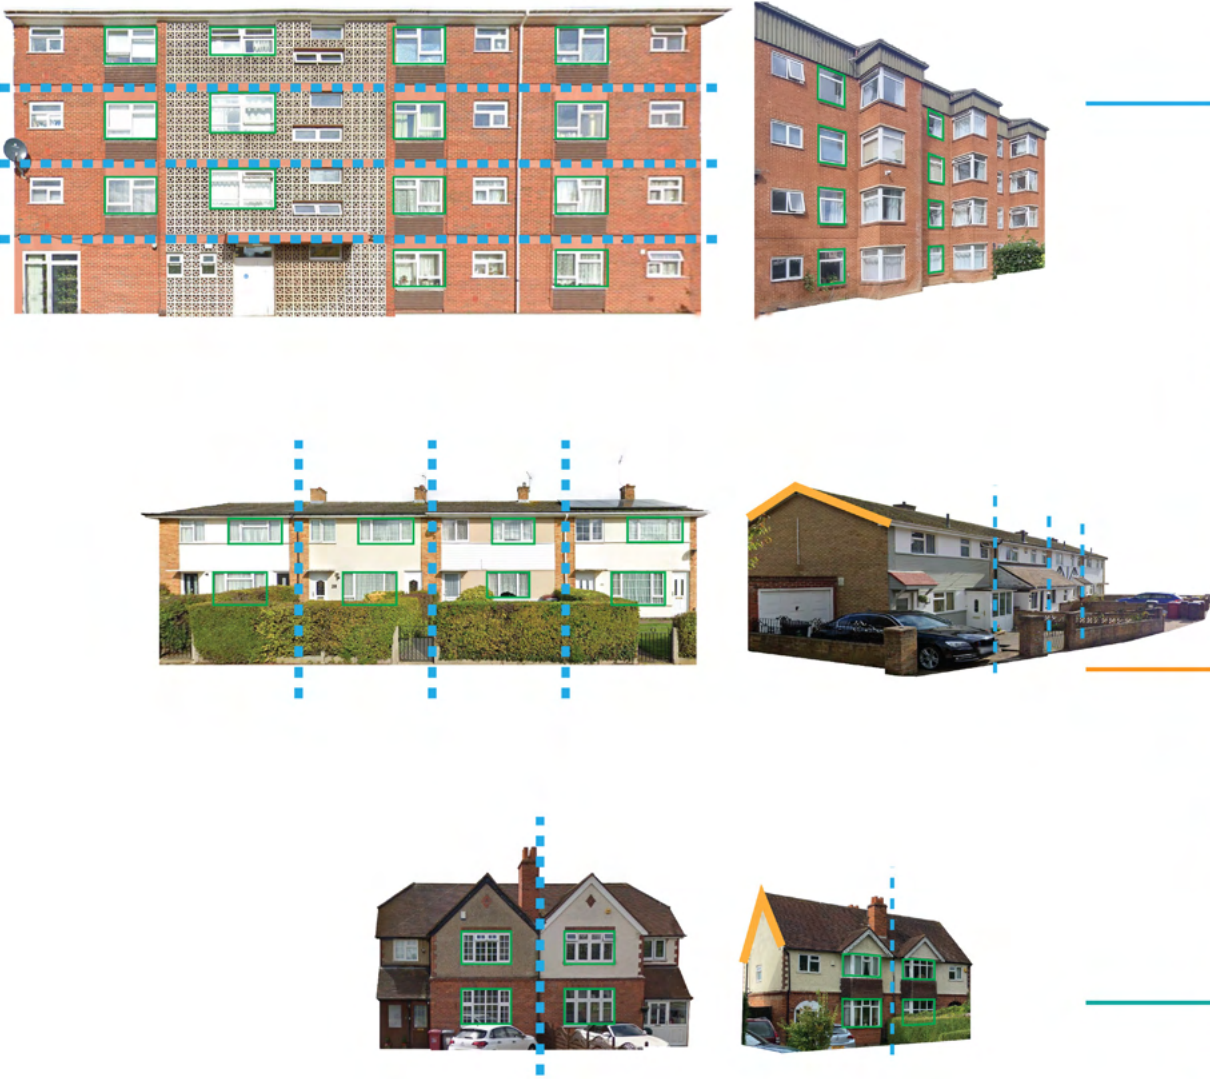
- Key:
- Flat Block
  - Terraced Flat Block
  - Terraced House
  - Semi-Detached House
  - Detached House
  - Flats - Prominent Zone
  - Terraces - Prominent Zone
  - Terraces - Prominent Zone
  - Semi - Prominent Zone
  - Terraced Street Relationship
  - Semi Turning Corner

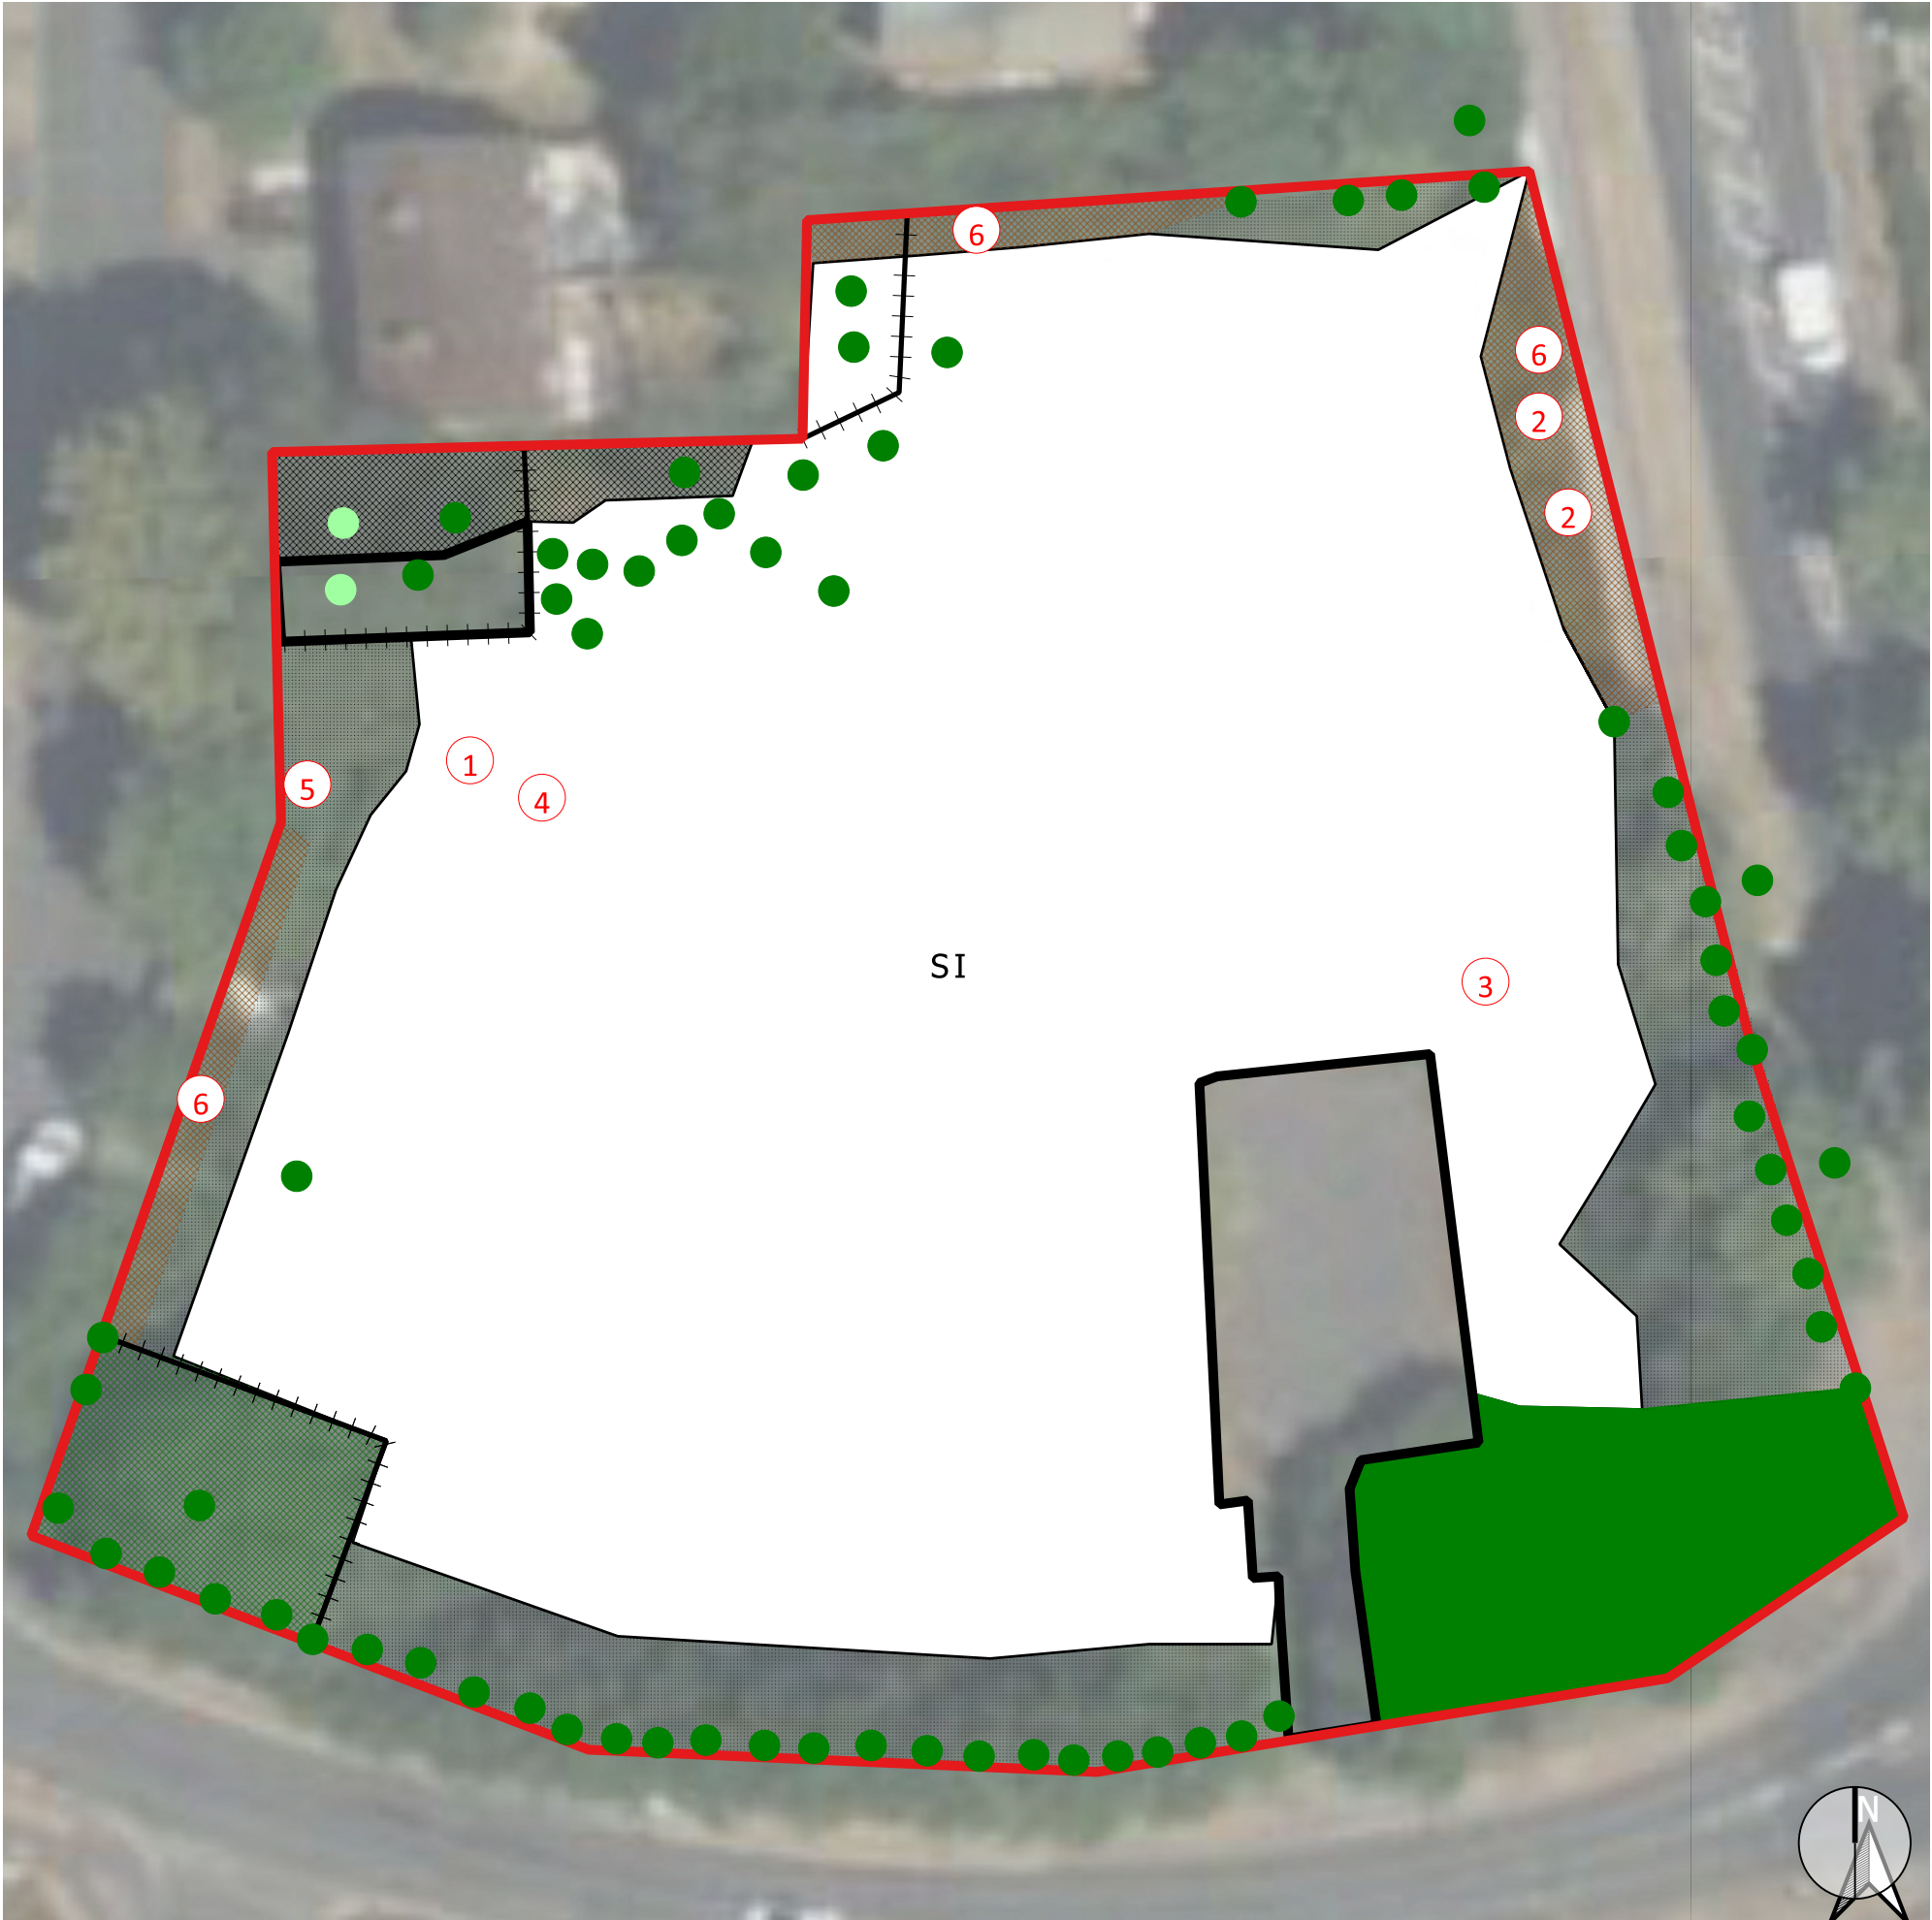
PEA Phase 1 Habitat Map (ADAS)

ADAS carried out a Preliminary Ecological Appraisal (3rd January 2023), identifying baseline conditions and presence of some mammals.. As a vacant site, scrub and un-managed planting has grown up providing habitats, but with significant fly tipping in certain areas of the site.

- Target Notes
- 1. Badger sett entrances
  - 2. Medium sized mammal push-throughs
  - 3. Rabbit droppings
  - 4. Mammal digging
  - 5. Log pile and nesting birds within
  - 6. Cotoneaster

Additional surveys on badger, bat and reptile activity, as well as checks for nesting birds will need to be undertaken during the appropriate seasons.

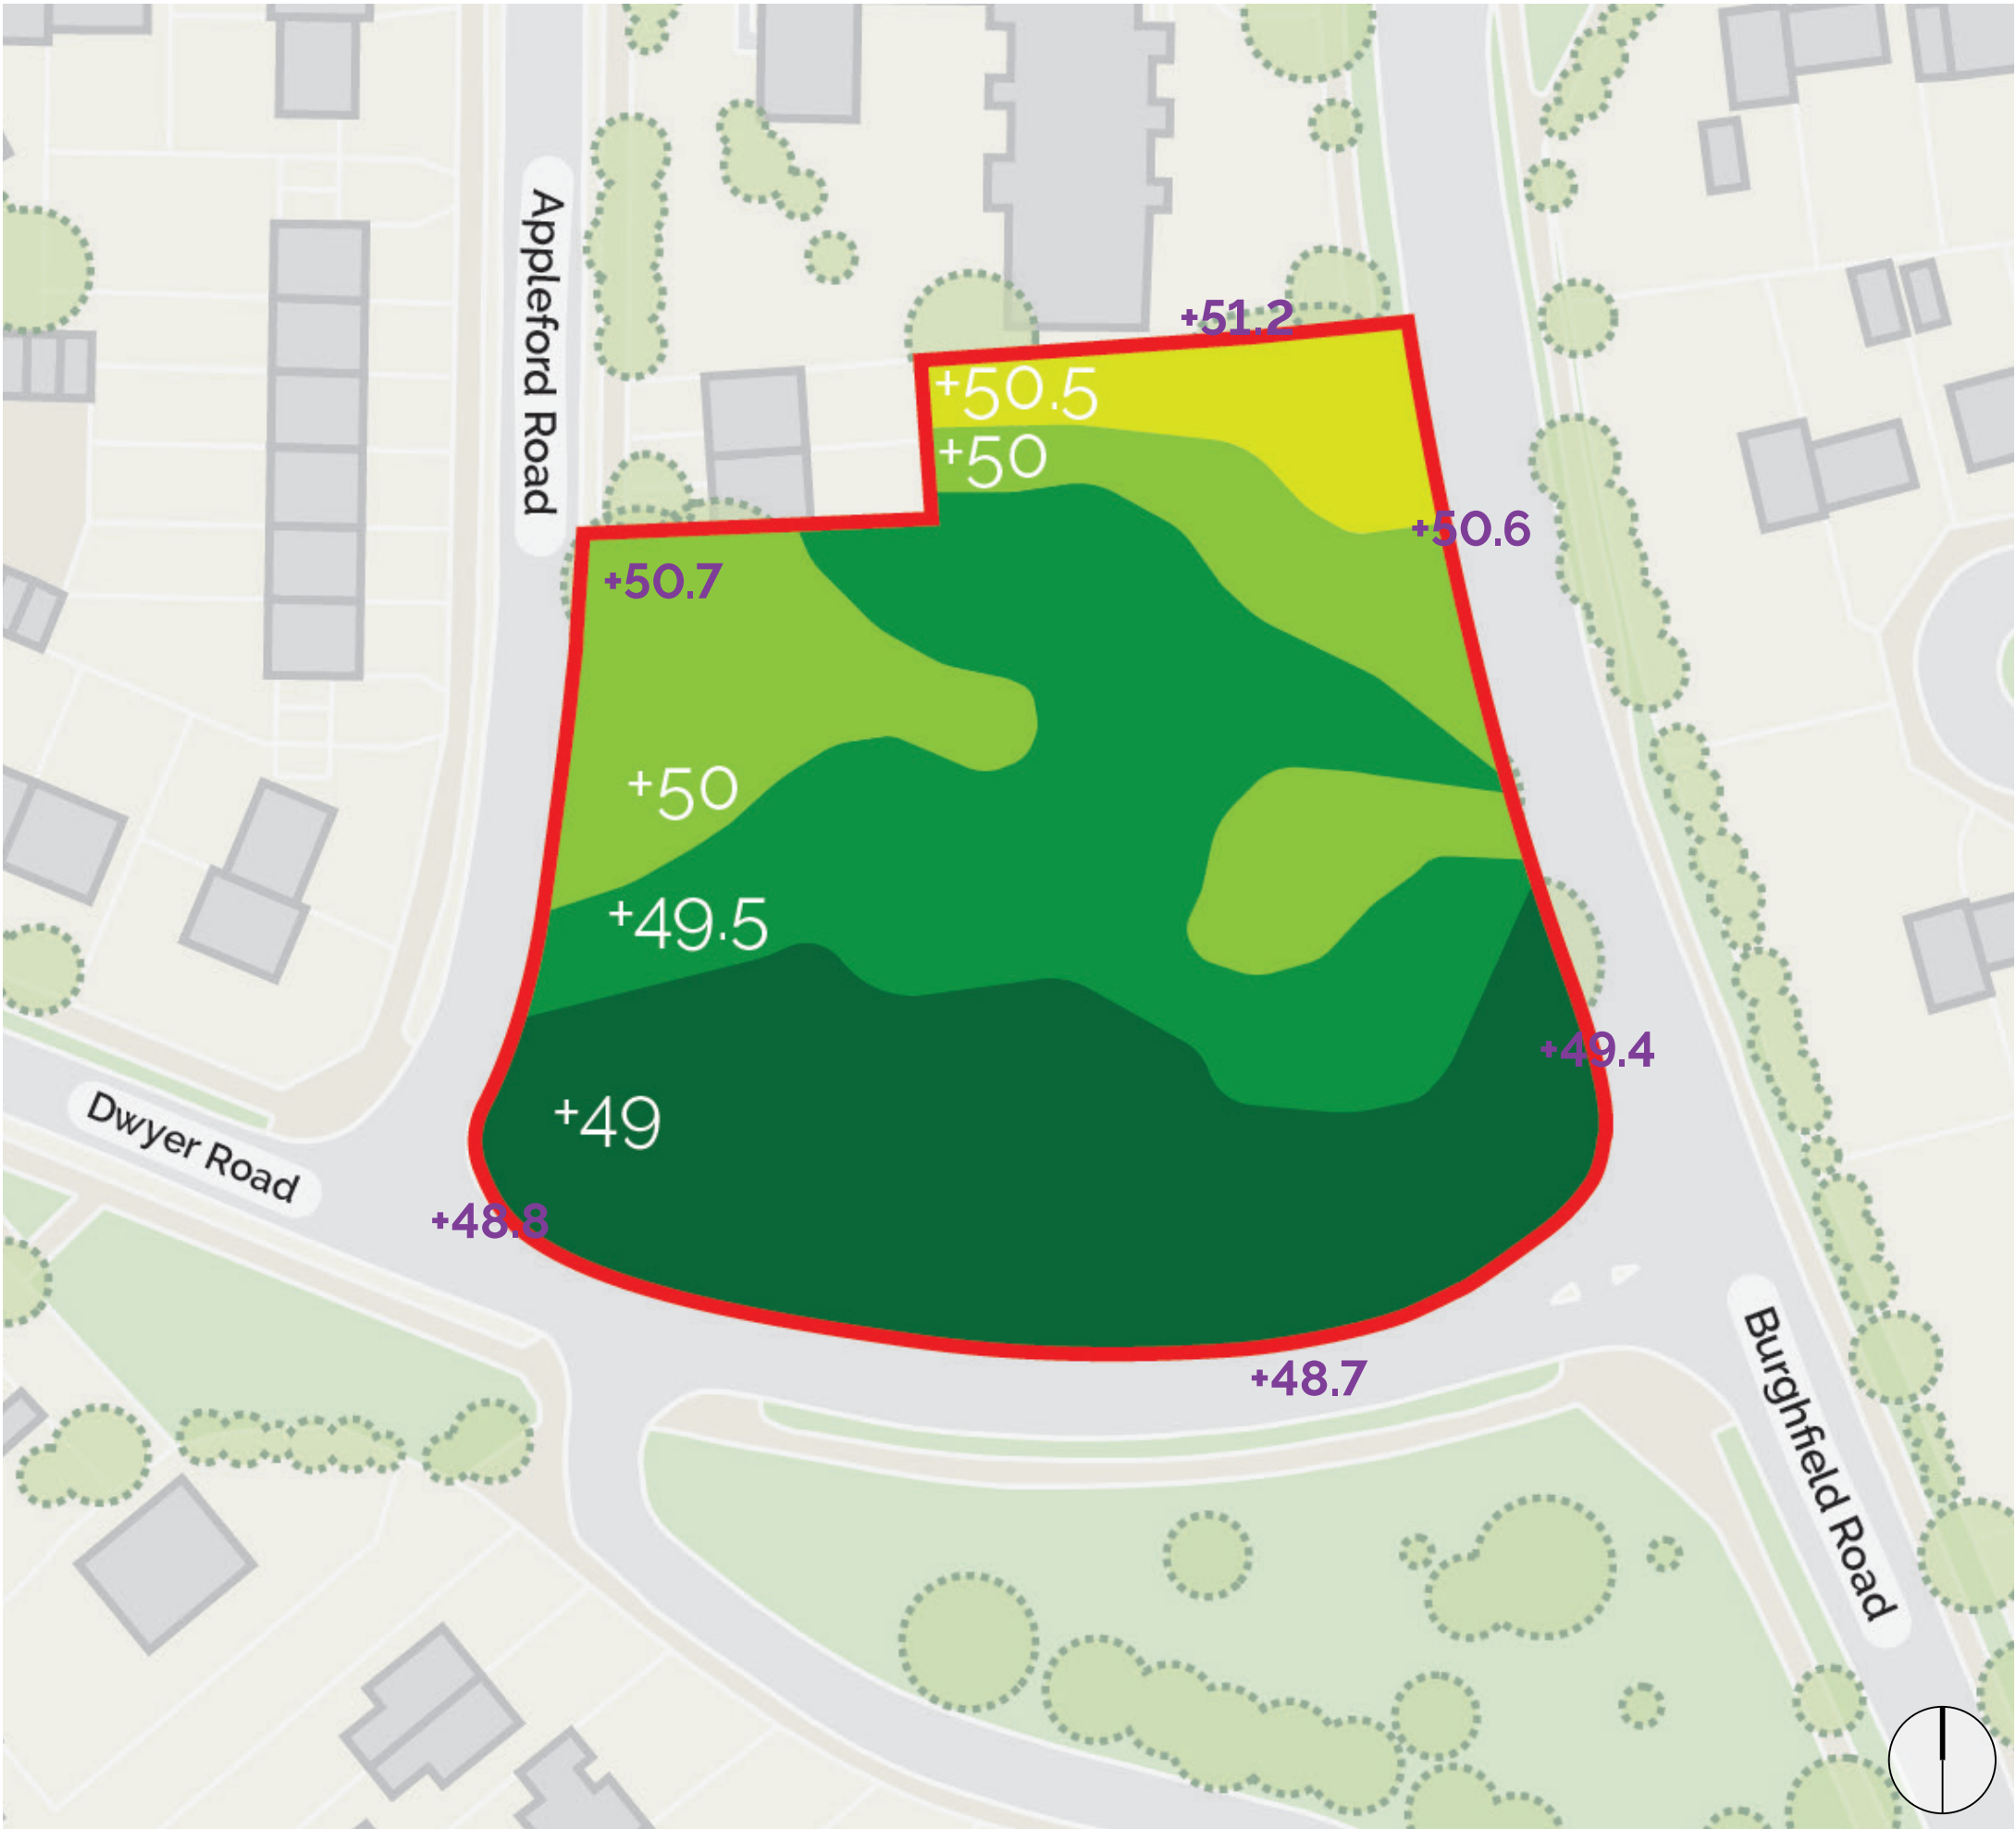
Existing Topography Diagram (not to scale)

- A site survey undertaken by Survey Solutions (22/12/21) confirmed site levels for the full site and adjacent pathways.
- The site topography falls approximately 3m north to south at its highest and lowest points
- The site is relatively level from east to west.

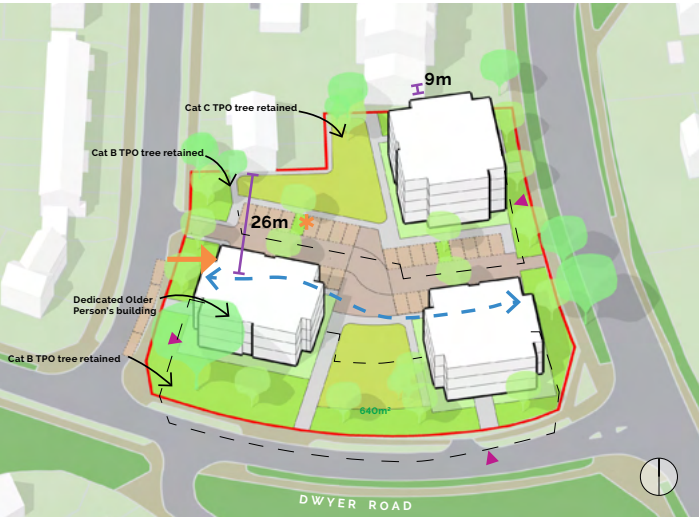
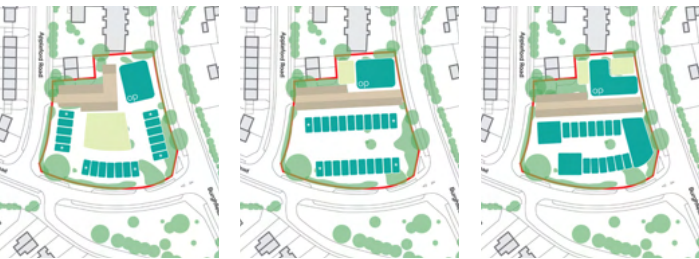
Early Concept Axo

- The above and other options were presented to the client team, exploring a range of housing typologies and ways of responding to initial site constraints.
- Client feedback on housing need was that family housing was a priority, with apartment accommodation required only for council tenants wishing to downsize.
- Subsequent design options tested arrangements of accommodating primarily individual houses, with a single, bespoke flat block for downsizers.

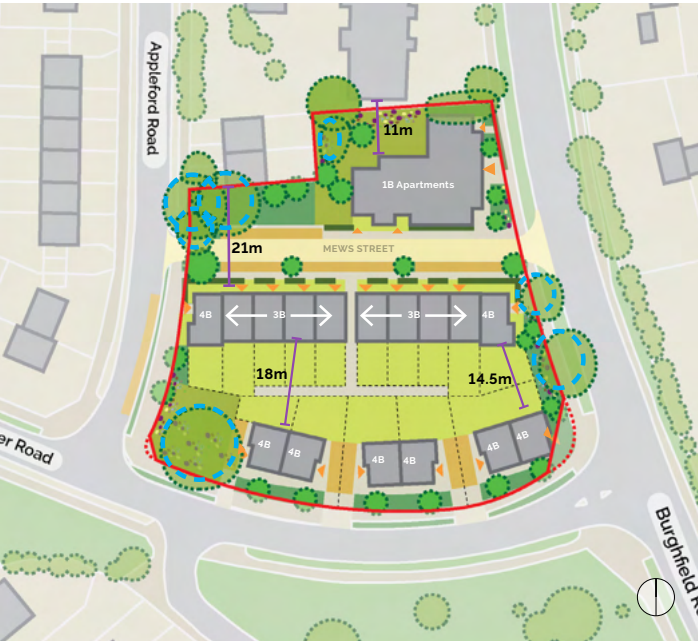
Stage 1 Concept plan

- Review flat block siting and appearance (sensitivity to neighbours)
- No objection to proposed housing mix
- Site access to be via Appleford Road only
- Parking provision must be within redline
- Driveways along Dwyer Road are acceptable
- Review proximity of parking to individual homes to the south (eastern 4bed)
- Biodiversity offsite contributions will likely be required to mitigate losses and achieve 10% net gain
- Any BNG measures should demonstrate additionality to existing council measures
- Retention of TPO trees is positive
- Integration of SUDs and green roofs should be considered

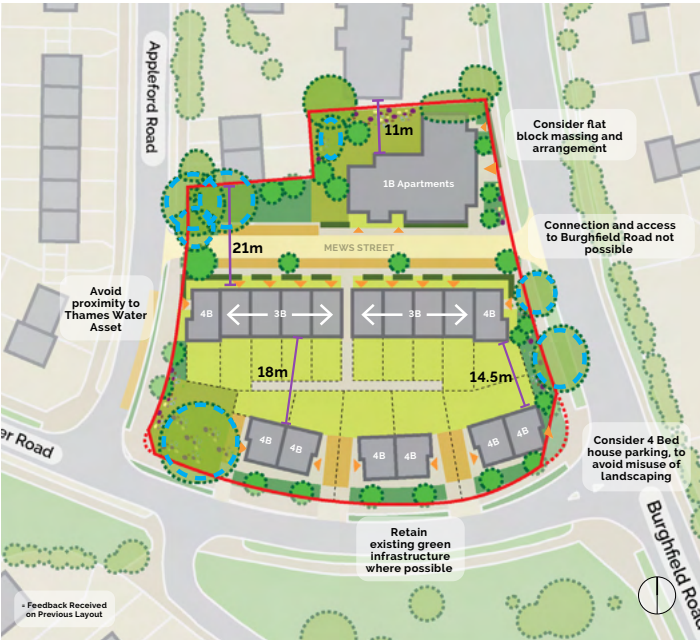
Stage 2 Developed plan

- Single direction access via Burghfield Road not possible in any arrangement
- Transport concerns about quantum and equity of parking provision (overproviding to south)
- Transport concerns about parking access to the south east home
- Daylight/Sunlight impact and townscape justification for flat block orientation acceptable
- Justification for storey heights acceptable.
