# **Preliminary Bat Roost Assessment and Nocturnal Surveys**

## **Land to the rear of Newcastle Road**

**Brett Property Lettings Ltd**

**Report to:** Brett Property Lettings Ltd  
**Report Title:** PBRA and Nocturnal Surveys Report: Land to rear of Newcastle Road  
**Version:** V1.0  
**Issue Date:** September 2022  
**Report Ref:** 18762

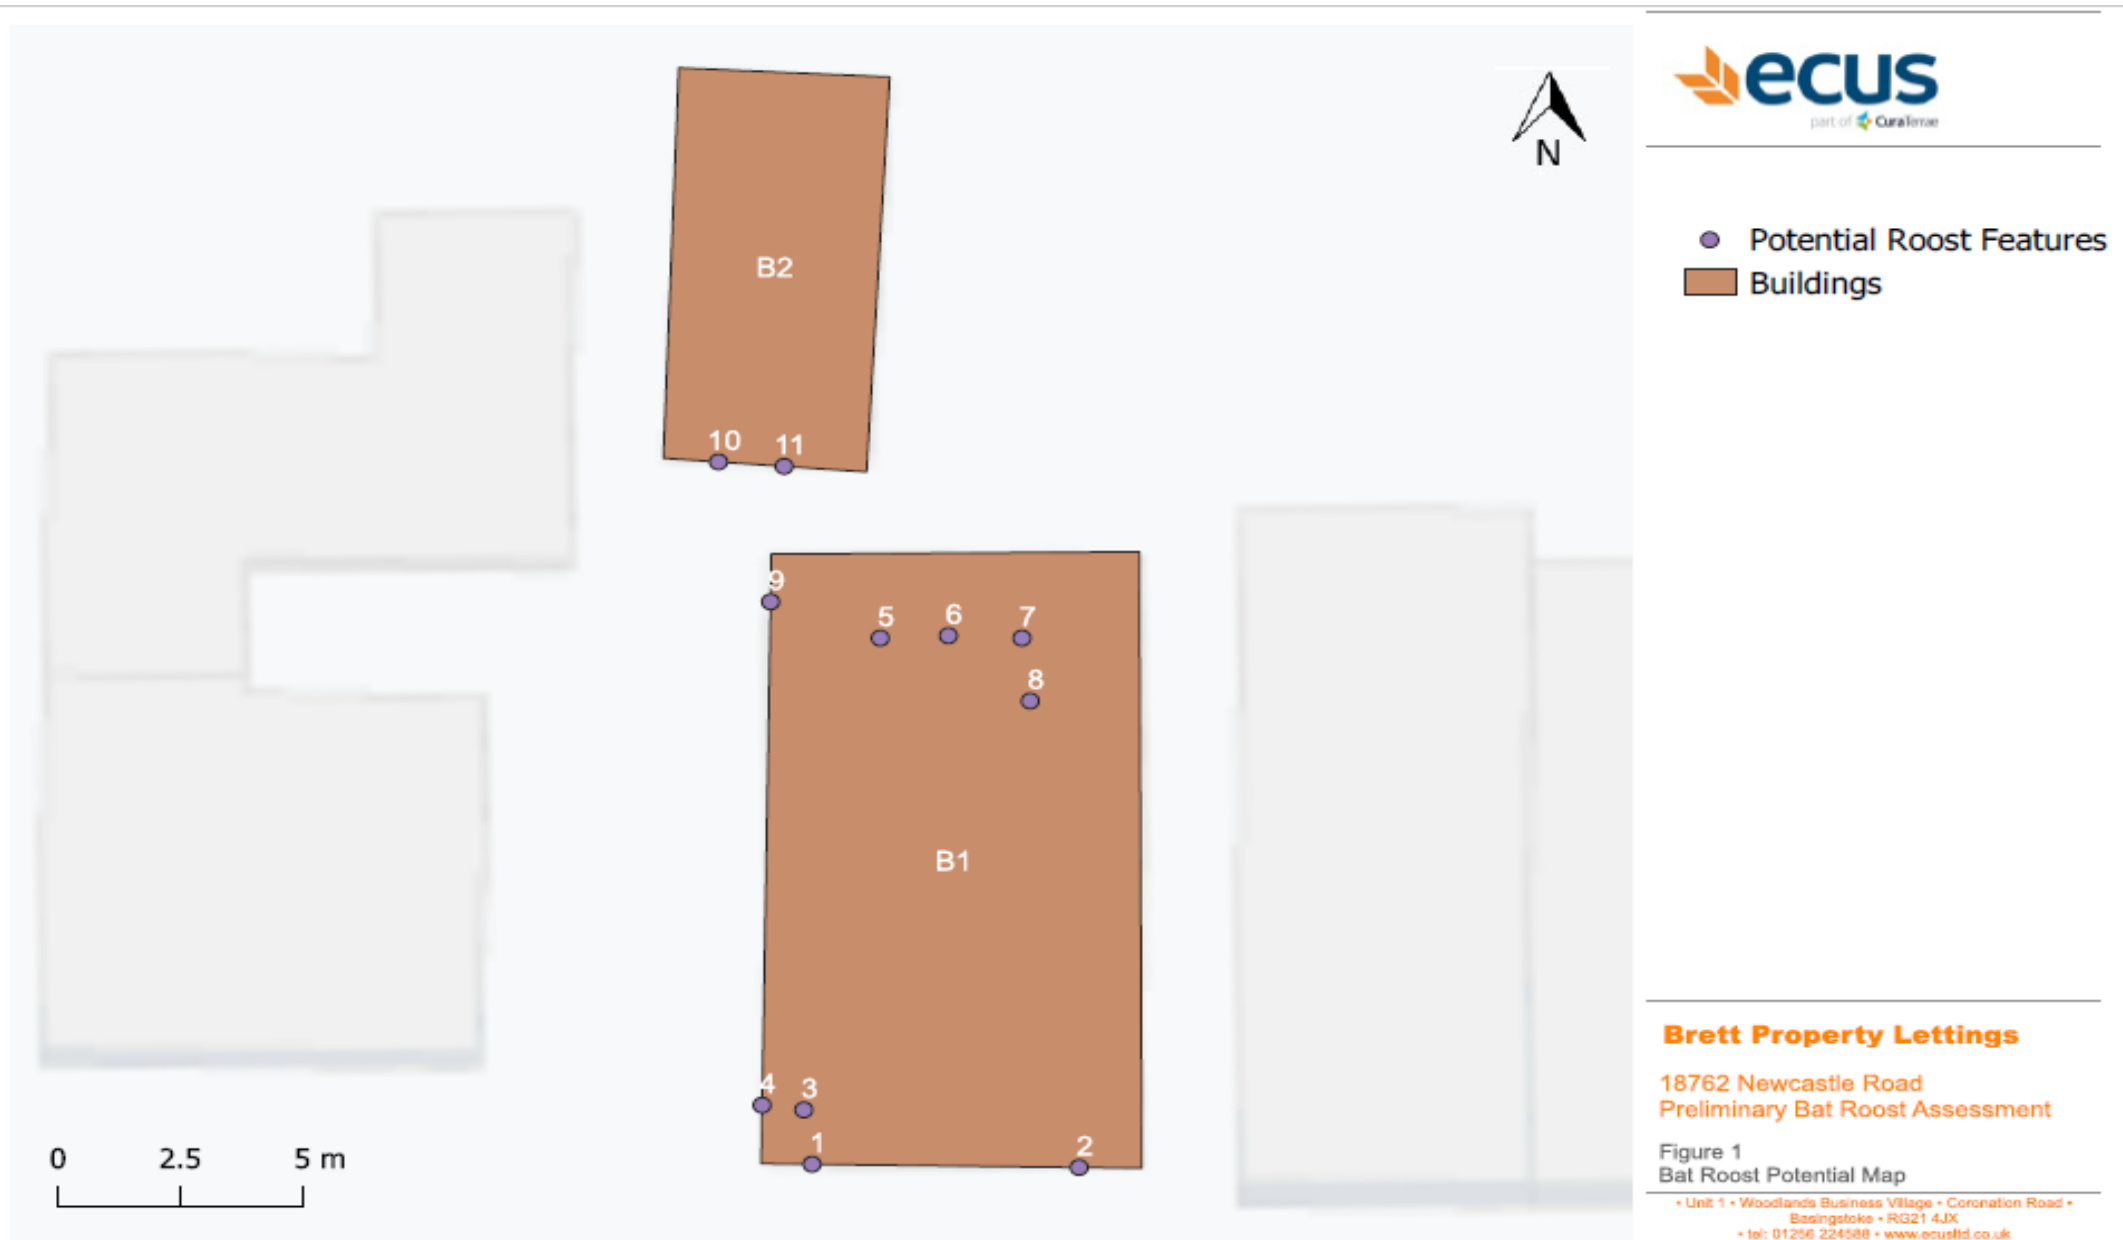
## Figure 1: Preliminary Bat Roost Assessment Findings

3.2.1 No evidence of roosting bats was recorded during the external inspection; however, numerous access points and roosting opportunities were observed. **Table 3** below provides details of the features identified. A reference number was allocated to each feature, this number corresponds to the feature's location on the Building Inspection Results Plan provided as **Appendix 1**.

**Table 3: External Building Inspection Results**

| Building | PRFs Present | Map Reference (See Appendix 1) | Suitability for Roosting Bats |
| B1 | Gaps in brick tiles | 1,2 | Moderate |
| | Gaps in lead flashing | 3 | |
| | Gaps underneath soffit | 4,5,7,8 | |

| | Missing mortar on ridge | 6 | |
| | Gap in brickwork | 9 | |
| B2 | Gaps underneath soffit. | 10,11 | Low |

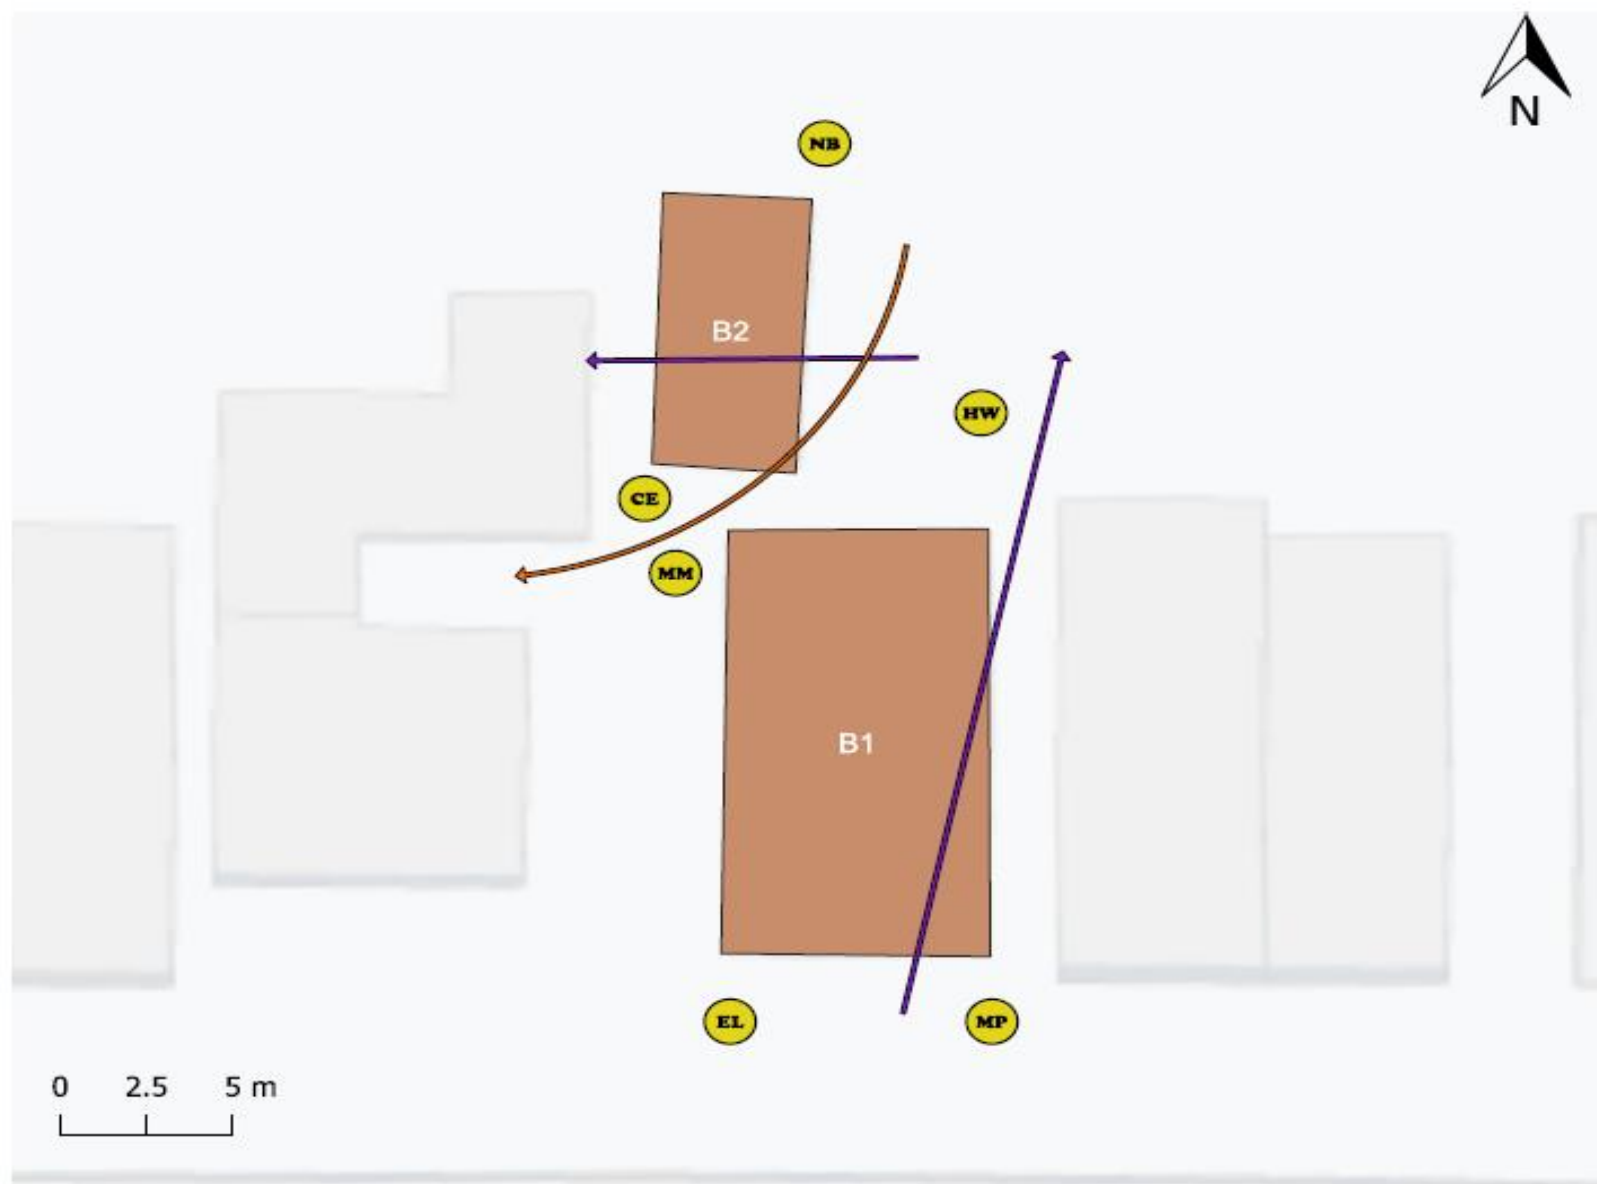
## **Figure 2: Dusk Emergence Survey 02 August 2022 Map**

3.3.2 No emergences were recorded from either of the buildings during the survey.

3.3.3 Moderate levels of bat activity were recorded during the dusk emergence survey. The first bat was recorded at 21:17 hrs (27 minutes after sunset) and was a common pipistrelle bat which was heard and not seen by the surveyor. Multiple commuting common pipistrelle and noctule bats were heard not seen by the surveyors throughout the duration of the surveys.

3.3.4 Soprano pipistrelle were recorded flying west-south west past B2, once at 21:25 and then at 21:32. A common pipistrelle was also seen passing west over B2 at 21:36.

3.3.5 The last recording pertained to a Noctule which was heard not seen at 21:56.

3.3.6 See **Figure 2** for surveyor locations and bat activity.

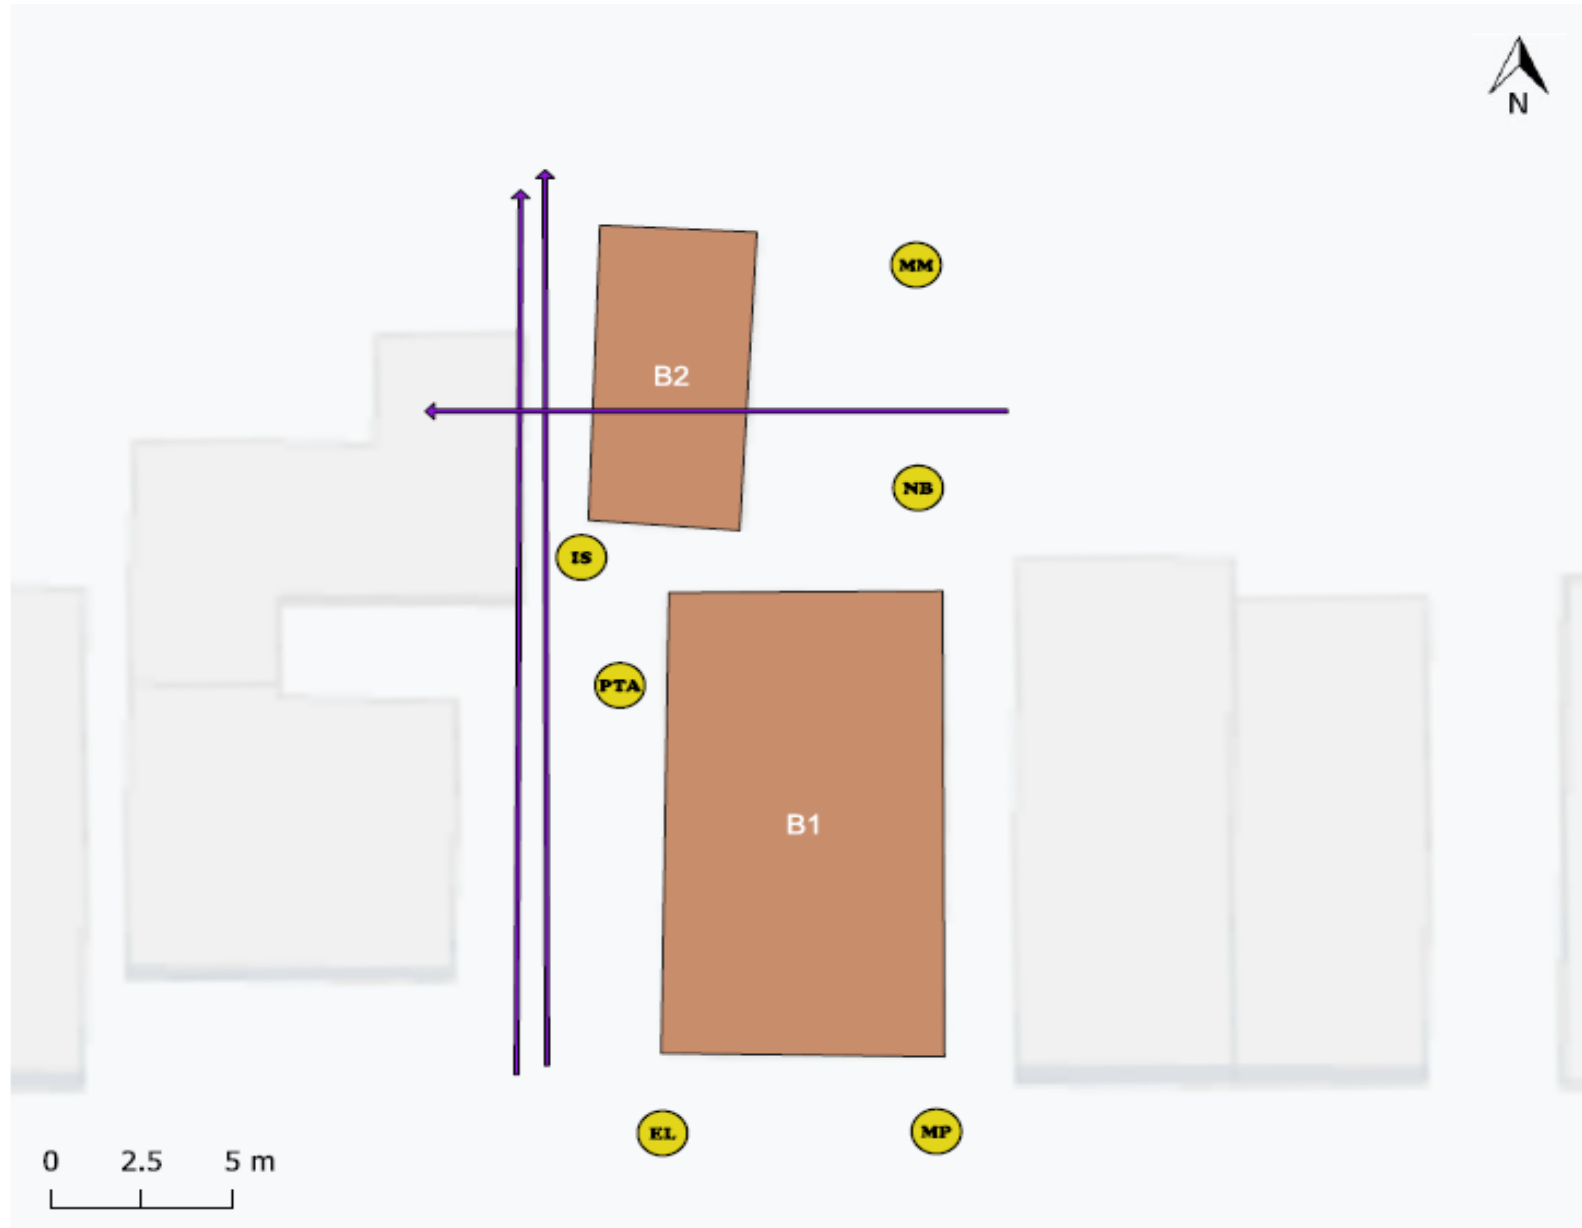
### **Figure 3: Dusk Emergence Survey 18 August 2022 Map**

3.3.7 No emergences were recorded from either of the buildings during the survey.

3.3.8 Low activity of common pipistrelle and noctule bats were recorded during the survey. The first bat was recorded at 20:40 hrs (19 minutes after sunset) and was a common pipistrelle bat which was heard and not seen by the surveyor.

3.3.9 Three observed common pipistrelle bat passes were recorded during the survey. These pertained to two bats commuting north, adjacent to the Site at 20:41 and 20:54 and a third individual commuting west over the top of B2.

3.3.10 See **Figure 3** for surveyor locations.

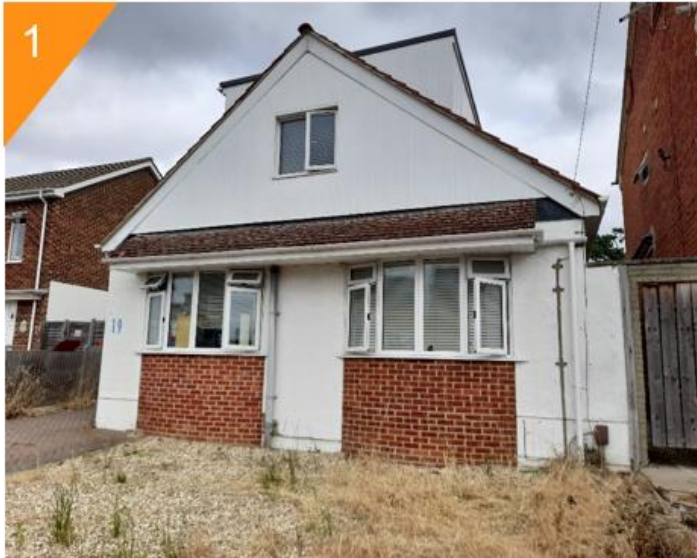
- Plate 1 Southern aspect of Building 1
- Plate 2 Northern aspect of Building 1
- Plate 3 Western aspect of Building 1
- Plate 4 Eastern aspect of Building 1, unable to attain clear view.

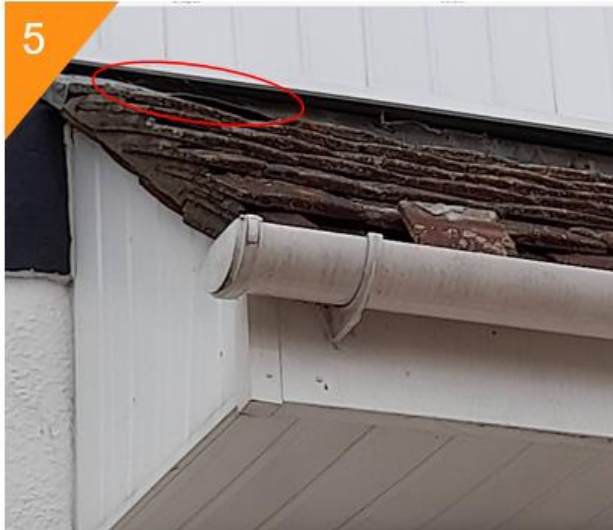
- Plate 1      Gap in lead flashing
- Plate 2      Gap underneath soffit
- Plate 3      Gaps in roof tiles of building 1
- Plate 4      Gap underneath soffit

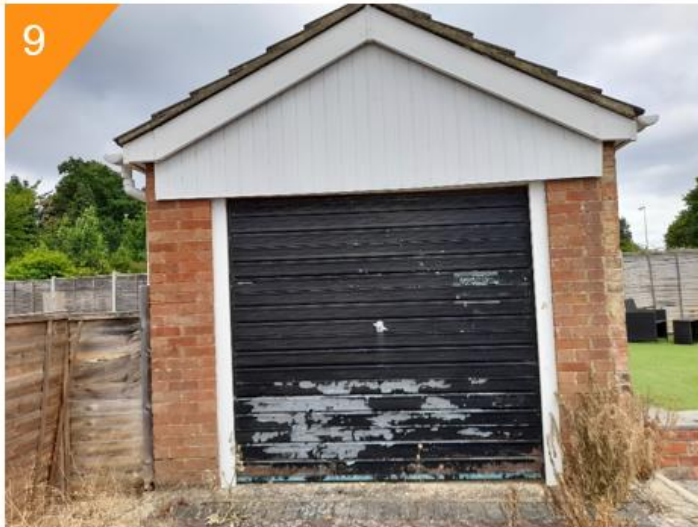
- Plate 1 Southern aspect of Building 2
- Plate 2 Eastern aspect of Building 2
- Plate 3 Gaps underneath soffit of Building 2
- Plate 4 View of Building 1 and adjacent buildings
