# Preliminary Ecological Appraisal

## Amethyst Lane

**Principal Author:** Rachel Richards

**Date:** 27 October 2022

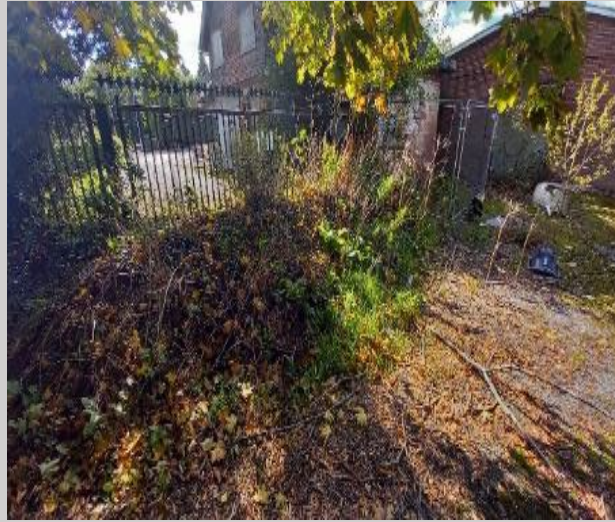
Target Note 1: Spoil heap with ephemeral vegetation.

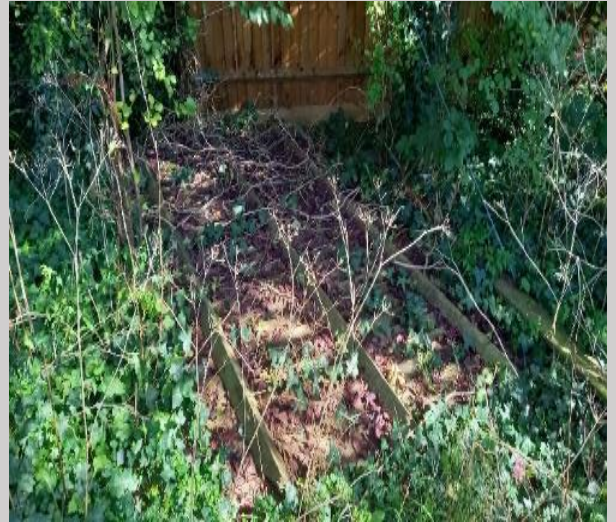
Target Note 2: Fallen fence pannel provides suitable refugia habitats for reptiles.

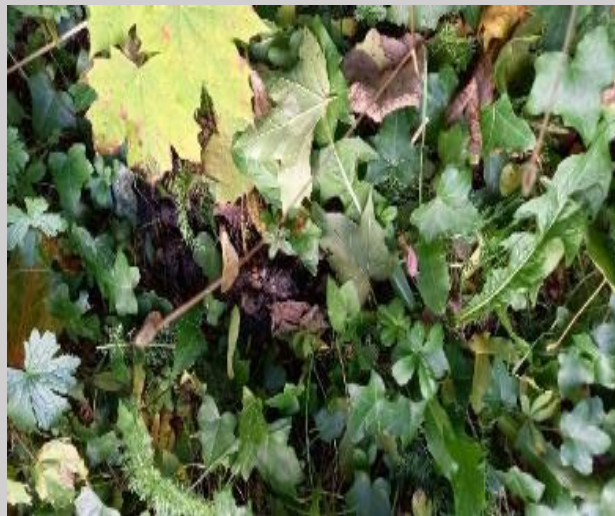
TVERC provided records of Badgers within 2 km of the site. During the Phase 1 survey evidence of Badgers was found within the north of the site. Latrines with three dung pits were found in two locations (see Target Note 3 and 6). A Badger sett with two entrances was also found within the northeast of the site (see Target Note 5). Clear Badger runs could be seen adjacent to the sett leading under the wooden fence (Target Note 4). During the survey, no signs of current occupation were found around either sett entrance. However, the path and latrines were all still visible, so the area has been used recently.

Target Note 3: Badger latrine in north west corner of site

Badgers are protected under The Protection of Badgers Act (1992) (as amended), to ensure no offence is committed it is recommended that a Badger survey of the site be completed to check for activity / any additional setts on site. If the sett is currently inactive the sett should then be closed to prevent Badgers from using the sett on to the site during the works. If the sett is active a licence will need to be applied for from Natural England. Closure of an active sett can only take place from July to November as the breeding season runs from December to June.

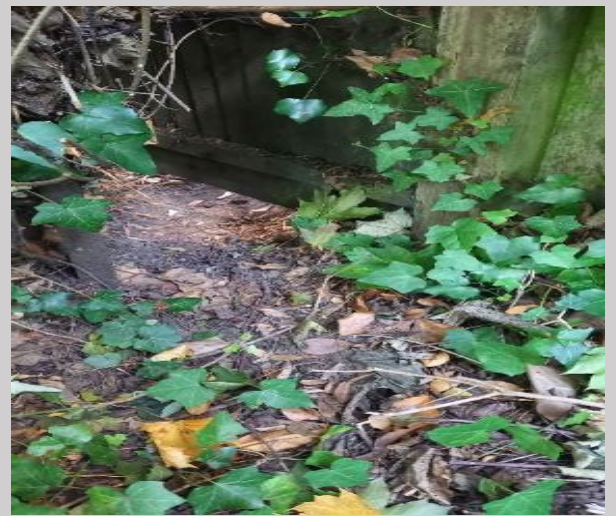
Target Note 4: Badger run under fence

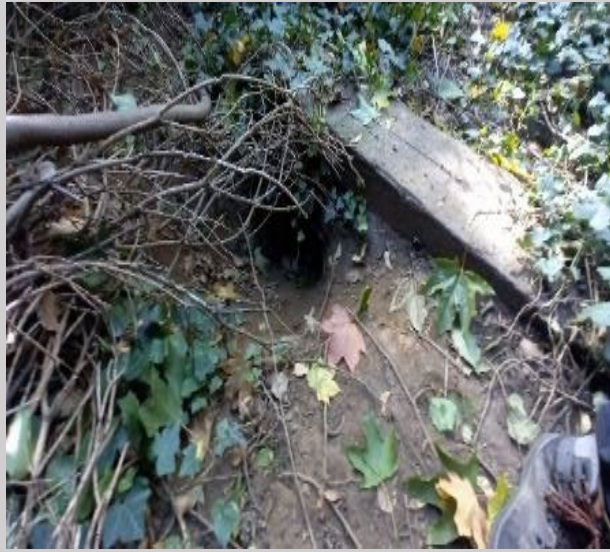
Target Note 5: Badger sett entrance

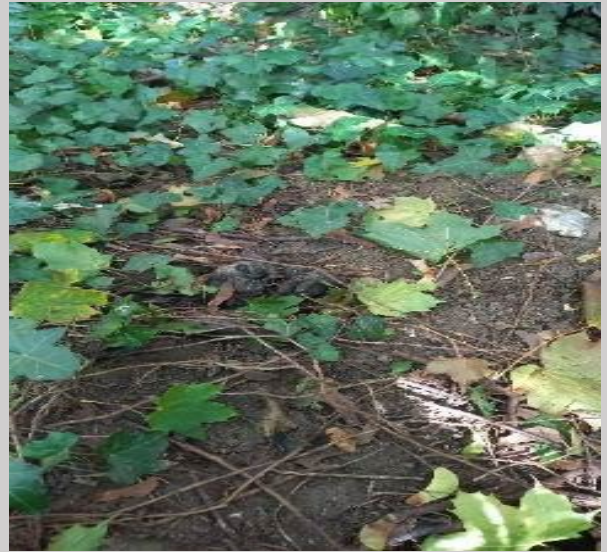
Target Note 6: Badger latrine found in northeast of the site

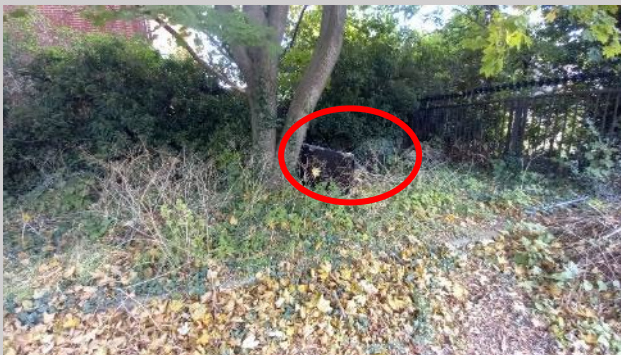
Target Note 7: Refuiga near south boundary

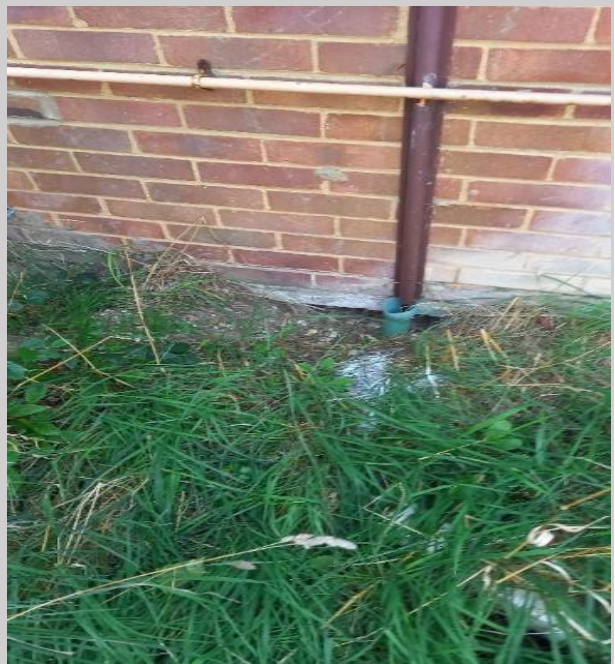
On the northern aspect of Building 2, evidence of a burrow under the building was found (see Target Note 8). There were also animal remains found close to the burrow (see Target Note 9) suggesting that this may have been a Fox (*Vulpes vulpes*) den.

Target Note 8: Possible burrow/den under Building 2

| Survey/Action | Rationale | When |
|---|---|---|
| <b>Mammal monitoring and closure of den/burrow</b> | A mammal den/burrow was found during phase 1 under Building 2. Monitoring of the den is required to understand if the den is active. The den will need to be closed before works begin | <b>Pre-construction:</b> Monitoring needs to happen over 1 month with weekly checking of camera traps. |

Underneath Building 2 is a mammal burrow/den with evidence of feeding remains adjacent to the entrance. It is likely to be a Fox den however, no other field signs were found during the survey. It is recommended that monitoring take place to identify if the burrow is active. Camera traps should be used for 1-month to monitor all activity associated with the den. If no activity is found the den should be closed before works begin. If the burrow is active to prevent an offence under the law a management plan for the closure and deterrence of the fox will need to be devised before works begin.

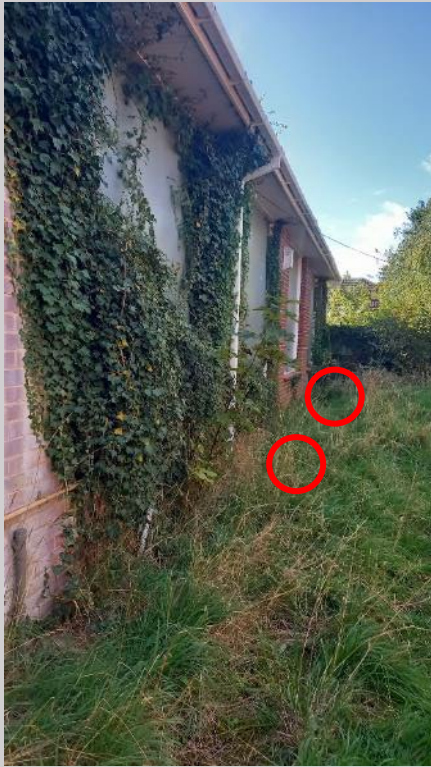
Target Note 9: Animals remains by Building 2 indicated by red circles

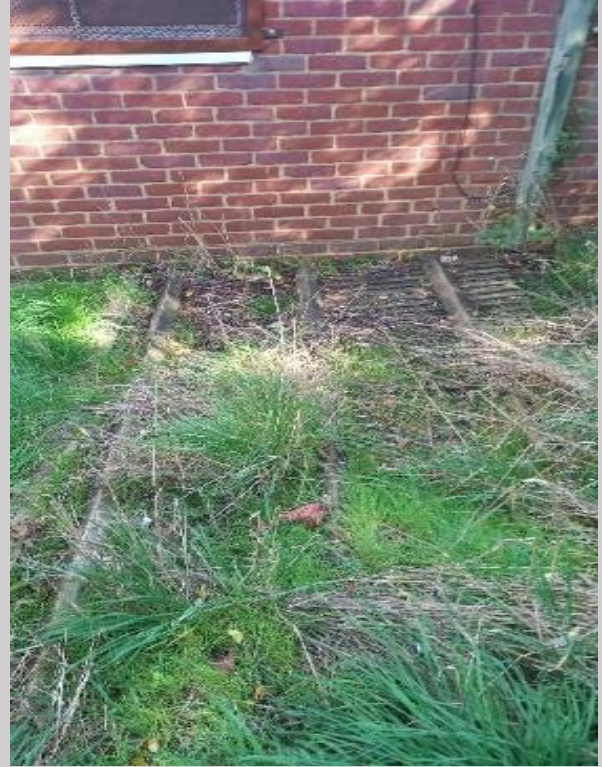
Target Note 10: Fallen fence panel provides suitable refugia habitats for reptiles.

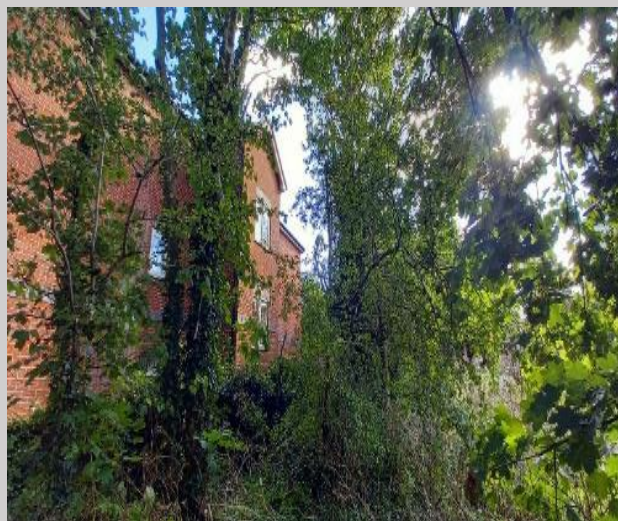
Within the northeast corner of the site was a small section of broadleaved plantation woodland (0.001 ha). The mature trees were part of ornamental planting however, with the lack of management on the site, younger trees have self-sown and the canopy area has become very dense cutting off light to the ground flora. The dominant tree species was Norway Maple (*Acer platanoides*) with occasional Field Elm (*Ulmus minor*). The ground flora was dominated by Common Ivy (*Hedera helix*) with Sweet Violet (*Viola odorata*) appearing frequently (Photograph 1 in Appendix 5).

Photograph 1: Small area of woodland in north-east corner of site.

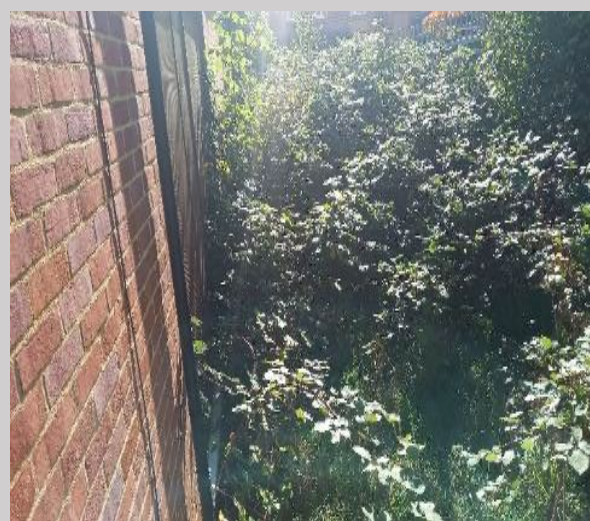
There were 3 small areas of scrub on site with the total area of scrub approximately >0.01 ha. The larger of the scrub areas (0.003 ha) was a section of bramble (*Rubus fruticosus* agg.) located on the northwest boundary of the site (Photograph 2) which was encroaching onto an amenity grassland.

Photograph 2: Bramble scrub

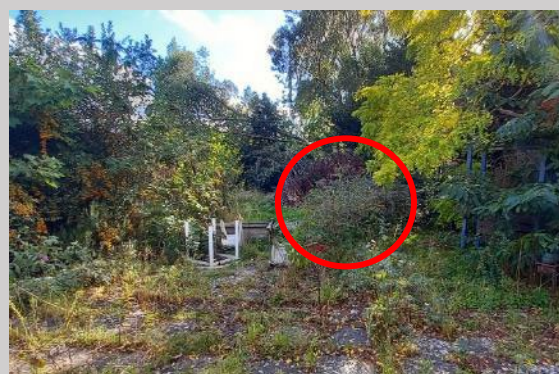
Photograph 4: Small area of bramble scrub south of Building 3

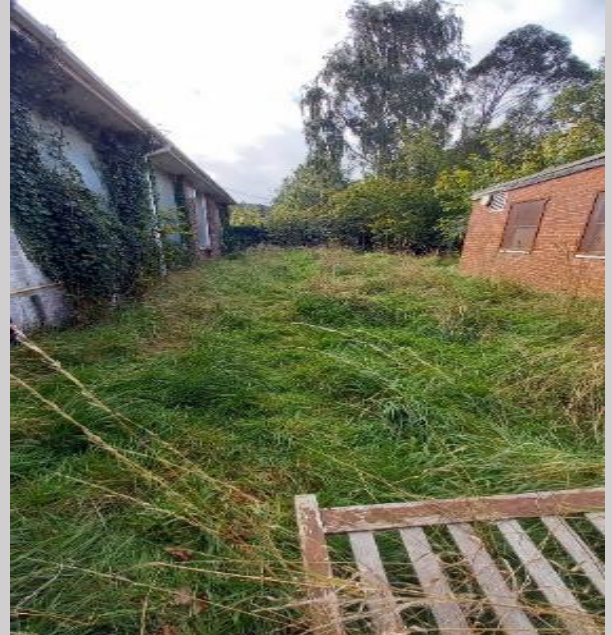
There were six areas of amenity grassland across the site all associated with the building on site with a total area of 0.14 ha. All the area had been unmanaged for some time but had not transitioned into other habitats such as semi-improved grassland. All areas of amenity grassland had the same composition with Perennial Rye-grass as the dominant species (Photograph 6). Cow Parsley (*Anthriscus sylvestris*), Creeping Buttercup (*Ranunculus repens*), Yarrow, Ribwort Plantain (*Plantago lanceolata*) and dandelion (*Taraxacum* sp.) were also present within the area of amenity grassland.

Photograph 6: Area of unmanaged amenity grassland

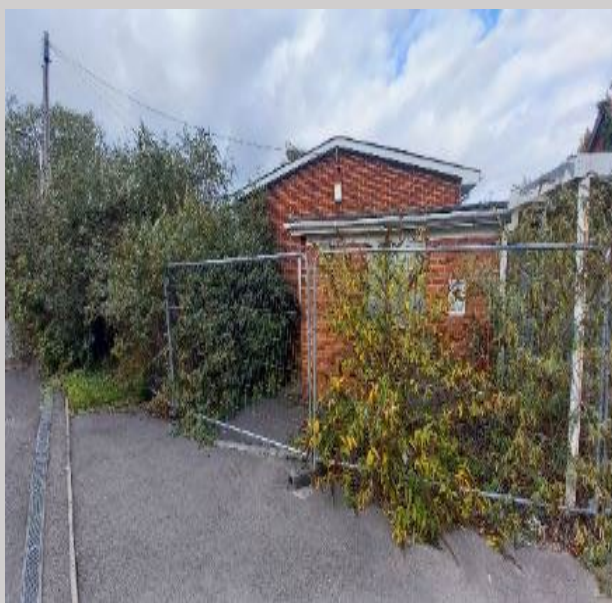
The areas of introduced shrub on site were associated with the ornamental gardening around the buildings on site (0.03 ha). The 3 areas of shrub to the south of the site associated with Building 1 and 2 were dominated by Butterfly bush (*Buddleja davidii*), which have become overgrown due to lack of management on site (Photograph 7). Within the shrub running along the southeast wall of Building 2, species like Cherry Laurel (*Prunus laurocerasus*), Mexican Orange Blossom (*Choisya ternate*) and Japanese Honeysuckle (*Lonicera japonica*) were also present (Photograph 8).

Photograph 7: Butterfly bush dominated area to the south of site

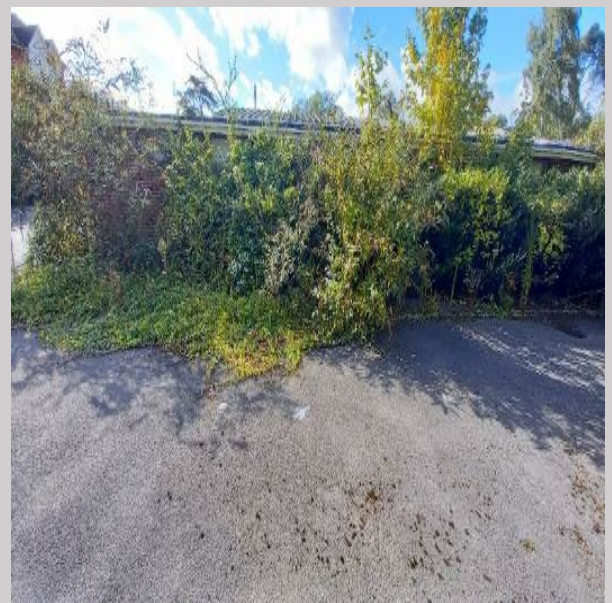
Photograph 8: Area of introduced shrub along wall of Building 2

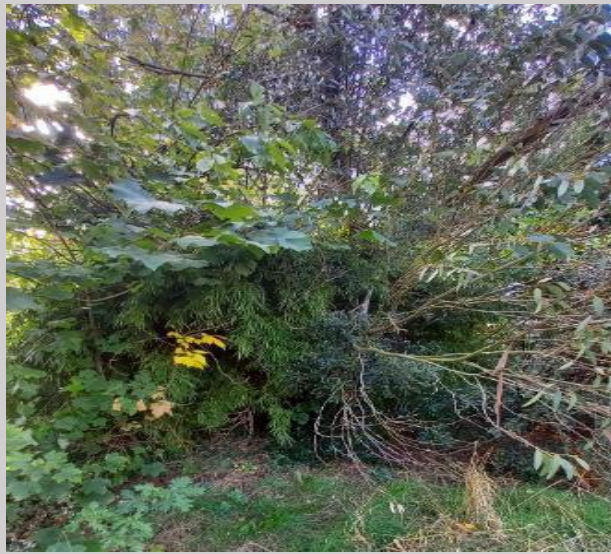
The two small sections of shrub were located to the west of Building 3 (0.002 and 0.0006 ha). The smaller of the two areas contained bamboo (*Poaceae* sp.) and Hollyberry Cotoneaster (*Cotoneaster bullatus*) which were encroaching from neighbouring residential properties (Photograph 9). The larger section contained was dominated by Butterfly Bush and firethorn (*Pyracantha* sp.).

Photograph 9: Bamboo encroaching from neighbouring residential property.

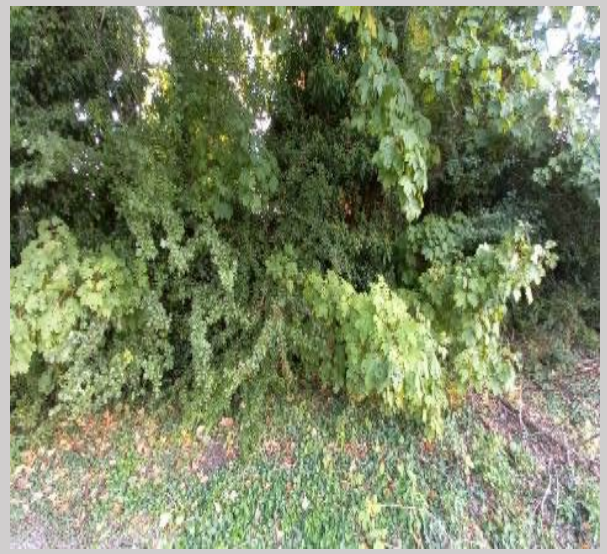
There were two sections of species-poor hedge with trees, with one section along the north boundary (38 m) and the other running along part of the east boundary of the site (27 m). Both sections were overgrown due to a lack of management. The smaller of the two-section contained Ivy and Hawthorn as the dominant species with frequent appearances of Privet (*Ligustrum ovalifolium*). The trees within this section were Sycamore (Photograph 10).

Photograph 10: Species-poor hedge along east boundary of site.

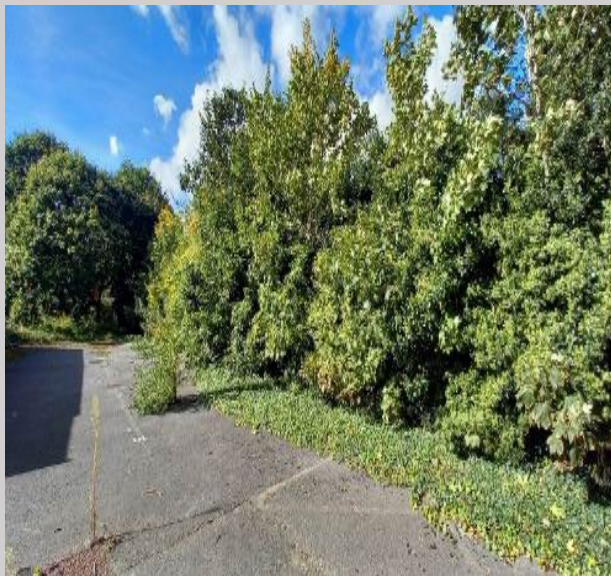
Photograph 11: Species-poor hedge with trees along north boundary

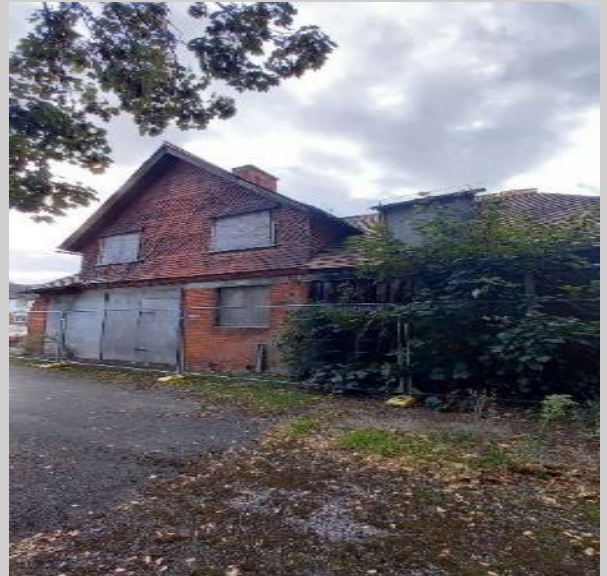
There was three main buildings within the site boundary and three structures / outbuildings. Building 1 (73.5 m<sup>2</sup>) was a two-storey red brick building with a tile roof and wooden soffit, the building was in poor condition. All windows were boarded up with wooded boards. Common Ivy covered a large section of the west and southern aspect of this building (Photographs 12 & 14).

Building 1 was a red brick two-storey building with tiled pitched roof that was in poor condition. The building had wooden soffit boxes on all aspects and wooden vents on the northern aspect of the building. All soffits, fascia and vent showed signs of damage. The southern and western aspects were partially obscured by Common Ivy. Due to the condition of the building, it was unsafe to access the internal section of the building. Building 1 had many features suitable to support roosting bats (see Table 4), most notable were gaps under missing or slipped roof tiles, gaps within the soffit boxes and gaps within the wooden fascia. A total of 46 potential roost features (PRFs) were observed on Building 1.

| Building | Features observed | Potential roosting points | Suitability |
|---|---|---|---|
| 1 | <p><b>External:</b> Contained building with a large number of lifted/broken roof tiles, damage to wooden soffit and fascia. Mortar missing around ridges tiles. Dormers on the western elevation provide the opportunity for entry. On the southern aspect of the building twenty-two tiles were missing or lifted.</p> <p><b>Internal:</b> Not surveyed</p> | External crevices under the wooden soffit, wooden fascia, missing slate tiles and missing mortar were located across all elevations. This could lead to a void space between the tiles and the membrane. Holes in stonework could lead to a void between internal cladding and stonework. | High |

Photograph 12: Building 1

Three surveys are recommended to be carried out on Buildings 1 and 3 due to the ‘high’ suitability/confirmed presence of roosting bats as per good practice guidance (Collins 2016) . The three surveys should be carried out between May and September, with at least two of the surveys between May and August. It is recommended that surveys are spaced at least two weeks apart and as close to optimal weather conditions as possible (sunset temperature 10°C or above, no rain or strong winds).

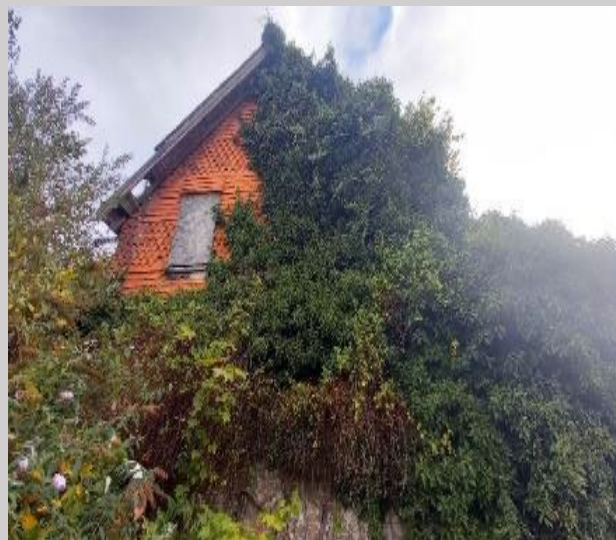
Photograph 13: Building 1 with substantial ivy cover

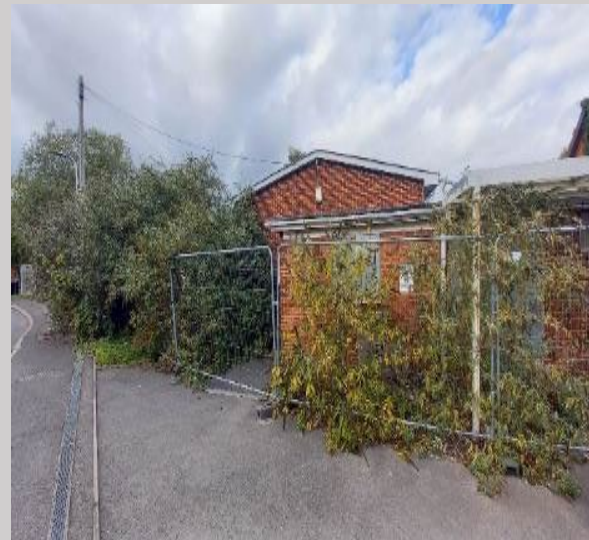
Building 2 was a single-storey building in good condition (376 m<sup>2</sup>). The roof on the main section of the building was slightly pitched with the abutments each having flat roofs. Both roof sections were covered

with bitumen (Photograph 14). There was a roof void between the roof and the panel ceiling tiles within the building which could be viewed due to damaged tiles inside however to access the roof void was possible.

Building 2 was a single-storey brick-and-mortar building which was in good condition. The building had metal flashing around all windows and roof edges. The main section of the roof was slightly pitched with the abutments each having a flat roof. Access was granted to the interior of this building however, access to the roof void was not possible. Some sections of the roof void could be viewed through damaged ceiling tiles (Photograph 20). Building 2 had some external features suitable for bats, these included small gaps in the brickwork and gaps within the flashing around the windows. A total of 4 PRFs were observed on Building 2 with features only found on the north and south aspect.

| Building | Features observed | Potential roosting points | Suitability |
|---|---|---|---|
| 2 | <p><b>External:</b> Contained building with some gaps in mortar on the southern and northern aspects. Small gaps are also present on the southern aspect around flashing.</p> <p><b>Internal:</b> No feature within the internal section of the building</p> | External crevices within missing mortar were on the north and south aspect. Could lead to a void space between the flashing and brickwork. | Medium |

Photograph 14: Southern aspect of Building 2

A PRA was completed on the building on site and roosting bats were confirmed to be present within Building 3 and Building 1 was deemed as having ‘high’ suitability. Although Building 2 had limited features, due to its proximity to a confirmed bat roost it was given ‘moderate’ suitability. It is likely the bats found on site are Pipistrelles as EPS licences have been granted for these species within the area.

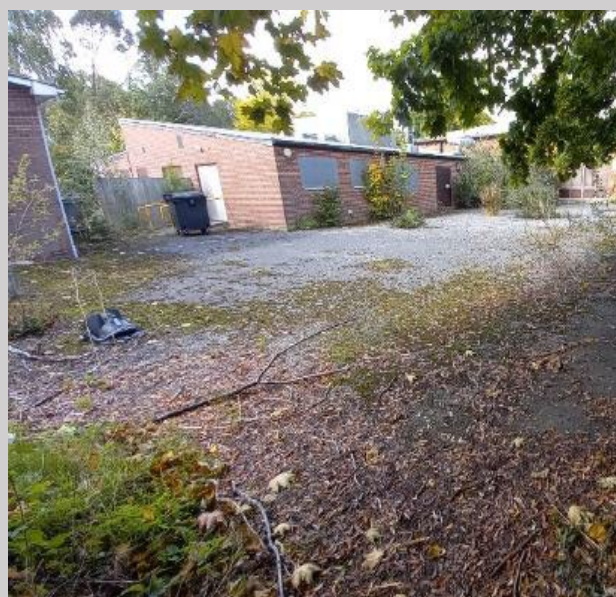
Building 3 was a single-storey brick and mortar building in good condition with a tall, pitched roof within the central section of the building (1199 m<sup>2</sup>). The outer sections had a slight pitch to the roof and was covered in bitumen (Photograph 15). Internal access was granted to this building however, no access to the roof void was possible.

Building 3 was a single-storey brick-and-mortar building in good condition. The building had a tall central section with a slightly pitched roof and a partially pitched abutment to the south. The building had wooden soffits and fascia, with a bitumen roof (Photograph 21). The windows and vent on all aspects were covered by metal grates (Photograph 22). Droppings were found on the southeast aspect of the exterior of the building and droppings were also found within the interior of the building (Photographs 23 & 24). The species of bat is not known at this point. The presence of dropping confirms that bats were present within Building 3. No access to any roof void was possible during this visit. A total of 3 PRFs were observed on Building 2 with features only found on the west and south aspect of the building.

Photograph 15: Southern aspect of Building 3 slight pitched roof

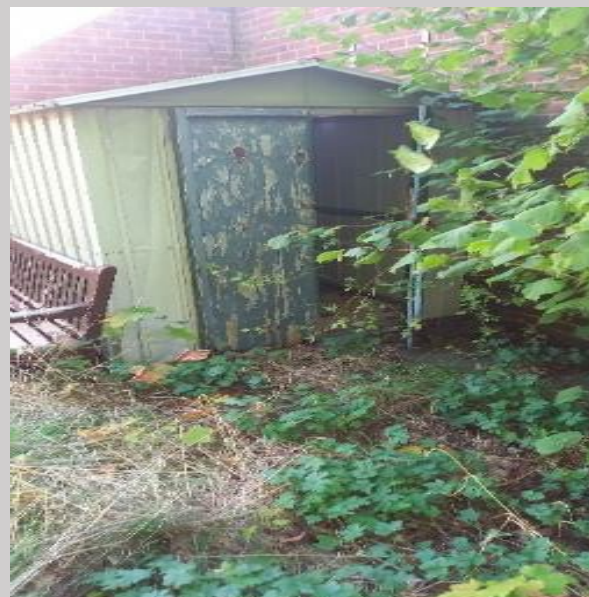
Outbuilding 1 was a small, corrugated shed with a wooden door which was 4.4m<sup>2</sup>. This was located in the northwest of the site behind Building 3 (Photograph 16)

Photograph 16: Outbuilding 1

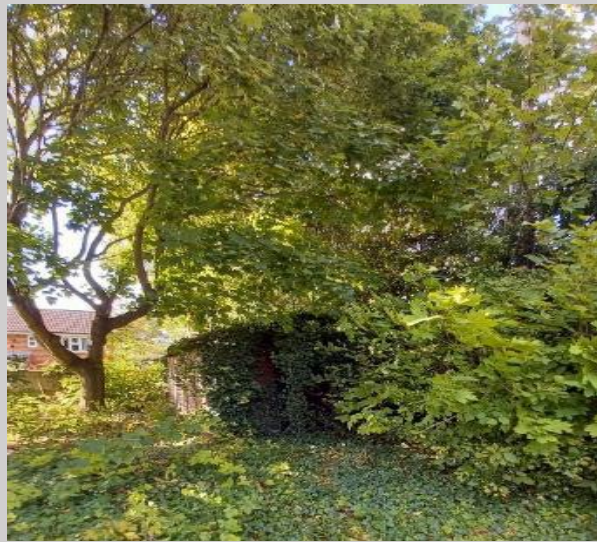
Outbuilding 2 was a large wooden shed (15.6 m<sup>2</sup>) that was in poor condition and had been predominantly covered with Common Ivy (Photograph 17).

Outbuildings 1 and 2 were located within the northeast corner of the site and both were used for storage. Outbuilding 1 was a corrugated metal shed with no potential roost features. Outbuilding 2 was a wooden shed with damage to the roof and wall due to weather and Common Ivy damage. The building had no suitable features for bats.

| Building | Features observed | Potential roosting points | Suitability |
|---|---|---|---|
| Outbuilding 2 | <p><b>External:</b> Wooded shed with damage to roof and south wall aspect. All aspects heavily covered with Common Ivy. No suitable features</p> <p><b>Internal:</b> The interior was well-lit with no suitable features.</p> | N/A | Negligible |

Photograph 17: Outbuilding 2

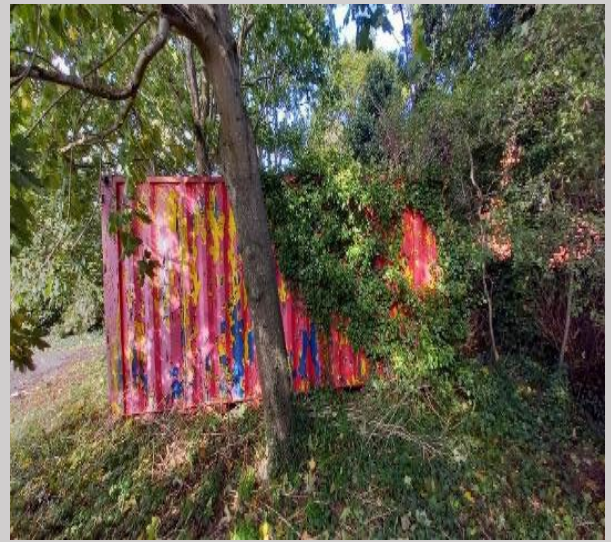
Outbuilding 3 was a large metal shipping container (12 m<sup>2</sup>) placed within the woodland found in the northeast section of the site (Photograph 18).

Photograph 18: Outbuilding 3

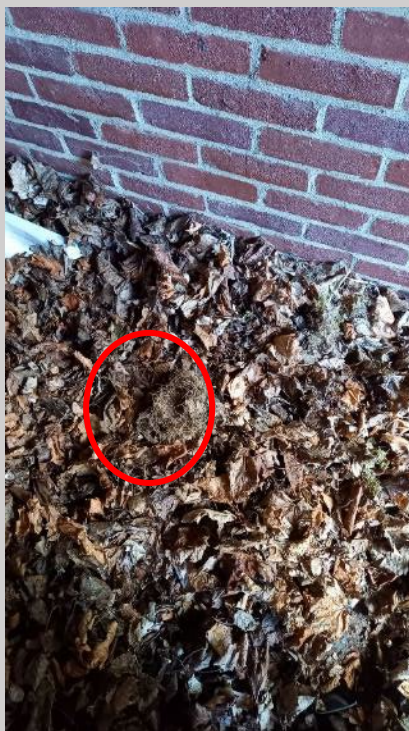
Building 1 had a suitable feature for nesting birds and an old bird's nest was found on the floor by Building 3 (Photograph 19). The scattered trees, hedges with trees and introduced shrubs all provided additional suitable habitats for nesting birds.

Photograph 19: Birds nest on the floor outside Building 3

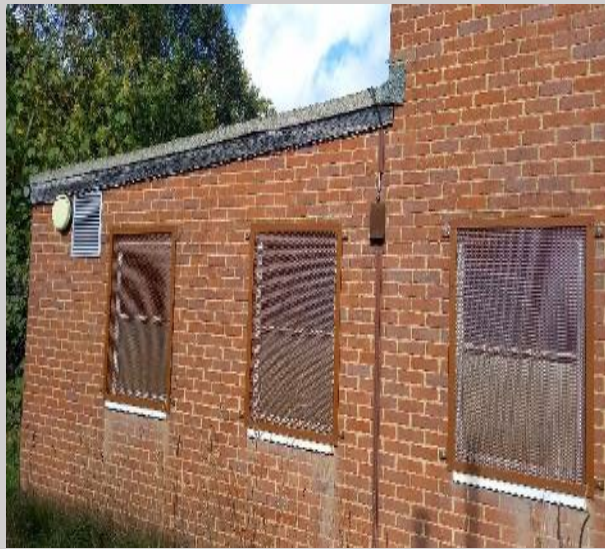
Photograph 21: Southern aspect of Building 3 with wood soffit

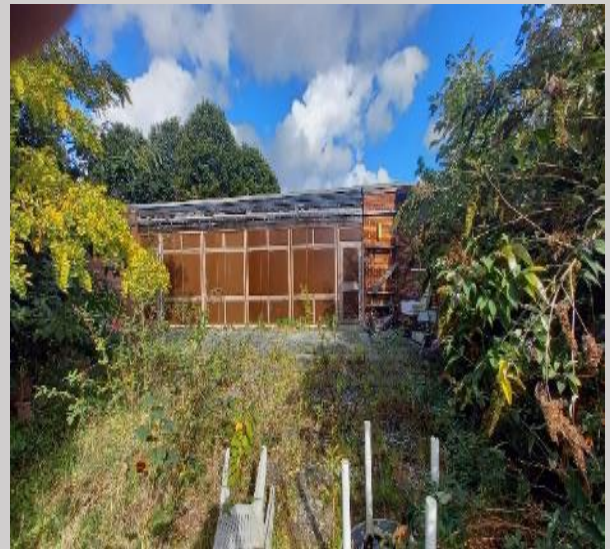
Photograph 22: Exterior windows of Building 3 covered by metal grates

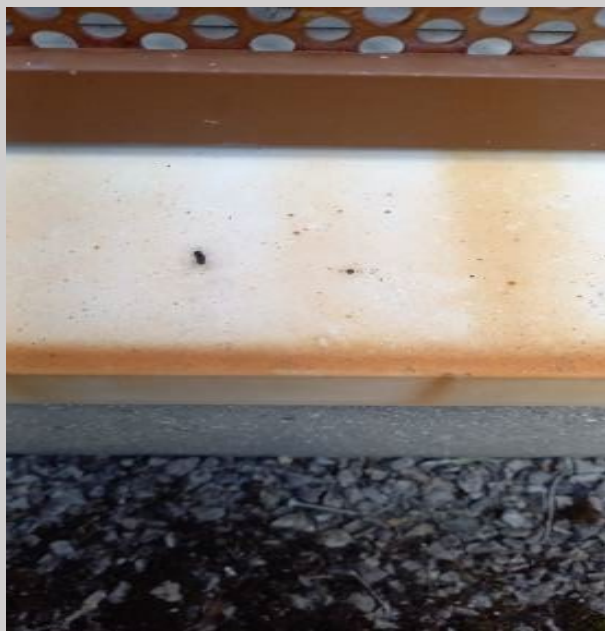
A PRA was carried out on all buildings and trees on site. All buildings on site are currently unused. Droppings were found in the interior and exterior of Building 3. Appendix 6 highlights key findings from the assessment.

| Building | Features observed | Potential roosting points | Suitability |
|---|---|---|---|
| 3 | <p><b>External:</b> Contained building with limited potential for entry. Gaps are found within the brickwork on the southwest aspect. On the southeast aspect gaps were found under external wall felt tiles.</p> <p><b>Internal:</b> Gaps found between wooden ceiling board and roof space with bat droppings underneath. No access to the roof void at the time of the survey</p> | <p>External crevices within missing mortar and gaps under felt tiles. Gaps were also found between drainage features and brickwork.</p> <p>Internally, gaps between the wooden ceiling and the roof void allowed bats to enter the internal structure through the roof void.</p> | Confirmed presence of bats |

Photograph 23: Bat dropping on exterior of Building 3

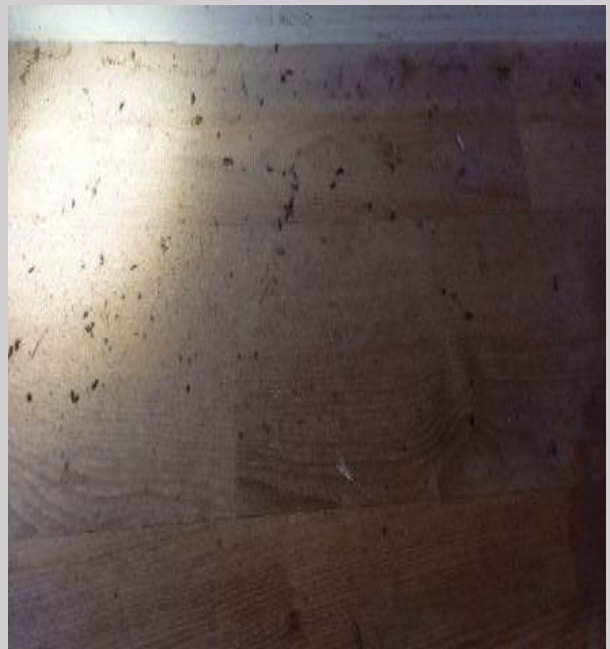
Photograph 24: Bat droppings in interior of Building 3
