## **Bat Mitigation Strategy**

**Commercial Premises, 35, Boulton Road,  
Reading RG2 0NH**

**Phase 1 Daytime Bat Assessment**

**PHASE 2 BAT SURVEY**

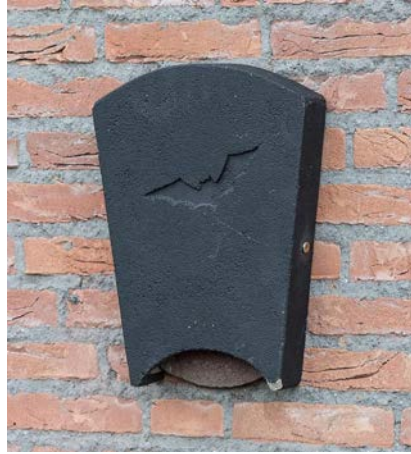
*Figure 9: The Beaumaris Woodstone Bat Box which can be fixed to external walls*

- 4.11 Once the new warehouse structure has been built, additional bat boxes, affixed to the building, will be provided. A total of four Beaumaris Woodstone Bat Boxes (see figure 9 below), or similar dependent on availability, will be affixed to the structure of the building on the western apex.
- 4.12 The location of these bat boxes is shown in Figure 10 and Figure 11 below.

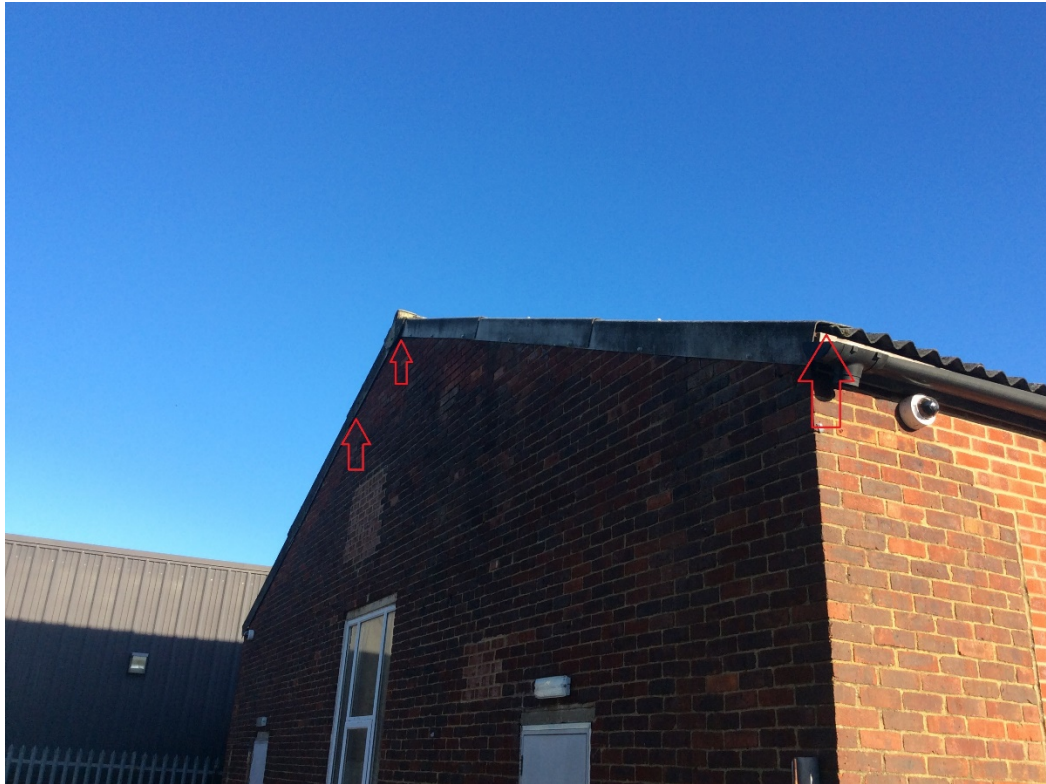
**Figure 2. West gable looking north.** Red arrows indicate potential access points for bats.

There was no evidence of bat activity within the building, however the fascias on the western gable end have some potential for roosting bats. The cement sheet roof is largely close-fitting but is lined internally with potential access above the guttering into the spaces beneath along the entire north and south elevations. The workshop therefore has low potential for bats and **a Phase 2 bat survey is recommended.**

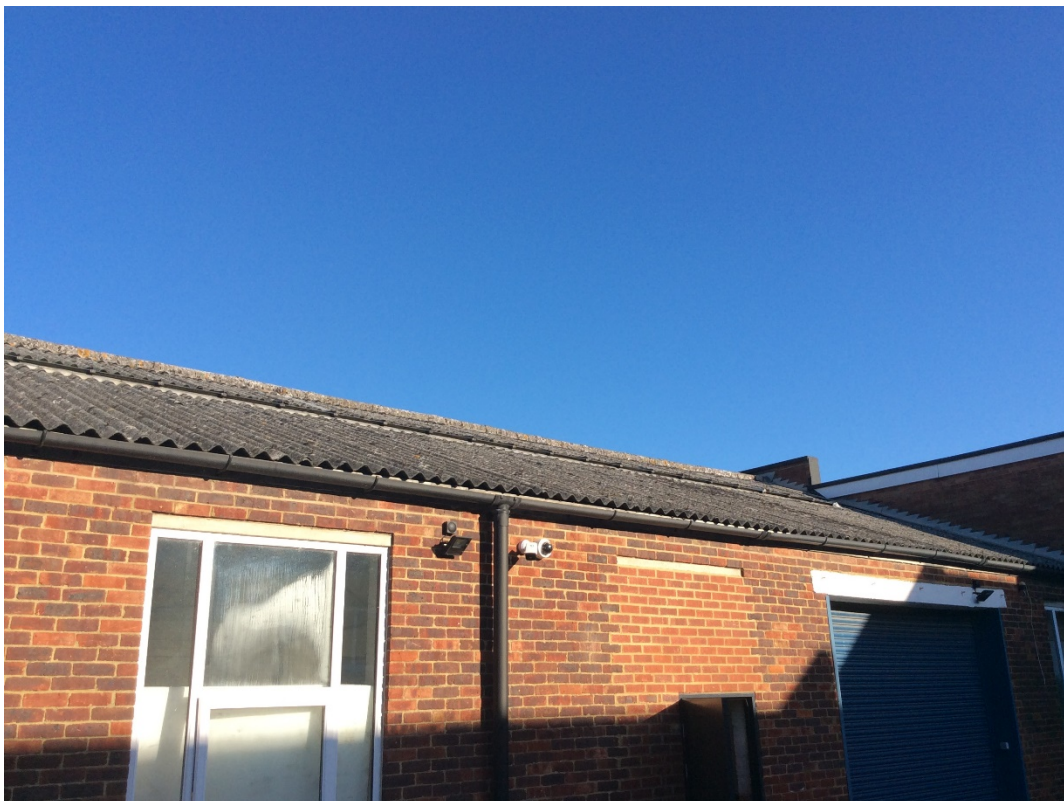
**Figure 2. Southern elevation looking north.** The corrugated sheeting is open above the guttering, providing potential access points into the spaces above the lining.

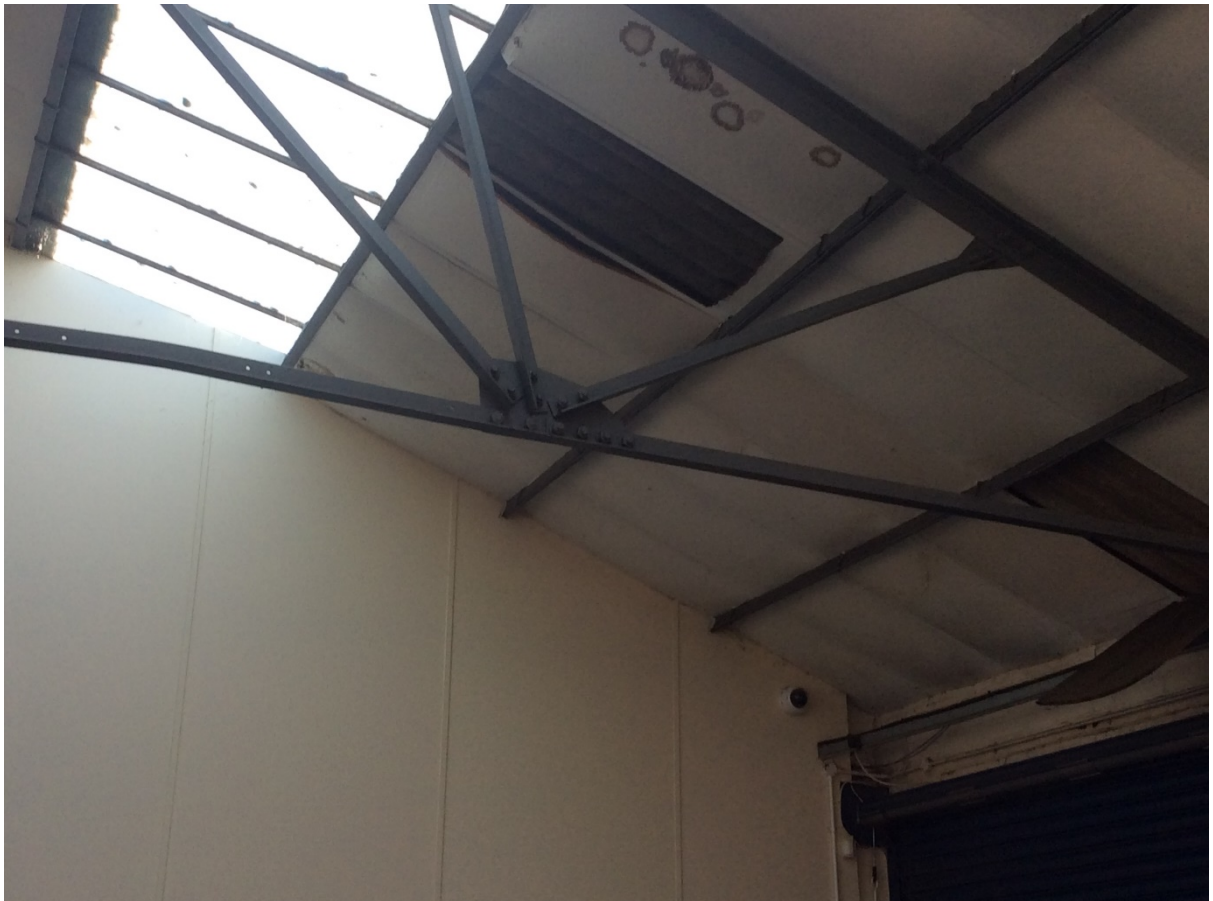
**Interior assessment:** There are no enclosed roof voids, but the roof is lined with fibre board sheets (several of which have failed due to leaks through the cement sheets above). The space between the lining and corrugated sheets is open above the guttering on both the north and south elevations, and therefore could be accessed by roosting bats.

**Figure 3. Interior of workshop looking east.**
