## Bat Emergence and Re-entry Surveys

Great Brighams Mead, Vastern Road, Reading, Berkshire, RG1 8DJ

Kings Oak Miami LLP

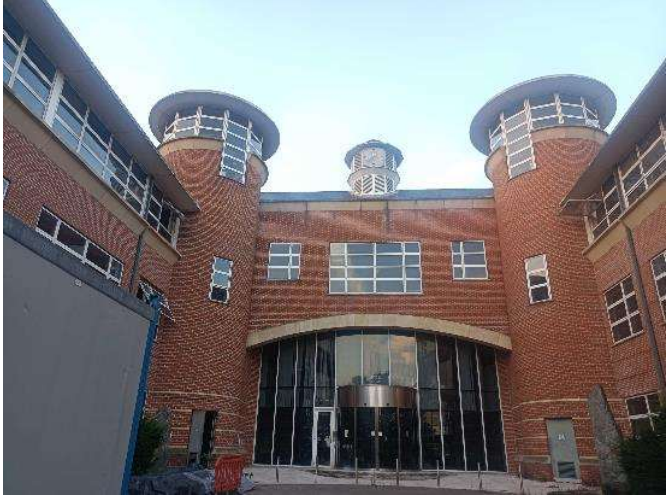
| B1 | 1 | <p><b>Summary: no emergences or re-entries were seen.</b></p> <p>At 20:41 three common pipistrelles were foraging in the central courtyard area in front of B1, until 21:03.</p> <p>At 21:06 a noctule was heard but not seen, constantly until 21:35.</p> <p>At 21:12 a common pipistrelle was heard but not seen, this re-occurred at 21:50.</p> | |

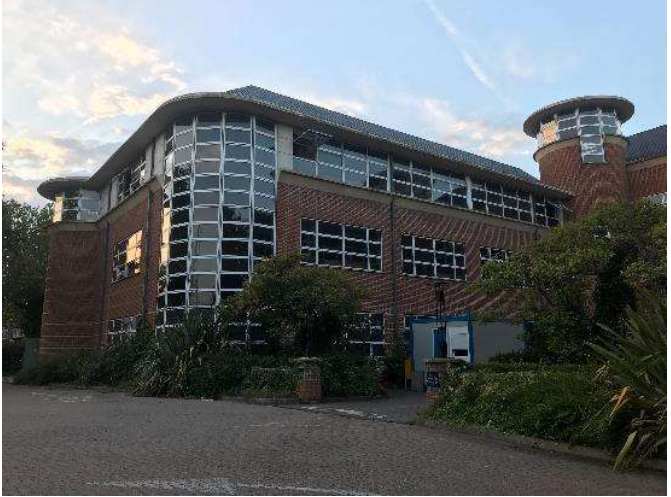
| B1 | 2 | <p><b>Summary: no emergences or re-entries were seen.</b></p> <p>At 20:41 two common pipistrelles were foraging from behind surveyor two and toward the courtyard, this re-occurred at 20:42.</p> <p>At 20:44 a common pipistrelle was foraging in front of B1.</p> <p>At 20:45 a common pipistrelle was foraging from behind surveyor two and toward the courtyard.</p> <p>At 20:52 a common pipistrelle was heard but not seen, this re-occurred at 21:02, 21:11, 21:13 and 21:37.</p> <p>At 21:06 a noctule was heard but not seen.</p> <p>At 21:47 a soprano pipistrelle was heard but not seen.</p> | |

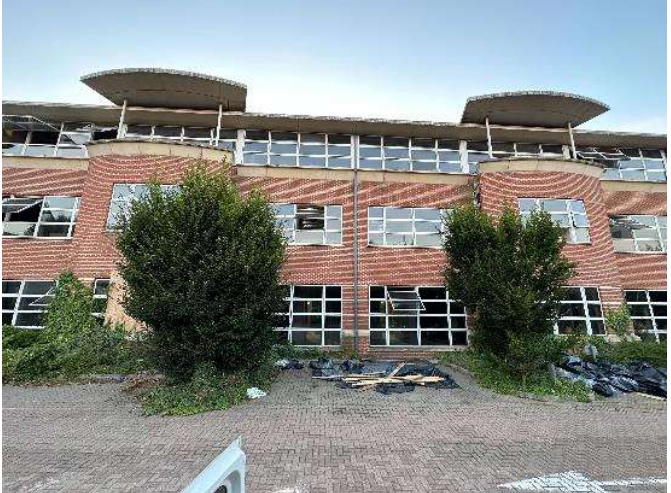
| B1 | 3 | <p><b>Summary: no emergences or re-entries were seen.</b></p> <p>At 20:42 a common pipistrelle was heard but not seen, this re-occurred at 20:45, 20:49, 20:50, 20:51, 20:54, 20:58 and 21:00.</p> <p>At 21:13 a soprano pipistrelle was heard but not seen, this re-occurred at 21:29.</p> | |

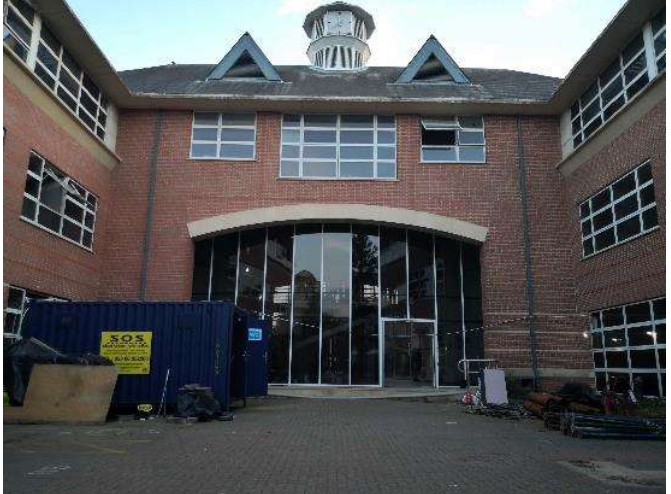
| B1 | 4 | <p><b>Summary: no emergences or re-entries were seen.</b></p> <p>At 20:46 until 20:56 approximately five common pipistrelles were foraging constantly in the courtyard at the rear of the building.</p> <p>At 20:55 a noctule was heard but not seen, this re-occurred at 21:00.</p> <p>At 21:02 a common pipistrelle passed NE → SW.</p> <p>At 21:02 a soprano pipistrelle was heard but not seen, this re-occurred at 21:46 and 21:53.</p> <p>At 21:32 a common pipistrelle was heard but not seen.</p> | |

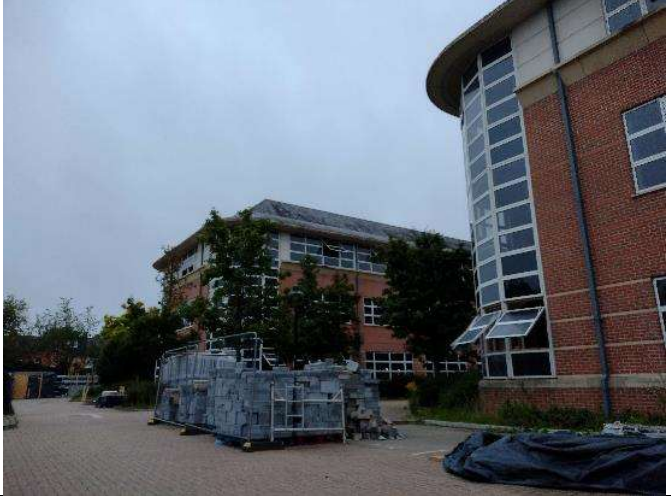
| B1 | 5 | <p><b>Summary: no emergences or re-entries were seen.</b></p> <p>At 20:45 a common pipistrelle was heard but not seen, this re-occurred at 21:21, 21:32 and 21:34.</p> <p>At 20:46 a common pipistrelle was foraging.</p> <p>At 20:56 two common pipistrelles passed from the courtyard at the rear of the building.</p> <p>At 20:59 a noctule was heard but not seen, this re-occurred at 21:04.</p> <p>At 21:18 a soprano pipistrelle passed along the rear of the building.</p> | |

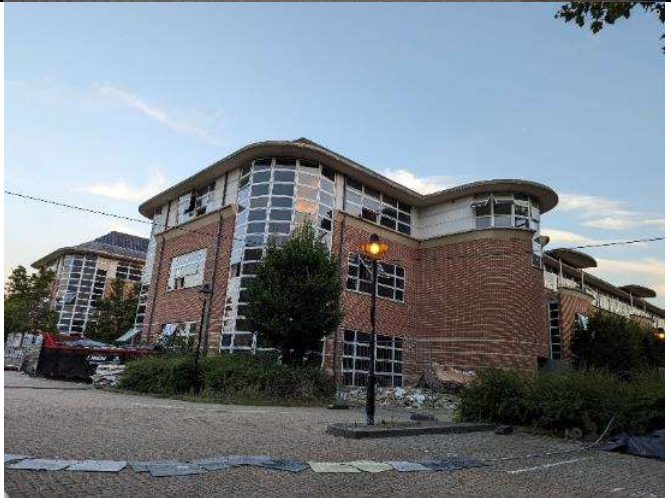
| B1 | 6 | <p><b>Summary: no emergences or re-entries seen.</b></p> <p>At 20:45 a common pipistrelle passed along the treeline and was foraging until 20:55.</p> <p>At 20:48 a common pipistrelle passed over the building.</p> <p>At 20:53 a common pipistrelle was heard but not seen, this re-occurred at 21:04, 21:05, 21:15, 21:17, 21:33 and 21:34.</p> <p>At 20:59 a noctule was heard but not seen, this re-occurred at 21:21, 21:23, 21:29 and 21:44.</p> <p>At 21:18 a soprano pipistrelle was heard but not seen, this re-occurred at 21:19.</p> | |

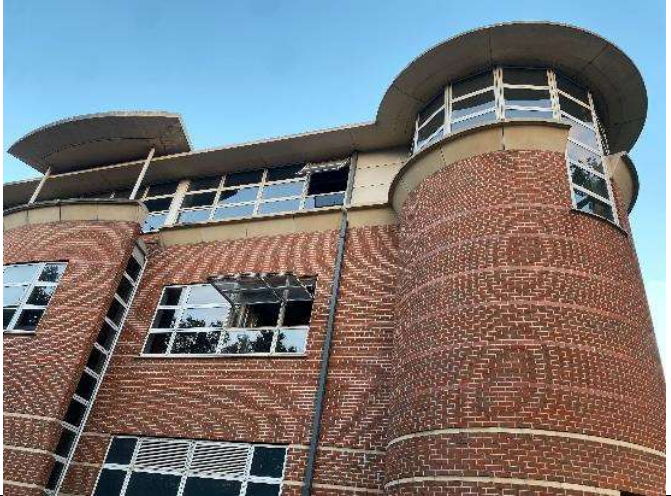
| B1 | 7 | <p><b>Summary: no emergences or re-entries were seen.</b></p> <p>At 20:42 two common pipistrelles were foraging between the building and the site boundary.</p> <p>At 21:19 a common pipistrelle was heard but not seen, this re-occurred at 21:34.</p> <p>At 21:30 a soprano pipistrelle was heard but not seen.</p> <p>At 21:35 a noctule was heard but not seen.</p> | |

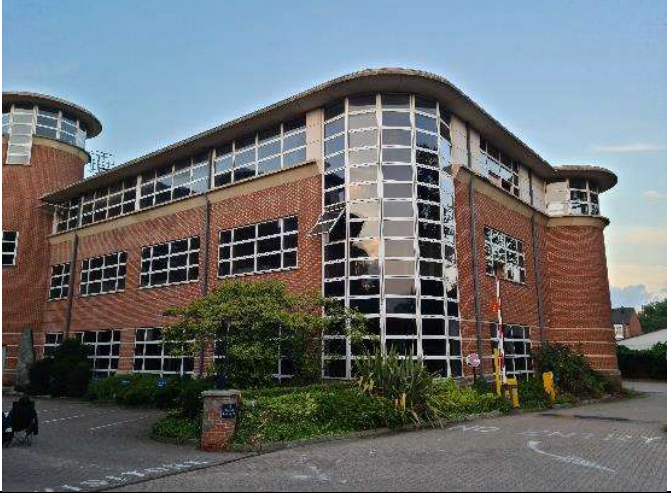
| B1 | 8 | <p><b>Summary: no emergences or re-entries were seen.</b></p> <p>At 20:41 a common pipistrelle was heard but not seen, this re-occurred at 20:53, 20:58, 21:03, 21:30, 21:37 and 21:50.</p> <p>At 20:42 a common pipistrelle passed from the east of the building and flew west.</p> <p>At 20:44 a common pipistrelle passed from above the building and flew southwest.</p> <p>At 20:45 two common pipistrelles were foraging in front of the building, this re-occurred at 20:48, and was consistent from 20:49 until 20:52.</p> <p>At 20:55 a common pipistrelle passed from above the building and flew southwest.</p> <p>At 20:56 a common pipistrelle passed from the east of the building and flew west.</p> <p>At 21:01 a common pipistrelle was foraging amongst the trees in the southeast of the site.</p> | |

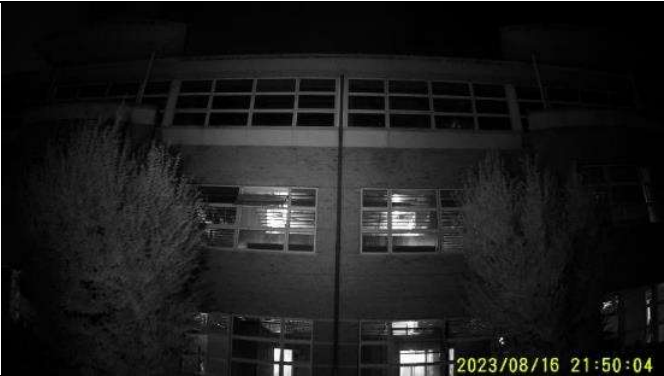
| B1 | 1 | No emergence or re-entries were recorded. | |

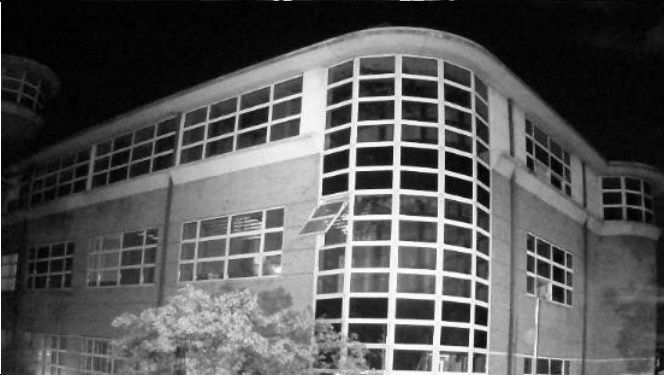
| B1 | 2 | No emergence or re-entries were recorded. | |

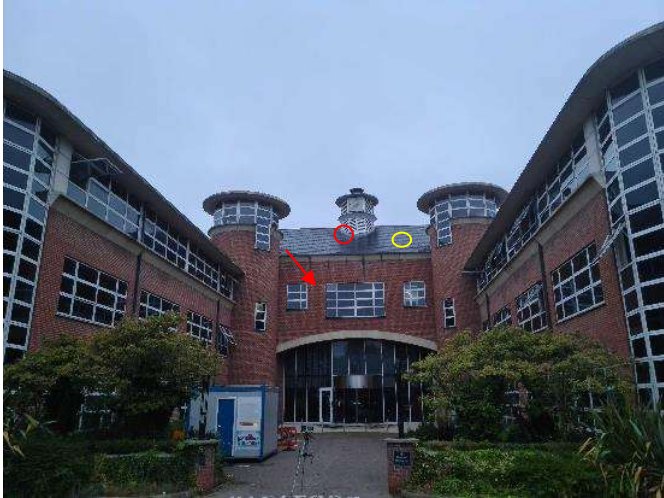
| B1 | 1 | <p><b>Summary: 10-12 CP emergences.</b></p> <p><b>At 20:03 a common pipistrelle emerged from the roof tiles behind the northwest turret and flew west</b> (see red arrow).</p> <p><b>At 20:04 approximately 8-10 common pipistrelles emerged from the roof tiles behind the northwest turret and flew north and east</b> (see red arrow).</p> <p>At 20:04, approximately 4-6 common pipistrelles were constantly active and foraging in front of B1 until 20:16.</p> <p><b>At 20:15 two common pipistrelles emerged from the west side of the central clocktower</b> (circled in red).</p> <p>At 20:17 a common pipistrelle was heard but not seen, this re-occurred at 20:22.</p> <p><b>At 20:21 an unidentified bat emerged from a roof tile between the clock tower and southeast turret, the bat flew east</b> (circled in yellow).</p> <p>At 20:24 an unidentified bat passed from the east over the building and flew west over the building.</p> | |

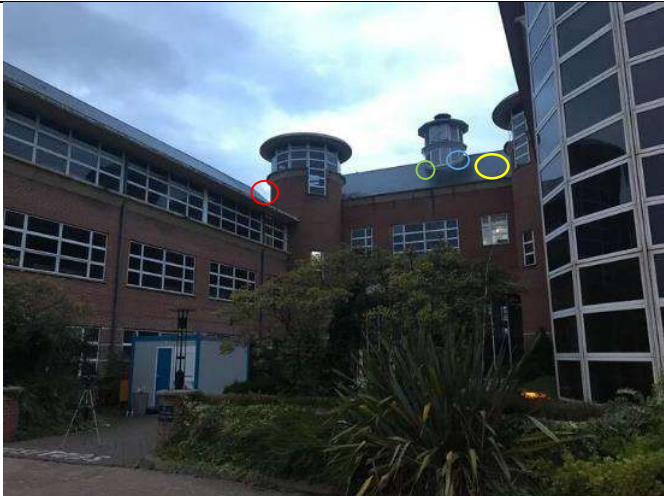
| B1 | 2 | <p><b>Summary: nine CP emergences.</b></p> <p>At 20:02 a common pipistrelle passed from the courtyard and flew south.</p> <p><b>At 20:03 four common pipistrelles emerged from the roof tiles behind the northwest turret</b> (same as P1) (see red circle).</p> <p><b>At 20:07 two common pipistrelles emerged from roof tiles between the clock tower and the southeast turret</b> (circled in yellow).</p> <p><b>At 20:11 two common pipistrelles emerged from the west side of the central clock tower</b> (circled in green).</p> <p><b>At 20:15 one common pipistrelle emerged from the east side of the central clock tower</b> (circled in blue).</p> <p>At 20:21 a common pipistrelle was heard but not seen, this re-occurred at 21:12 and 21:23.</p> | |

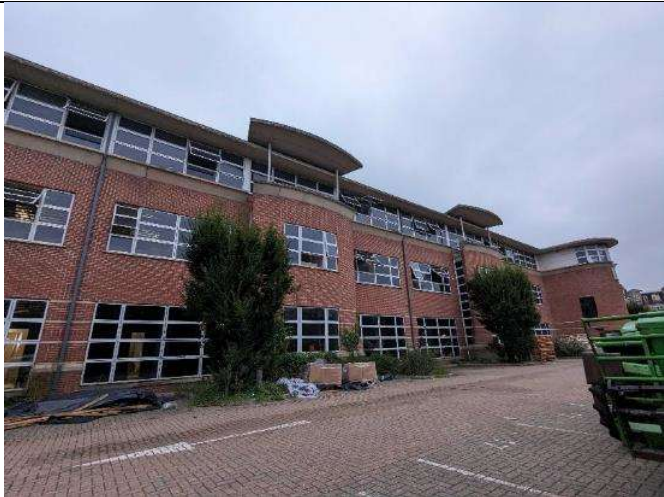
| B1 | 3 | <p><b>Summary: no emergences or re-entries were seen.</b></p> <p>At 20:02 a common pipistrelle flew along the western elevation of the building.</p> <p>At 20:06 a common pipistrelle passed across and over the building.</p> <p>At 20:06 a common pipistrelle flew along the eastern elevation of the building, this activity re-occurred frequently throughout the duration of the survey, with the last activity being recorded at 20:39.</p> <p>At 20:39 a noctule was heard, but not seen, every few minutes until 20:58.</p> | |

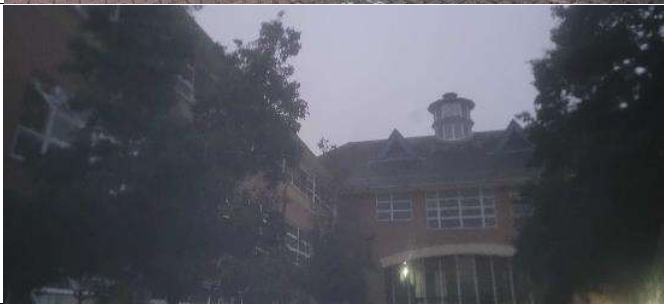
| B1 | 4 | <p><b>Summary: no emergences or re-entries were seen.</b></p> <p>From 19:54 until 21:12 there was continuous common pipistrelle foraging and intermittent commuting activity. Common pipistrelle bats were observed foraging in the courtyard at the rear of the building and were seen passing over and across the building.</p> | |

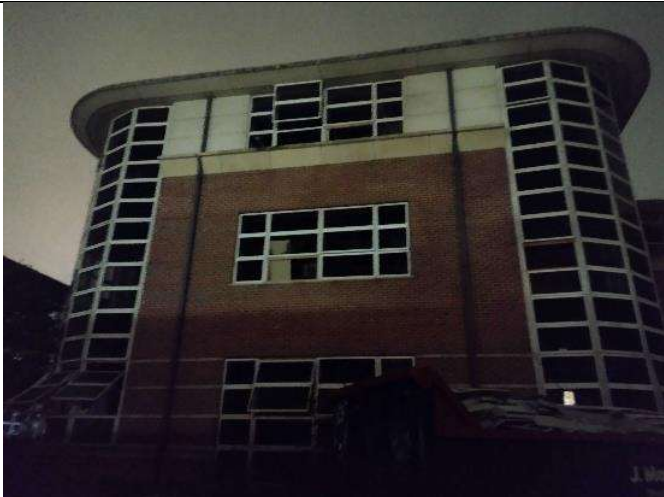
| B1 | 5 | <p><b>Summary: no emergences or re-entries were seen.</b></p> <p>At 20:14 a common pipistrelle passed over the building.<br/> At 20:16 a common pipistrelle was heard but not seen.<br/> At 20:17 a common pipistrelle was observed foraging in the courtyard at the rear of the building.<br/> At 20:47 a soprano pipistrelle was heard but not seen.<br/> At 21:17 a noctule was heard but not seen.</p> | |

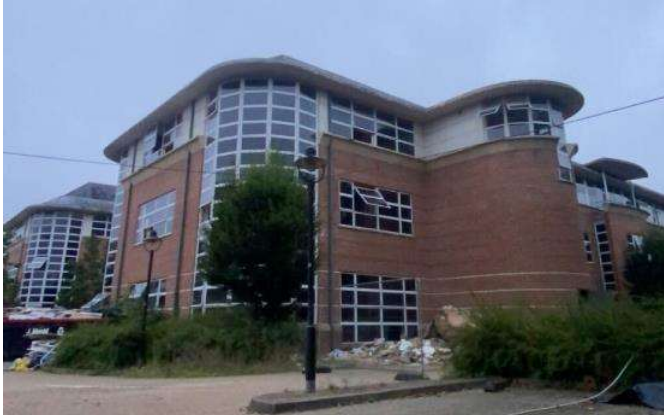
| B1 | 6 | <p><b>Summary: no emergences or re-entries were seen.</b></p> <p>At 20:05 a common pipistrelle was heard but not seen, this re-occurred at 20:16.<br/> At 20:30 a noctule was heard but not seen, this re-occurred occasionally throughout the survey and was recorded for the last time at 20:54.<br/> At 21:12 a myotis was heard but not seen.</p> | |

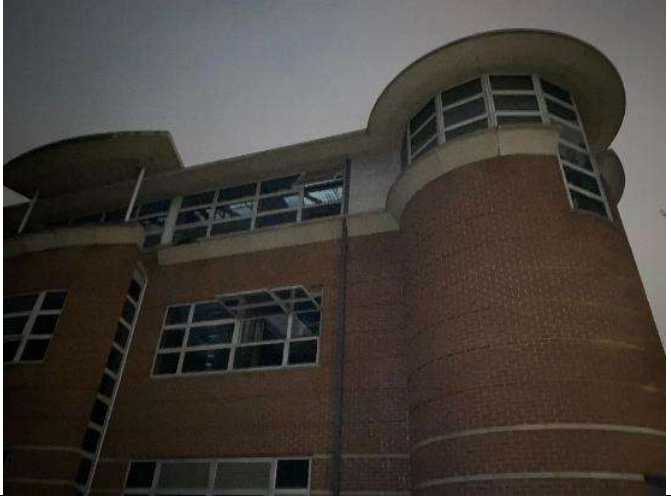
| B1 | 7 | <p><b>Summary: no emergences or re-entries were seen.</b></p> <p>At 20:00 a common pipistrelle was heard but not seen, this re-occurred at 20:10 and 20:58.</p> <p>At 20:30 a common pipistrelle was foraging between the building and the trees.</p> <p>At 20:47 a soprano pipistrelle passed behind surveyor seven along the site boundary.</p> <p>At 21:04 a soprano pipistrelle was heard but not seen.</p> | |

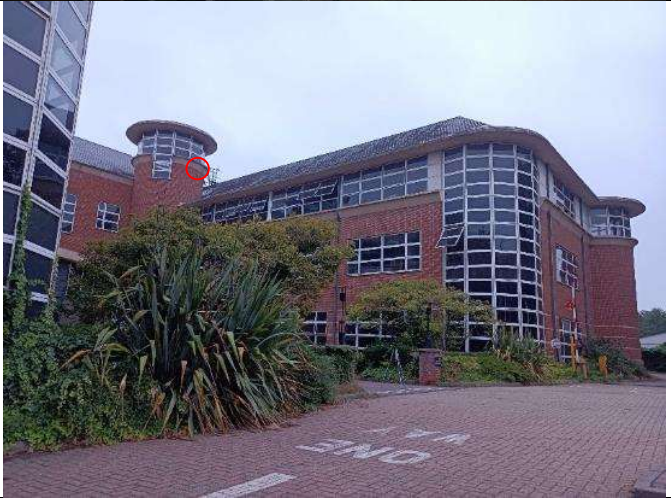
| B1 | 8 | <p><b>Summary: One CP emergence.</b></p> <p>At 20:00 a common pipistrelle passed W → N.</p> <p>At 20:04 a common pipistrelle was heard but not seen, this re-occurred at 21:22.</p> <p>At 20:06 approximately seven common pipistrelles flew south across the building.</p> <p>At 20:10 a common pipistrelle flew E → W over the building.</p> <p><b>At 20:16 a common pipistrelle was observed emerging from a join in the concrete on the southeast turret (circled in red).</b></p> <p>At 20:16 four common pipistrelles flew south across the building.</p> <p>At 20:43 a noctule was heard but not seen.</p> | |

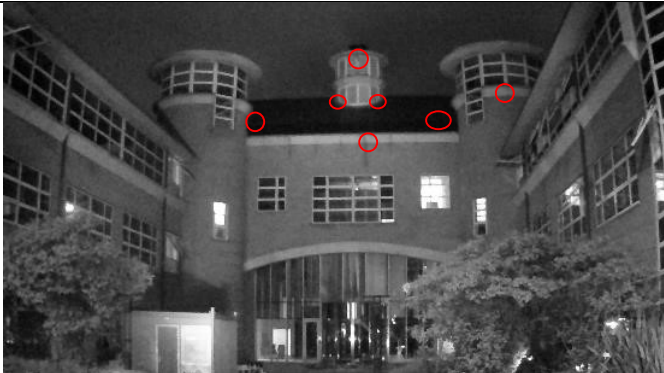
| B1 | 1 | Approximately 14 bats were recorded emerging from seven different locations on the south elevation of B1, not all emergences were observed by the surveyors in positions 1, 2, and 8. The locations are circled in red. | |

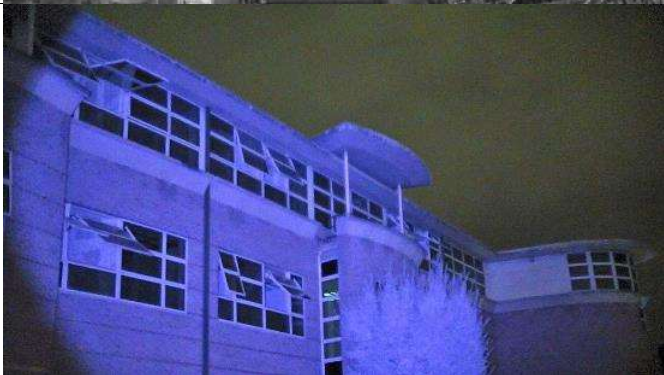
| B1 | 2 | No emergences or re-entries were recorded. | |

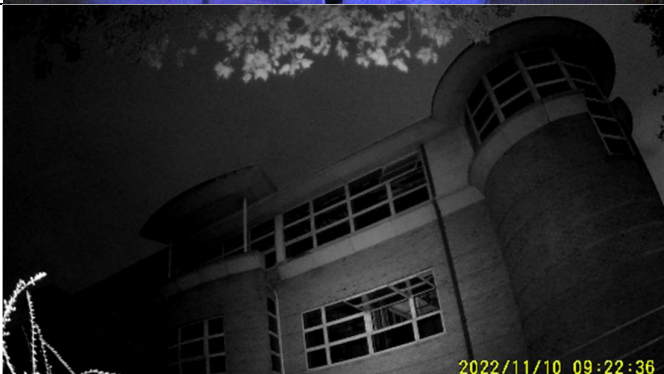
| B1 | 3 | No emergences or re-entries were recorded. | |

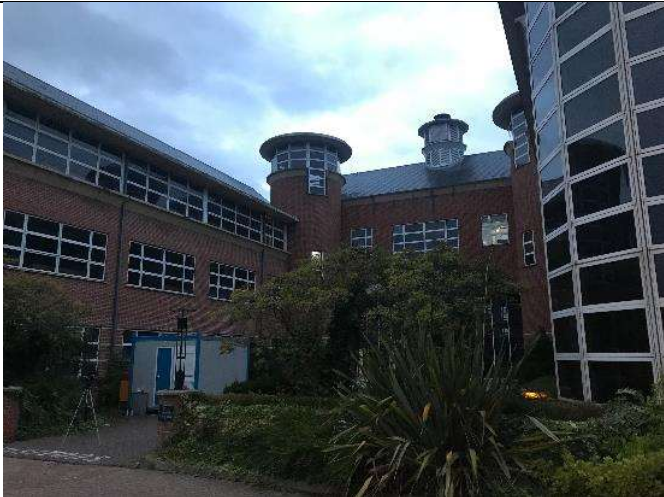
| B1 | 1 | <p><b>Summary: no emergences or re-entries were seen.</b></p> <p>At 20:14 a common pipistrelle was heard but not seen, this re-occurred at 20:15, 20:23 and 20:26.</p> | |

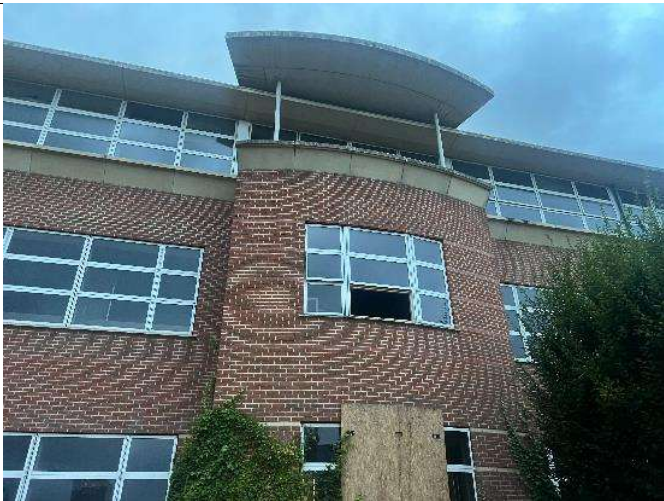
| B1 | 2 | <p><b>Summary: no emergences or re-entries were seen.</b></p> <p>At 19:52 a common pipistrelle was heard but not seen, this re-occurred frequently throughout the night and the final recording was noted at 20:26.</p> | |

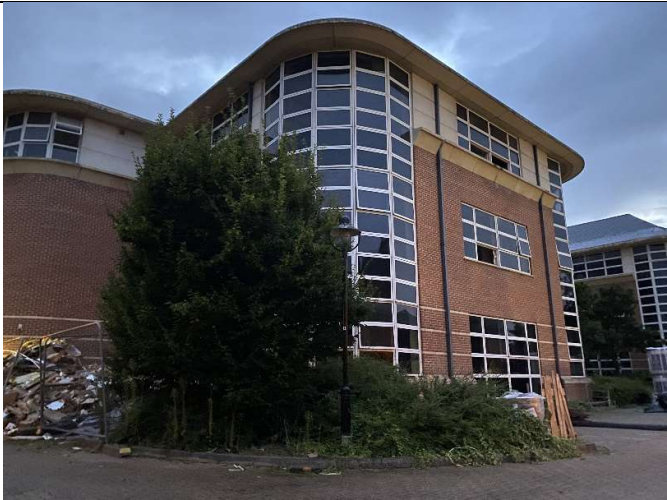
| B1 | 3 | <p><b>Summary: no emergences or re-entries were seen.</b></p> <p>At 19:47 a Soprano pipistrelle was heard but no seen, likely commuting northwest of the site.</p> <p>At 19:56 a common pipistrelle was heard but not seen, this reoccurred at 20:02, 20:07, and 20:11.</p> | |

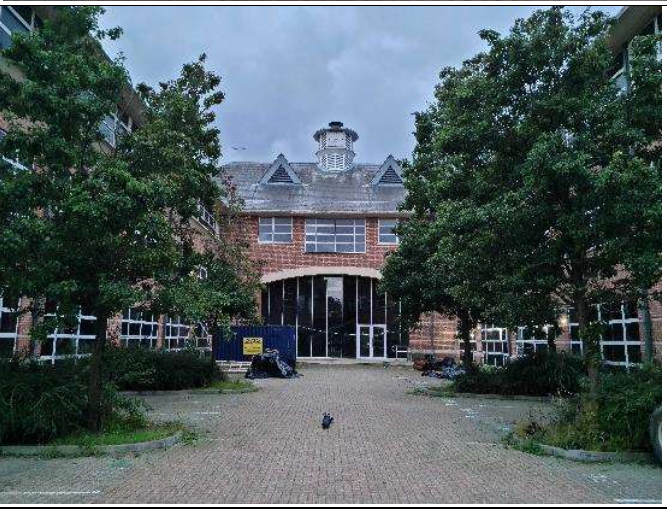
| B1 | 4 | <p><b>Summary: no emergences or re-entries were seen.</b></p> <p>At 19:47 a common pipistrelle was heard but not seen, this re-occurred at 19:53, 20:07, 20:10 and 20:24.</p> | |

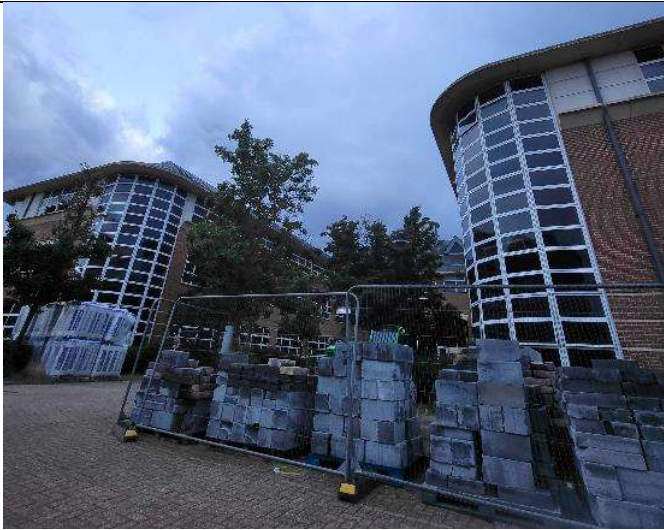
| B1 | 5 | <p><b>Summary: no emergences or re-entries were seen.</b></p> <p>At 19:46 a soprano pipistrelle was heard but not seen.</p> | |

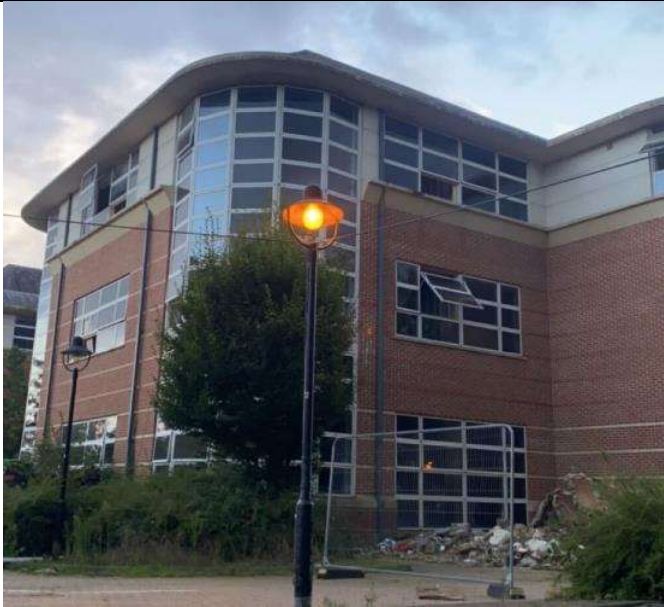
| B1 | 6 | <p><b>Summary: no emergences or re-entries were seen.</b></p> <p>At 20:11 a common pipistrelle was heard but not seen, this re-occurred at 20:15, 20:20 and 20:25.</p> | |

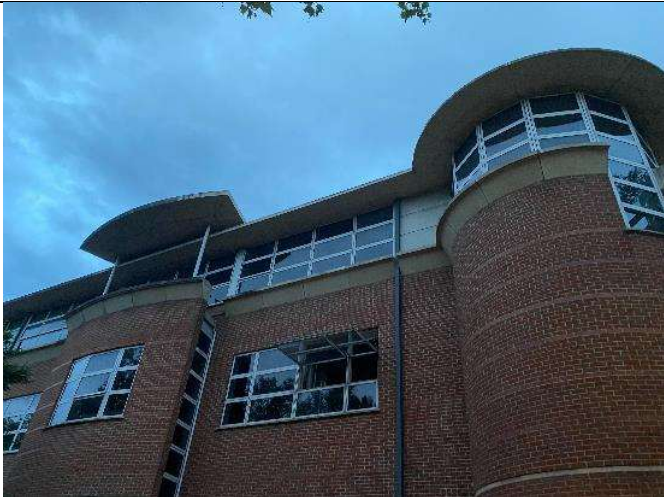
| B1 | 7 | <p><b>Summary: no emergences or re-entries were seen.</b></p> <p>At 20:16 a common pipistrelle was heard but not seen, this re-occurred at 20:18, 20:20 and 20:26.</p> | |

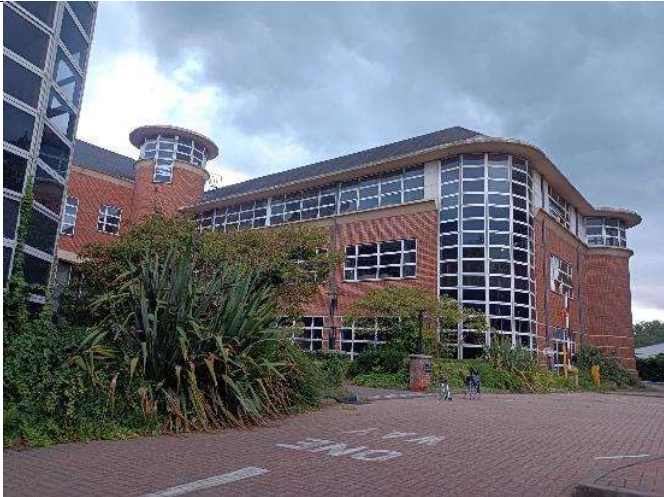
| B1 | 8 | <p><b>Summary: no emergences or re-entries were seen.</b></p> <p>At 20:15 a common pipistrelle was heard but not seen, this re-occurred at 20:17 and 20:23.</p> | |

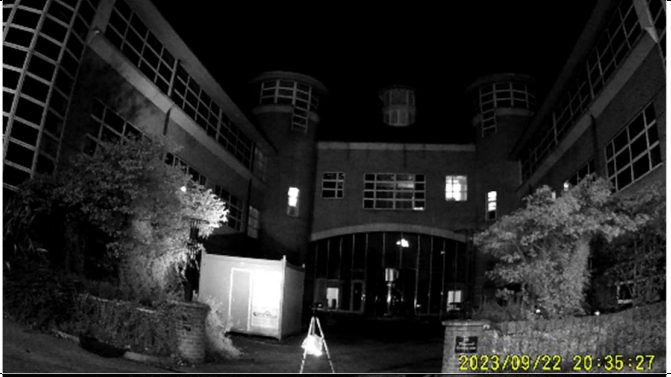
| B1 | 1 | No emergencies or re-entries were recorded. | |

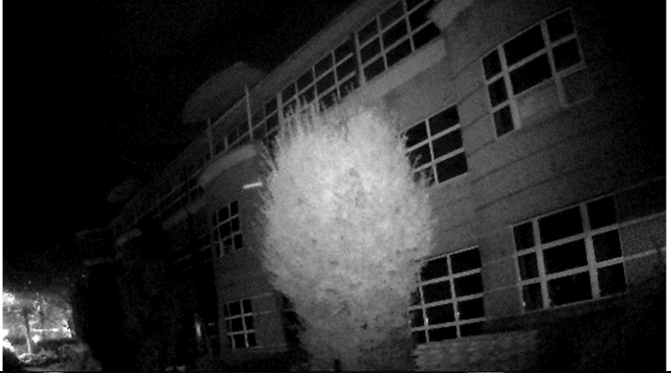
| B1 | 2 | No emergencies or re-entries were recorded. | |

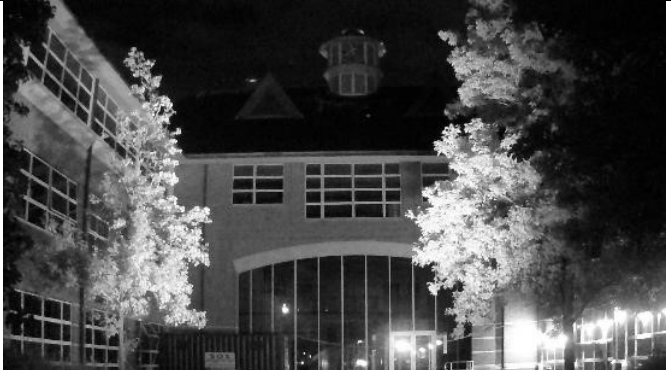
| B1 | 3 | No emergencies or re-entries were recorded. | |

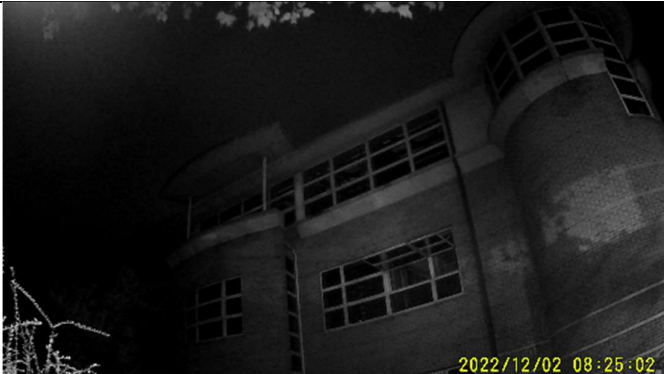
| B1 | 4 | No emergences or re-entries were recorded. | |
