# 8 Ardler Road, Caversham, Reading, Berkshire

08/08/2023

Phase 1 Bat Surveys:

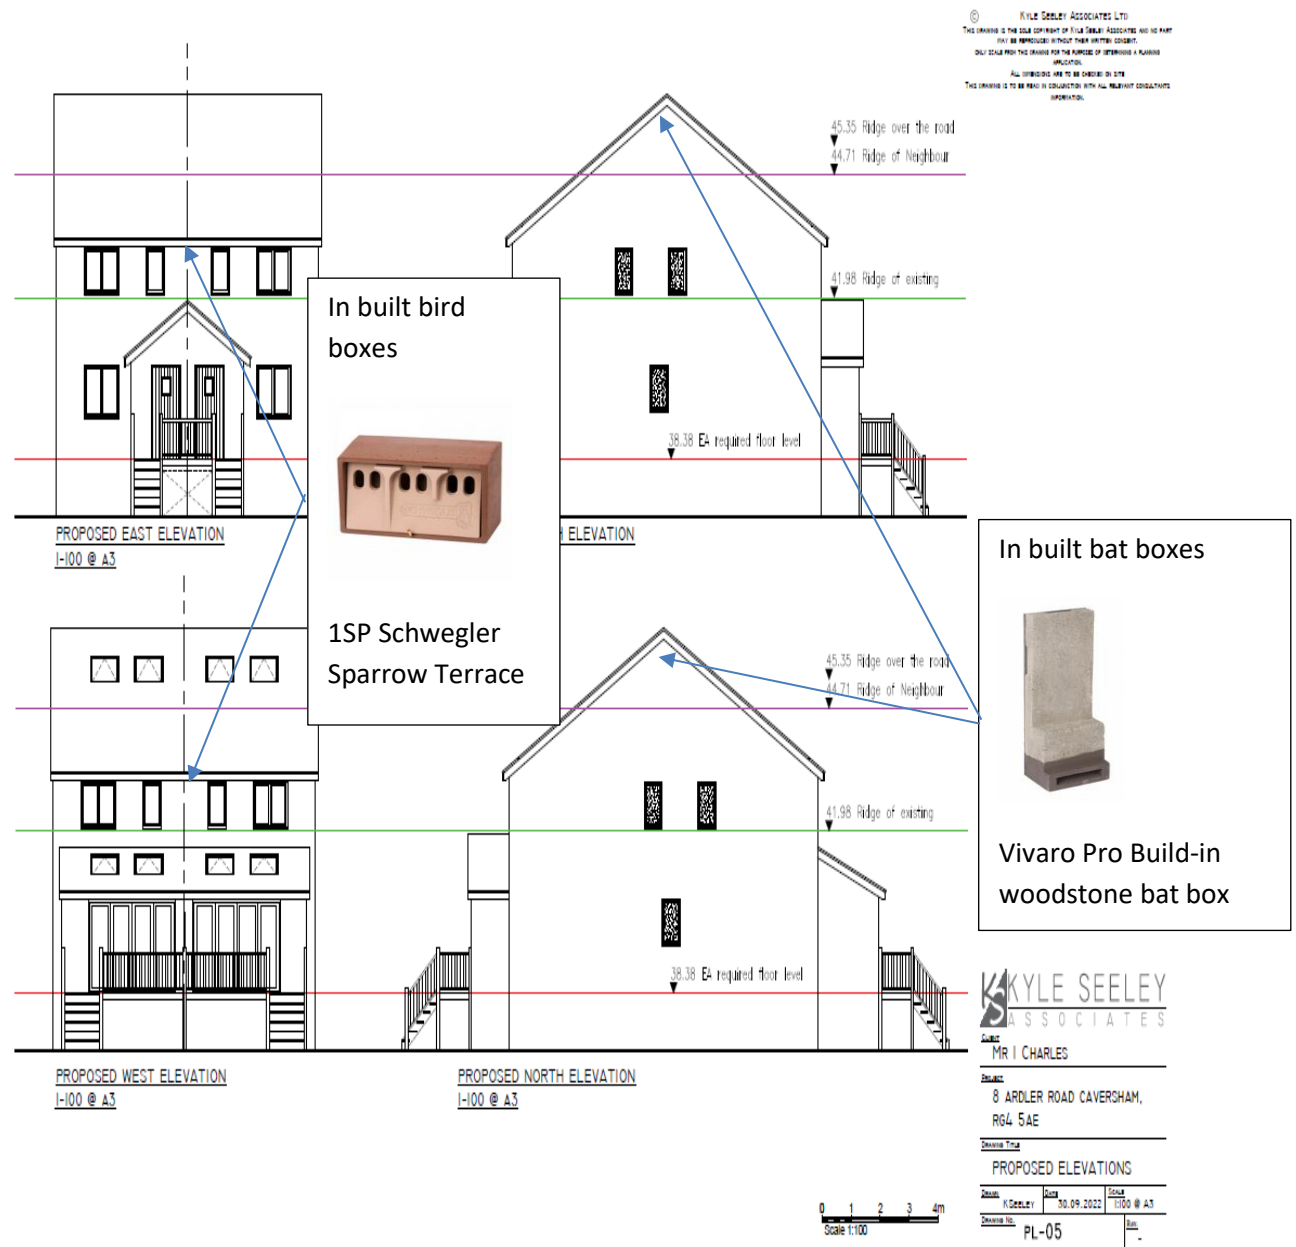
**Figure 1: Proposed Bio enhancements.**

- 3.7 It is recommended that built in bat and bird boxes are incorporated into all the new elevations of the proposed building. These should be placed as high as possible with minimal to no light spill on them, with clear flight paths to and from. Further information can be obtained either form an ecologist or the manufactures/suppliers of the boxes.

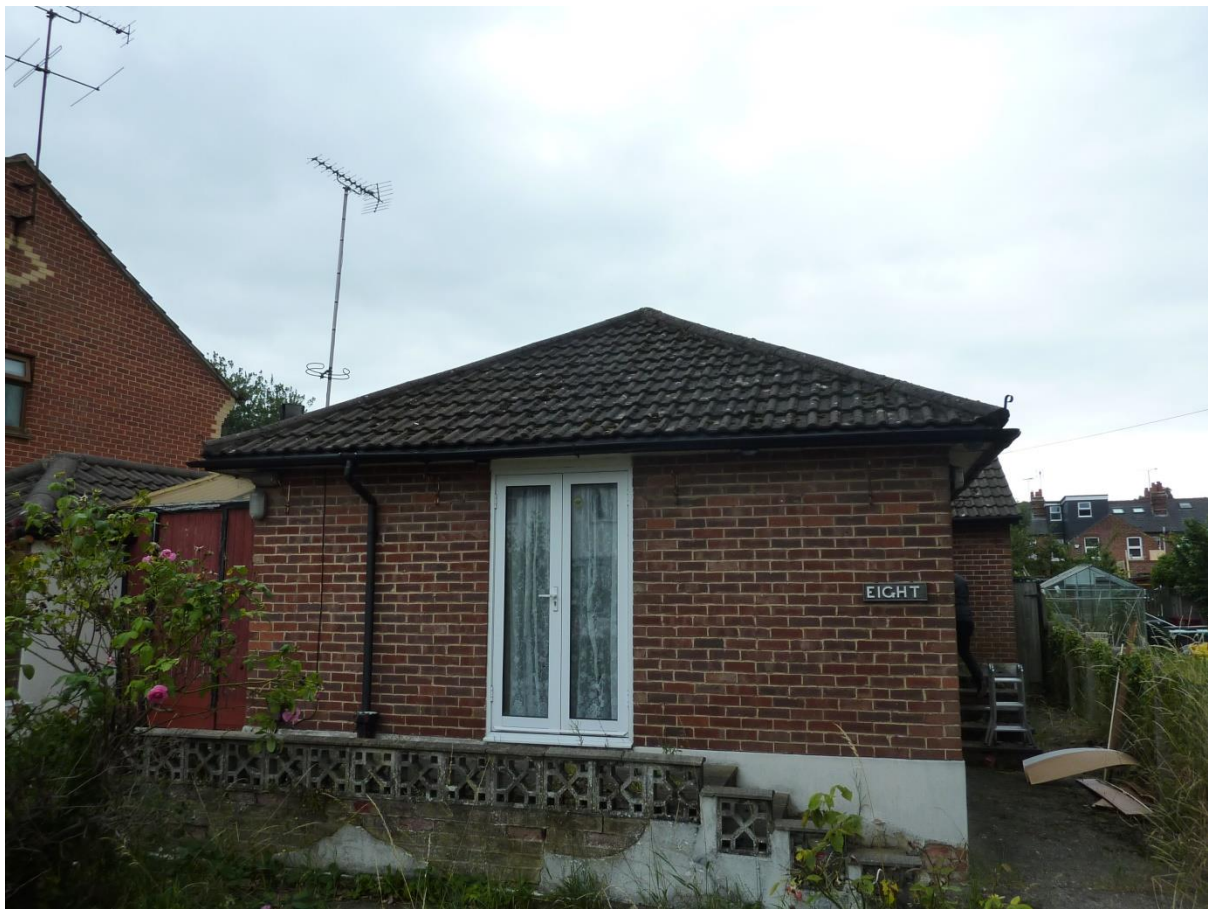
**Picture 1:** The eastern elevation

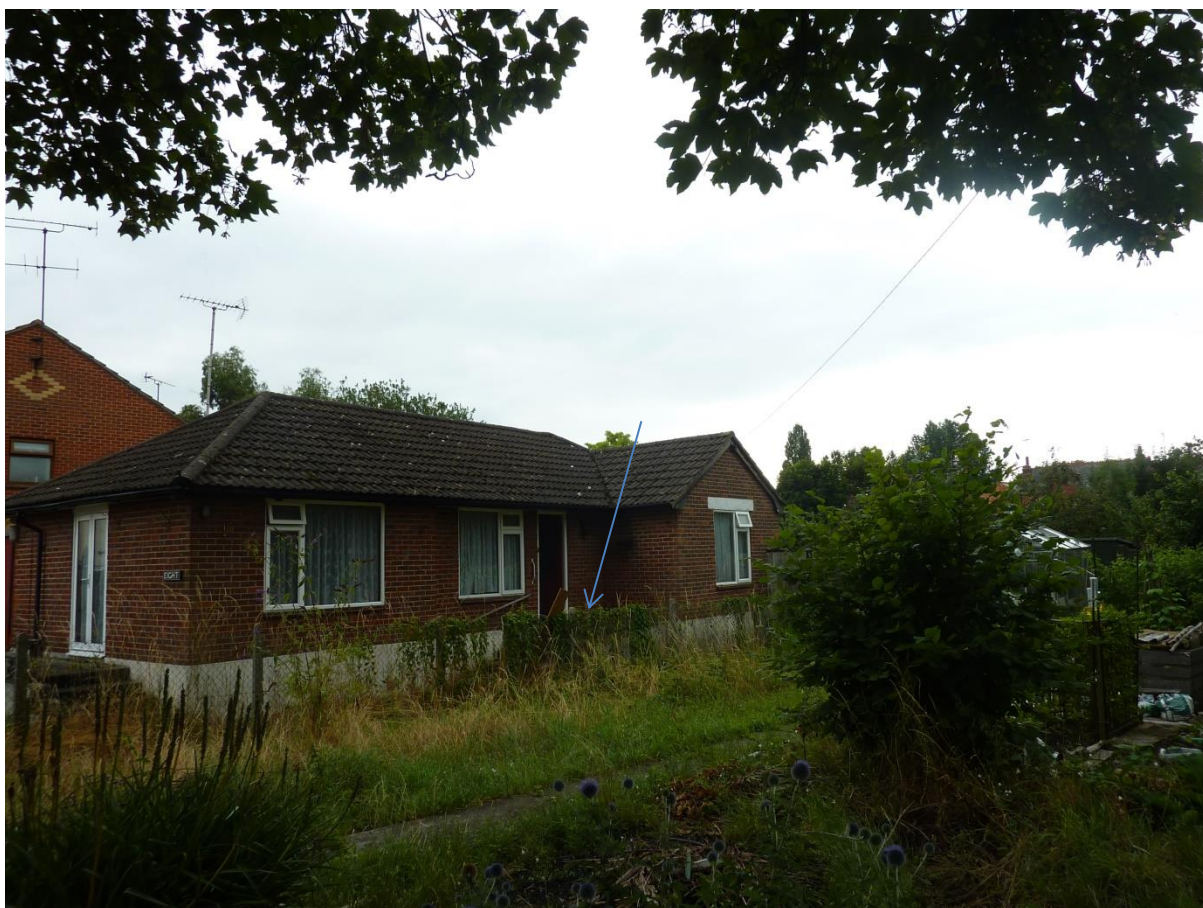
**Picture 2:** The northern elevation of the building, this picture is taken from the neighbouring plot the chain link fence is the boundary for this property (arrowed).

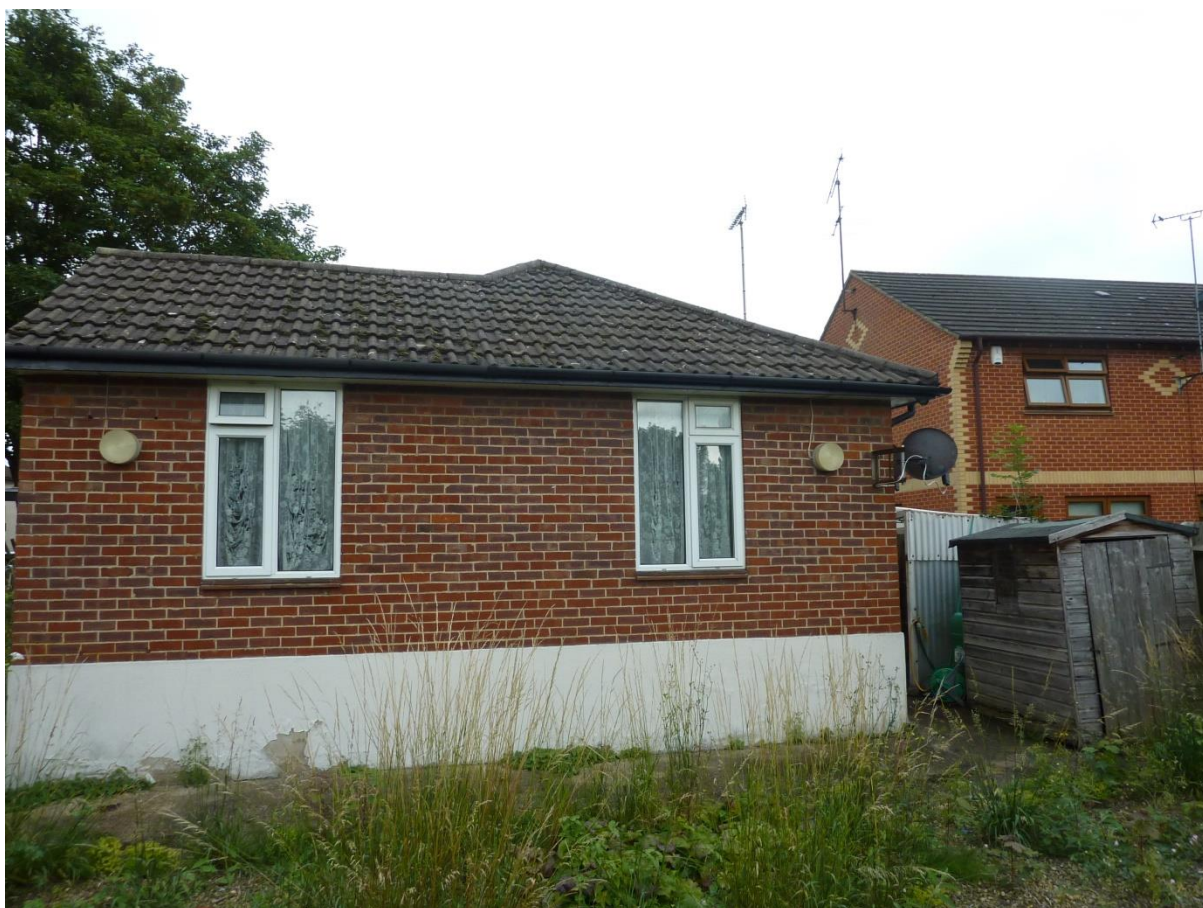
**Picture 3:** Showing the western elevation

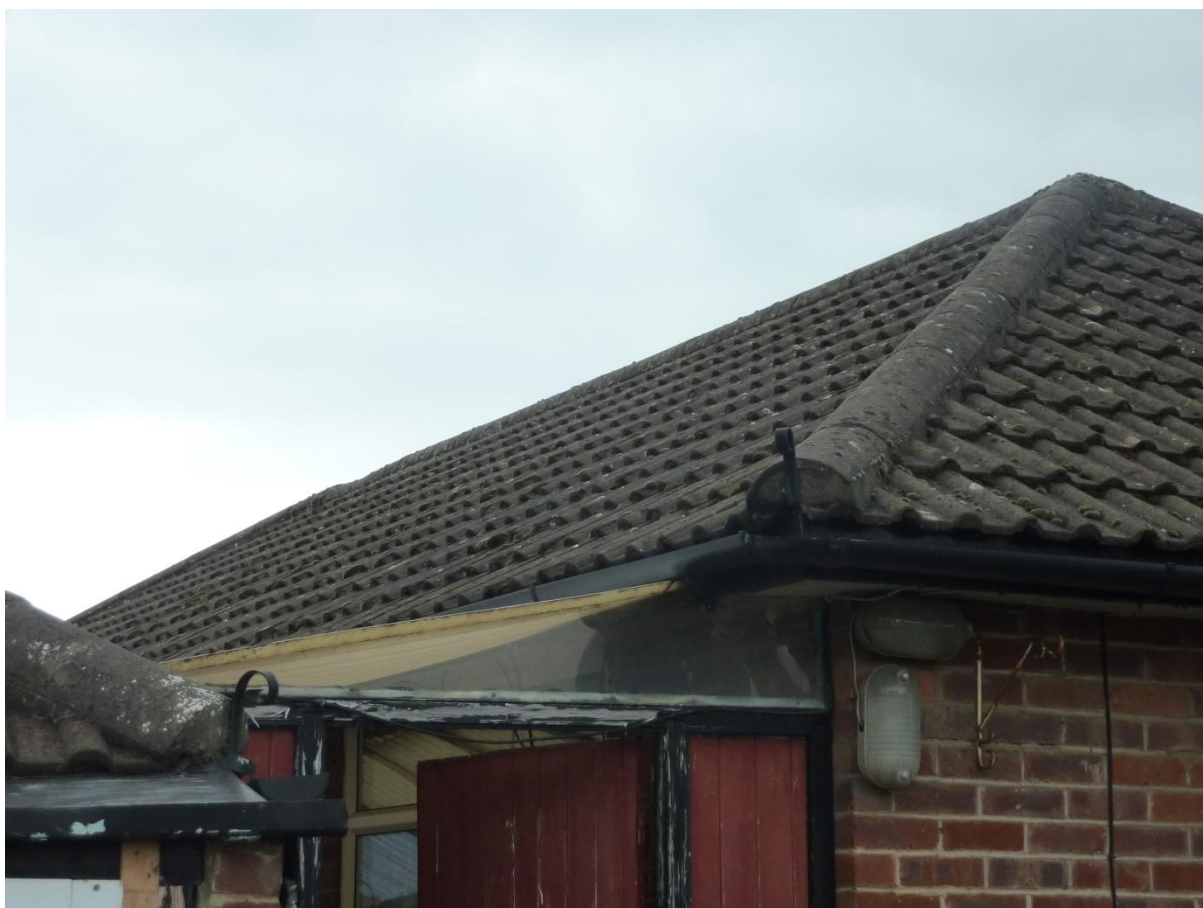
**Picture 4:** Showing the southern elevation

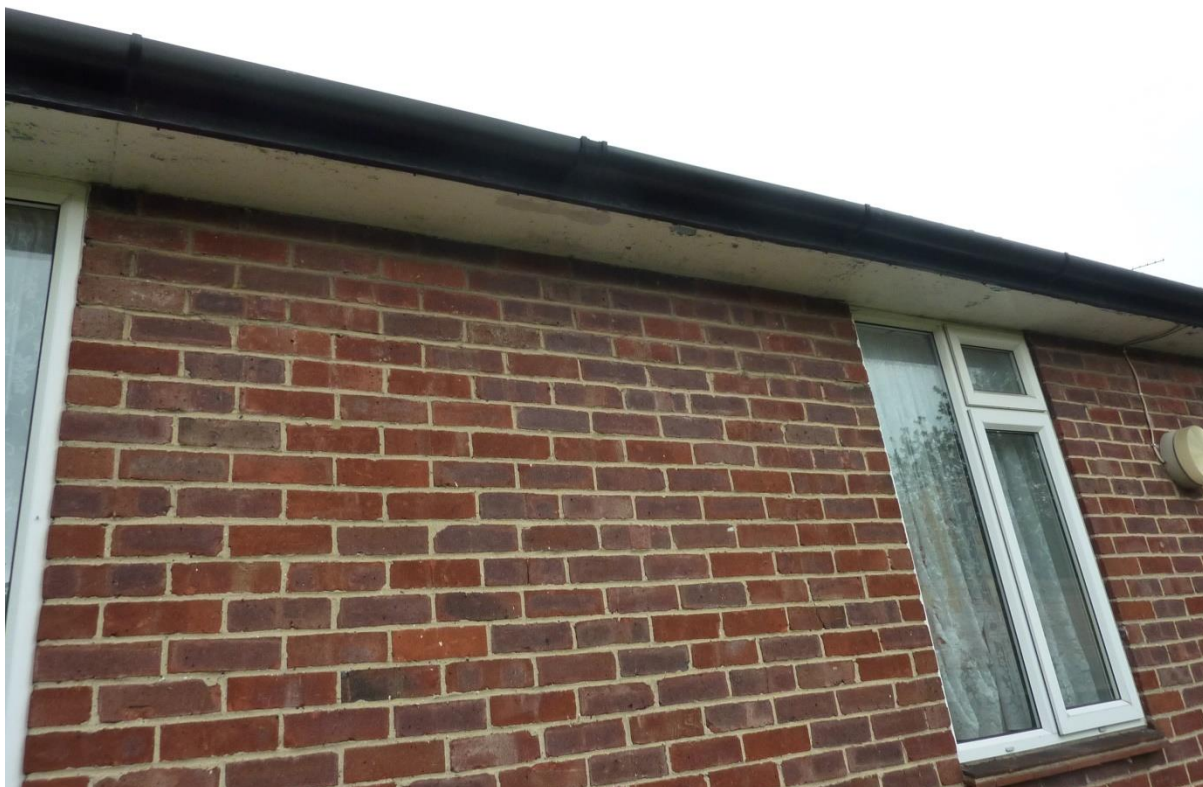
- 2.3 8 Ardler road is a single storey brick-built building with a cavity which seems to been built around the 1970's.
- 2.4 The eaves are tight fitting and are made with concrete fibre board; there are no gaps that would help the ingress of bats into this building.

- 2.5 The windows are mostly of uPVC construction and there are no gaps around any of the facias which would allow ingress.
- 2.6 The roof is made with tight fitting clay/concrete tiles there are no gaps or missing tiles, the ridge is made of a similar material again there are no gaps.

**Picture 5:** Showing the tight eaves and the UPVC windows
