# Preliminary Ecological Appraisal

Hexham Road, Reading

For  
Reading Borough Council

June 2021

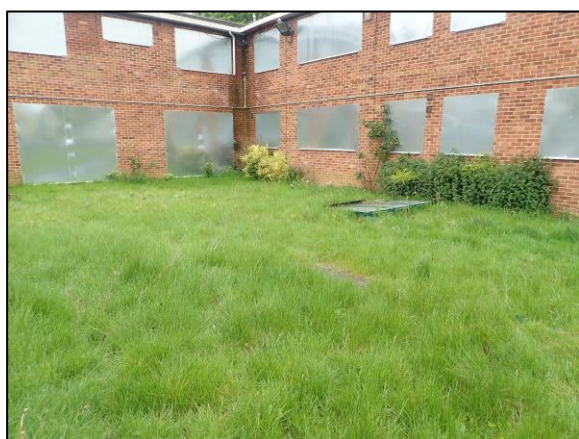
**Photo 3** Amenity grass to front of building

- 3.8. The main habitats present at and around the site are shown in the Phase 1 habitat map in Appendix 3.
- 3.9. Much of the grassland area of the site appears to be more regularly managed with a shorter sward height. See Photos 3 and 4.

- 3.10. These areas are found around the more publicly visible areas to the front (north) and side (west) parts of the site. These amenity grassland areas have a low to moderate diversity of common and widespread herb species within the sward. Species include, for example at Target Note (TN) 2 prickly lettuce *Lactuca serriola*, dandelion *Taraxacum* agg., cinquefoil *Potentilla reptans*, hedgerow cranesbill *Geranium pyrenaicum*, doves-foot cranesbill *G. molle*, yarrow *Achillea millefolium*, red dead-nettle *Lamium purpureum*, white dead-nettle *L. album*, common field speedwell *Veronica persica*, and field bindweed *Convolvulus arvensis*.

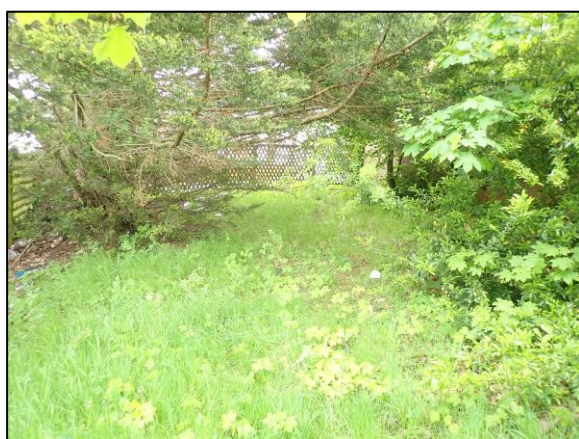
**Photo 5** Grassland at TN1

- 3.11. There is a smaller area of longer grass to the north-east corner of the site (TN1). As this is less regularly managed (Photo 5), it has been coded as semi-improved grassland. This area is somewhat shaded by trees, and herb species found in this area are common and widespread. They include ivy *Hedera helix*, wood avens *Geum urbanum*, meadow buttercup *Ranunculus acris*, herb-Robert *Geranium robertianum*, cleavers *Galium aparine*, smooth sow-thistle *Sonchus oleraceus*, great willowherb *Epilobium hirsutum*, common vetch *Vicia sativa*, sweet violet *Viola odorata*, daisy *Bellis perennis*, yarrow, cats-ear *Hypochaeris radicata*, ox-eye daisy *Leucanthemum vulgare*, and common cinquefoil.

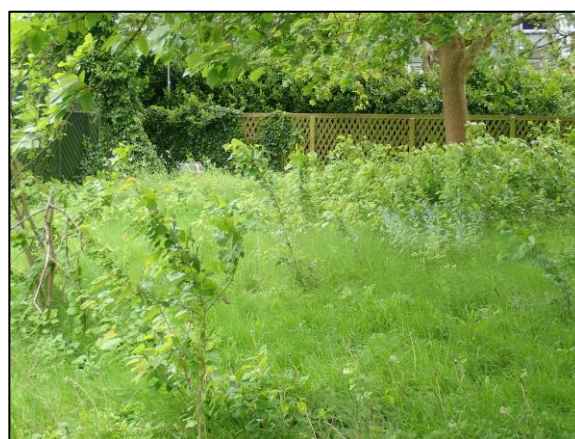
**Photo 6** Grassland and trees at TN3

- 3.12. There is a larger area of semi-improved grassland to the south-west part of the site (TN3, Photo 6). Species here include smooth sow-thistle, cow parsley *Anthriscus sylvestris*, sweet violet, hairy wood rush, common vetch, creeping

buttercup *R. repens*, wood avens, dandelion, cleavers, yarrow, ox-eye daisy, herb-Robert, green alkanet *Pentaglottis sempervirens*, as well as garden escapes such as aquilegia and Spanish bluebell *Hyacinthoides hispanica*.

- 3.13. There are several mature cherry *Prunus* sp. and sycamore *Acer pseudoplatanus* trees in this area, as well as numerous cherry and sycamore saplings across the grass sward.

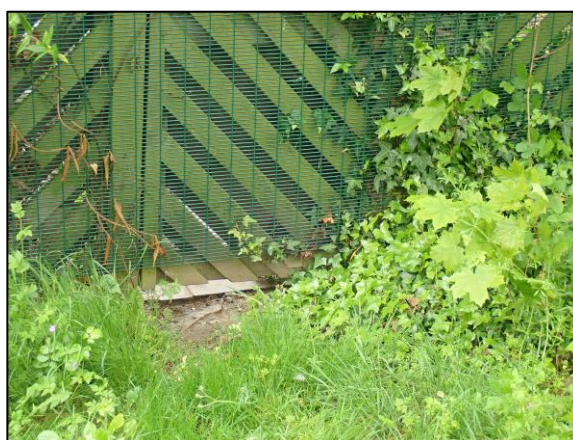
**Photo 10** Push-under beneath rear fence

- 3.17. No direct clear evidence of badger was seen on site. A distinct mammal track was noted around the south-eastern part of the site from beneath a push-under beneath the fence dividing the more formal rear gardens from the western part of the site (Photo 10). It is considered more likely that this path and push-under is evidence of fox *Vulpes vulpes*.

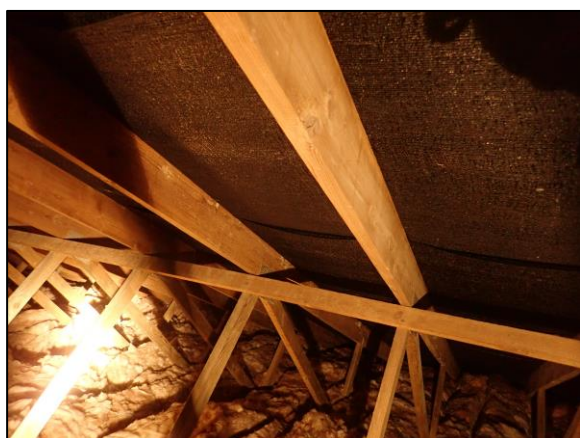
- 3.20. The roofing felt was found to be in good condition throughout and no areas of visible external light were seen (Photos 17 and 18).
- 3.21. Externally, the heavy concrete tiles across the roof faces were found to be in good condition with no apparent areas of damage or slipped tile that could allow bats to access any crevices beneath them or to access the loft areas (see Photos 19-22).
- 3.22. The soffit boxes were in fair condition and although some minor deterioration was noted, they were generally tightly-fitting to the external walls with no gaps between the brickwork and soffit. The soffits around the courtyard have plastic fly mesh vents to them (Photos 23 and 24).

**Photo 17** Roofing felt in good condition

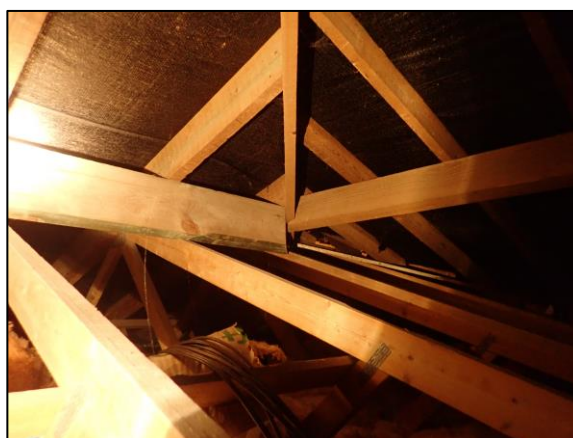
**Photo 18** Timber joints and felt in good condition

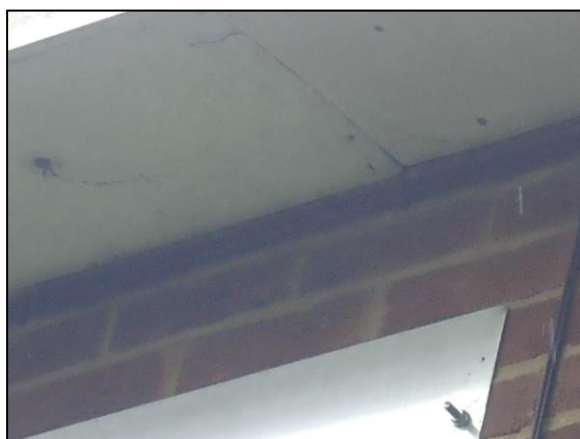
**Photo 23** Soffit around building
