EXISTING DILAPIDATED BASEMENT EXTERNAL STEPS  
(To be removed)

| Project | Refurbishment & Alterations<br>Carlisle House<br>Reading<br>RG1 7NG | | | | | Drawing | Drawing & Photographic Recording:<br>Existing Basement External Steps | | | |

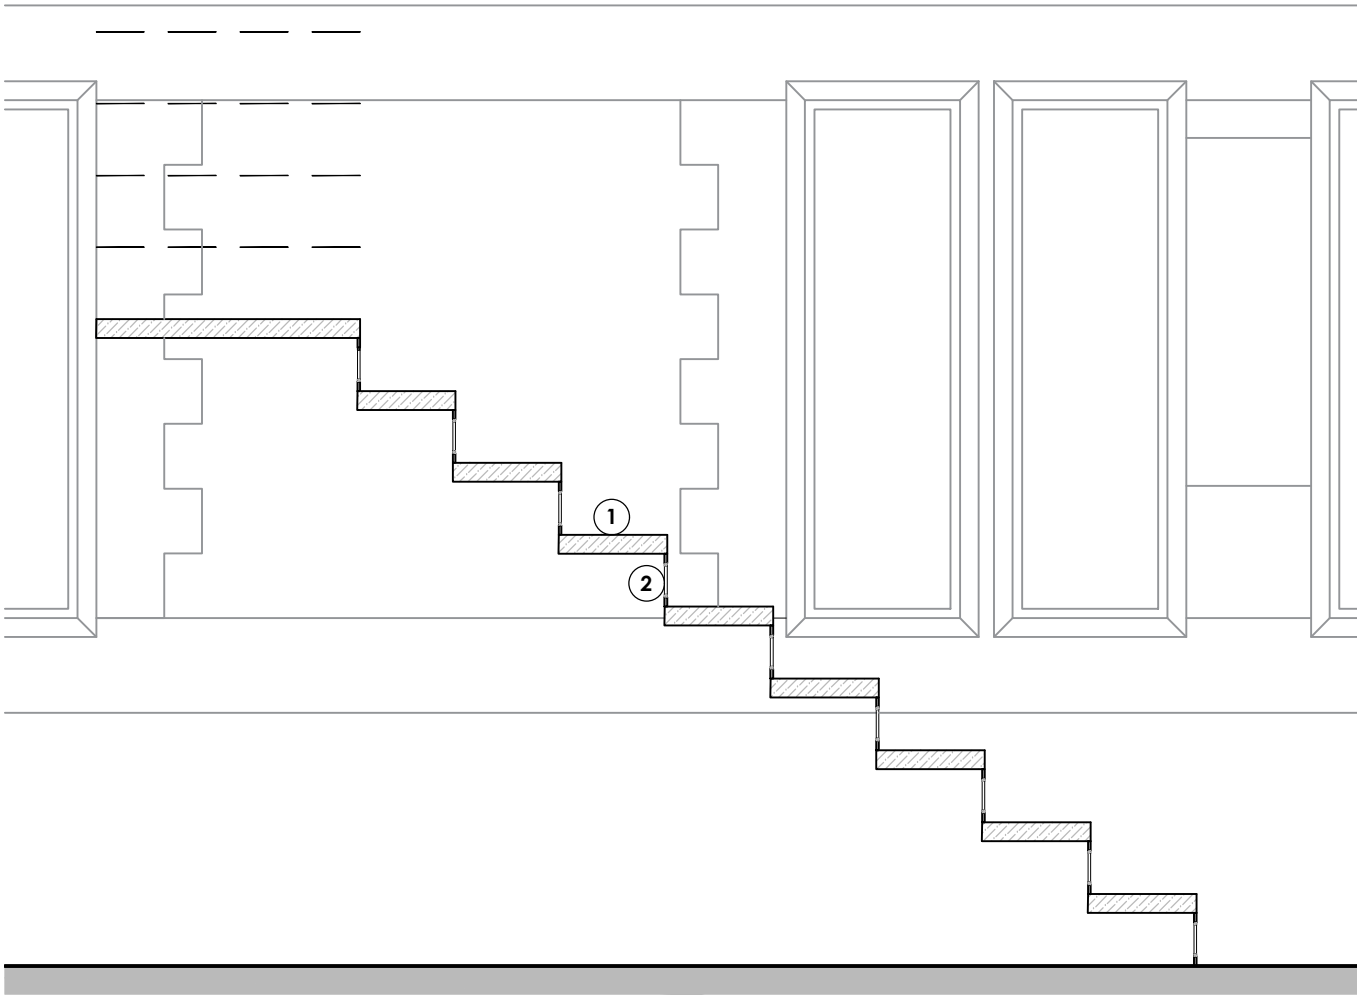
SECTION 1/20

- MATERIAL KEY**
- ① Natural stone slab stair tread
  - ② Cast iron riser with decorative circular pattern and frame
