**Project / Site name: Battle Hospital**

**Battle Hospital, Portman Way, Reading, RG30 1AH – HP7**

On the 16<sup>th</sup> May 2022 Enzygo Geo Environmental Limited undertook a site inspection to excavate a hand pit (HP7) to confirm the presence of a Geotextile no-dig barrier beneath 400mm minimum clean materials. The location of the Hand Pit is shown on drawing CRM.1265.007.GE.D.001 in Appendix B.

## APPENDIX A – PHOTOGRAPHS

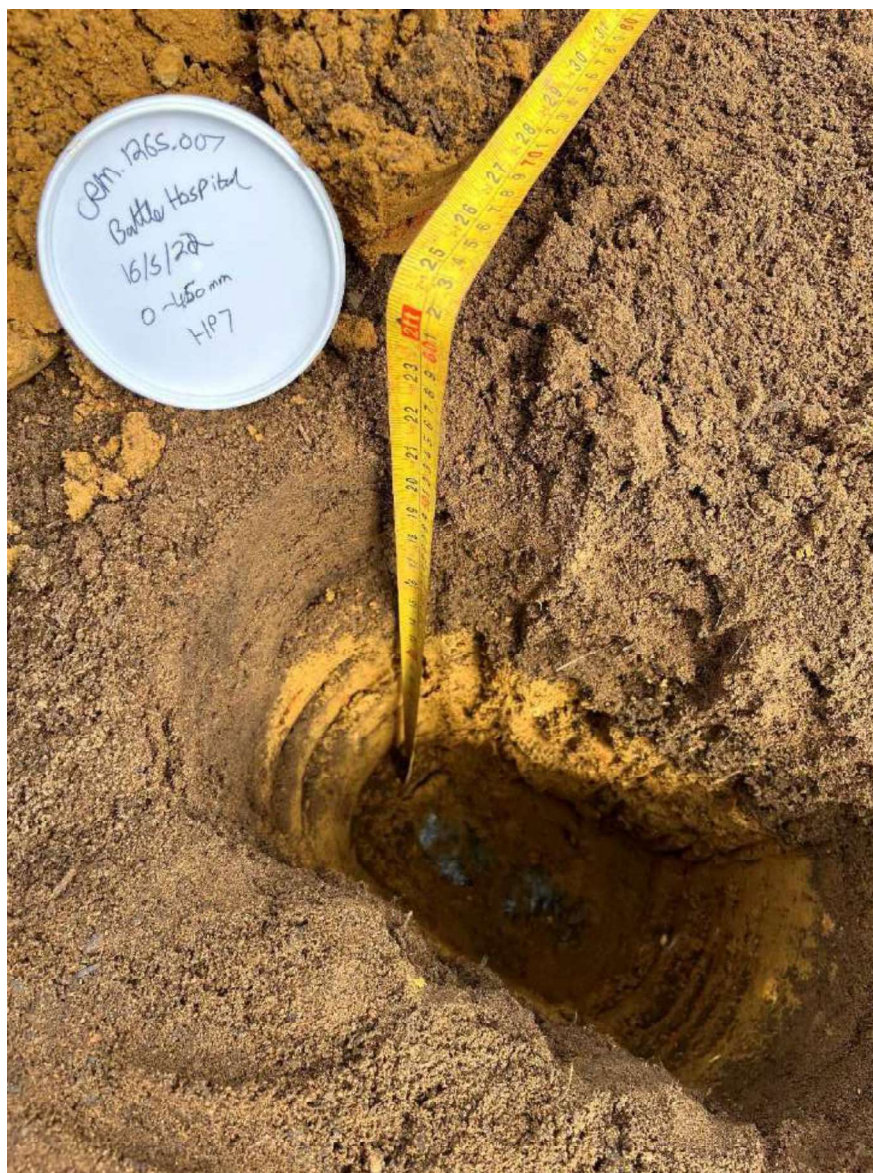
## HP7

Hand Pit confirmed the presence of 400mm minimum of cover soils over a Geotextile no dig barrier, meeting the required depth for communal gardens and open space areas. Photographs of the hand pit are included in Appendix A. Samples were recovered from the Hand Pit, and submitted to the laboratories of I2 who are UKAS and MCERTS accredited for testing.

Based on the site inspection undertaken, information provided and results it is considered that the cover soils within Hand Pit HP7 are in accordance with the approved Remedial Methodology.
