# GEOSHIELD Verification Report

Westside CFA Piling - Balfour Beatty/Galldris

Gas membrane to specification BS8485 2015

AREA SURVEYED: Installation to lift shaft - Platform 2.

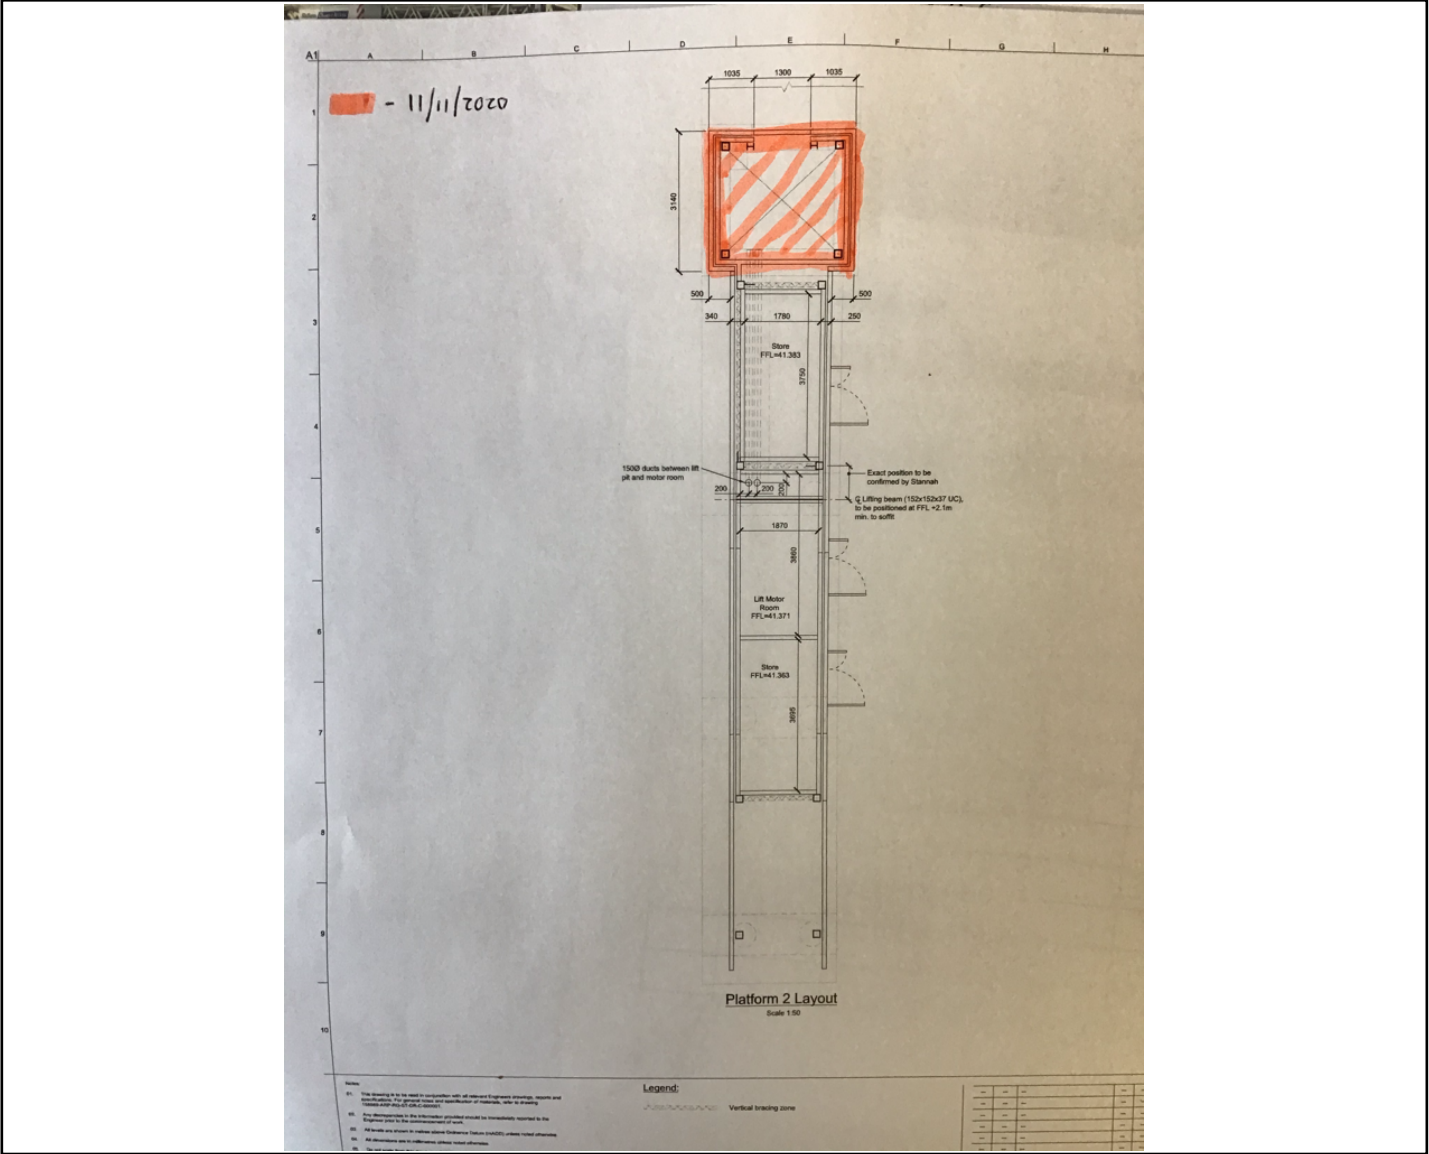
## VERIFICATION LAYOUT

Area highlighted above in orange is where verification took place during this visit.

Installation to lift shaft on Platform 2.

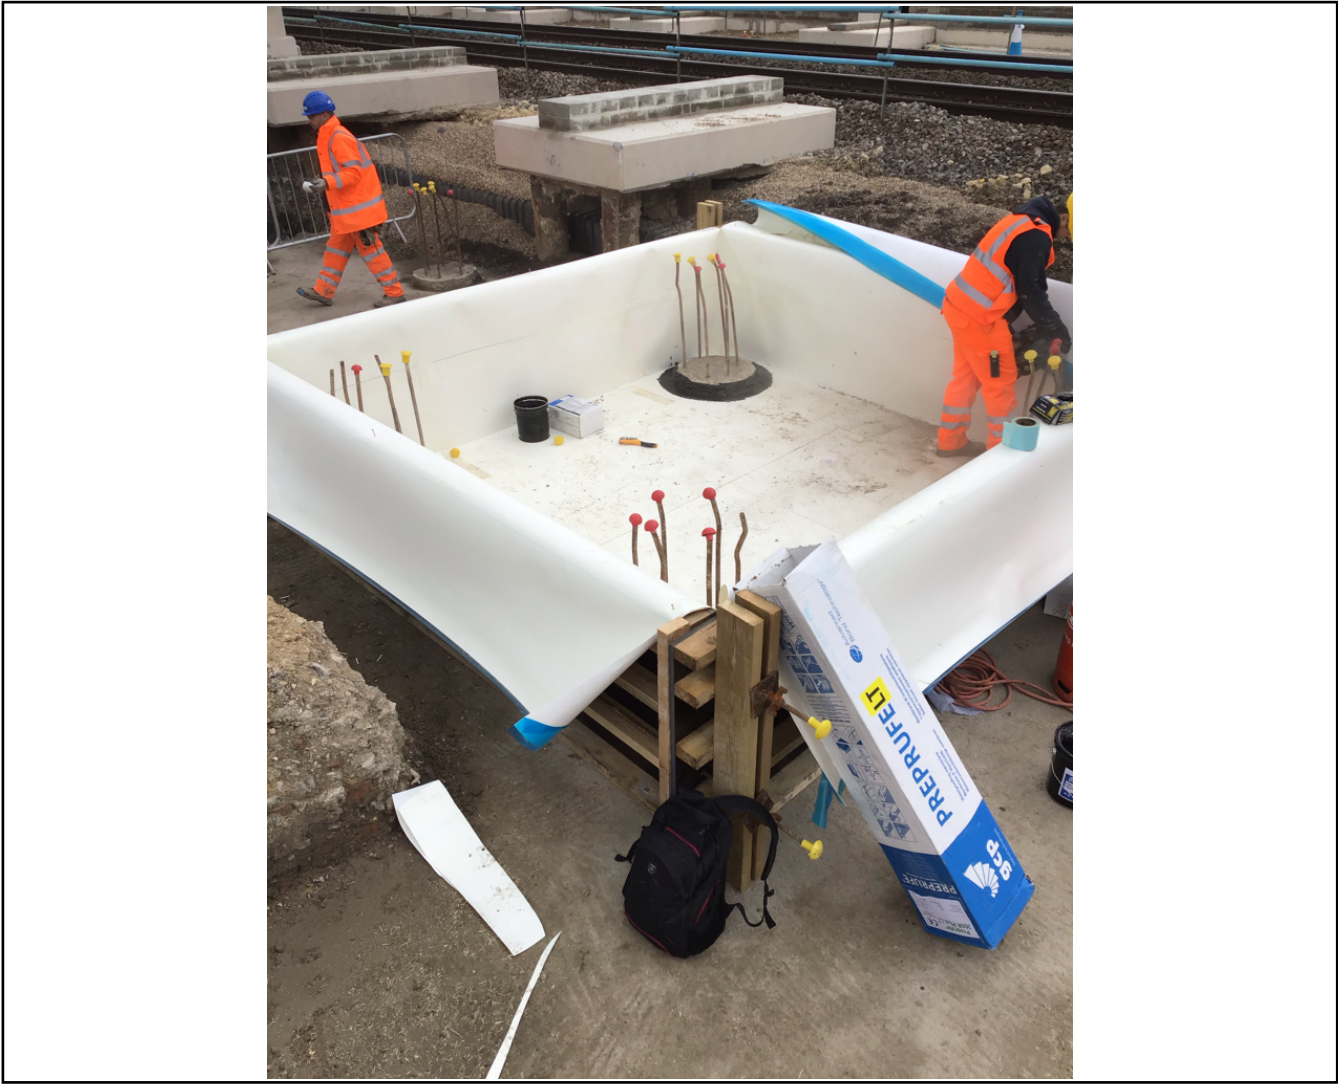
## OVERVIEW PHOTOGRAPHS

Overview photograph showing installation completed to lift shaft - Platform 2.

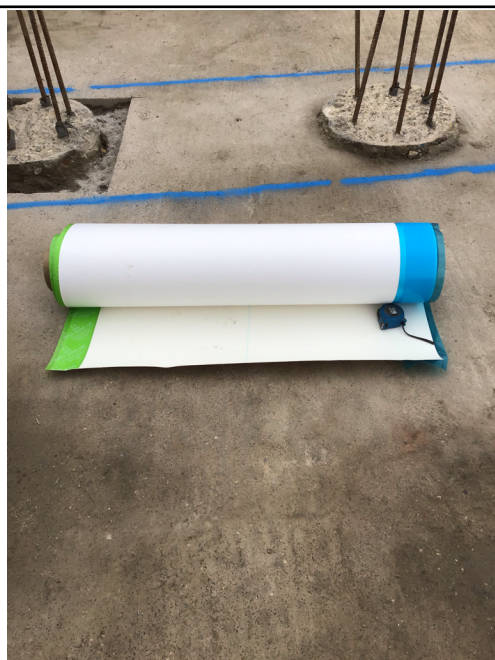
NOTES: Installation of PrePrufe 300R Plus LT membrane.

The first photograph below shows the material used during the installation of the lift shaft on Platform 2. The installers have taped all joints and laps in the membrane, to manufacturers specification, using the pre-formed tape joints within the membrane.

All joints and laps in the membrane were sealed to manufacturers specification, using the taped joints within the material.

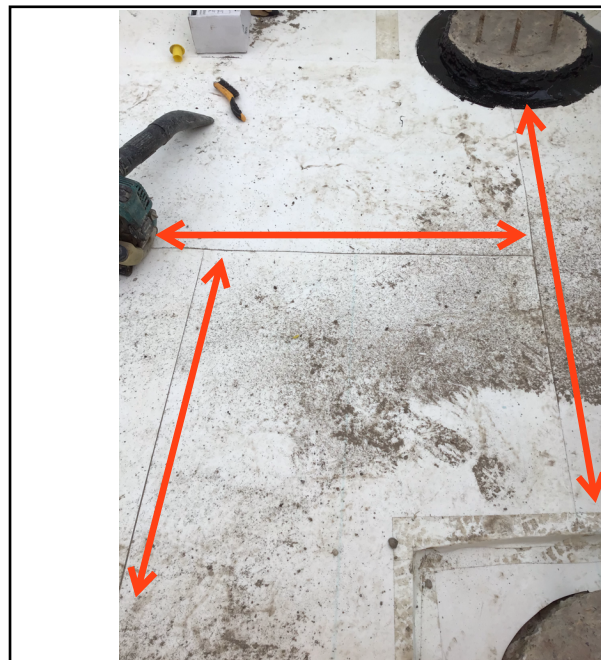
The second photograph above shows an example of the sealed lap joints that have been inspected during this visit.

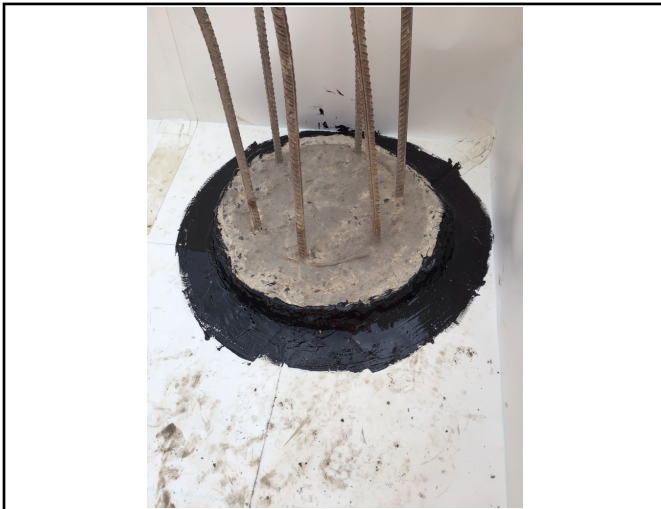
The first photograph below shows an example of a sealed pile head, within the area verified during this visit. The installers have cut the PrePrufe 300R Plus LT membrane tightly around the pile head, and applied the Bituthene Liquid membrane to the pile.

All pile heads were also sealed to manufacturers specification and as per the design details, using Bituthene liquid membrane.

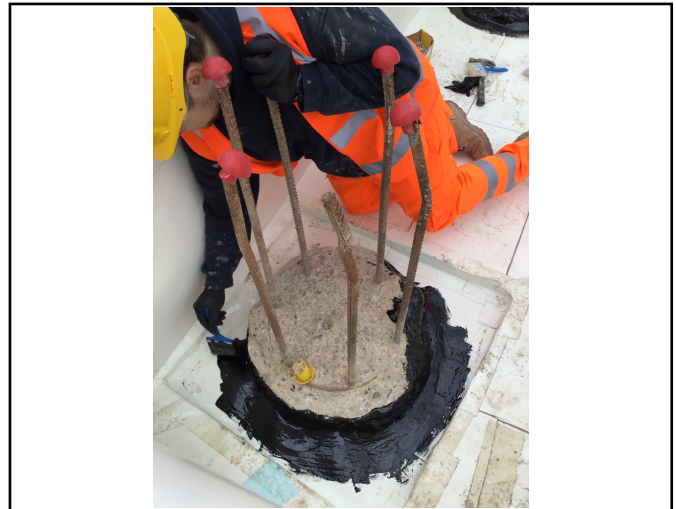
The second photograph below shows the installer from Fastglobe, applying the Bituthene Liquid Membrane to the pile head. The Bituthene has been applied a minimum of 100mm onto the pile, and a minimum of 75mm onto the PrePrufe 300R membrane, as per the design details.

A continuous coating has been applied, with no holes or gaps present.

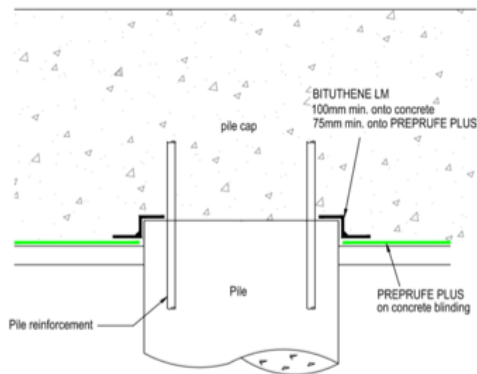
PILE DETAIL - LARGE DIAMETER  
800MM OR GREATER  
SECTION

The drawing above shows the detail used for sealing the pile heads within the lift

shaft that was verified during this visit.

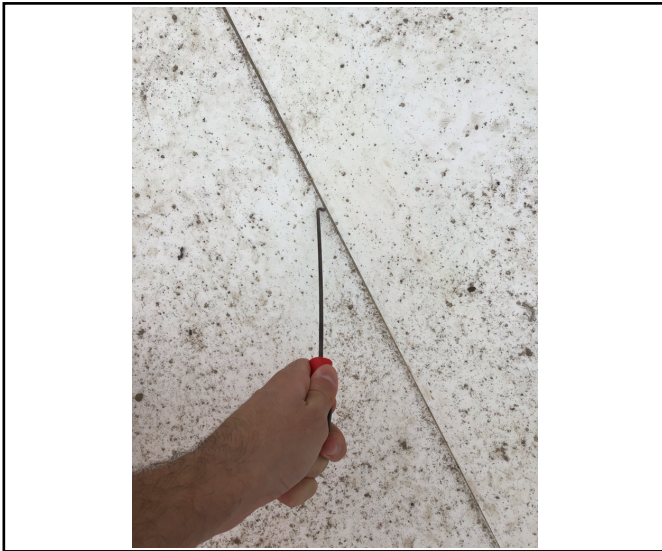
Pick and probe test example.

A visual, pick and probe examination was carried out to the area of works, with no faults or defects being identified during this visit.

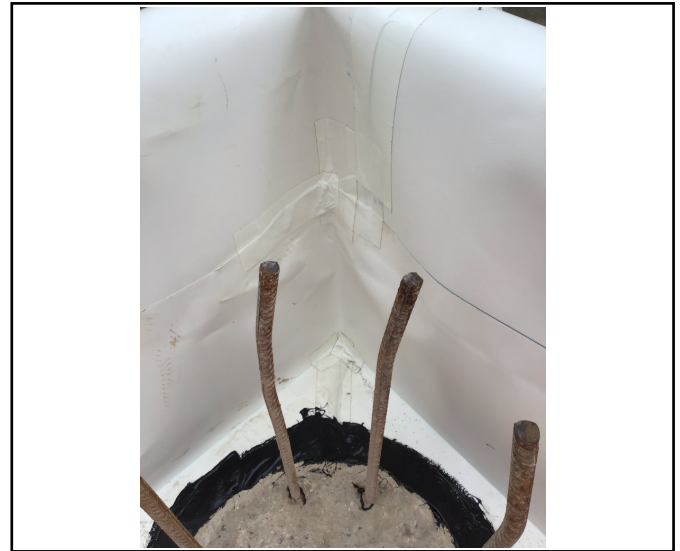
Reinforced corner detail.

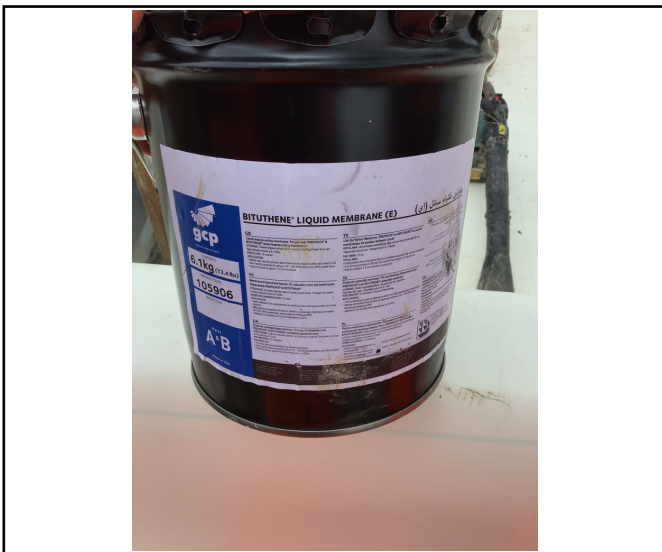
Bituthene liquid membrane used

around pile heads.

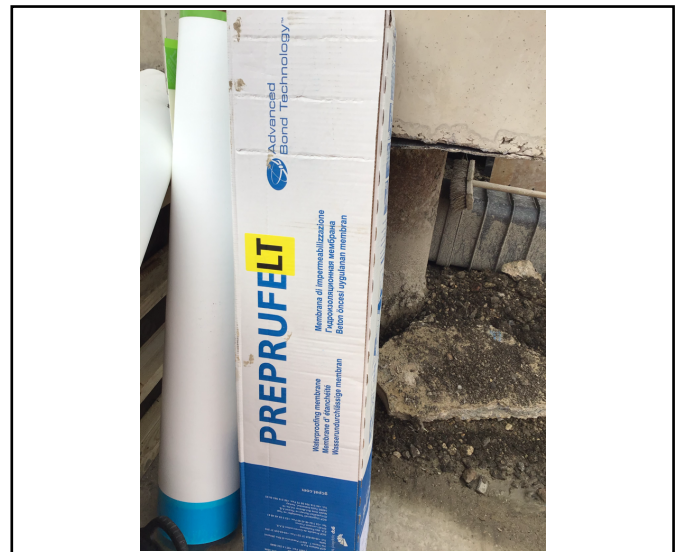
PrePrufe 300R Plus LT membrane

used on lift shaft.
