EXISTING NON ORIGINAL FITTED STORAGE CUPBOARD DOOR D-F-16 & D-F-17 DETAILS  
(To be removed)

EXISTING NON ORIGINAL FITTED STORAGE CUPBOARD & DOOR D-F-06 DETAILS  
(To be removed)

| Project | Refurbishment & Alterations<br>Carlisle House, 118 Oxford Road<br>Reading<br>RG1 7NG | | | | | Drawing | Drawing & Photographic Recording: Ex. Storage<br>Cupboard & Doors D-F-06, 16 & 17 | | | | | |
| | | | | | | Job-Dwg<br>Number | 18009-PL-33 | | | Rev. | - | |

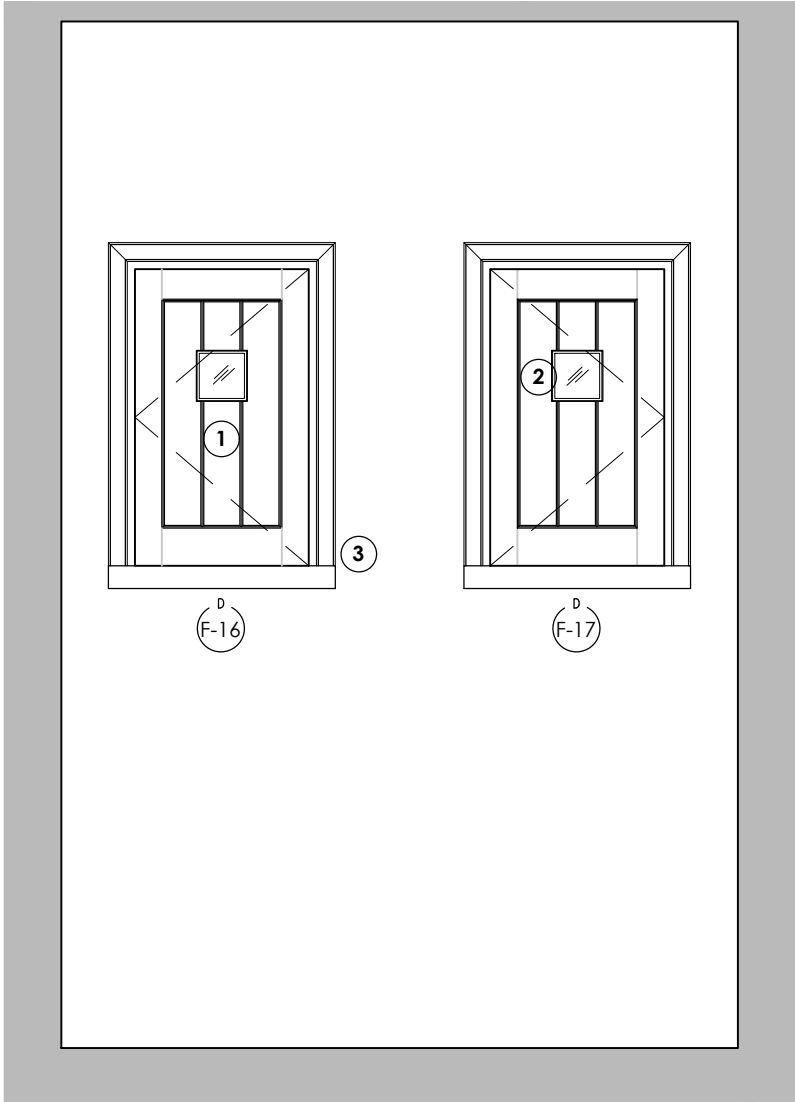
ELEVATION A 1/20

- ① Painted timber closeboarded hatch
- ② Obscure glazed panel to hatch
- ③ Painted timber architrave and sill detail
- ④ Painted timber 3-panel door with plain flat panels
- ⑤ Painted timber architrave with plinth block detail
