| Project | Refurbishment & Alterations<br>Carlisle House<br>Reading<br>RG1 7NG | | | | | Drawing | Drawing & Photographic Recording:<br>Existing Non-Original Cornice & Frieze | | | |
| | | | | | | Job-Dwg<br>Number | 18009-PL-36 | | Rev. | - |

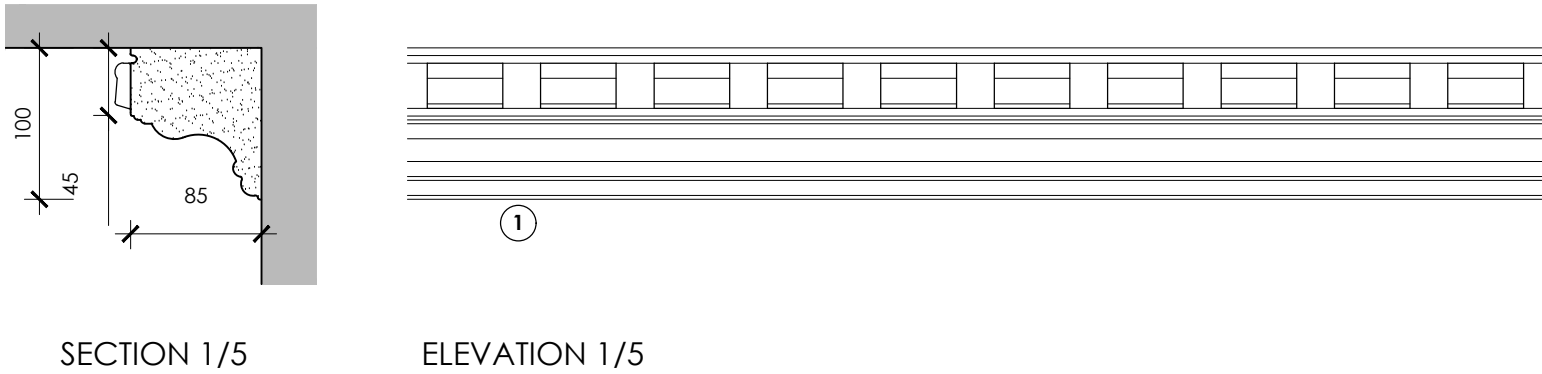
EXISTING FLAT 2 LOUNGE NON ORIGINAL CORNICE  
(To be removed)

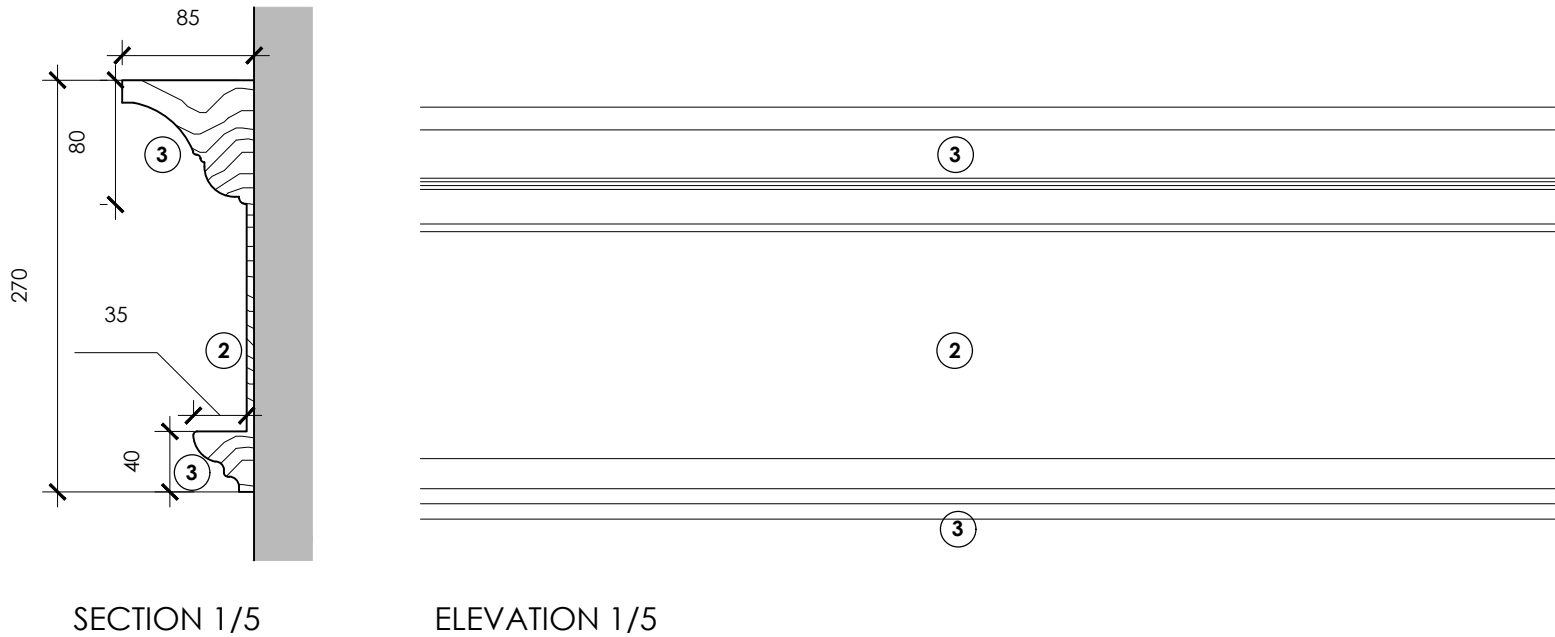
EXISTING FLAT 2 LOUNGE NON ORIGINAL FRIEZE  
(To be removed)

- ① Decorative plaster cornice
- ② Textured lincrusta wallpaper with grape & vine leaf motif
- ③ Painted timber frieze moulding details
