# Heritage Impact Assessment

Listed Building Consent for Internal  
Alterations

26 Yew Lane, Coley Park, Reading, RG1 6DA

March 2023

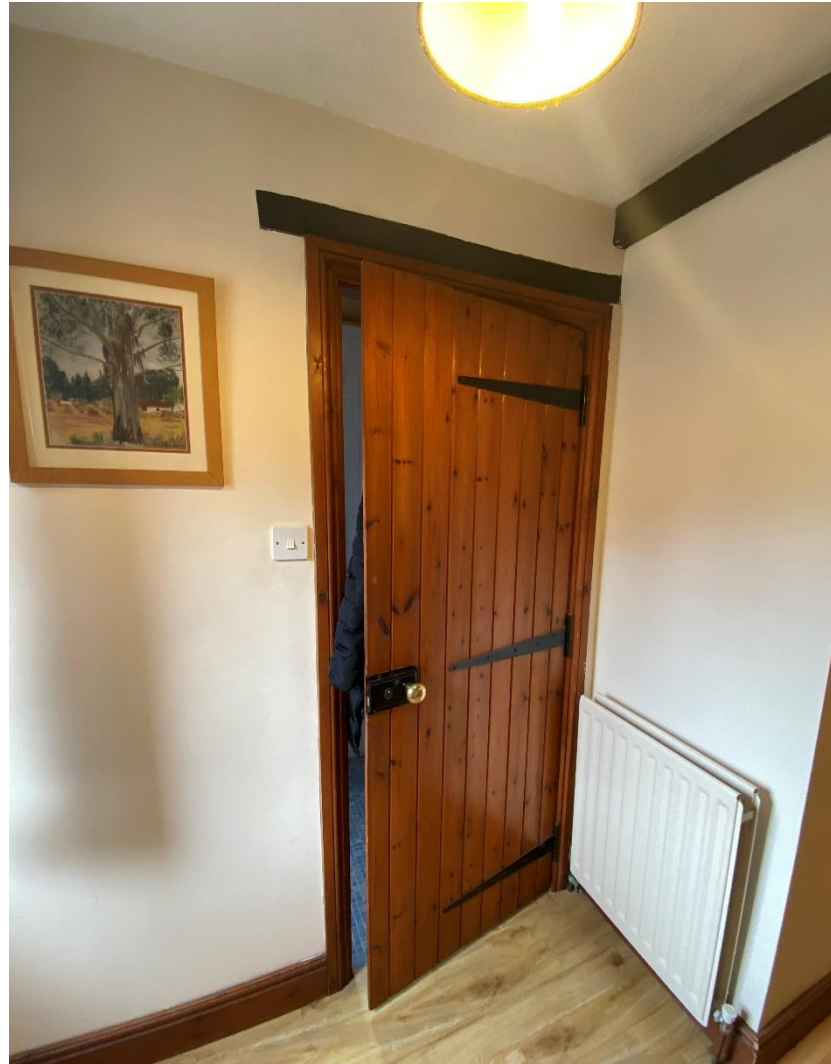
*Figure 7 - Main entrance to the relevant area of the Site. Note the timber beam framing extending to the area and use as door lintel.*

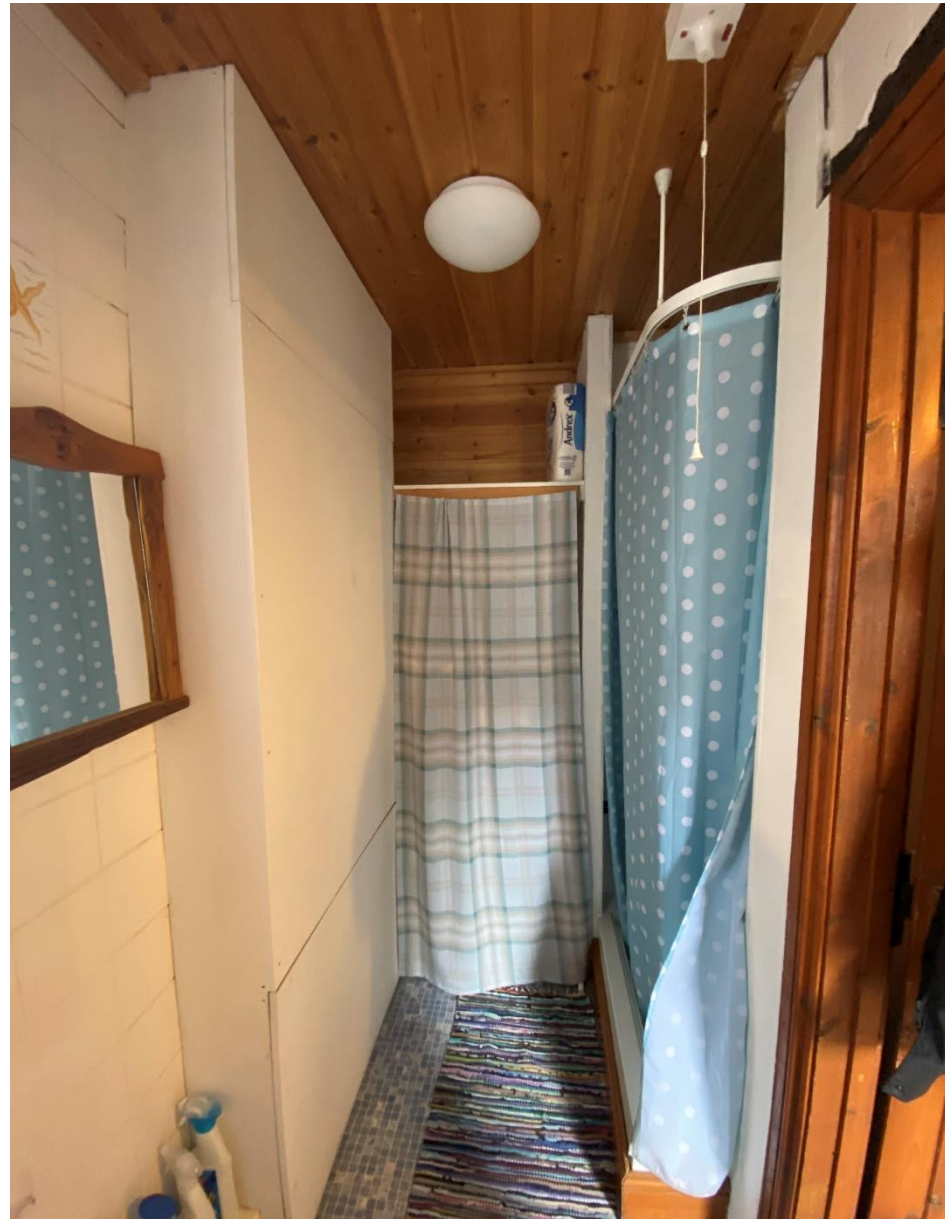
*Figure 8 – Internal view of the shower room*

- 6.8 Design guidance on the two later spaces has been defined chiefly by ensuring continuity of character with the building and by the utilitarian needs of the space. The area now labelled as 'study' has had its walls painted a cream/off-white with doors frames and skirting boards left as exposed wood. This is the same general design found throughout the first floor of the building. The continuity of this design has therefore mitigated the changes the works have made to the historic layout. The current shower room is, by necessity, more utilitarian in design. Use as a bathroom will mean this room will experience higher levels of moisture/damp and material changes were required to accommodate this. The shower room is tiled on two walls with laminated panelling covering the remaining two, as well as the ceiling, with the floor composed of mosaic tiles. Further to this, there is a portion of timber boxing protruding slightly from the northern wall which disguises the unsightly inner workings/pipes which serve the shower. Whilst these elements are divergent from the existing design throughout the Site, it is argued that the utilitarian needs of accommodating the shower space outweigh the desire to create continuity of design throughout the entire house. Bathrooms/shower spaces are areas of a building which will experience higher levels of moisture and therefore are at greater risk of suffering from damp and mould. A further change required to facilitate use as a bathroom is the creation of an extractor/filter system. This has been installed in the Site's northern elevation with two extracting units visible on the external of the building (Figure 13). This system is required to further facilitate the level of moisture that the room will experience. There is also a pre-existing window to further serve as ventilation for the room. Whilst this is a modern installation it is considered that the benefits of protecting the building from damp/mould outweighs

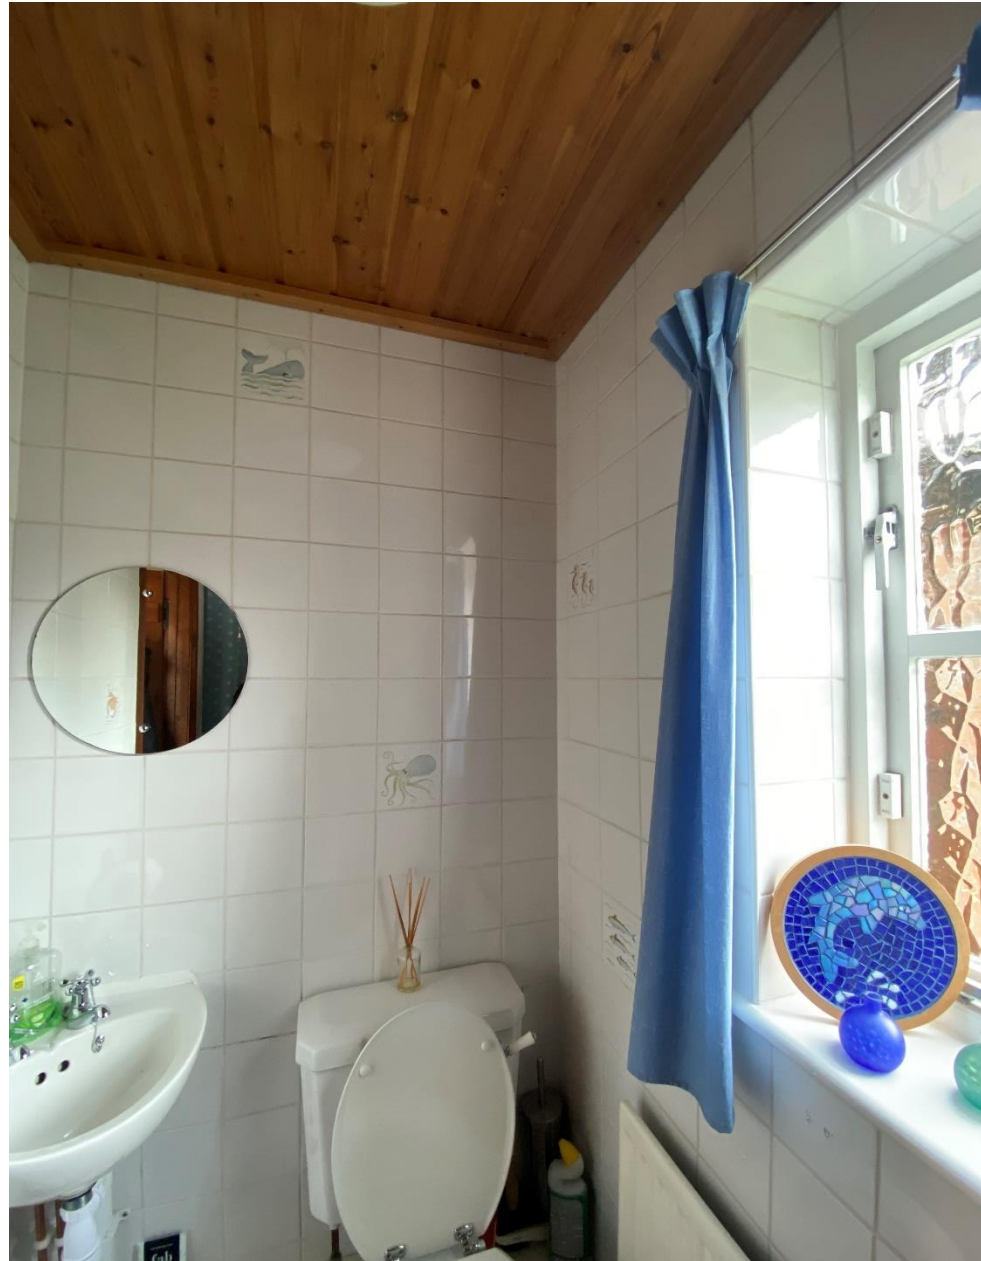
*Figure 9 – Alternative view to shower room. Pre-existing window visible.*

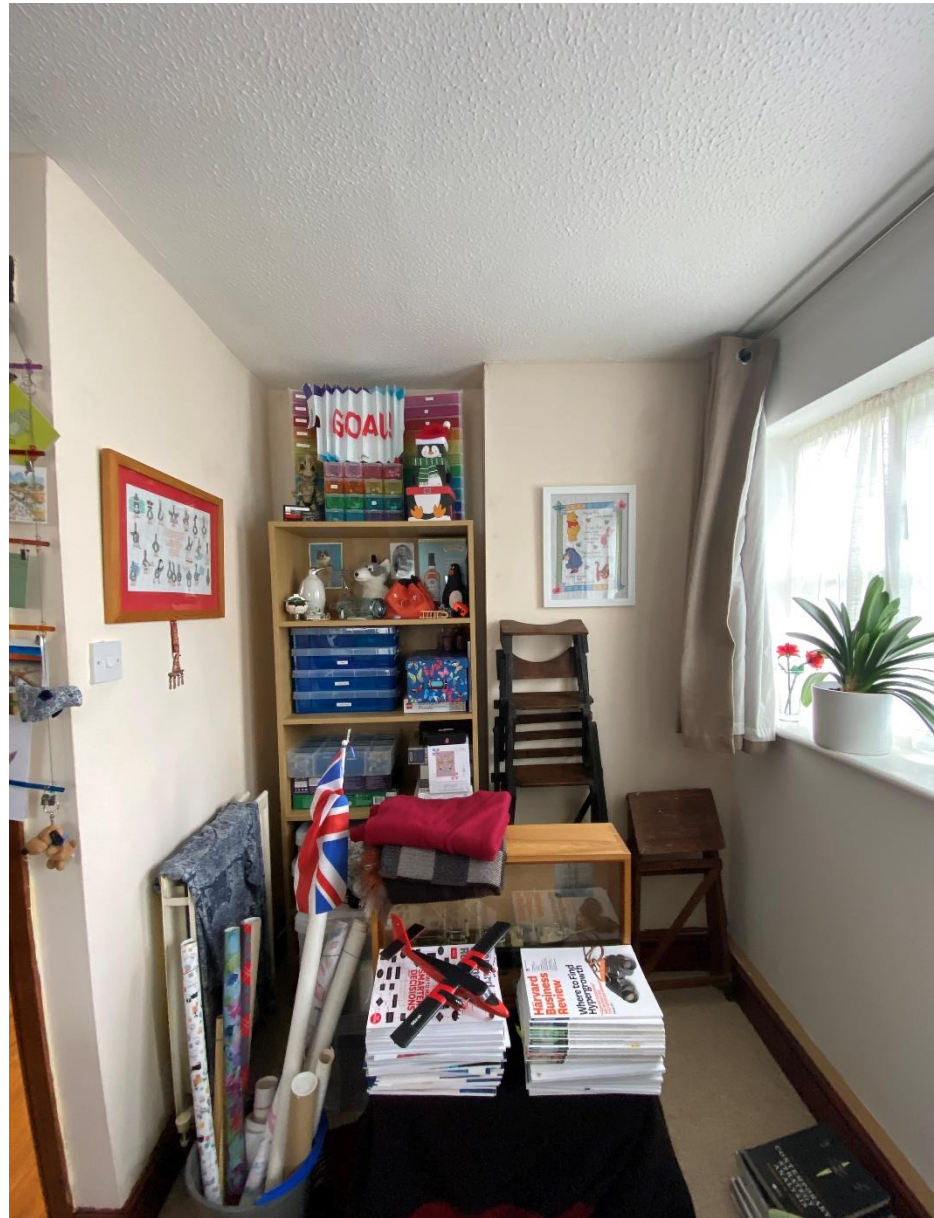
Figure 10 – Study/small bedroom. Far wall is stud wall dividing from shower room.

6.7 Whilst these works have deviated from the historic layout, it is considered to be a minimal change and does not harm the Site's significance. The internal alterations made to accommodate these changes may have included the demolition of a wall, however, there is no further historic information to confirm this. Moreover, it is likely that this was a stud wall and was installed as part of the 1986 conversion, based on other existing internal walls within the building. Further to this, a stud wall was installed to extend the shower room and partition it from the small bedroom/study (Figure 10). This alteration is a change from the historic layout; however, it is not considered to constitute harm to the Site's significance, furthermore

the partition wall being stud, means it is a reversible alteration. As detailed in 6.4, the Site's significance is chiefly derived from its historical association with the wider Coley Park Farm Site. Architecturally, the Site's significance is derived from the retention of historic material, most notably historic timbers and the inglenook fireplace within the main living space and retained brick on the external of the Site. In this respect, the works have had no direct impact on these elements of significance and as such are considered to have resulted in no harm.

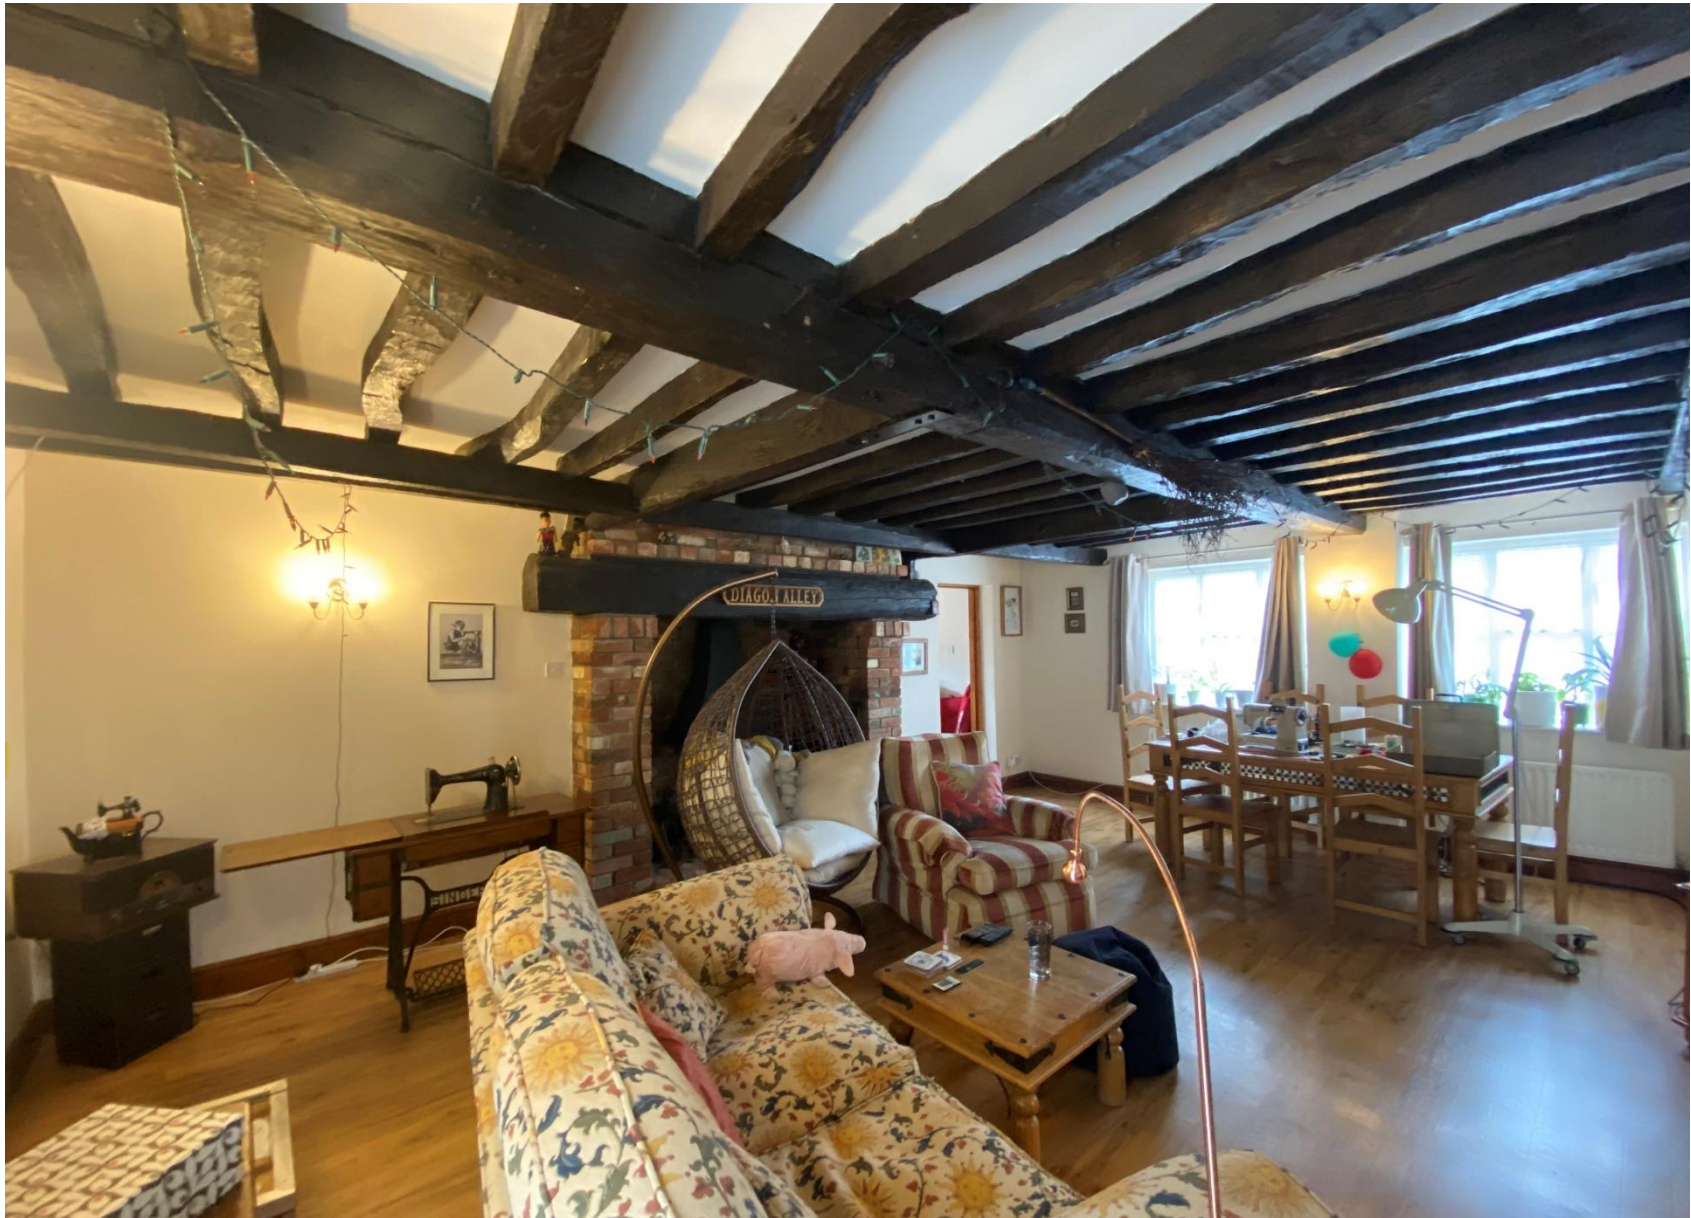
Figure 11 – Main living room. The architectural and historic features found within this room contribute to the Site's significance.

6.10 The works have allowed the Site to better function as a private living space. The Site is of a reduced scale compared to most modern dwellings, with the available space compressed by the extent of the main living room, which contains within it the majority of historic and architectural significance for the Site. In this respect it is argued that the proposal provides a public benefit. Para 8 of the NPPF states that a public benefit refers to anything which aids the delivery of the economic, social or environmental objectives of sustainable development. Within the social objective of this development, it is stated:

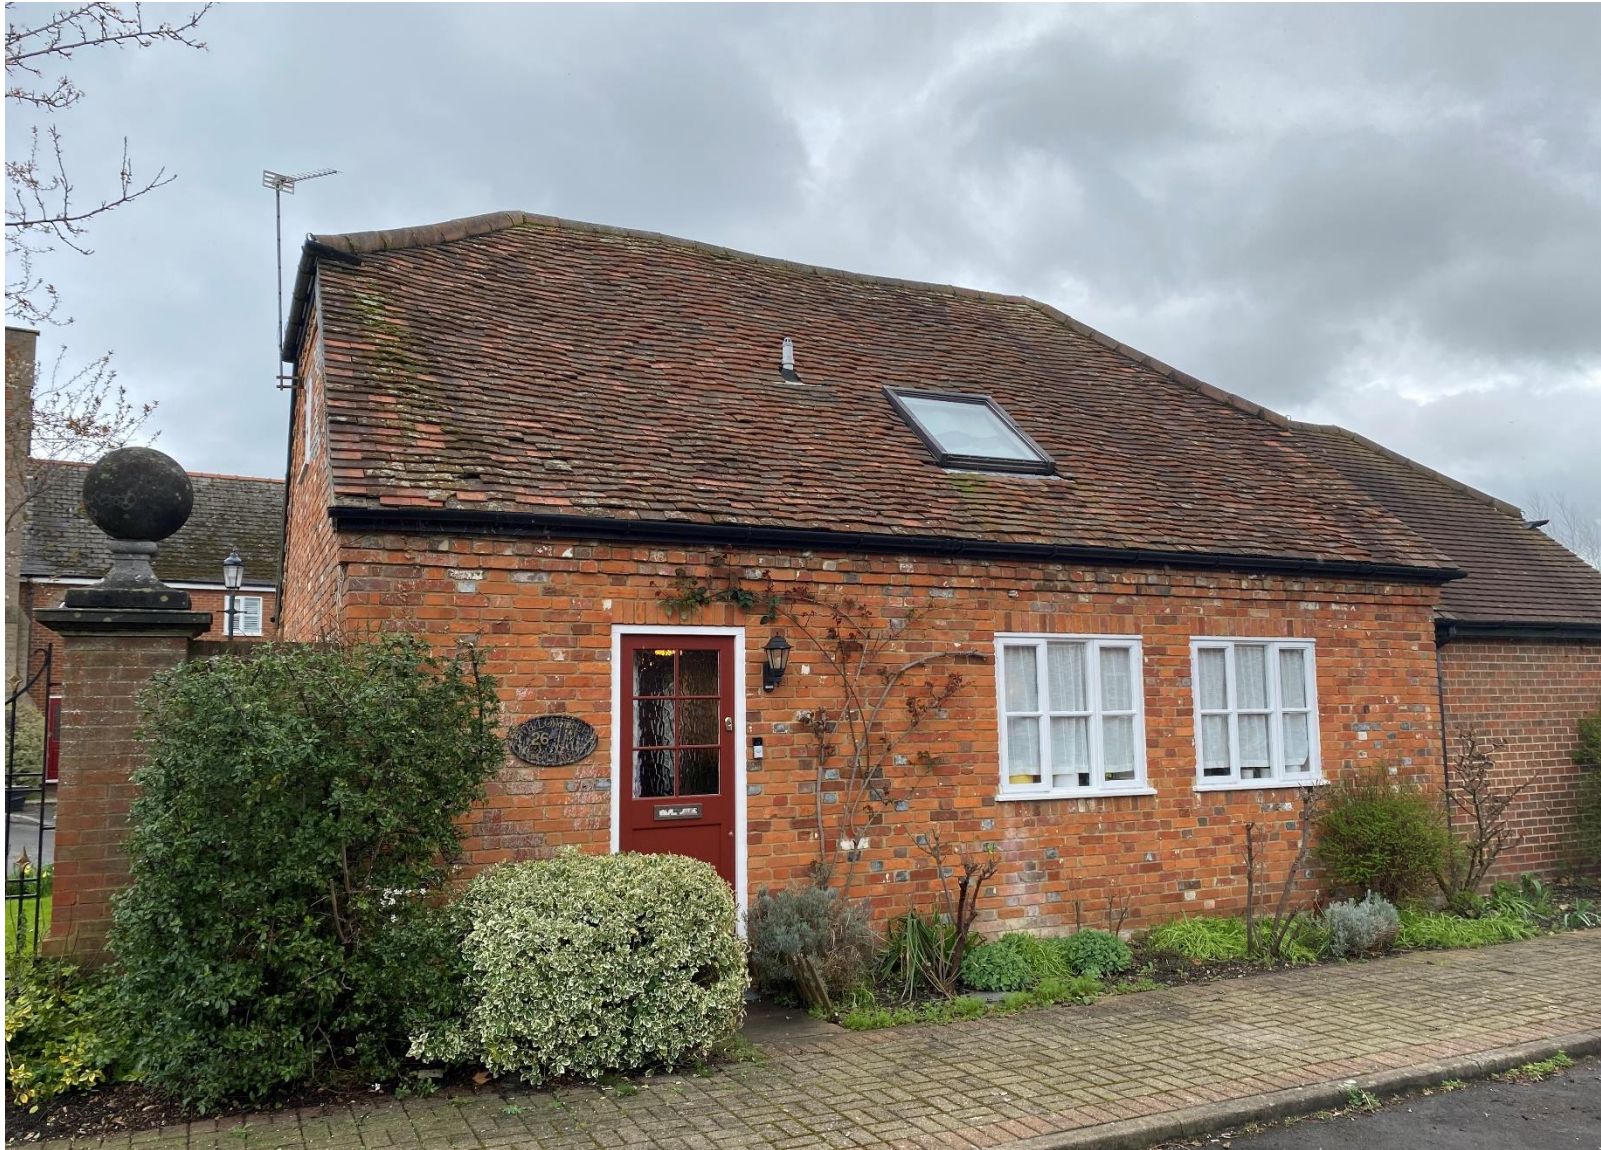
*Figure 12 – Western elevation of the Site. The later garage (now in use as kitchen) is viewable on the right.*

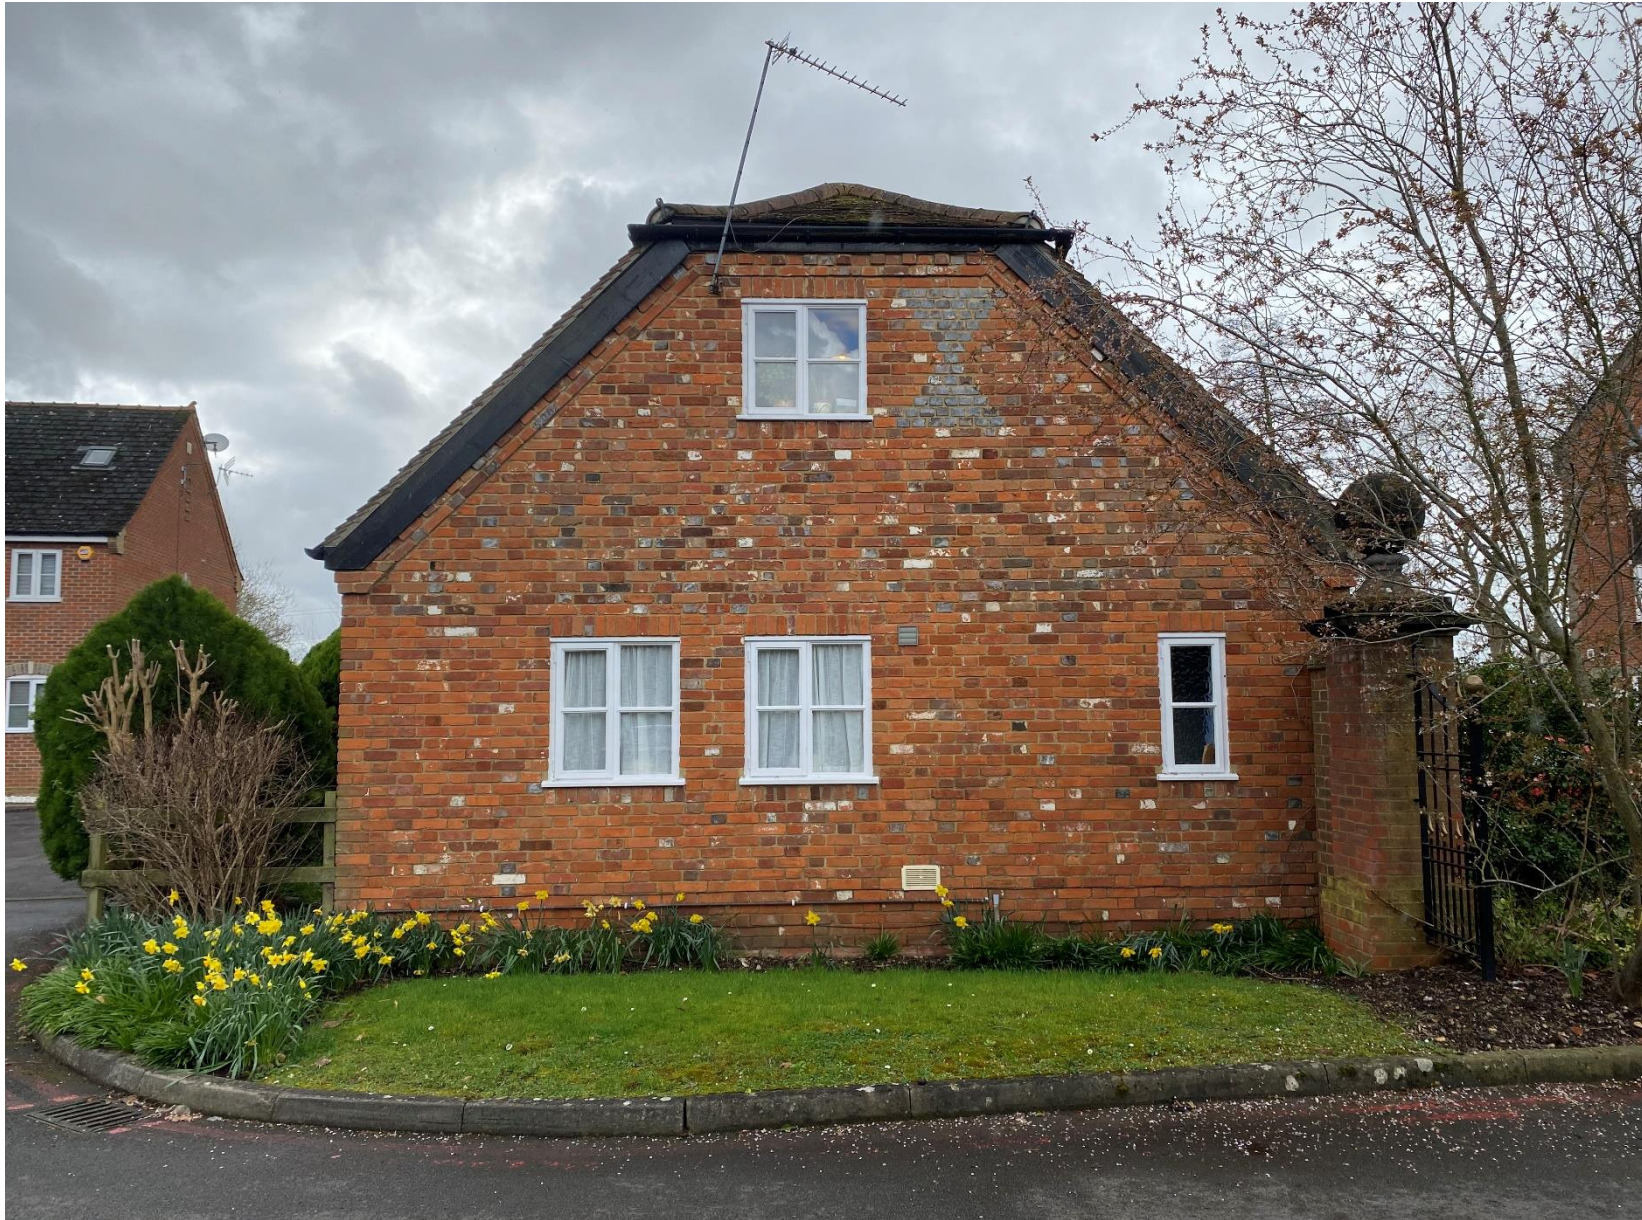
*Figure 13 – The Site's north elevation. The proposal location is on this elevation, the pre-existing window and external filters are viewable.*

6.4 The Site is of some historic and architectural interest. The Site dates from the mid to late 18<sup>th</sup> century and is mostly constructed from red-brick with intermittent blue-brick occasionally used. This is likely due to repair work, with blue brick being considered stronger and impervious to weather conditions. Furthermore, the random, lack of pattern in their use indicates an ad-hoc approach of installation. However, there is one external display

of blue brick that shows design, on the Site's north elevation (Figure 13). The roof consists of plain tiles and is half-hipped. There is a later extension located on the southern elevation which does use these same materials and therefore allows for continuity of character. The Site is 1 ½ storeys in height and is of a smaller scale compared to its neighbouring buildings (Figure 15). The building features 7 wooden casement windows, with two further rooflights on the west and eastern sections of the roof. Whilst these windows are wooden in construction, it is noted that they are not original and were likely installed in the 1986 conversion. Internally there is further historic and architectural interest added through the retention of timber framing and a large open-hearth fireplace. The Site is therefore of some historic and architectural interest, though it should be noted that the official listing confirms that the Site is included on the list for group value with the rest of the Coley Park Farm estate. Whilst there have been a number of archaeological finds within the vicinity of the Site, it is considered that the nature of the works carried out would not have involved excavation and therefore would not have posed any risk to any unseen archaeological interest. It is considered that the majority of the Site's significance is derived from its historic relationship within the Coley Park Farm estate. The Site contributes to this historic form and layout of the farmstead, which remains legible despite considerable modern alteration and additions. Most of the architectural significance is derived from the survival of exposed timber framing and feature inglenook fireplace internally within the Site. Further to this, there is retention of historic brickwork on the external of the property, which does offer further architectural significance.

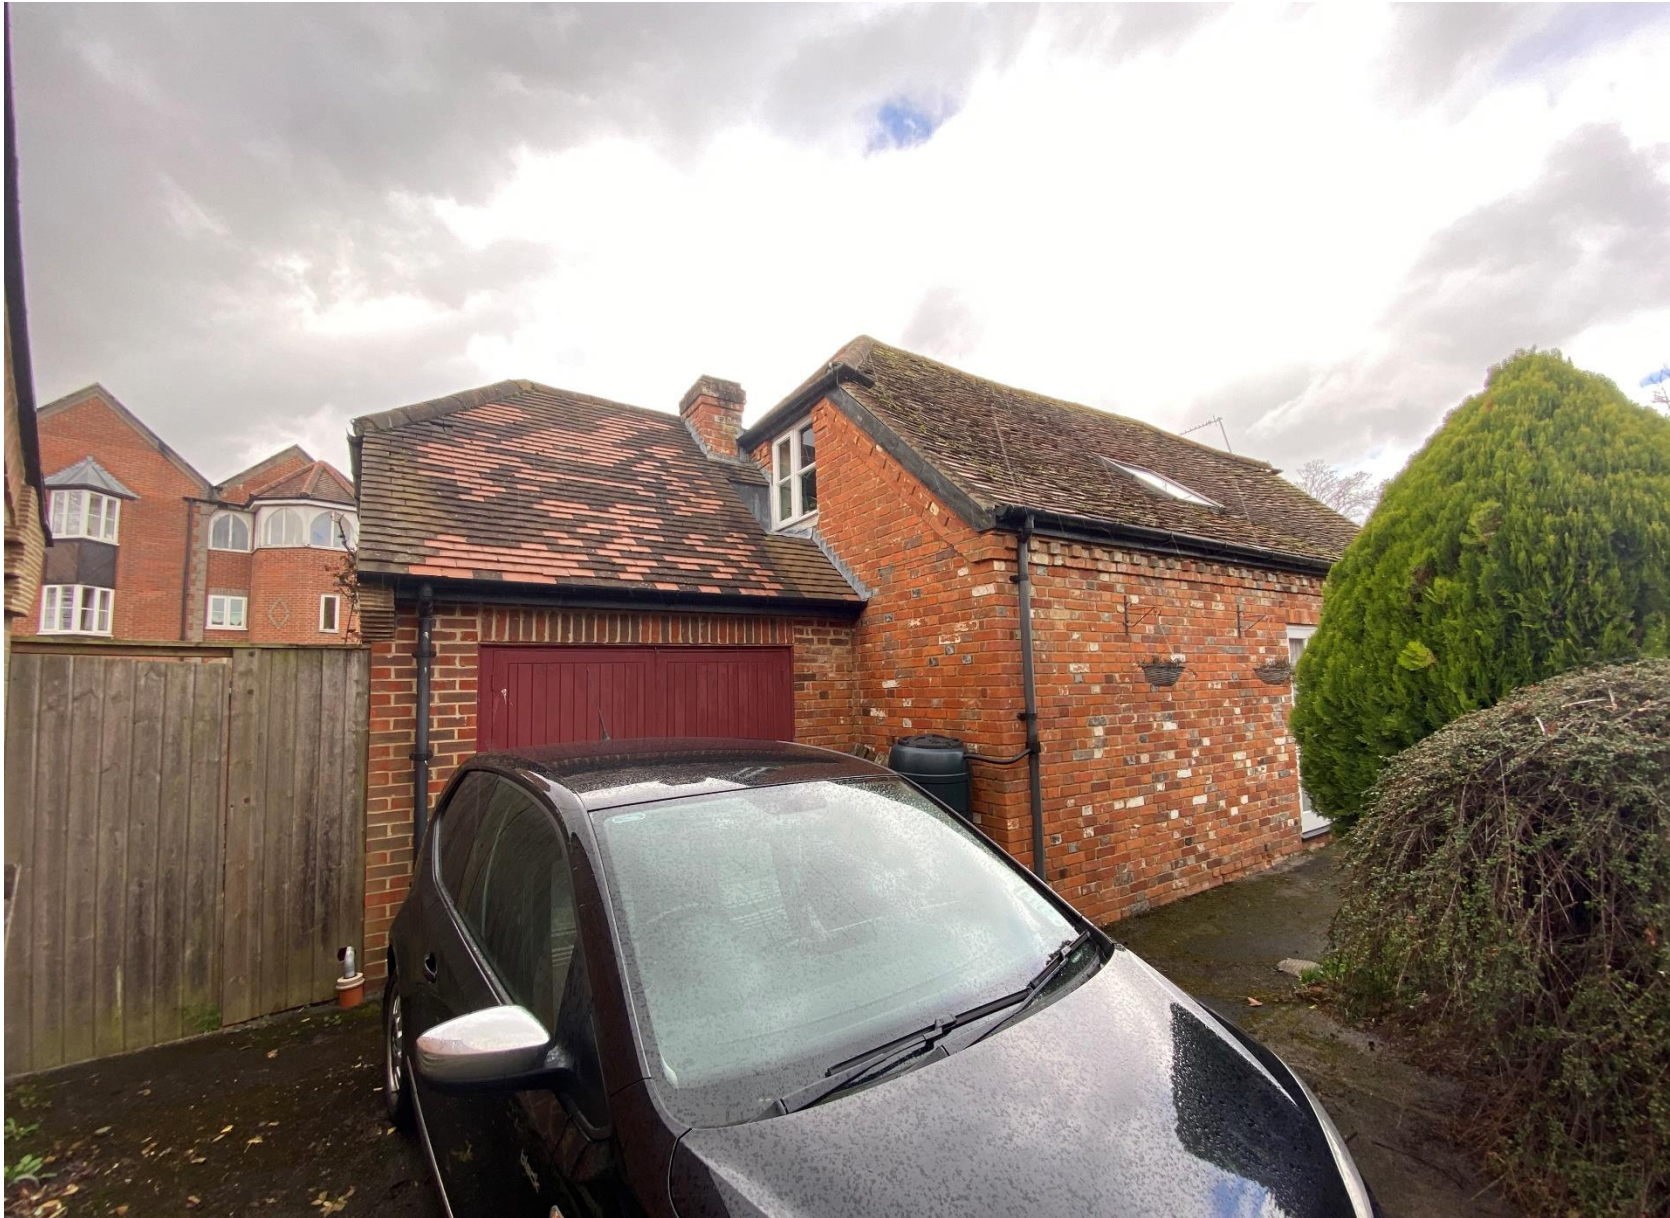
*Figure 14 – The Site's east elevation. The later garage extension (which is now in use as the kitchen) is clearly visible.*

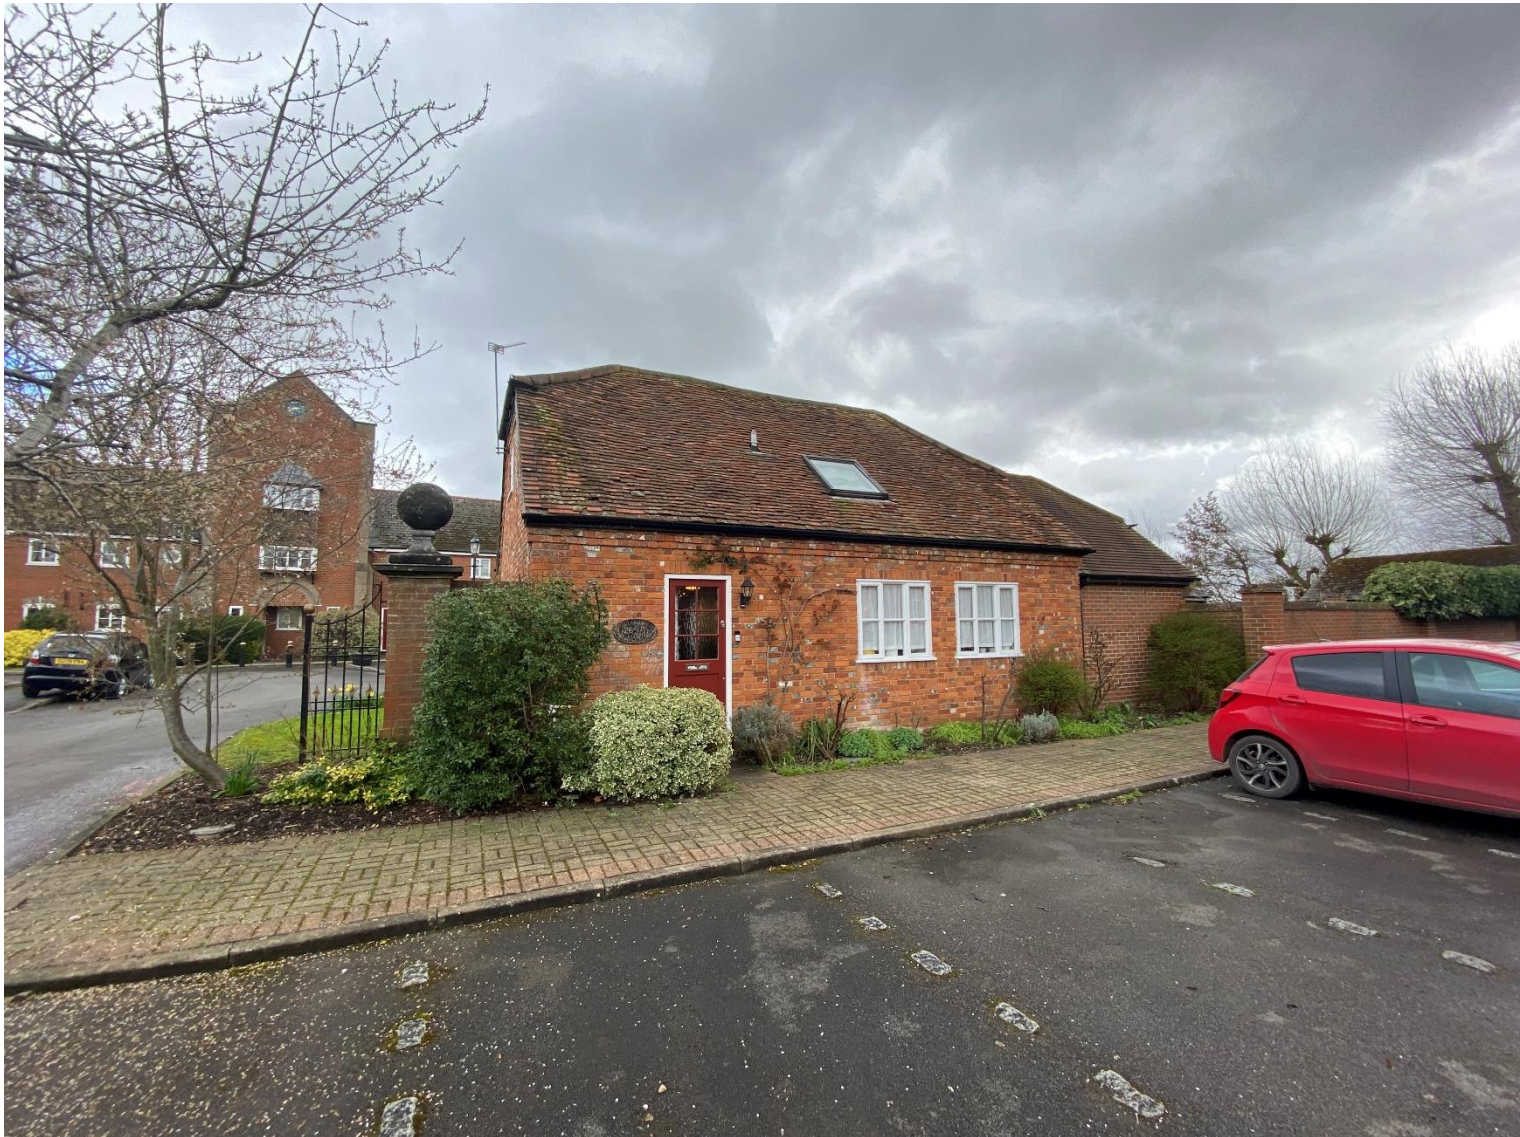
*Figure 15 – The Site is in limited scale when compared to neighbouring buildings.*

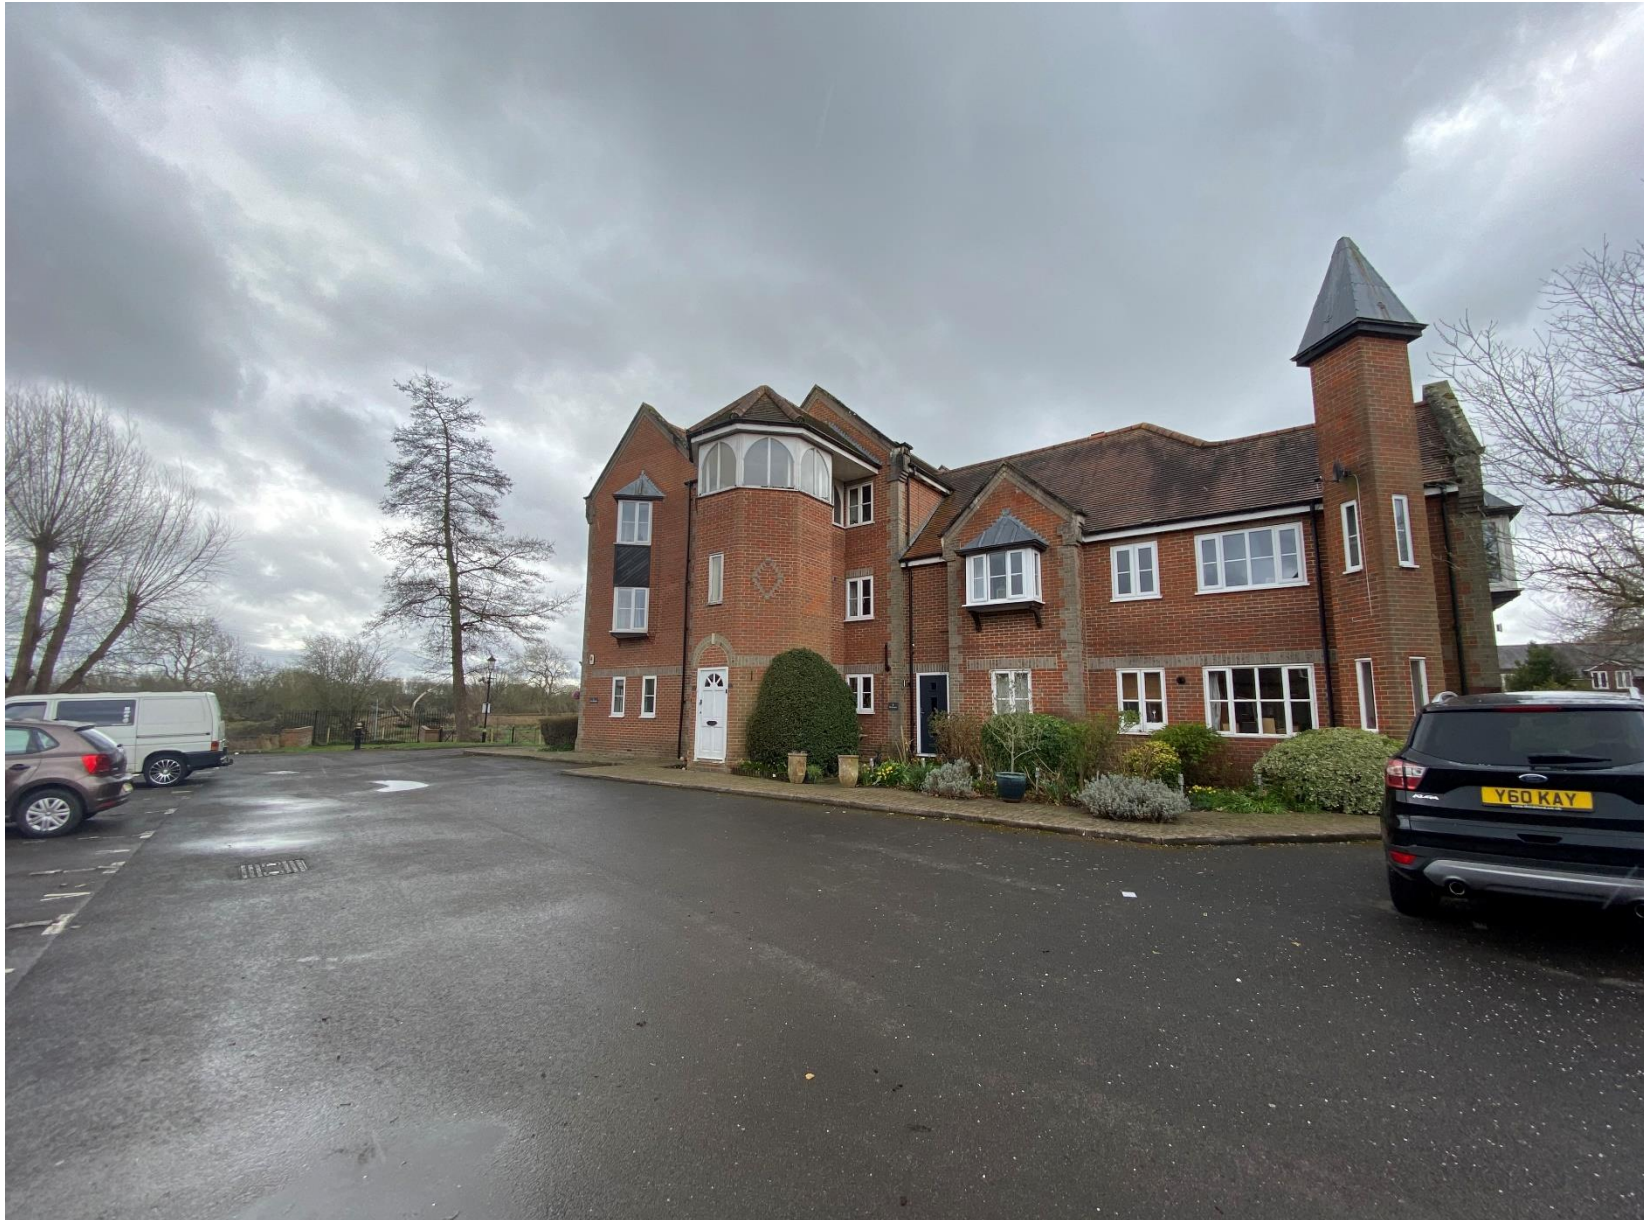
*Figure 16 – Later development directly opposite to the Site. This is of a significantly larger scale than neighbouring buildings and is divergent in character from the historic Coley Park Farm estate.*

- 6.5 Coley Park Farm was converted in February 1986. Alongside the conversion of the existing farm buildings and cottages was the construction of 34 new dwellings (ref no. 85/TP/0820). Figure 16 shows an apartment block constructed during this period which is parallel to the Site. The design is divergent from the historic farmstead and is significantly greater in scale than the Site. Concerning the Site itself, an extension was added to the historic core to create space for a garage (Figure 14). This is dated later which is reflected in the visible change in brickwork and roof tiling. Further to this, the building has seen any historic windows replaced with modern

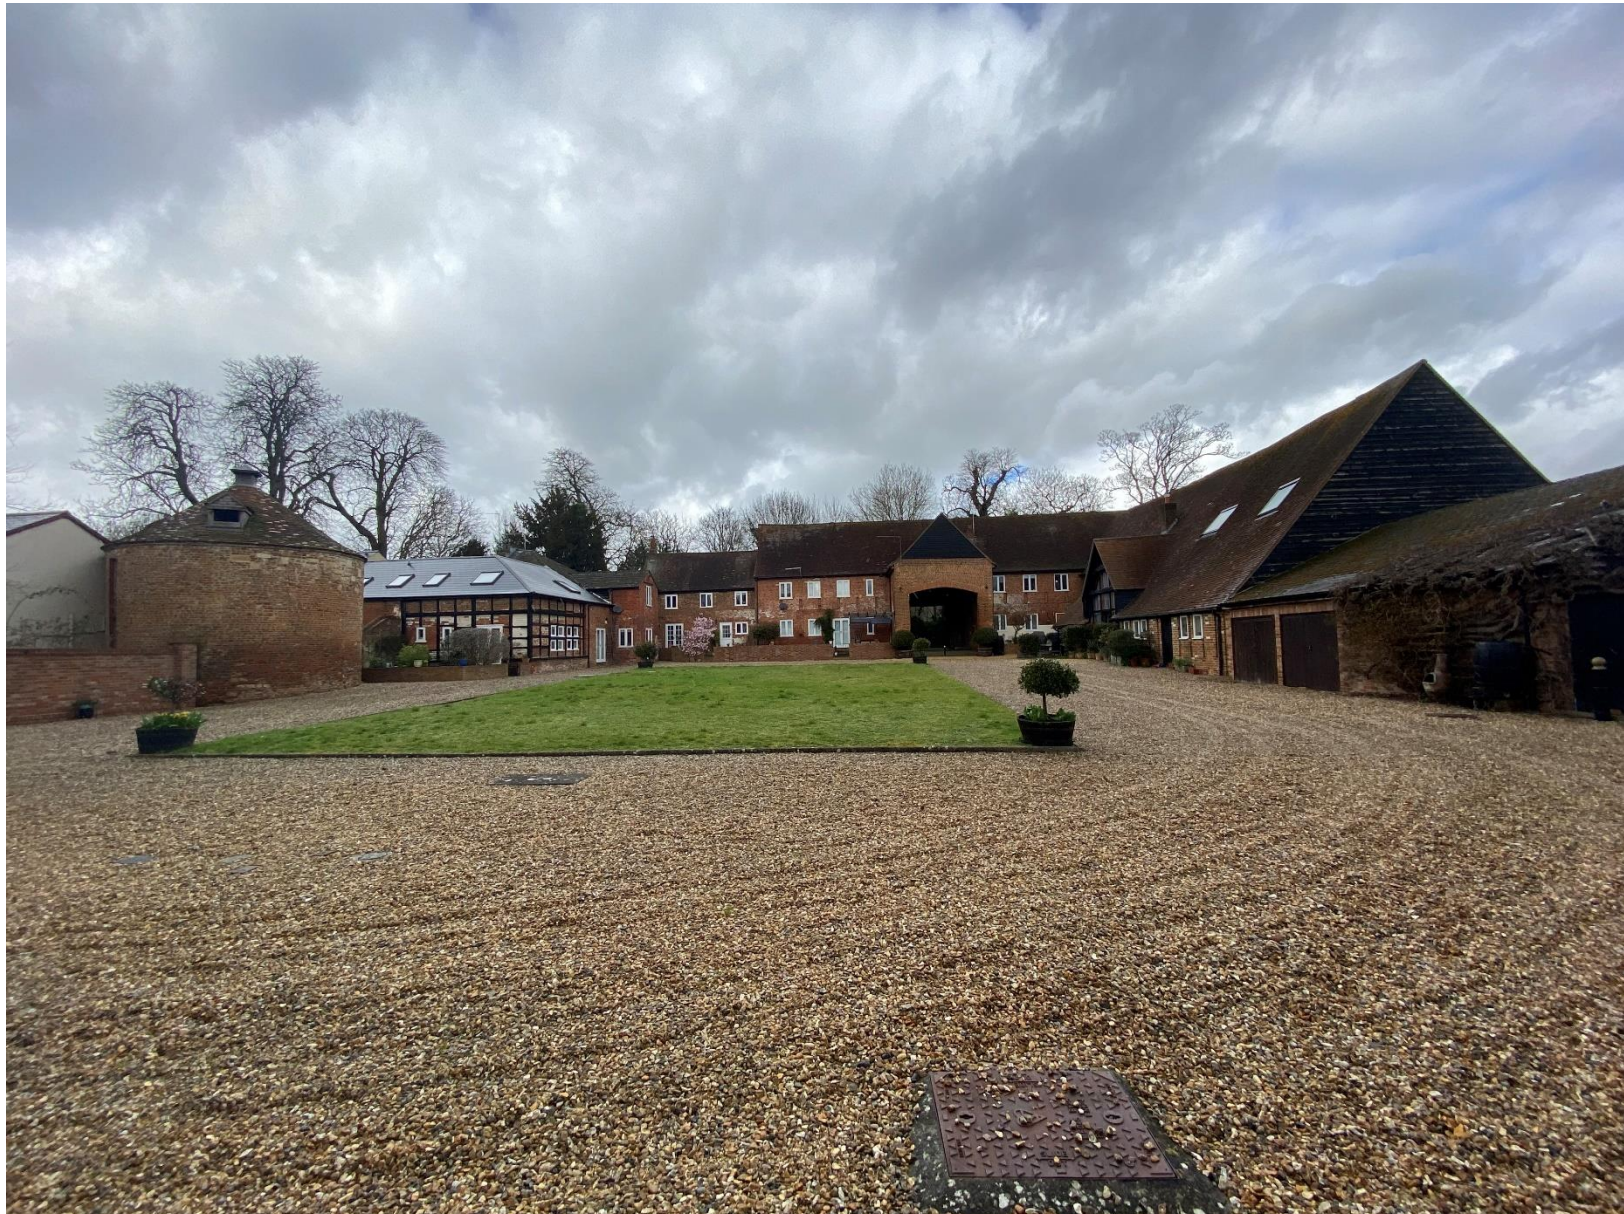
*Figure 17 – Coley Park Farm estate. The historic layout of the farmstead is still legible, with surviving buildings such as the dovecote (left) adding historic significance to the area.*

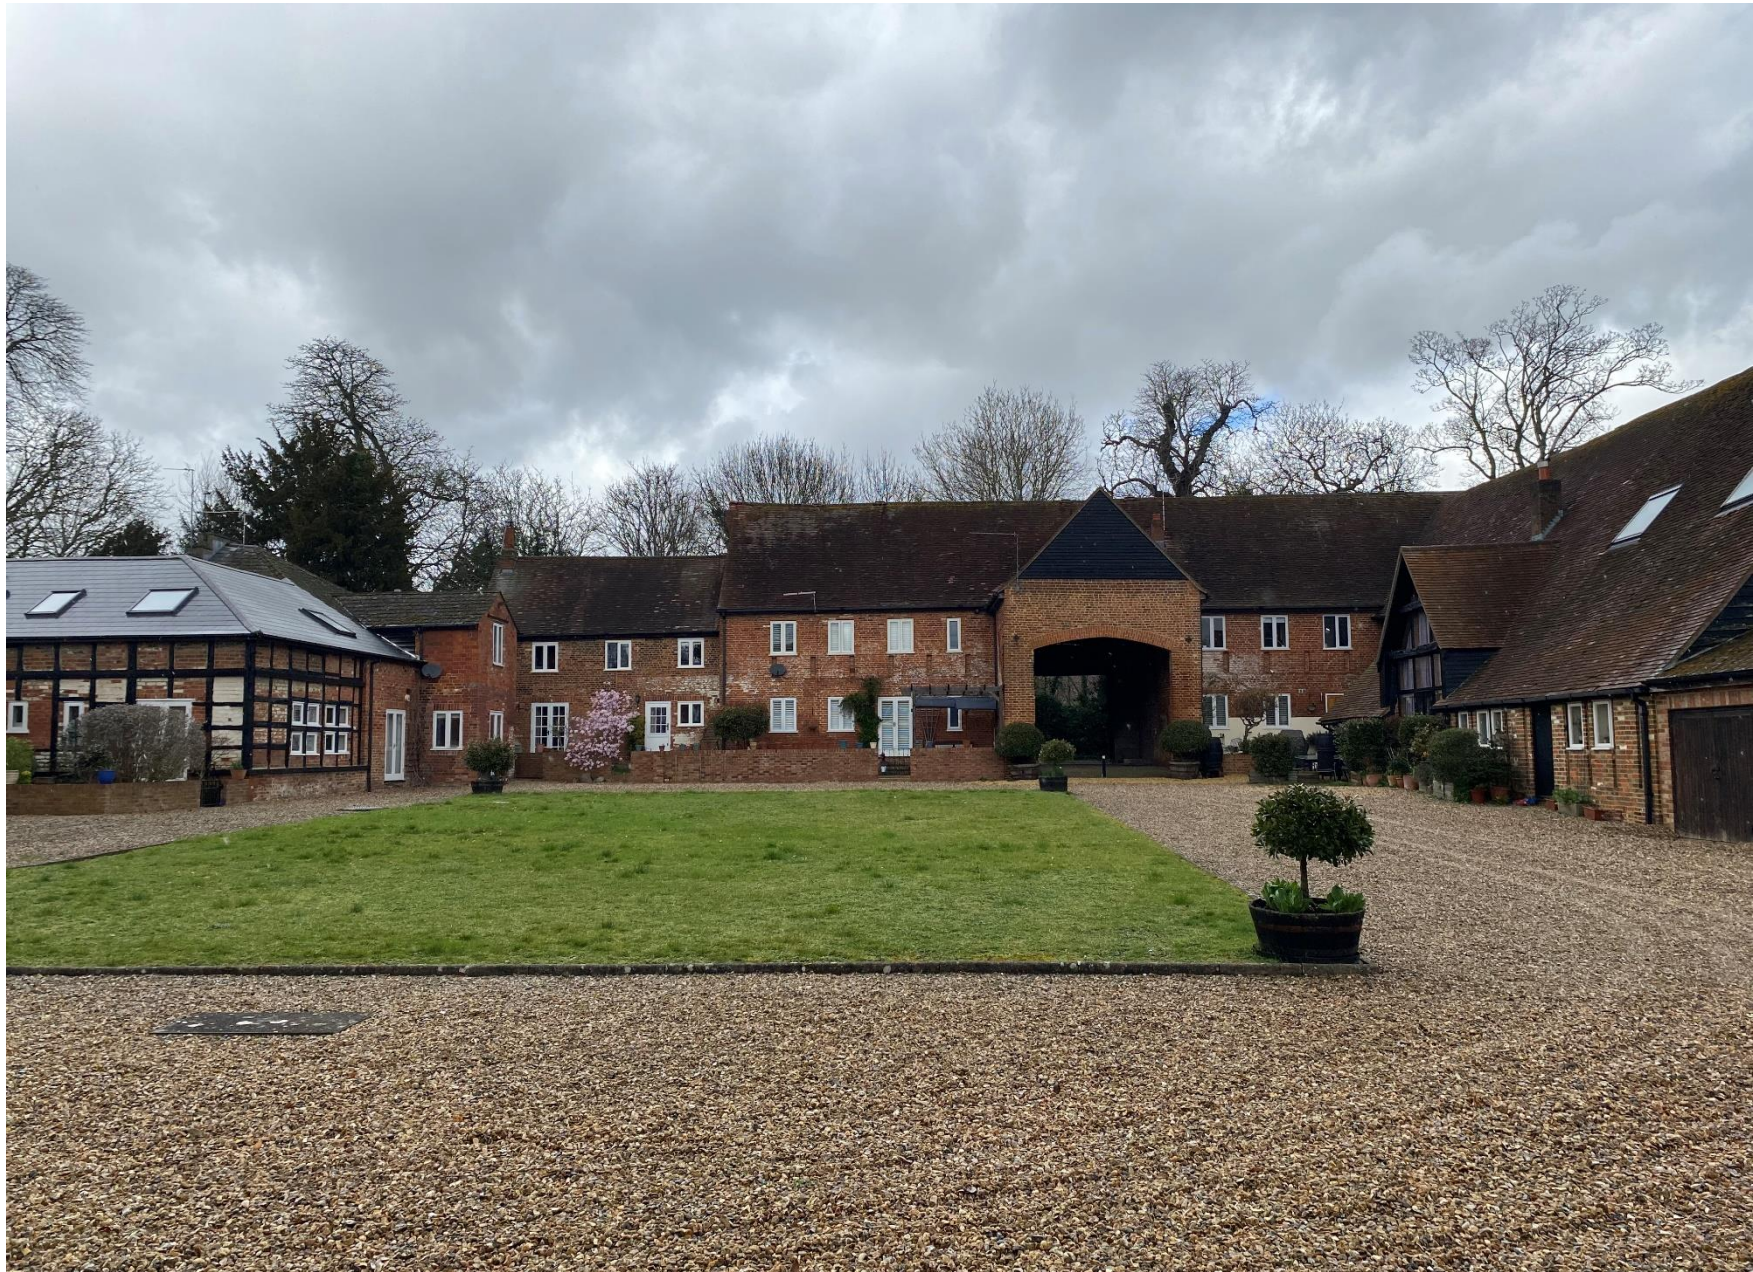
*Figure 18 – Closer view of the historic farmstead. The main farm dwellings and barns have been converted into residential. This was carried out in 1986 and involved the conversion of the Site.*
