For the Site of: 7 Blagrave Street, Reading, RG1 1PJ

# Preliminary Roost Assessment (PRA)

Building structure reference - B1 (Main Building)

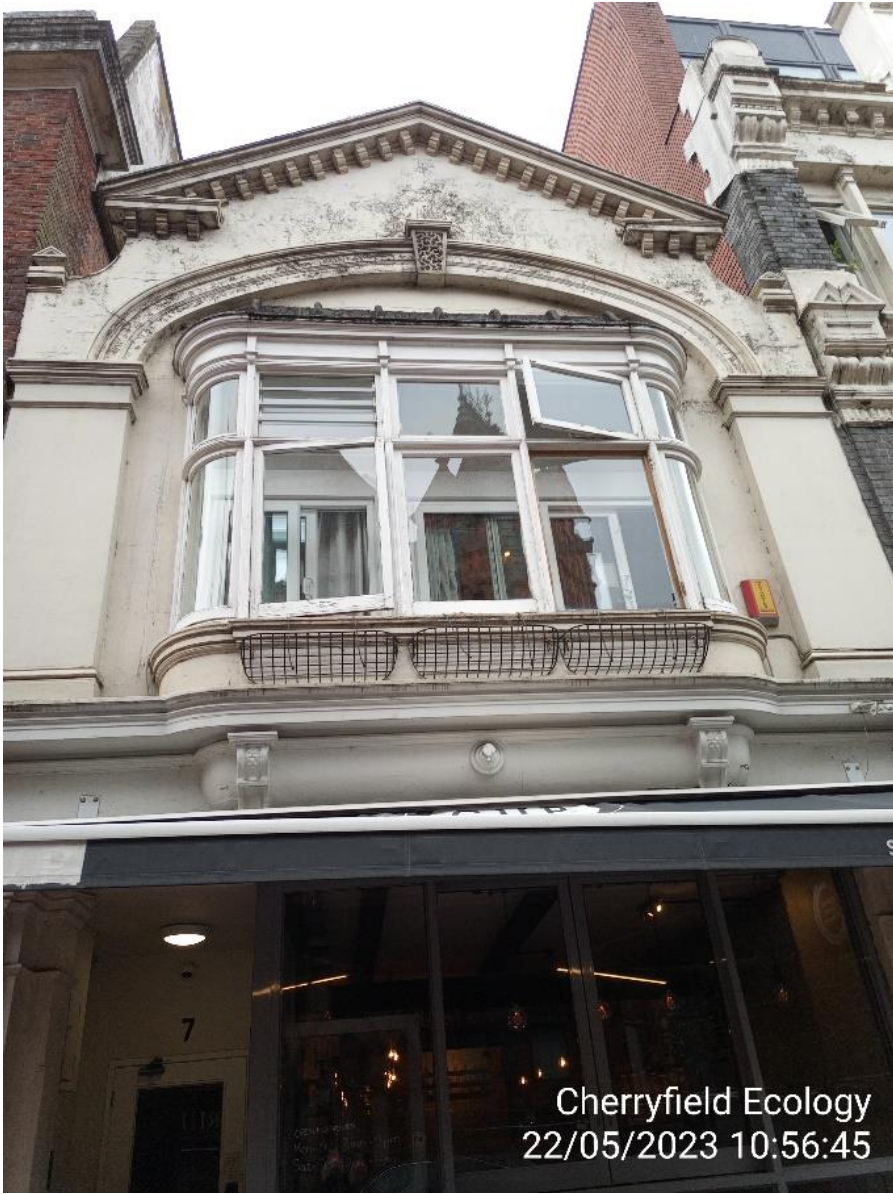
| Building/Tree/Structure Number | Description |
|---|---|
| B1 | <p><b>External</b></p> <p>Two storey building with a Georgian style façade to the front consisting of rendered plaster with a lead capped bay window to the front. The rear of the building consists of stretcher bonded brick with a single</p> <p>Figure 2: front elevation</p> |

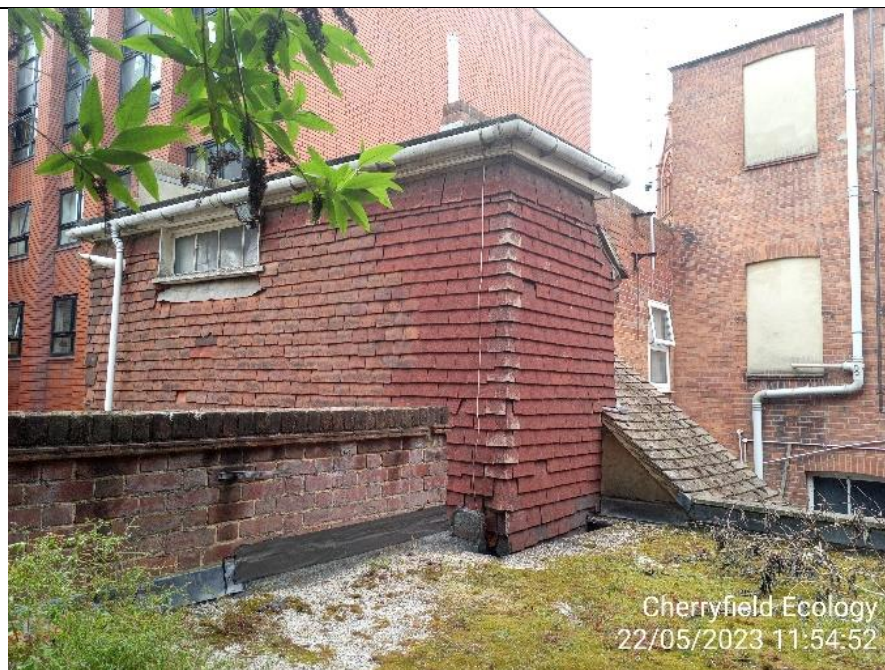
Figure 3: Rear elevation

| Potential for bat use | <p>Level of likelihood of presence -</p> <p>B1 - Moderate</p> <p>B1 provides Moderate potential for roosting bats due to the multiple gaps beneath hung tile to the rear of the property and gaps beneath the molded lead capping on the bay window to the front.</p> |

**B1 - Presence/Likely Absence surveys** will be required (two surveys, a minimum of two weeks apart).

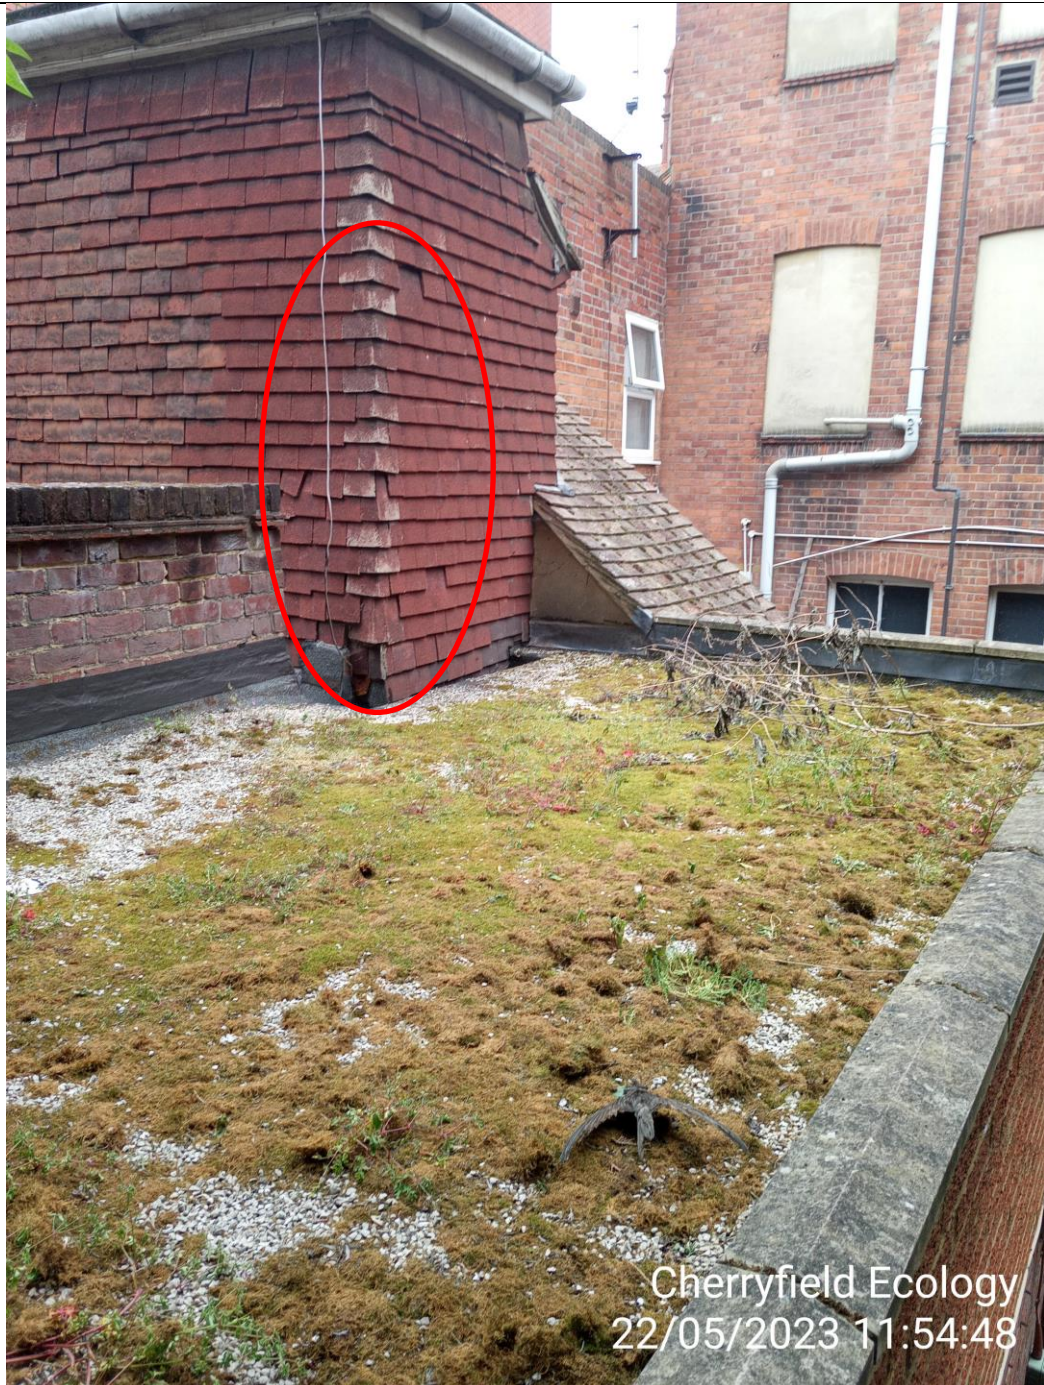
Figure 4: Example of lifted, broken and missing hanging tile with bat roost ptoential

B1 provides Moderate potential for roosting bats due to the presence of, lifted, broken and missing hanging tile and gaps in the lead capping on the bay window present on the building. There are also bat records and granted protected species licenses within close proximity to the site.

The suitable bat roosting features e.g. lead flashing. will be stripped by hand only. All areas across the roof/wall tops/weatherboarding etc. will be checked for bats i.e. endoscope (where possible) and via destructive search. If bats are found, these will be removed by hand (Ecologist only) and placed in bat boxes that will be in place before works begin.
