# Carlisle House 2023

Garden Design

Garden Support Statement

Soft Landscaping Information

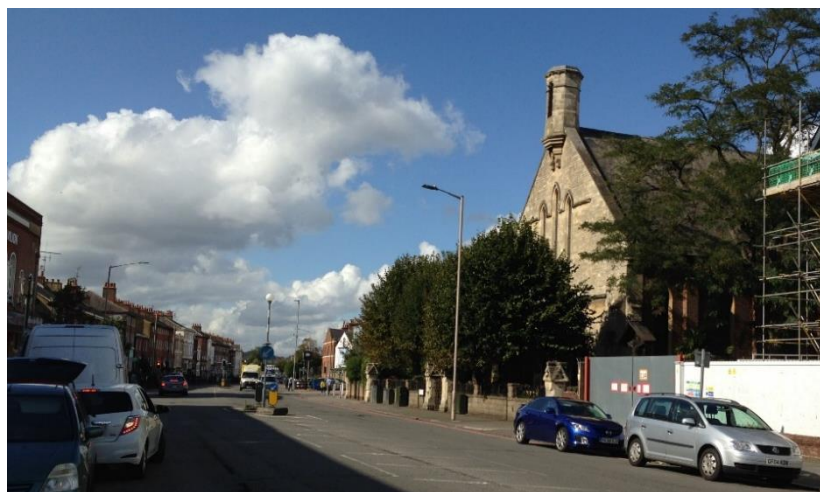
FIGURE 7 IMAGE TAKEN IN 2020 OF THE SAME SCENE GA

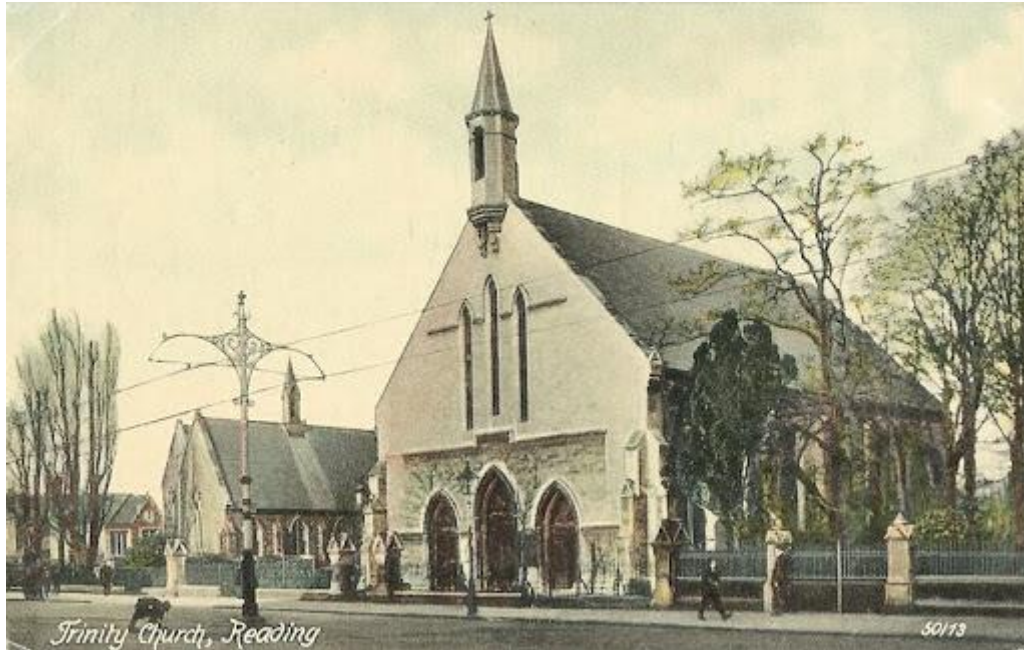
FIGURE 8 IMAGE OF HOLY TRINITY CHURCH 1900s, COURTESY OF READING MUSEUM 1978.440.2

Postcard Views show the railings and piers that were the original entrance to the garden.

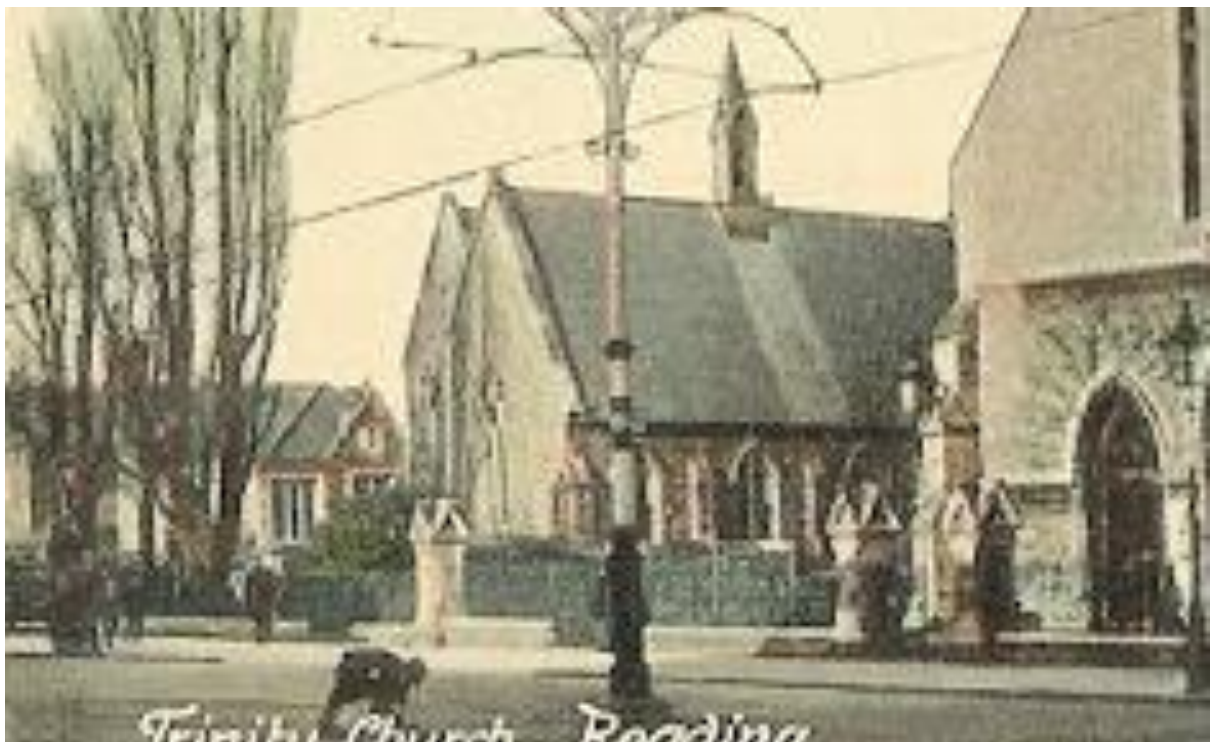
FIGURE 9 DETAIL SHOWING THE RAILINGS AND PIERS THAT WERE THE ORIGINAL GARDEN ENTRANCE

The existing wall and gate will be replaced by railings and gate (see Weston and Co 18009-PL-17) which will re-align and re-define the pedestrian route from the road to the house, giving a 'sense of place' to the site. The pedestrian will be guided from the street in to a small circular courtyard with planting colour from spring right through to winter. The railings will provide continuity with the existing western boundary which at the moment are hidden by overgrown shrubs.

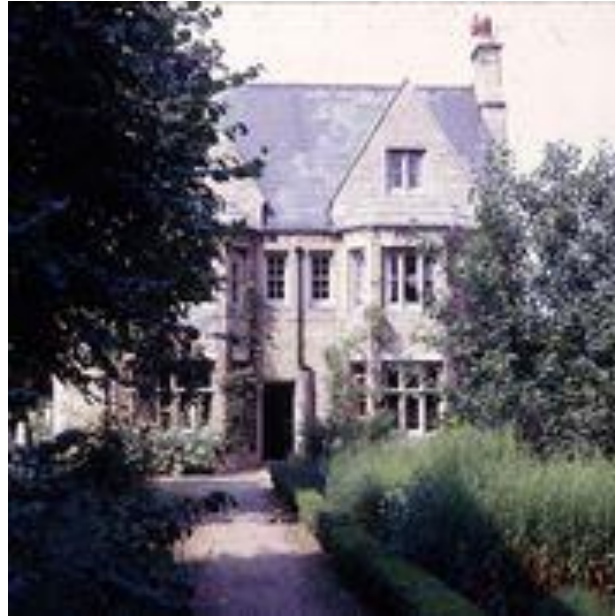
This photograph was taken in 1970. The elegant façade of Carlisle House can clearly be seen from the path and garden.

**FIGURE 11** IMAGE OF CARLISLE HOUSE SEEN FROM THE GARDEN 1970. COURTESY OF READING LIBRARY

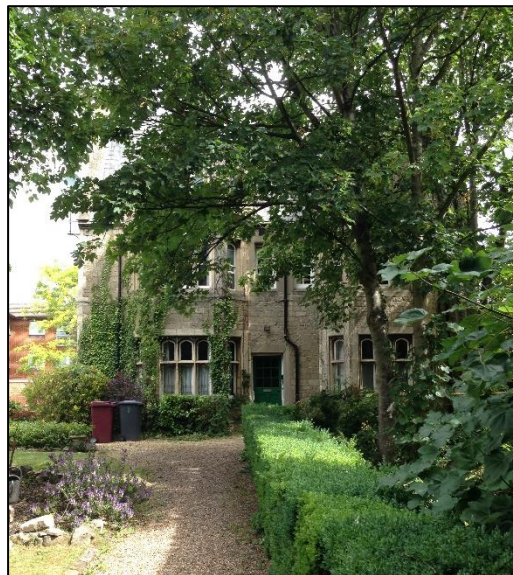
**FIGURE 12** IMAGE TAKEN IN 2020 SHOWS MOST OF THE GARDEN IN SHADE DUE TO SELF-SEEDED SYCAMORES GA

By 2020 the view is very different. The architecture can no longer be seen and the self-

Seeded Sycamore trees have become dominant and cast large shadows across the garden, limiting the type of plants that can survive in such conditions. The Box hedging has become wider, taller and has at some point experienced Box Blight.

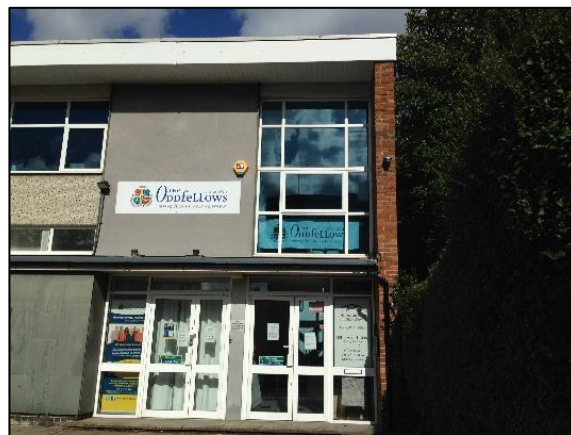
The replacement of the Trinity Boys and Girls School next door to the west of the site, with the building of the Odd Fellows Hall has also had a detrimental effect. The once elegant railings of the street entrance to Carlisle House are so overgrown by shrubs and in such shade that the resulting aspect is a dark and hidden alley way. The modern walling is also not in keeping with the stature of the listing of Carlisle House and the curtilage boundaries that once surrounded the site.

**FIGURE 13 THE GARDEN ENTRANCE BY ODDFELLOWS HALL TO CARLISLE HOUSE RESEMBLES A DARK ALLEYWAY GA**

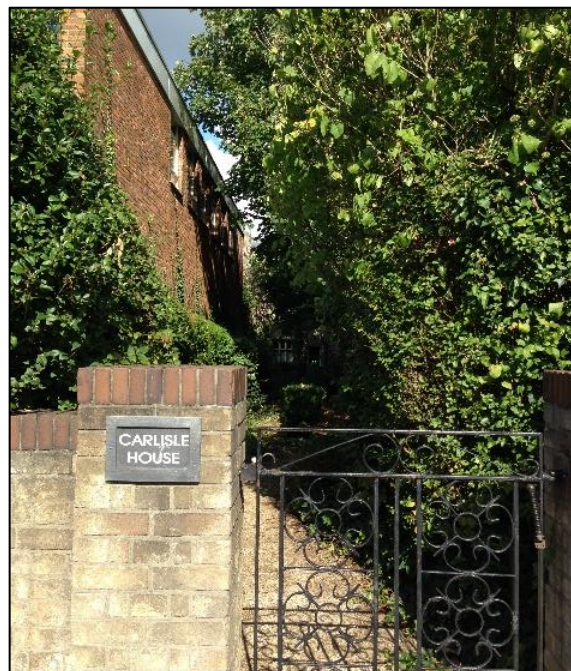
**FIGURE 14 EXISTING ENTRANCE TO THE GARDEN FROM OXFORD ROAD IS CURRENTLY MODERN BRICKWORK GA**

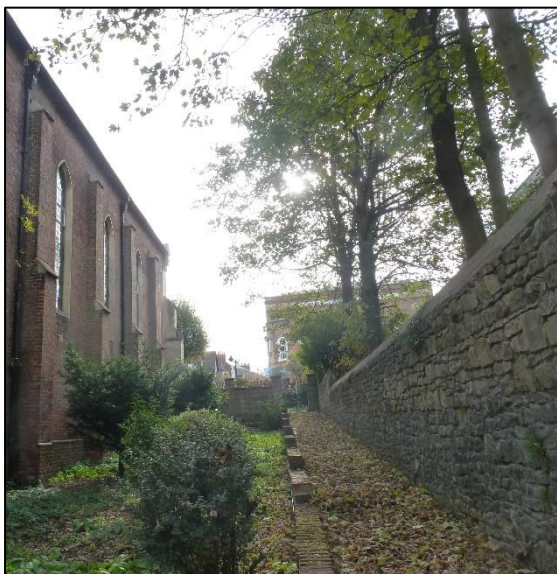
**FIGURE 15** LARGE SELF-SEEDED SYCAMORES ARE NOW DAMAGING THE WALLING GA

Large self-seeded Sycamore trees on the east of the site have been left to grow out of hand and are now damaging the boundary wall between Carlisle House and Trinity Church. They have previously been pollarded but their re-growth does not allow much light in to the garden. The garden used to have a much lighter airier more elegant feel, and this is what we would like to retrieve. A more elegant garden to enhance the elegance of Carlisle House. Therefore the removal of the Sycamores would be preferred so that ornamental trees more suited to a garden of this listed stature can be planted. Rootguard barriers in the tree planting pits of new trees will divert the roots away from the wall.

Sycamore trees causing damage to walling and causing shade in the garden in Carlisle House

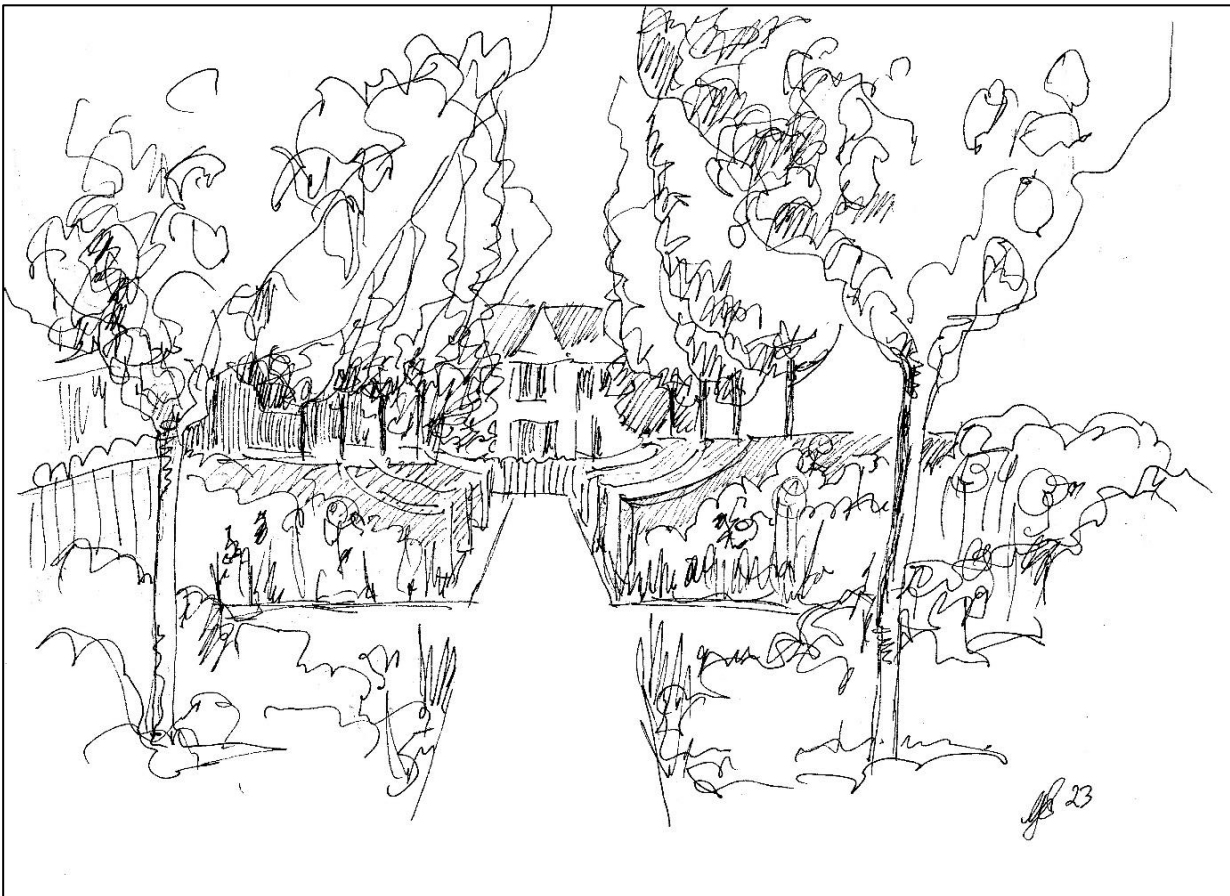
**FIGURE 21 COURTYARD AND PATH SHOWING NEW *TILIA*  
AND *CARPINUS* WITH VIEW TO THE HOUSE GA**

Two *Tilia cordata* 'Greenspire' trees have been chosen to provide continuity of street scene with the existing *Tilia* in front of Holy Trinity Church. The new curved buttressed shaped yew hedging at the northern end of this courtyard helps to provide interest and prevent the area from becoming a wind tunnel. The avenue of *Carpinus Betula Fastigiata* each side of the path help to provide much needed greenery in the vicinity of Oddfellow's Hall and mitigate the loss of the *Sycamore* trees.

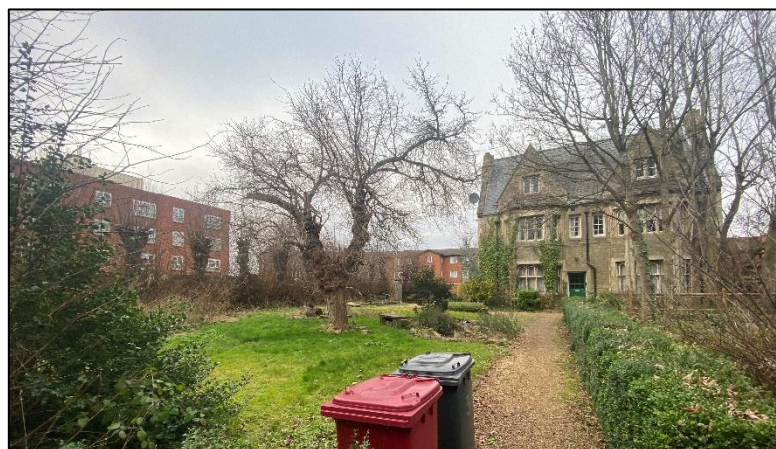
The main garden will have a more open feel with repeated planting patterns to provide continuity and flowing texture and colour. The haphazard planting beds will be removed and the area will return to lawn. The Mulberry tree will be at the centre of the design, providing sculptural interest and maturity. The borders will now be on the edge of the lawn and there will be a new pathway to the new Cycle Store/Garden Loggia Seat building.

**FIGURE 26** VIEW OF LARGE MULBERRY TREE THAT FORMS THE FOCAL POINT OF THE WHOLE GARDEN AND NEW DESIGN WESTON AND CO

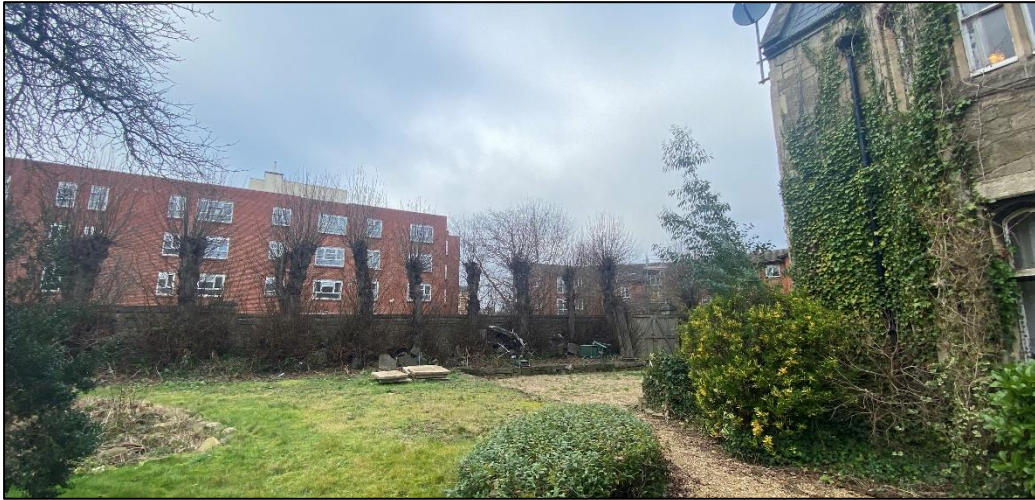
**FIGURE 27 POLLARDED LIME TREES ON THE WESTERN BOUNDARY** WESTON AND CO

A significant row of lime trees run along the inside of the west boundary. There is one missing in the corner which we will replace. It is proposed that these trees are regularly trimmed to keep to just above the highest pollarded height like a high hedge. This still gives privacy to the garden of Carlisle House from a series of tall apartment buildings to the west and to the north but it keeps regular maintenance achievable.

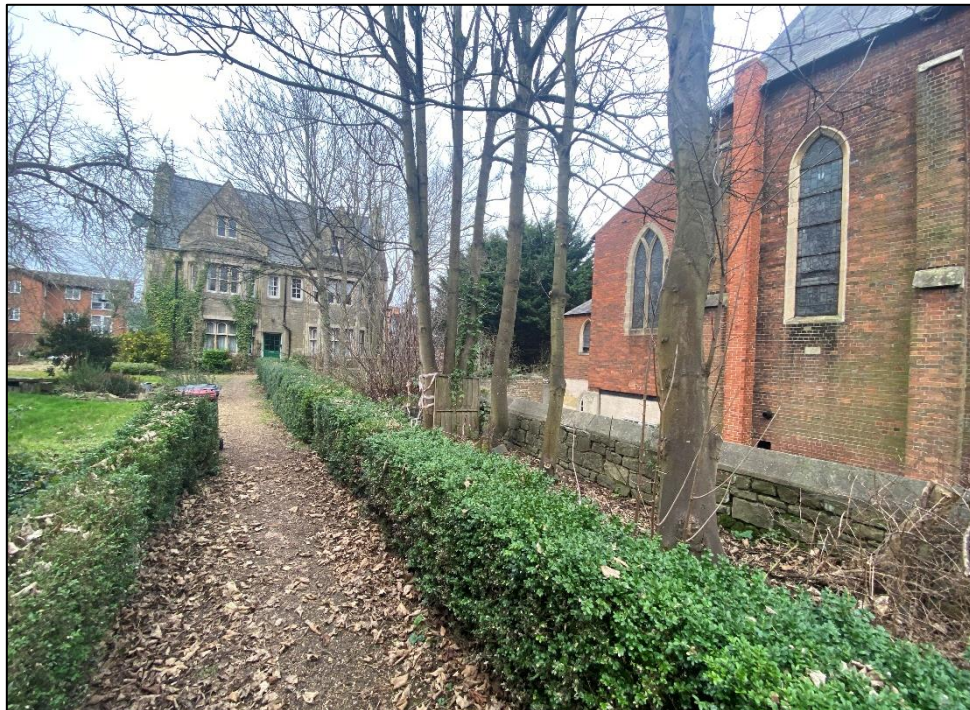
**FIGURE 28 LARGE SELF-SEEDED SYCAMORES CAST GREAT SHADE OVER MUCH OF THE GARDEN**  
WESTON AND CO

On the eastern boundary are the self-seeded maple trees which have taken over this side of the garden, casting much of it in shade.

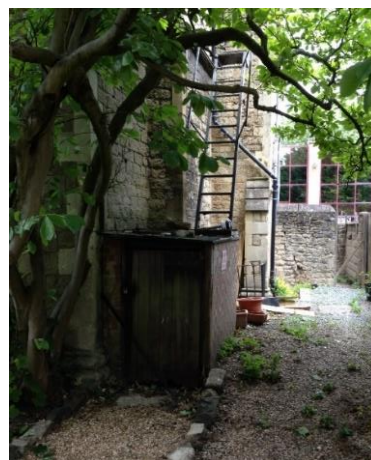
FIGURE 31 MATURE EXISTING MAGNOLIA ON THE SOUTH EAST CORNER OF THE HOUSE TO BE SUPPORTED BY A NEW IRON ARCH GA

Another plant of interest is an arching Magnolia by the south east corner of the house. This mature plant will be kept and a supportive archway structure will be made to support its branches. This will help to stop any damage in the future from branches becoming too heavy and also allow tenants access underneath in to a courtyard area.
