## Phase 1 Preliminary Risk Assessment

### **Savoys Properties**

266 Kentwood Hill, Tilehurst, Reading, RG31 6DR

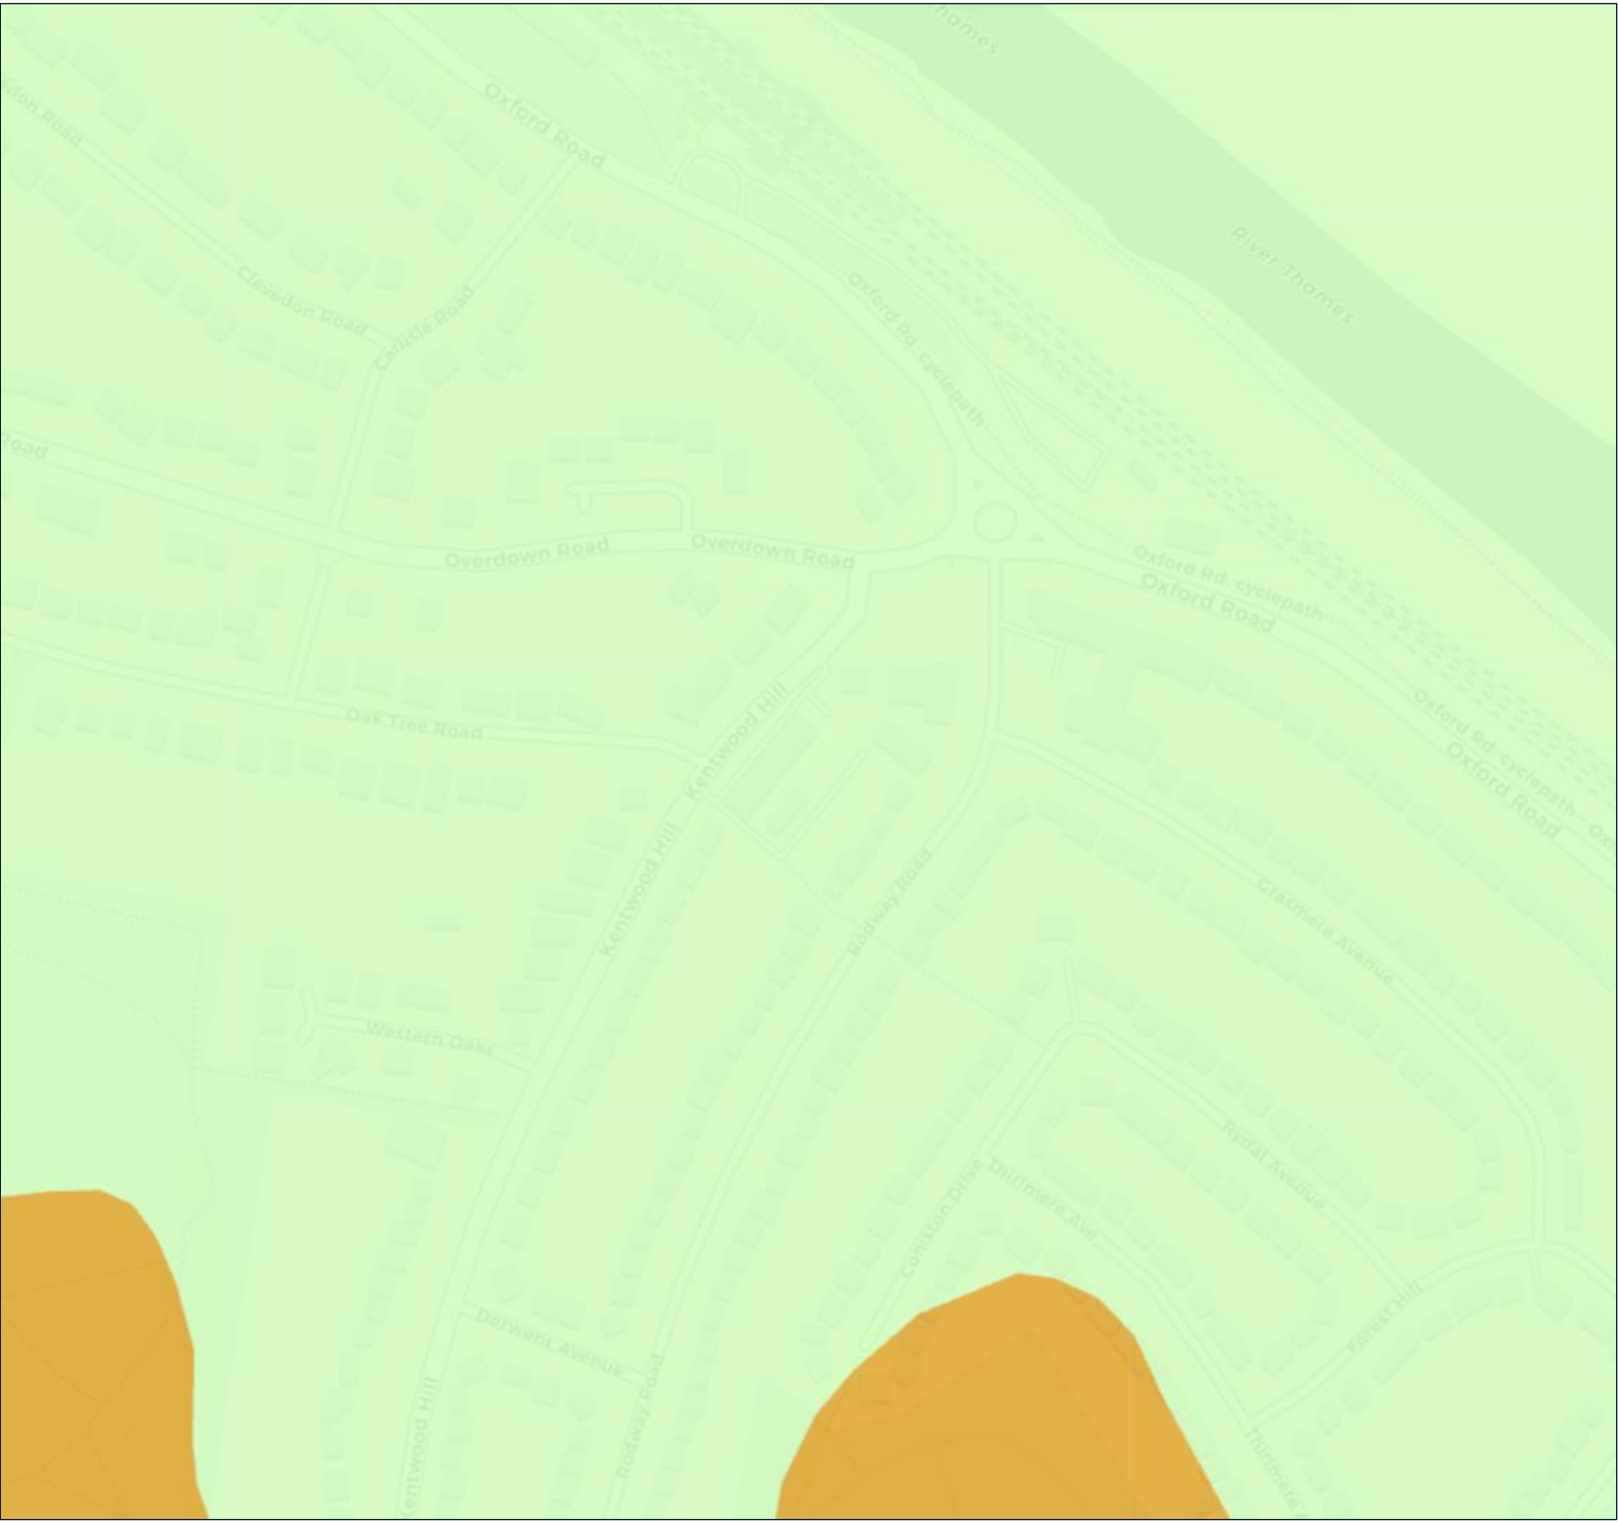
| Appendix - Geological Maps | |
|---|---|
| BGS map showing bedrock geology on site | |

| Environmental Factor | | Details | |
|---|---|---|---|
| | Bedrock Geology | | Seaford Chalk Formation and Newhaven Chalk Formation – comprising firm/soft to medium hard white chalk with flint and marl seams |

Records show that there is an historical landfill 430m south east of the site that accepted inert and industrial waste. There is no record of the date this landfill was completed, however, due to the distance of this landfill from the site and the lower permeability geology in this location (Lambeth Group) the risk to the site from the migration of ground gases is considered to be low.
