# LEIGHTON PARK SCHOOL

## DEMOLITION AND REFURBISHMENT AT GROVE HOUSE

### BAT ACTIVITY SURVEY - ADDENDUM REPORT

DOCUMENT REF: E22108001/Doc 02. 20 MAY 2022

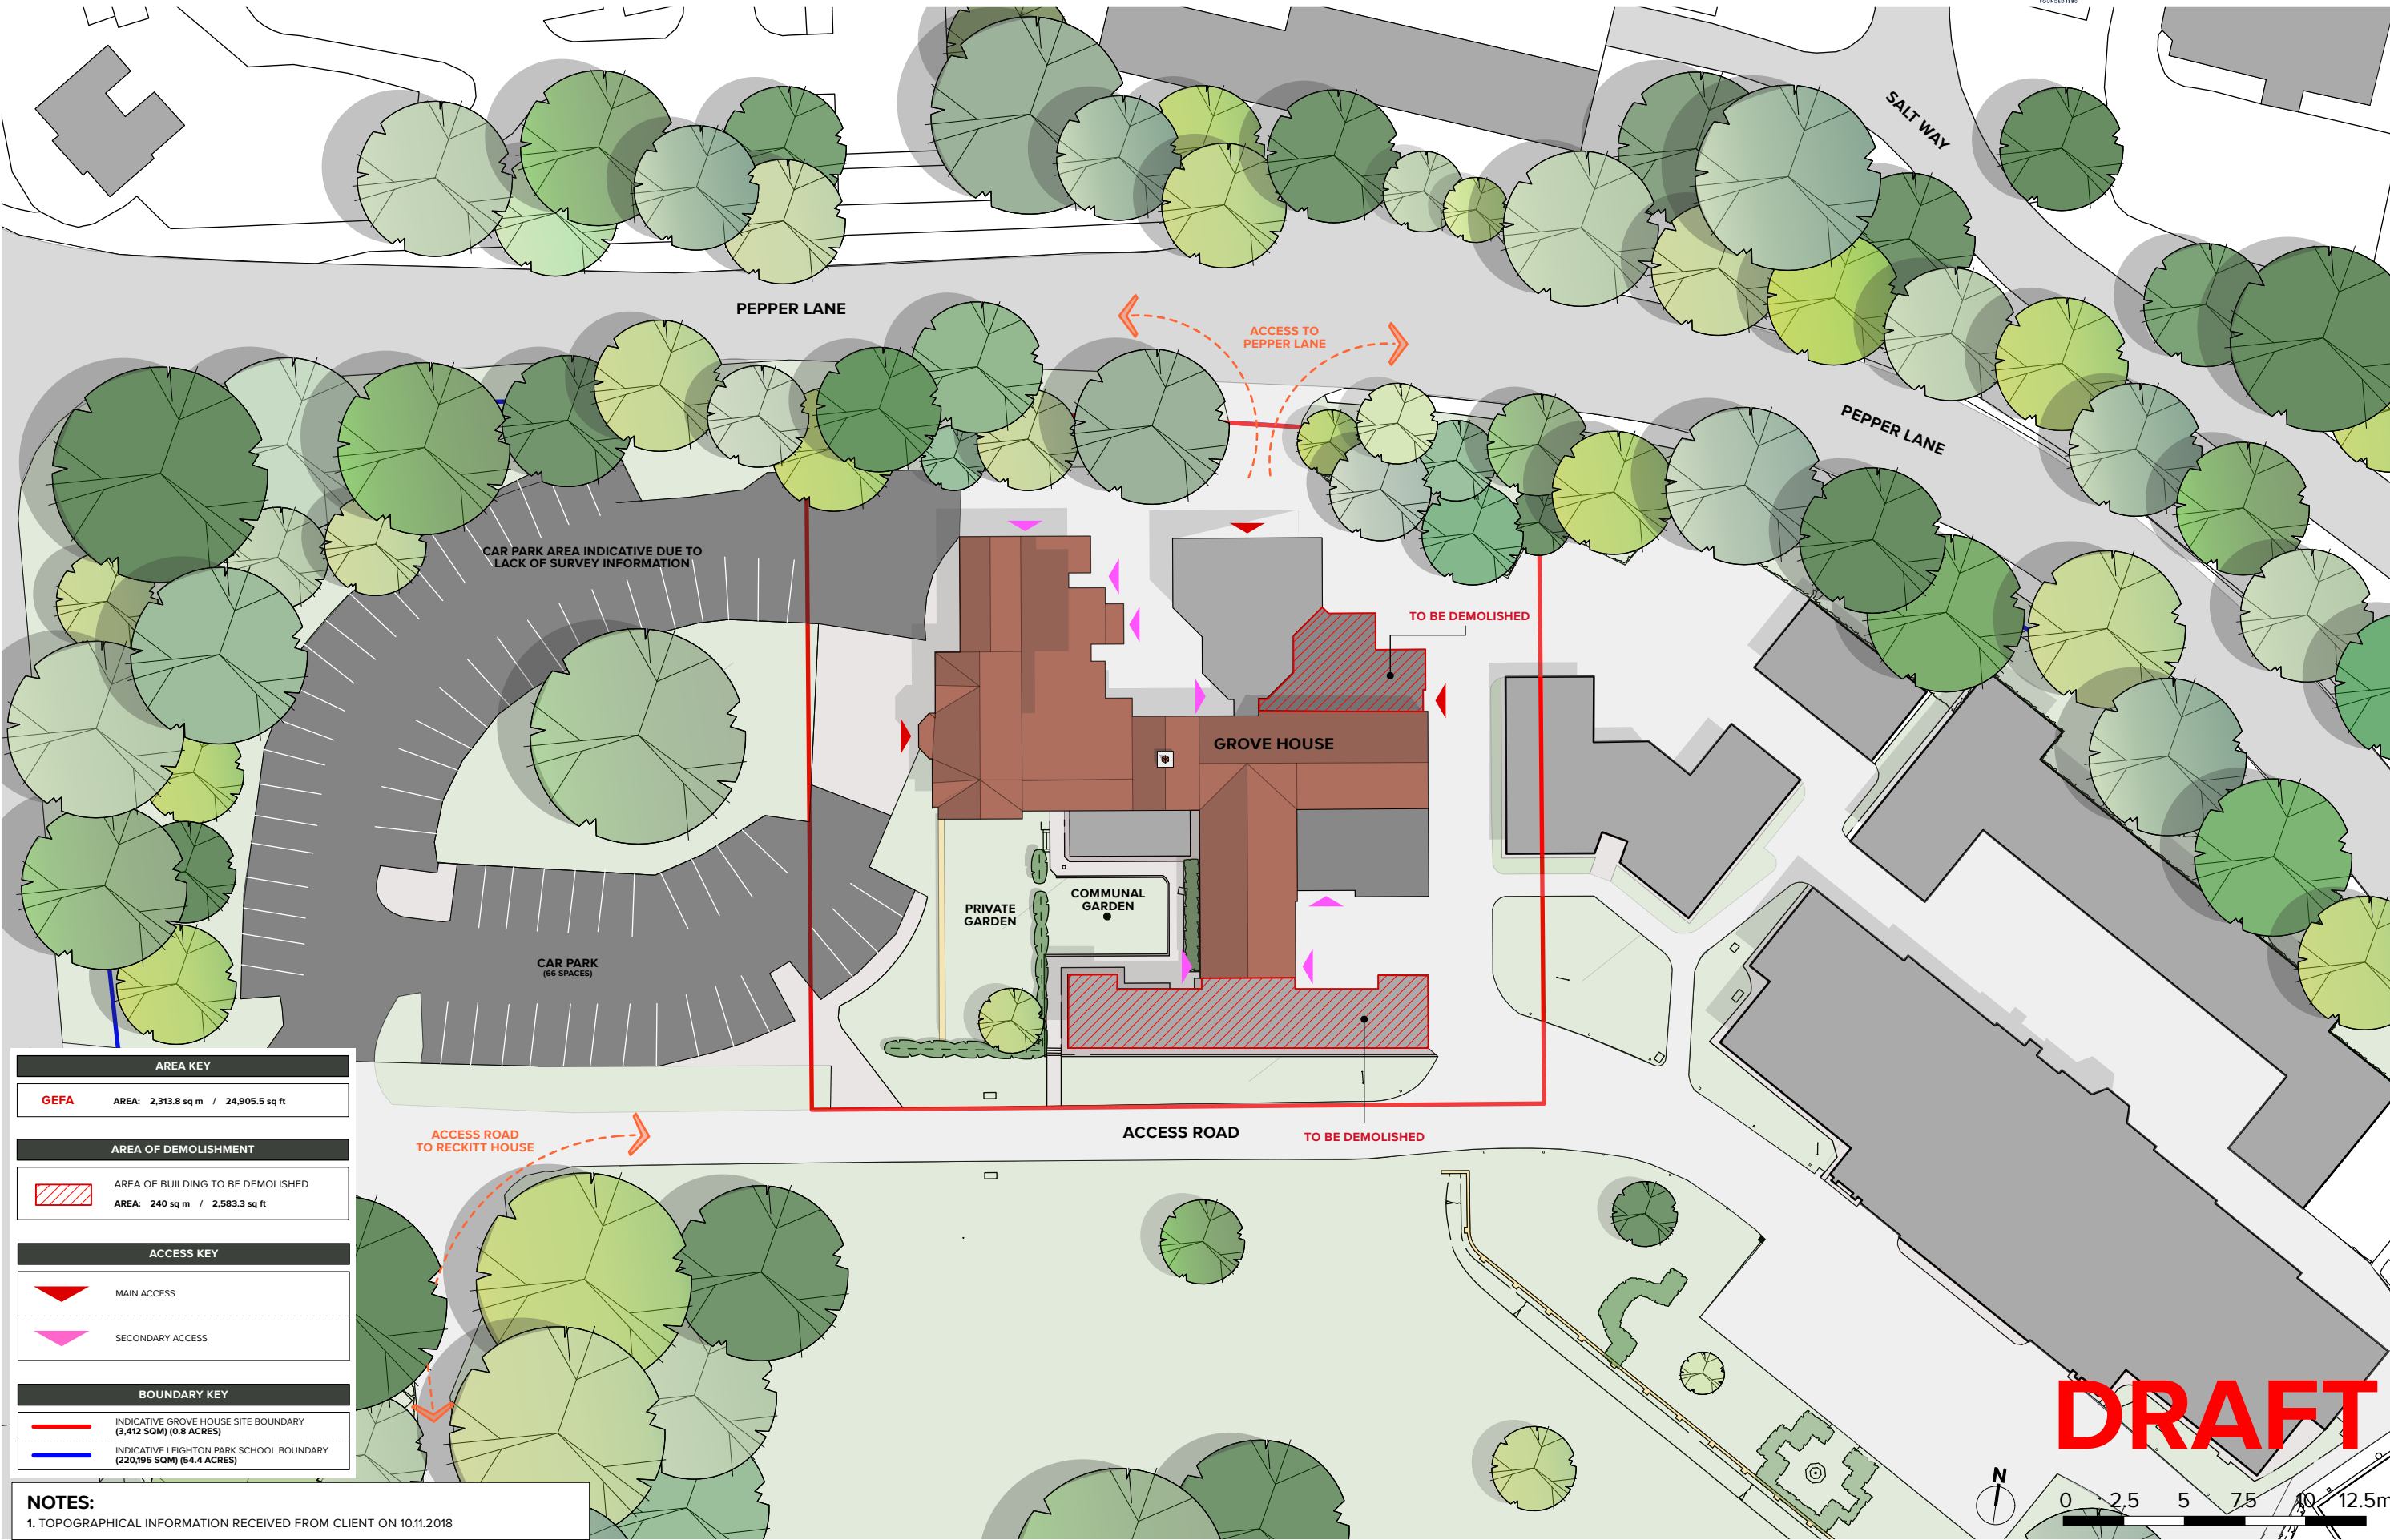
**APPENDIX I      LOCATION PLAN SHOWING AREAS PROPOSED FOR DEMOLITION**

| AREA KEY | |
|---|---|
| | AREA OF BUILDING TO BE DEMOLISHED<br>AREA: 240 sq m / 2,583.3 sq ft |

- 4.1 The combination of daytime inspection and dusk emergence survey has established the likely absence of roosting bats from the areas of Grove House proposed for demolition or refurbishment works (see Plan in Appendix I). On this basis, no specific mitigation or licensing would be required for the works although the adoption of 'reasonable avoidance measures' would be appropriate.
