## 4 Kidmore Road, Reading

Preliminary Roost Assessment  
Mr P. Byfield

December 2022

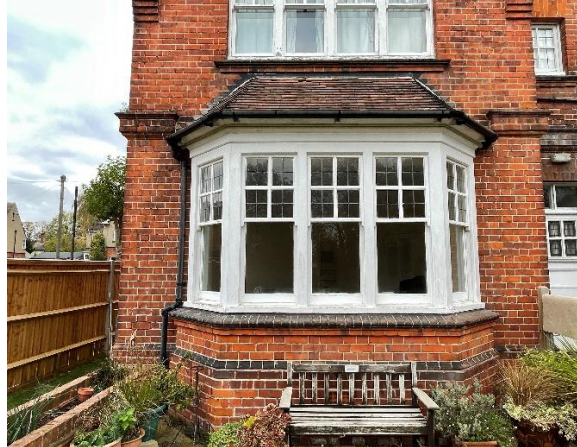
| Building | External description | Internal description |
|---|---|---|
| 1 – main house. | A large three storey detached building.<br>The roof of the bay window and patio door was a pitch design and clad with machine made clay tiles.<br>The walls were constructed from brick.<br>No PRF were recorded in the roof cladding.<br>No evidence of bats recorded externally. | No void accessible in either of the two spaces seen in photos 1 and 2.<br>No PRF were recorded internally.<br>No evidence of bats was recorded internally. |

Photo 1 – Building 1, bay window

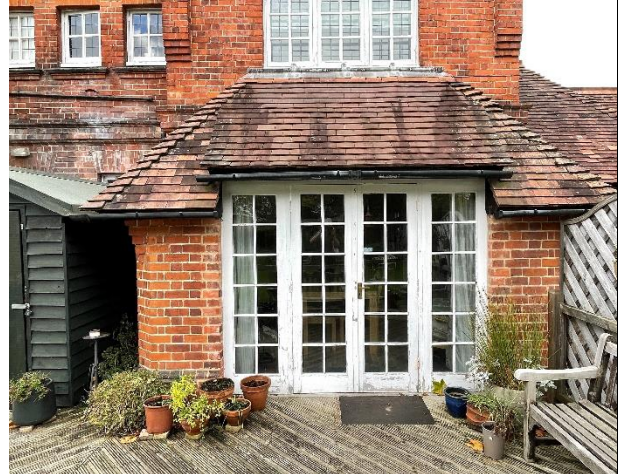
Photo 2 – Building 1, porch doors

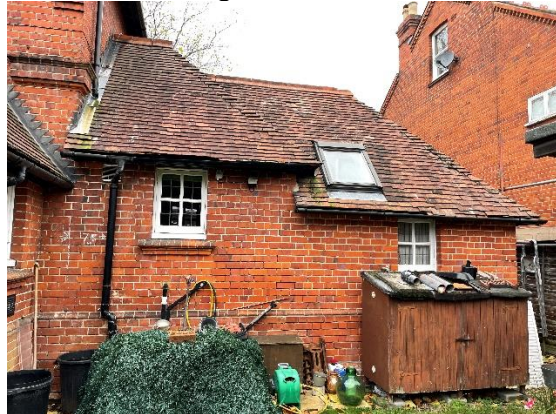
| Building | External description | Internal description |
|---|---|---|
| 2 – single storey extension | A more recent extension of the original house.<br>The roof was of a dual pitch design, clad with machine made clay tiles.<br>A MODERATE number of PRF were recorded where roof tiles were slightly misaligned, slipping or missing.<br>No evidence of bats was recorded externally. | A large single roof void was present in the single storey extension.<br>There was no felt present, and the tiles laid directly onto the wooden battens.<br>Approximately 100 bat droppings were scattered throughout the void area. There were no significant accumulations in any one place.<br>From their shape and size the droppings are believed to be from brown long-eared bats. |

Photo 3 – Building 2, roof

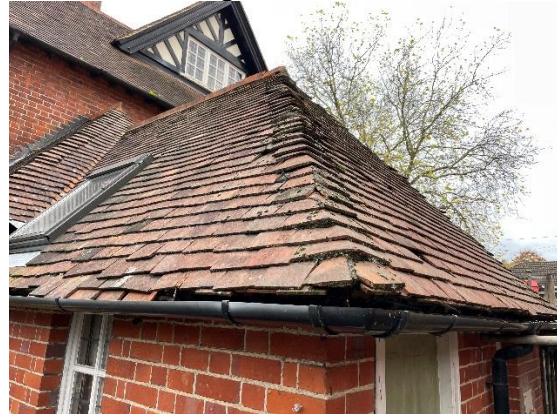
Photo 4 – Building 1, roof

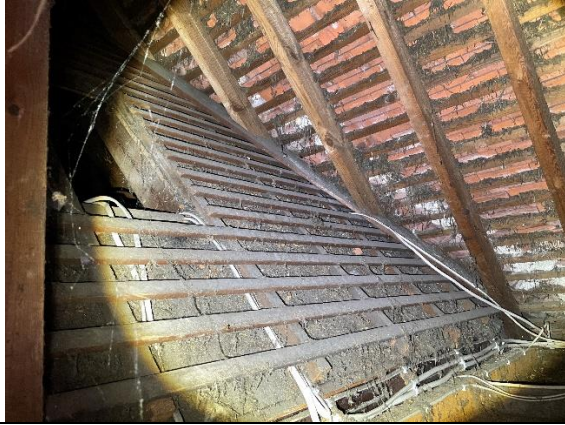
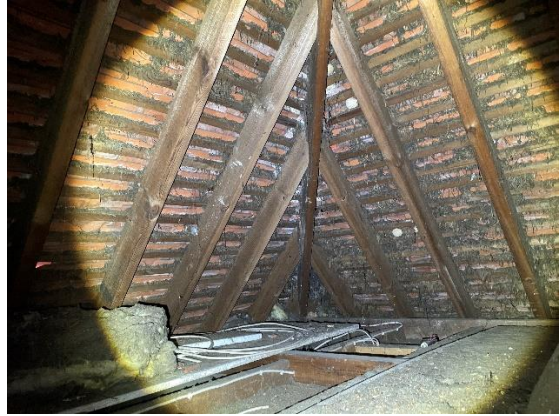
| Building | Bat Roost Potential | Reason | Recommendations |
|---|---|---|---|
| 2 – single storey extension | <b>CONFIRMED</b> | <ul style="list-style-type: none"> <li>A MODERATE number of PRF were recorded externally</li> <li>C100 bat droppings recorded in the roof void, suspected BLE.</li> </ul> | No further survey work required |

Photo 5 – Building 2, inside void

Photo 6 – Building 2, inside void
