# ECOLOGY ASSESSMENT

FOR NICK WOOLEY

10 GUN STREET, READING | NOVEMBER 2022 |

VERSION 1

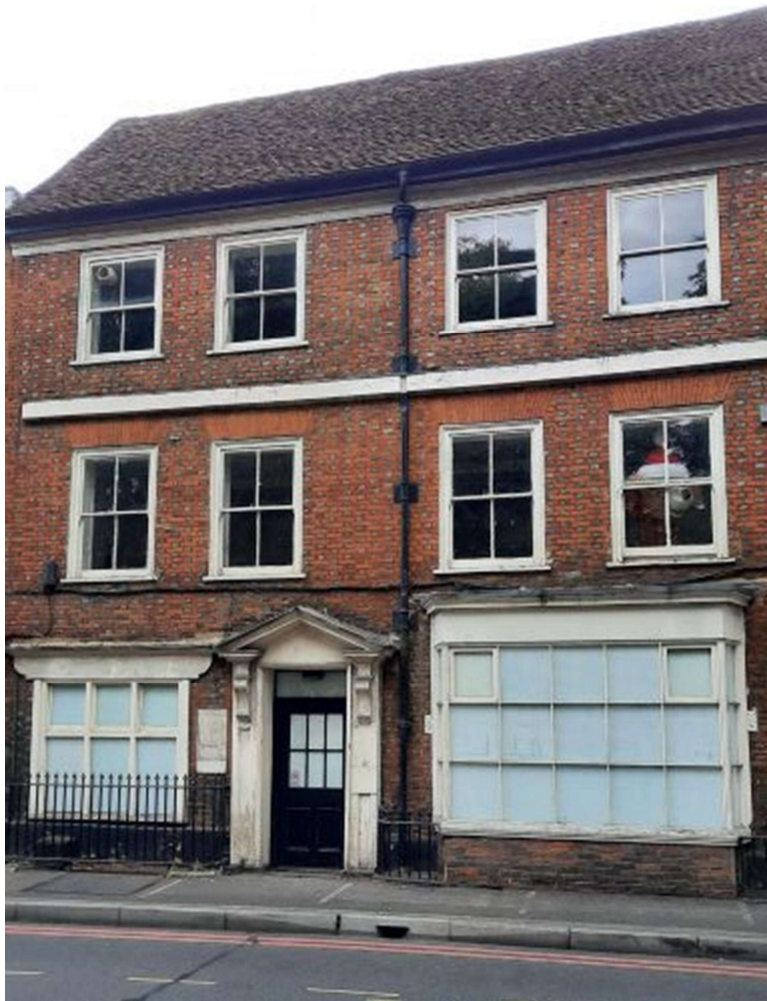
Picture 1: Northern elevation.

The northern elevation is in good overall condition with no apparent gaps or crevices within the brickwork. However, the age and style of the property means there is potential for small gaps and crevices around lintels and window frames that could have the potential to support small roosts suitable for individual or low numbers of bats.

The same is true of the roof tiles, which appear to be in overall good condition but are of an age and style that they are irregularly shaped and therefore provide small gaps that have the potential to support small roosts suitable for individual or low numbers of bats. The northern aspect makes it less suitable for bat roosts which typically favour a more southerly aspect. A photograph of the northern elevation is provided below:

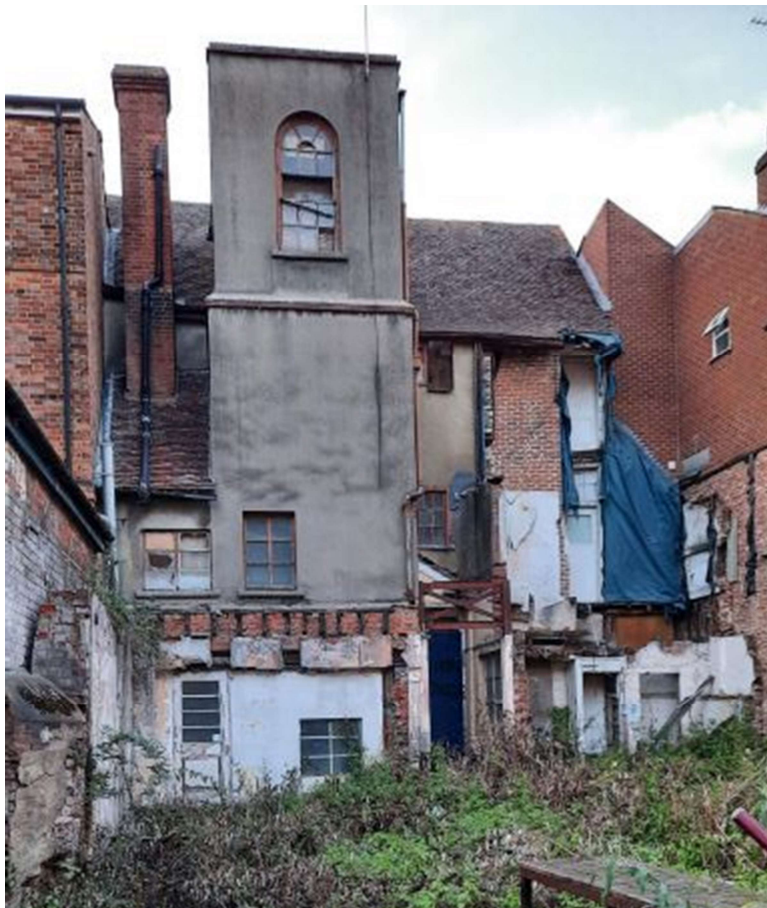
Picture 2: Southern elevation

The south elevation comprises the exterior of the original building with signs of a number of subsequent revisions. The original southern side of the pitched roof is present across the full length of the three-storey elevation. A similar, smaller section of pitched roof is present on a two-storey section of the building that extends southwards and has a tall, brick chimney upon it.

A square tower also extends south from the original elevation which houses a stairwell. It comprises brick at the ground floor level and is rendered above. The remaining external wall is part exposed brickwork and part rendered but also includes exposed interior features, such as interior doorways, where extensions have been removed. A large amount of damage is visible, including large gaps in the brickwork and a large gap at the eastern end of the roof eaves. Some exposed features are covered in plastic sheeting. There are a number of windows present which are typically boarded internally with glass panes missing or broken.

The southern elevation provides a number of PRF's and access points into the building. The sections of tiled roof are similar to the northern elevation and provide a number of small gaps suitable for individual or small numbers of bats. The damaged section of roof provides access into the roof void and potentially into a void between the loft floor (which is boarded) and the ceiling below.

The damaged sections of wall provide small roosting opportunities within small gaps and cracks but also provide potential access points into larger voids and into the interior of the building. The broken windows also provide potential access into the interior of the building where boarding behind is either missing or in poor condition.

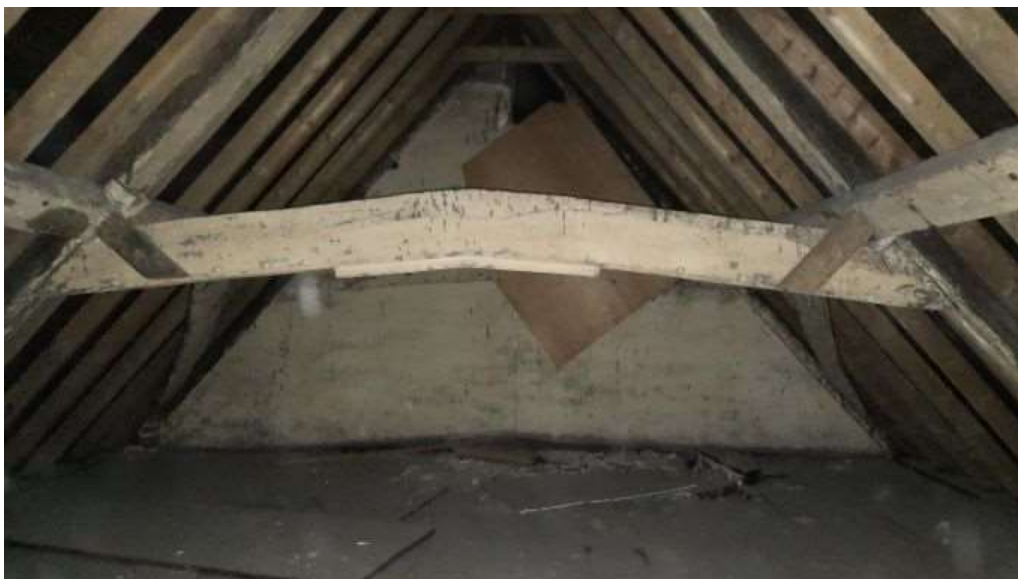
Picture 3: Loft space

The loft is accessible by the main staircase and the floor is fully boarded but the space is currently unused. It is constructed by a timber 'A' frame which is lined behind and generally in good condition. Brick walls make up the gable ends and large gaps are present at the top at each end of the loft providing connectivity to the adjoining properties.

The damage identified to the exterior provides a large access point in the south east corner of the roof and a further, small, access point was identified on the southern side, further west. This gap was full of cobwebs and unlikely to have been recently used by bats.

The loft void itself provided a suitable feature for large numbers of bats to roost. The wooden frame appeared to be in good condition and well connected so provided limited gaps or crevices for bats to roost within.

The floor and vertical beams were thoroughly searched and no bat droppings or bat feeding remains were found to be present. Rat droppings were present throughout.

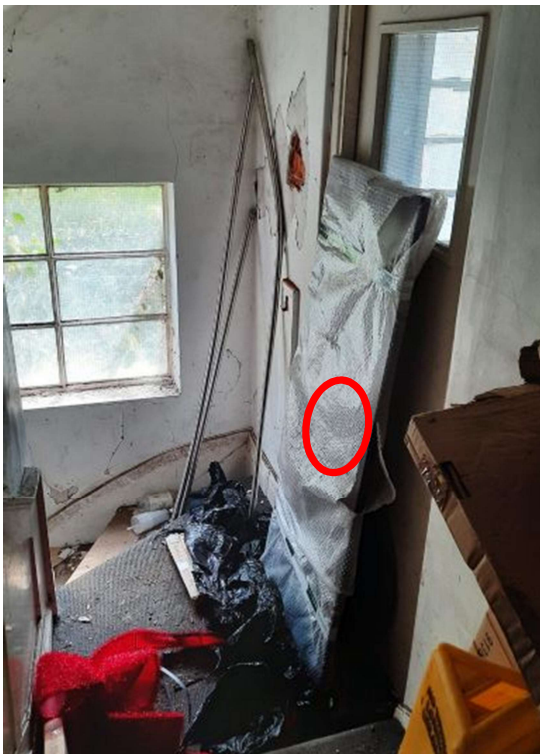
Pictures 4 to 8: Interior

The main interior of the building was previously used as office space and was divided into a number of rooms used for that purpose, plus toilet and kitchen areas. The majority of these areas were well lit by the large windows in the north elevation and no areas were free from daylight, except for an internal kitchen area on the first floor that was closed off to the rest of the interior.

The majority of the interior walls and ceilings were intact and where there was damage this was superficial. The exception to this was the areas of damage already noted on the southern exterior where a number of gaps were present which opened up into the interior of the building. There were also a small number of inspection hatches that had been created in the ceiling which provided access to the space above the ceiling.

No other signs of bat presence were identified despite all floors and surfaces being thoroughly checked. Rat droppings were present. There is potential for other stored materials within the interior to provide similar sub-optimal roosting conditions to the board, although no signs of bats using other materials were identified.

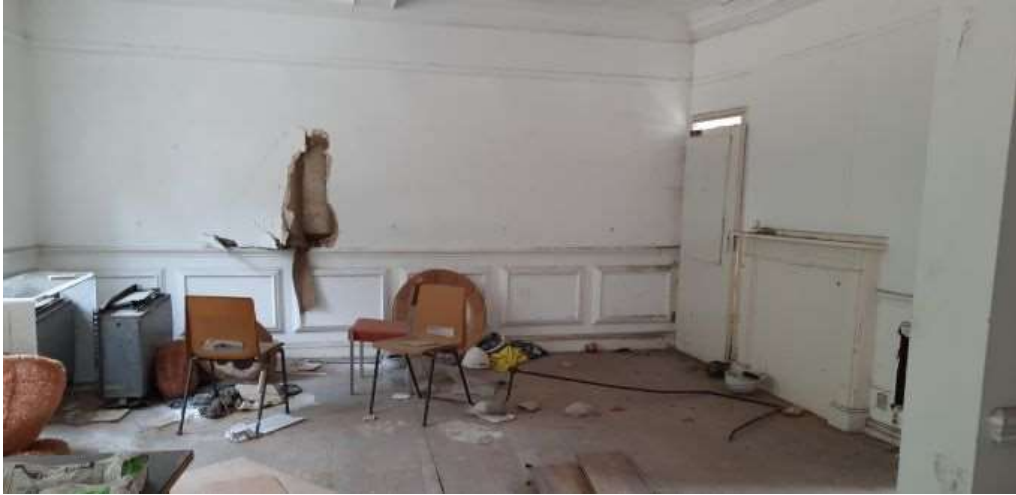
The overall suitability of the interior as a roost space was low due to it being well lit and having relatively few voids, cracks or crevices for bats to utilise. However, a single bat dropping was identified behind a board leaning against a door on the ground floor. The dropping was old and was characteristic of a pipistrelle bat dropping. The board was considered a sub-optimal roosting location and the absence of other signs of bat presence suggested its use had been minimal.

Picture 1: Bubble-wrapped board leaning against interior door on ground floor where a single bat dropping was identified, attached to the rear (approximate location indicated by the red circle).

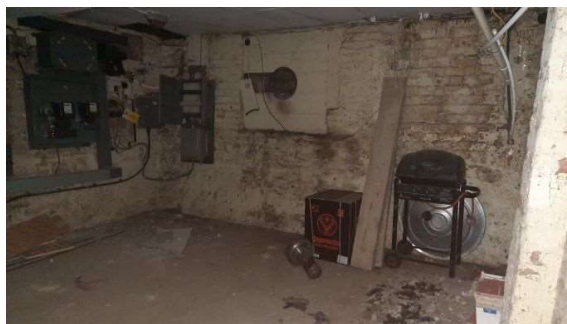
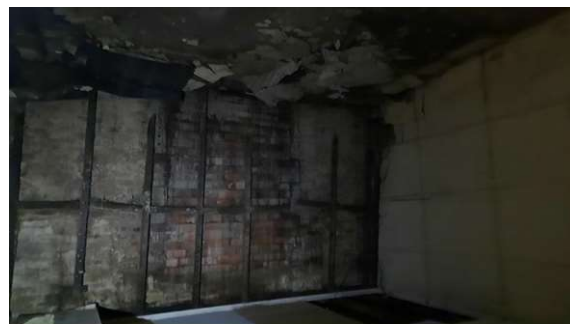
Picture 9 and 10: Basement

All surfaces were thoroughly searched for signs of bat activity and none were found. Rat droppings were present throughout. The basement is a suitable location for a hibernation roost although no signs to suggest its use as such were identified.

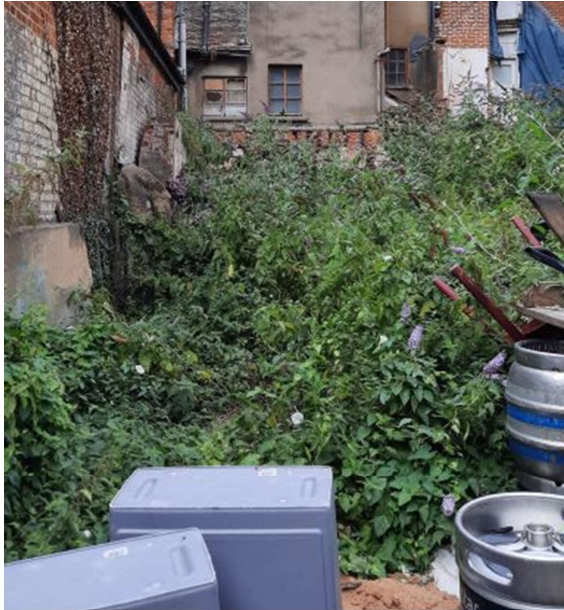
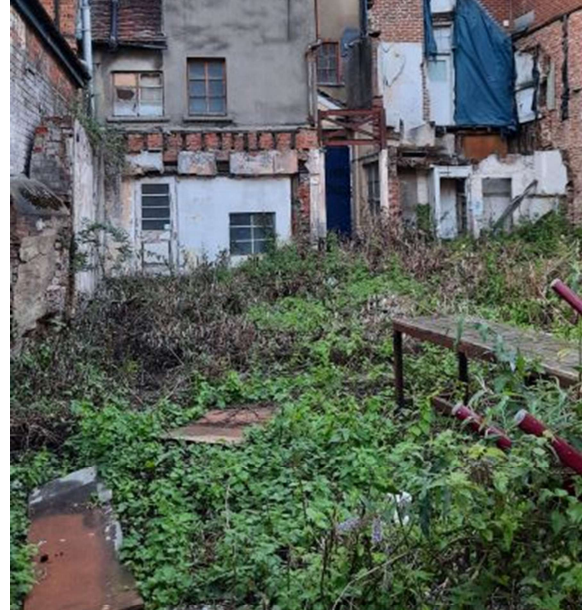
Picture 11 & 12: Yard (before and after vegetation cut)

The area to the south of the building predominantly comprised scattered vegetation where species such as buddleia *Buddleja davidii* and hedge bindweed *Calystegia sepium* had established over rubble and bare ground left following the demolition of the former extensions. An area of hard standing was present at the southern end of the site which was used to store materials. A large amount of materials and debris were also present throughout the vegetated area.

The Holy Brook Stream also provided a limited foraging resource immediately east of the site. Due to it being in a culvert for most its length, and the absence of a natural bank profile or significant areas of vegetation, the culvert was considered relatively poor habitat for foraging bats.

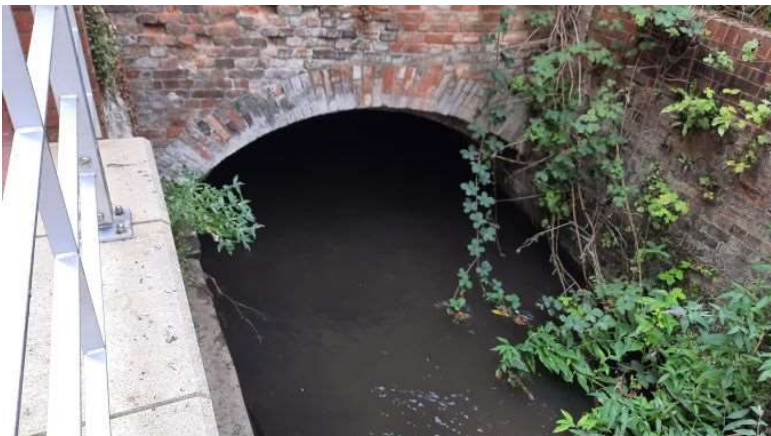
Picture 13: Culvert

The culvert that runs beneath the site was assessed from the point it exits the culvert immediately east of the site boundary. The culvert is constructed from brick and is believed to have been first culverted in the 19<sup>th</sup> Century. The brickwork around the culvert exit and the brick walls that formed the channel sides after the culvert appeared old but were generally intact and well rendered. No obvious gaps or cracks that could provide bat roost potential were evident. The full length of the culvert below the site could not be accessed so it is unknown what the condition of the brickwork is for the full length.

At the time of the survey, during a prolonged dry period, the water in the channel was shallow and slow flowing. The top of the culvert was approximately 1m above the water but this distance is likely to be less when water levels are higher. This would further limit opportunities for bats to roost.

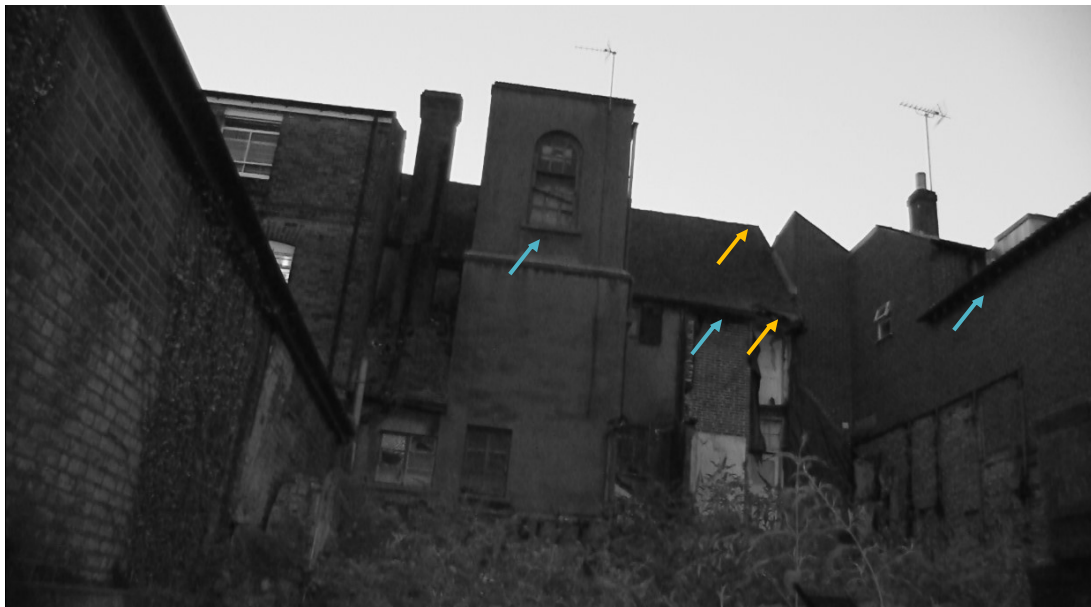
Picture 13: Identified and possible roost features

The building was found to support a low number of common pipistrelle bats with individual bats found to use a number of small, crevice type roost features on the southern elevation. A total of four different roost features were potentially identified with each supporting a single bat.

The findings of the surveys suggest the building on the site and the adjoining building to the east both support day roosts for low numbers of common pipistrelle. It is possible that the bats may also utilise other small, crevice type PRF's found across the southern elevation.

The roost features are shown on Picture 13 below with light blue arrows showing confirmed roost locations and yellow arrows showing possible roost locations.

The proposals for the site are for an extension to the south elevation which would result in the loss of two confirmed roost locations and one possible roost location. The possible roost location at the

roof ridge would not be directly affected by the proposals but could be affected should any remedial works to the roof be required.
