**Heritage Statement & Impact Assessment**

Old Grove House  
St Barnabas Road  
Reading  
RG4 8RA

July 2022

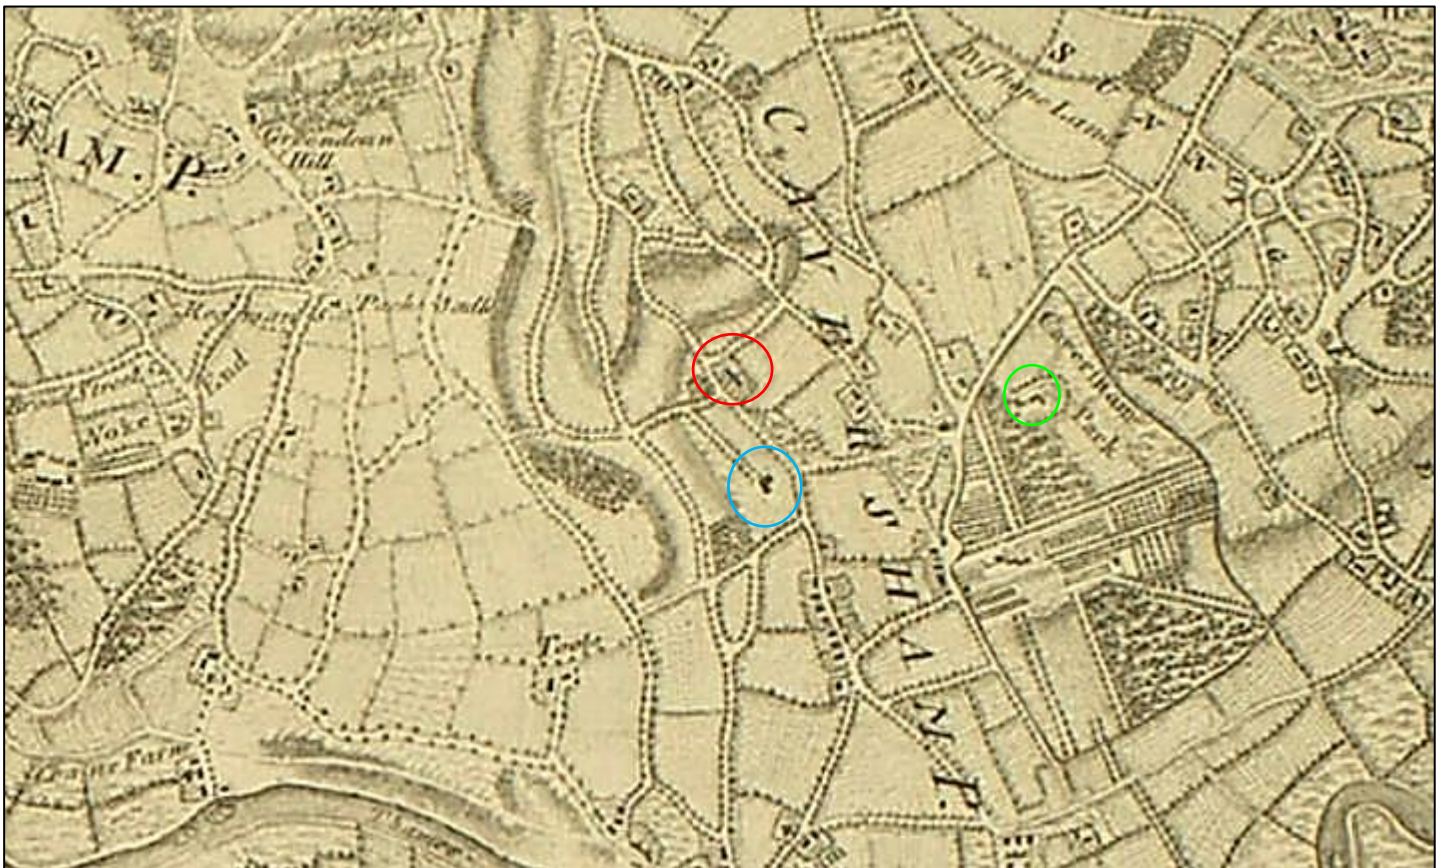
Figure 4: Rocques Map of Berkshire published 1761- Old Grove House highlighted in red, Caversham Grove highlighted in blue, Caversham Park highlighted in green

In terms of Old Grove House, the earliest map from 1761 illustrates what appears to be two semi-detached properties in the centre of the plot suggesting that Old Grove House may have once been part of a larger pair of buildings or that the building standing today was once two attached dwellings (Figure 4).

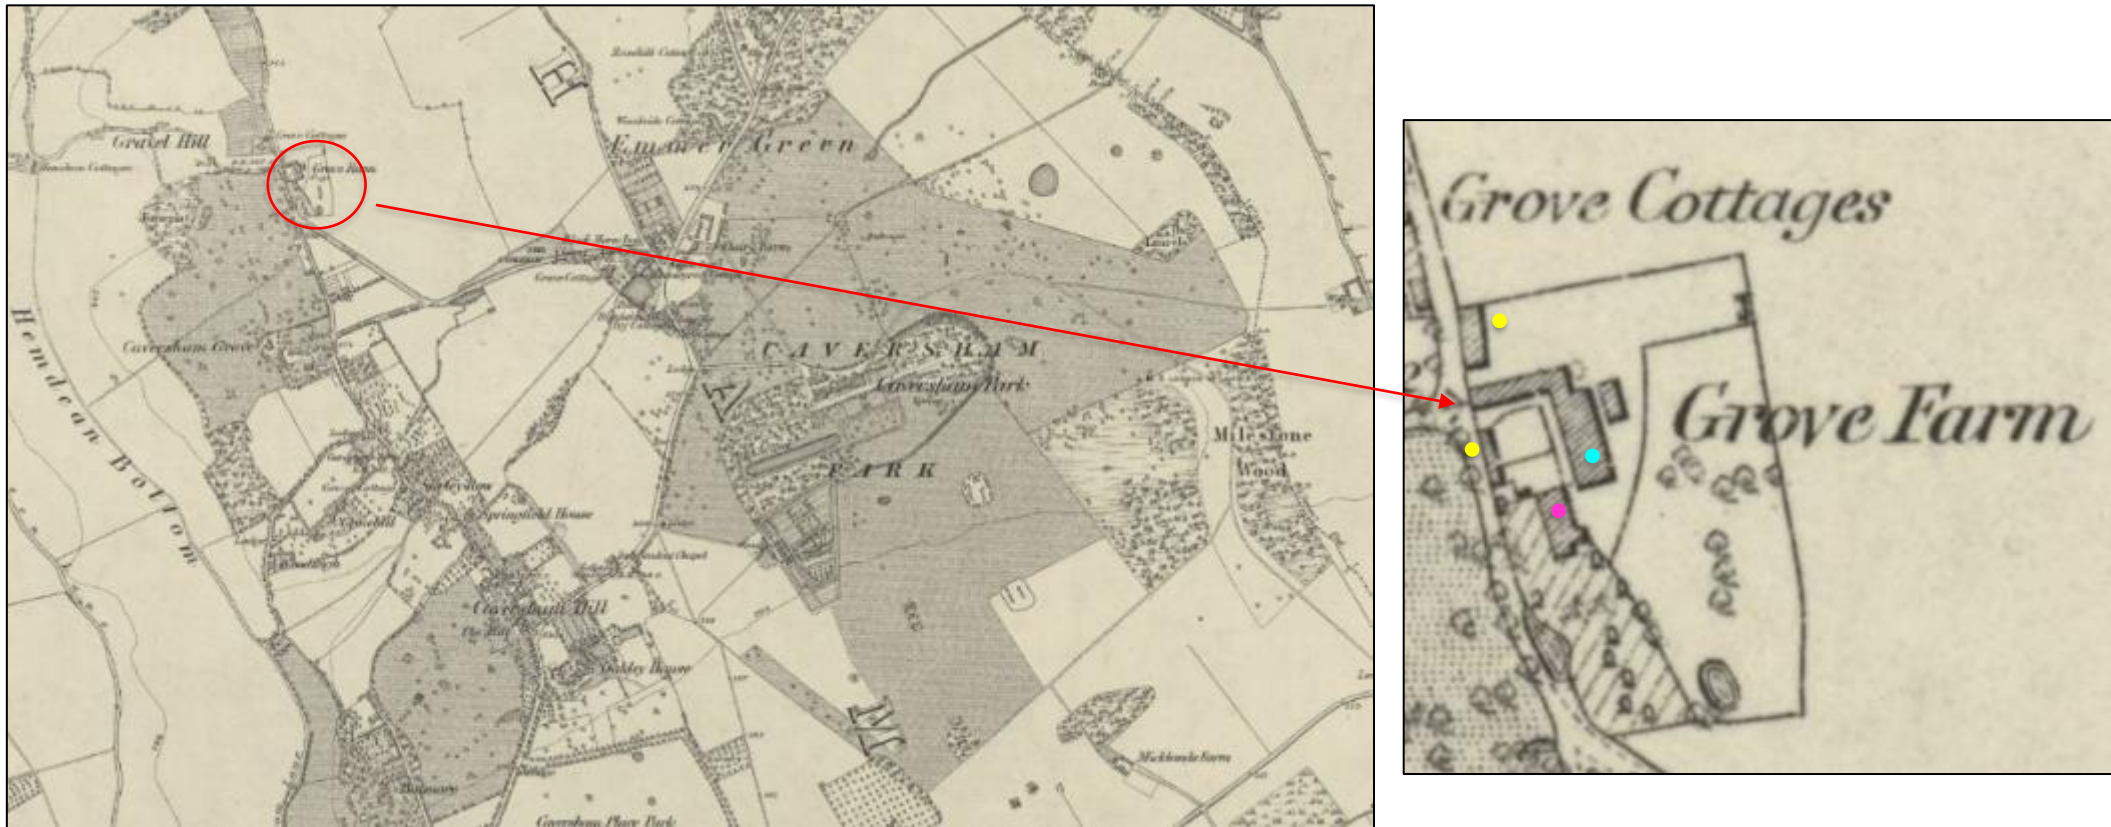
Figure 5: Extract of Ordnance Survey 25 Inch Map: **Oxfordshire Sheet LVI** Surveyed: 1877 & Published 1882. Approx. site location highlighted in red  
 Detail (right): Old Grove House highlighted in pink-note the small extension along the eastern elevation and small attached building to the north west, the L-shaped barn which is part of the existing barn today is highlighted in blue, further outbuildings associated with the property are highlighted in yellow. Note the orchards and landscaped gardens to the east and south

The later OS map dating from 1877 illustrates a detached building with a northern courtyard delineated by outbuildings to the west and an L-shaped barn complex to the north and south. Also visible on the map is a landscaped garden to the south-east of the principal building and orchard to the west (Figure 5).

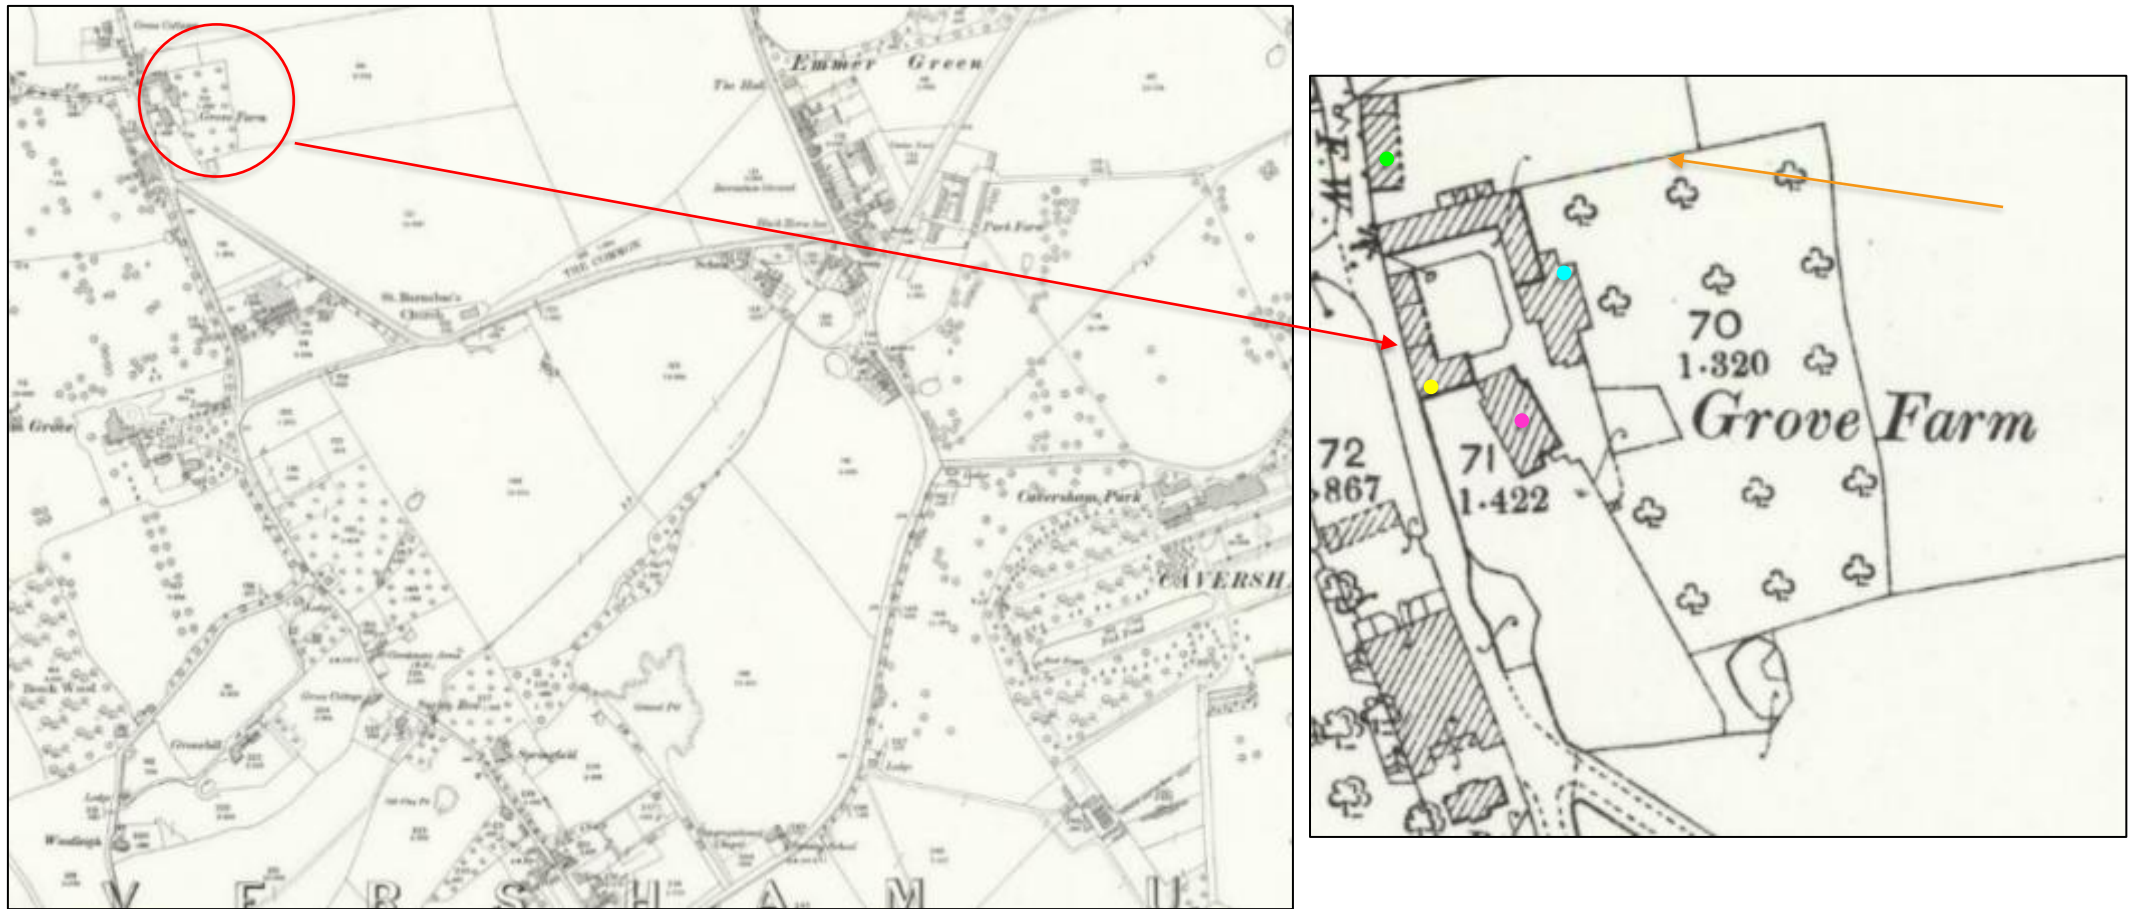
Figure 6: Extract of Ordnance Survey 25 Inch Map: **Oxfordshire LVI.11** Revised: 1897 & Published 1899. Approx. site location highlighted in red  
 Detail (right): Old Grove House highlighted in pink- note the projecting eastern extension visible on the above map has been demolished, the western most outbuilding which is highlighted in yellow has been extended eastwards creating an L-shaped building attached to the house (this is visible on the early 20<sup>th</sup> century photograph below **Figure 16**), the north-eastern L shaped barn highlighted in blue has been extended slightly along its northern elevation, the northern most outbuilding highlighted in green has been removed from the immediate boundary of the house (see orange arrow). Note the annotation of the formal garden to the south has been removed, and the orchard formalised to the east.

Little change is annotated on the 1899 map save for a handful of extensions; the western most outbuilding has been extended eastwards almost joining the principal house whilst the L-shaped barn has been extended to the north- the detached outbuilding to the east on the earlier map has been demolished (Figure 6).

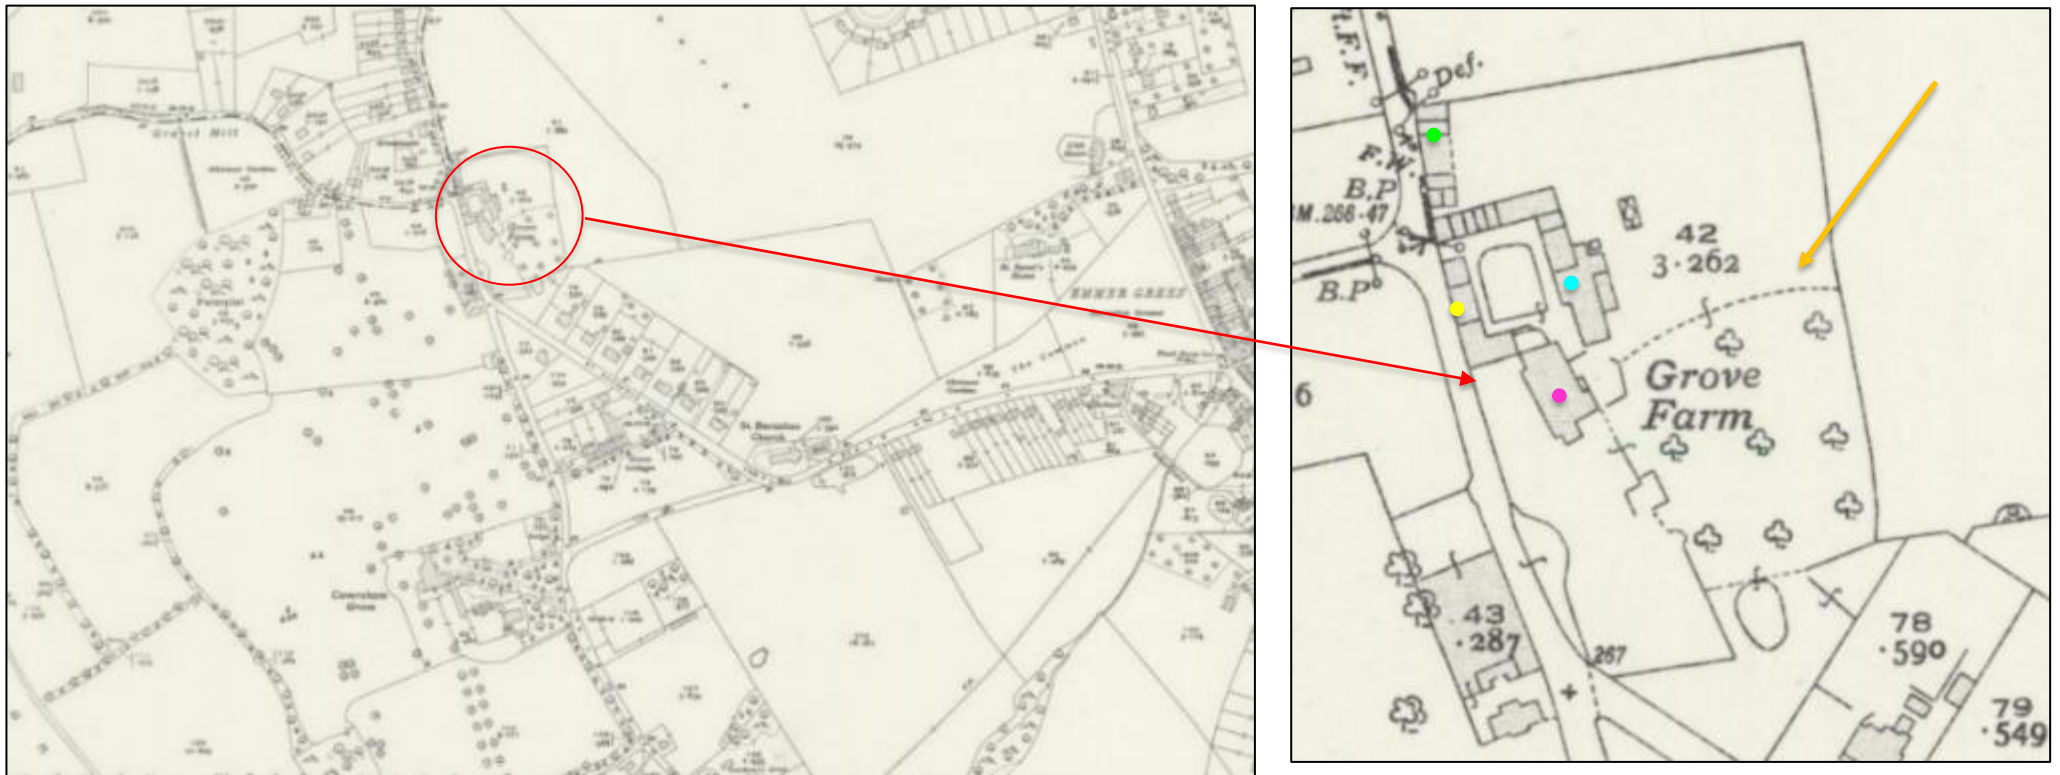
Figure 7: Extract of Ordnance Survey 25 Inch Map: **Berkshire XXIX.11** Revised: 1936 & Published 1938. Approx. site location highlighted in red  
 Detail (right): Old Grove House is highlighted in pink- note the eastern projection and northern infill (likely to be the boiler room today), the western most outbuilding which is highlighted in yellow has been further extended eastwards creating an enclosed small garden to the front of the northern end of the house (this building is visible on the early 20<sup>th</sup> century photograph below **Figure 16**), the north-eastern L shaped barn highlighted in blue has been further extended slightly along its north-eastern elevation, the northern most outbuilding highlighted in green has been included once again within the immediate boundary of the house (see orange arrow). Note the annotation of the formal garden to the south has been removed, and the orchard reduced in size to the east.

The 1936 OS map shows the plot being extended northwards to incorporate the building there- interestingly it was part of the original plot in the late 19<sup>th</sup> century but was enclosed separately at the beginning of the 20<sup>th</sup> century (Figure 7). There is now an extensive range of outbuildings to the north creating a fully enclosed courtyard whilst the orchard to the east has been reduced in size. Old Grove House appears to have been slightly extended to the south and east; it is likely the former is the conservatory still present on site today (Figure 7).

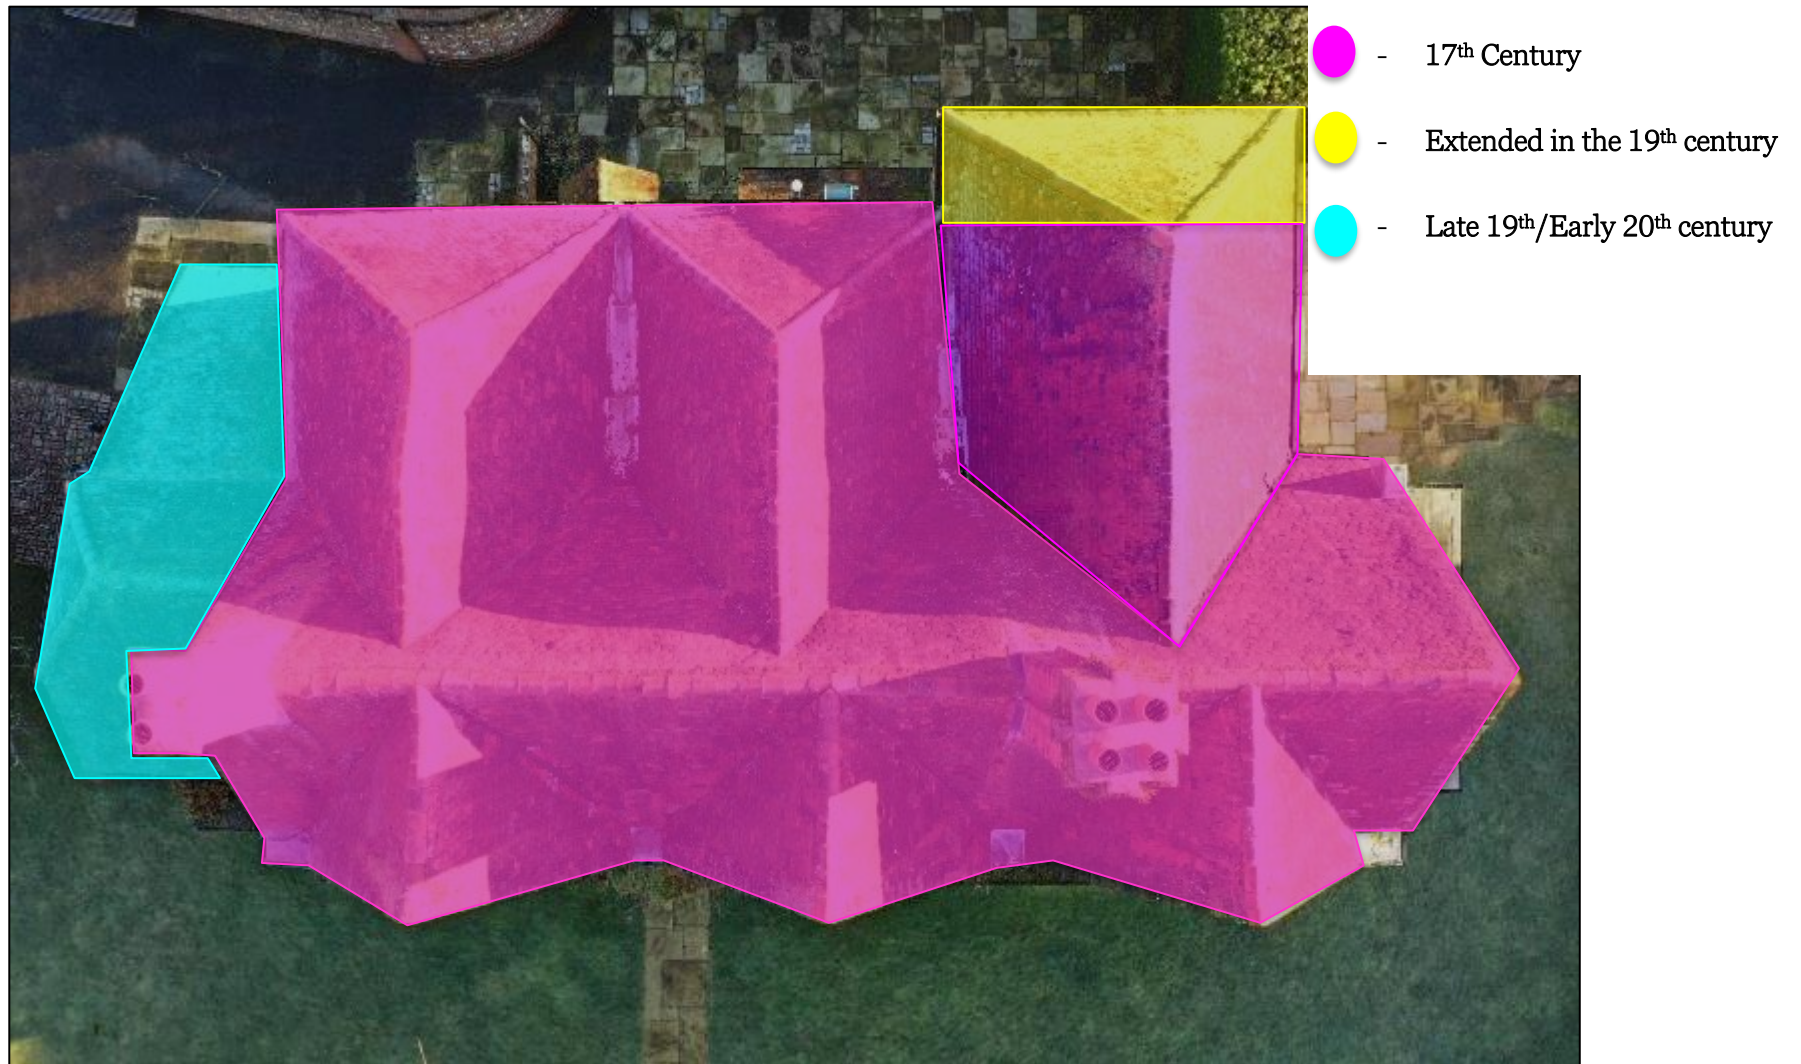
*Figure 12: Drone photo of clay tile roof- The entirety of the main roof was re-covered last in a single phase of development, as evidenced by the presence of non-permeable bitumastic sarking felt, which probably took place in the 1970s or 1980s.*

A condition survey was undertaken by Janus Conservation on the 25<sup>th</sup> January 2022. In the report the condition of the roof was assessed. The report noted:

*The roofing tiles used at that time appear to have been a mixture of salvaged units, probably those deemed reusable from the previous roof covering, and new. There is then a disparity of condition between old and new tiles, with many of the former exhibiting moderate to acute spalling - which essentially means they have eroded due to weathering which has compromised their structure.*

*Many internal repairs were noted to the sarking felt and it was seen to be fraying and perishing in places, which is common when the felt is of significant age. Several slipped and missing tiles were also noted across the roof covering itself along with historic patch repairs externally.*

*Overall, therefore, the roof covering is showing signs of advanced age including the beginnings of nail fatigue - when the mechanical fixings fail - which is terminal once it takes hold.'*

The recommendation from the report, states 'Whilst the roof's life expectancy could be extended by undertaking a phase of repair and maintenance. The evidence suggests that it is now coming towards the end of its serviceable life and will require replacing within the next 5, or certainly the next 10 years.'

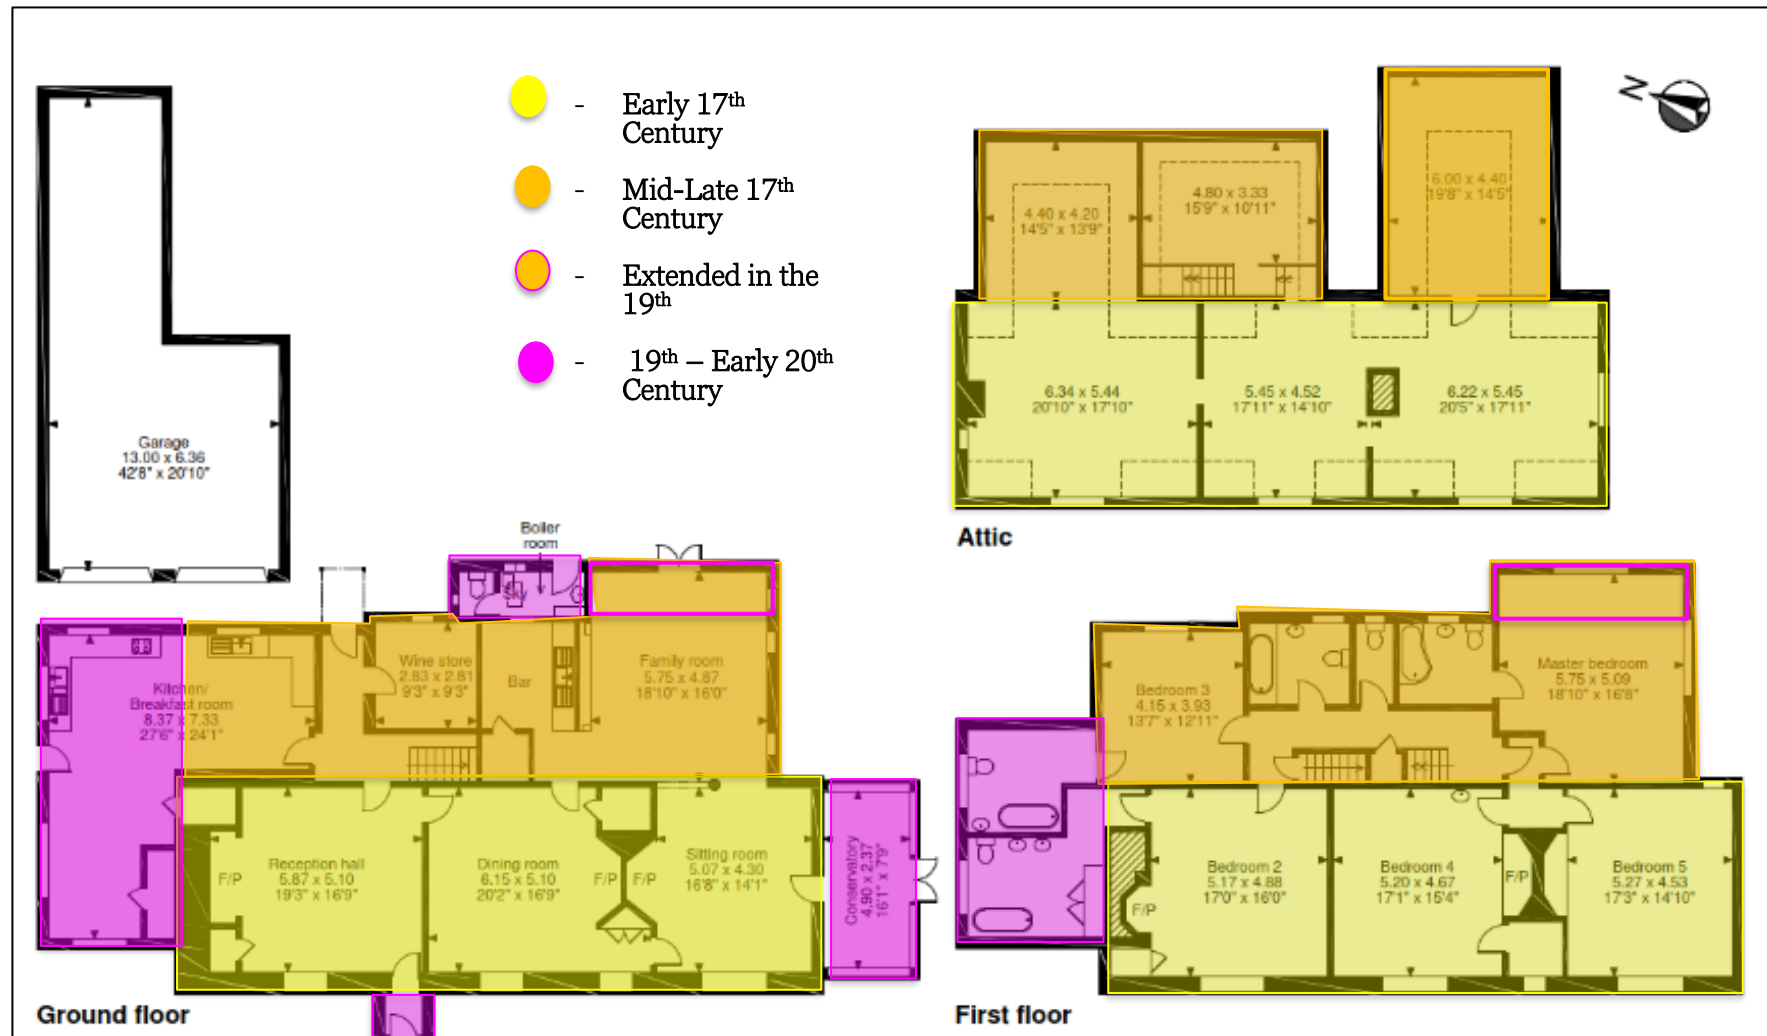
Figure 13: Potential phasing plan of Old Grove House

The original early 17<sup>th</sup> century dwelling may have consisted of an attic, 2 units at ground floor and two units at first floor with a separate unit, likely to be a service area, to the north of the property (likely to be the current main reception room and part of the current kitchen). This would also be replicated at first floor level. Entrance to the property may have been where the two casement window is to the right of the porch (Error! Reference source not found.) with a lobby present directly on entry with doors leading both left and right, as is typical for a baffle / lobby entry house (**Figure 14**). The staircase to the property may have been located to the side rear side of the fireplace, evidence of which could be read in the space/void behind the fireplace where there is high ceilings within which could have facilitated the necessary head height (**Figure 29 & Figure 30**).

The OS maps suggest that the southernmost projecting gable of the east elevation was extended in the late 19<sup>th</sup> century (**Figure 18 & Figure 30**) alongside the kitchen at the northern end of the building which appears to have replaced a smaller extension to wrap around both the northern and eastern sides (**Figure 21**). By the early 20<sup>th</sup> century the property had been extended further to the south to include the existing conservatory/garden room thought to date from the 1930s (**Figure 22**). Over the course of the 19<sup>th</sup> and 20<sup>th</sup> century the house has been altered both externally and internally.

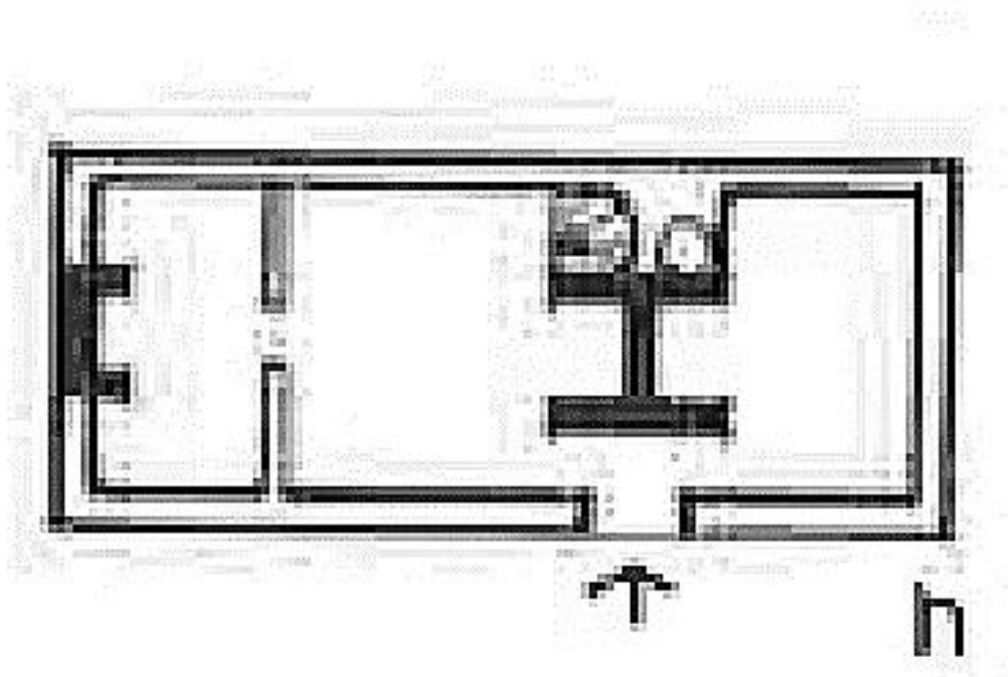
*Figure 14: The early 17<sup>th</sup> century part of Old Grove House is potentially based upon lobby/baffle entry plan form- taken from “Vernacular Architecture: An Illustrated Handbook (2000) by R. W. Brunskill.*

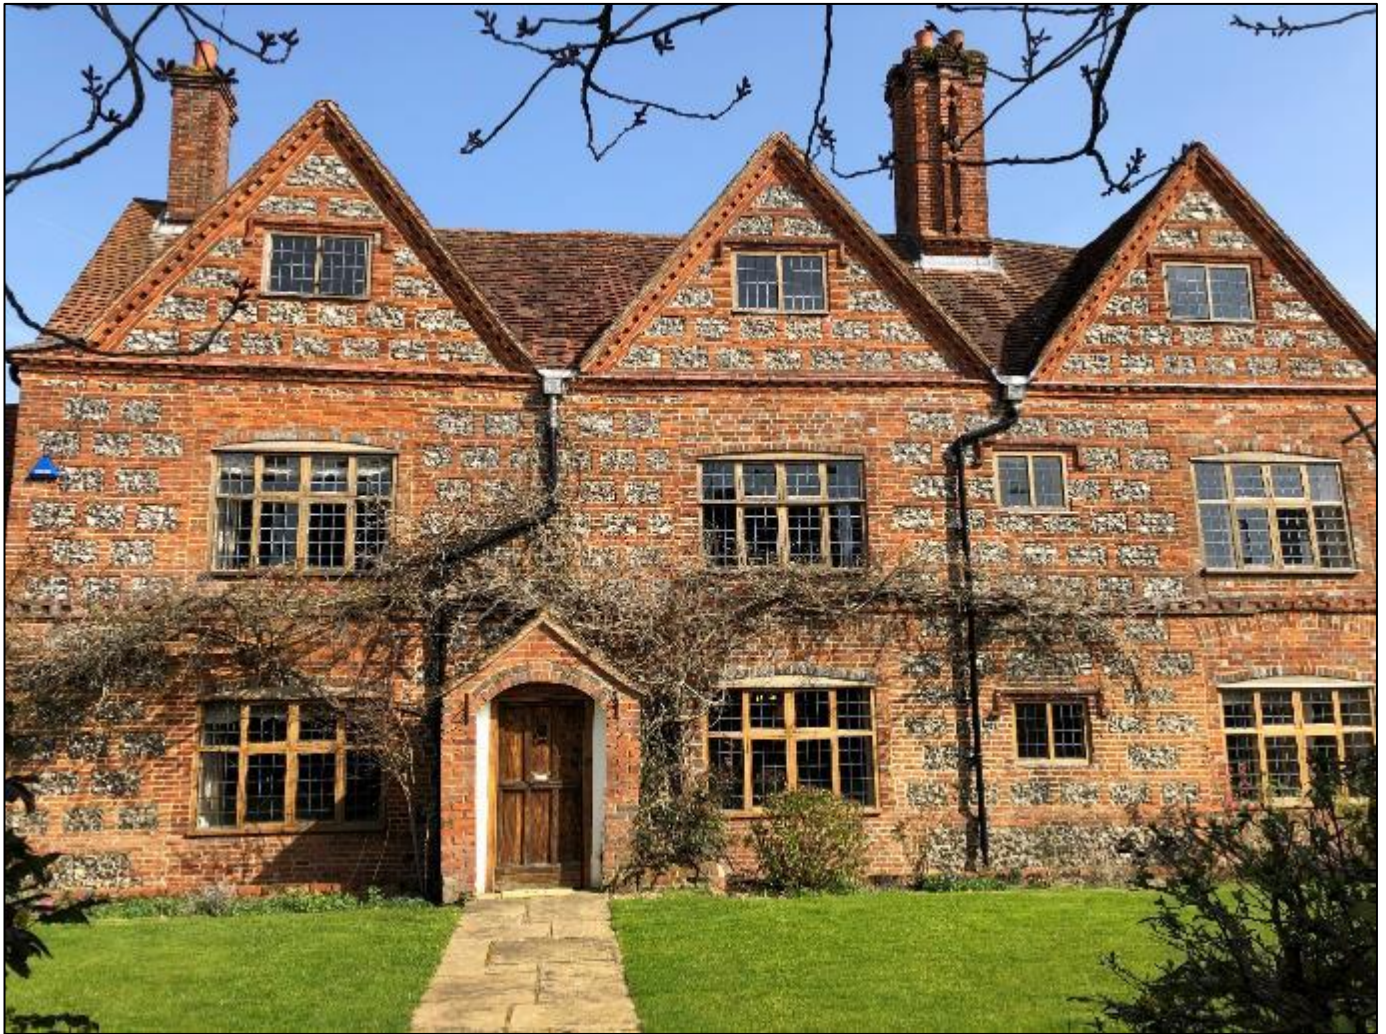
*Figure 15: West elevation of Old Grove House*

Old Grove House is a Grade II\* listed property thought to date from the early to mid-17<sup>th</sup> century. The property consists of 3 bays, 2 storeys high with an attic. There are two chimney stacks; the stack to the right of the centre has projecting brick panels on each side and a corbelled head.

The west elevation is constructed of brick in horizontal and vertical banding with staggered flint panels, brick quoins, and a dentil string course at first floor level. To the eaves there are small cut brick dentil cornicing which is continued up the gable verges (**Figure 15**).

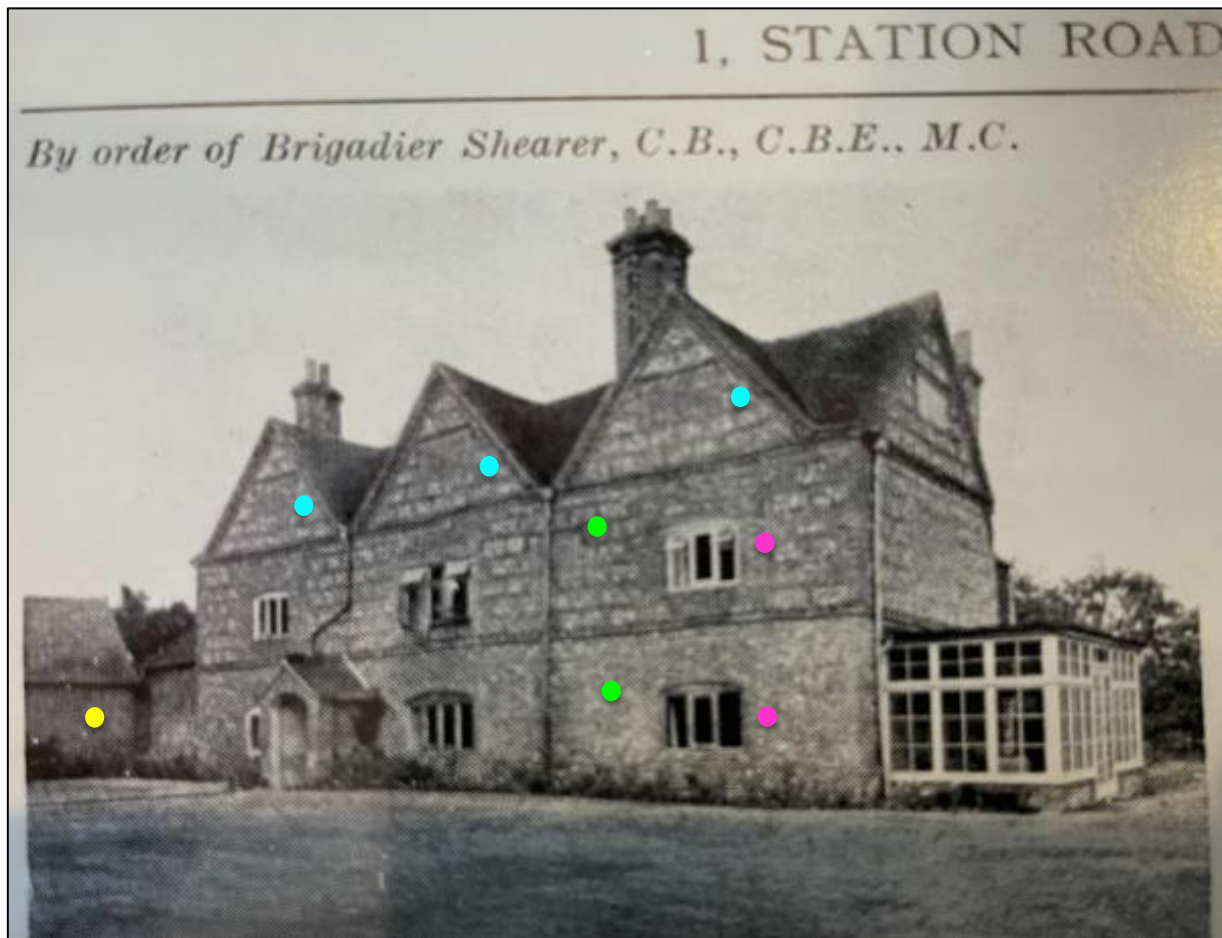
*Figure 16: Early 20th Century photograph from Country Life- blocked off windows in the 3 projecting gables now open (highlighted in blue), example of smaller windows in situ at the beginning of the 20<sup>th</sup> century- these have been replaced with larger, wider units (highlighted in pink), blocked off window on the first floor under a hood moulding but no evidence of a hood moulding on the ground floor- both now open windows (highlighted in green), evidence of former outbuilding (now demolished) which once ran east-west to the north of the principal building and kitchen (highlighted in yellow)*

| Figure 16: Early 20 <sup>th</sup> Century photograph from Country Life- blocked off windows in the 3 projecting gables now open (highlighted in blue), example of smaller windows in situ at the beginning of the 20 <sup>th</sup> century- these have been replaced with larger, wider units (highlighted in pink), blocked off window on the first floor under a hood moulding but no evidence of a hood moulding on the ground floor- both now open windows (highlighted in green), evidence of former outbuilding (now demolished) which once ran east-west to the north of the principal building and kitchen (highlighted in yellow) ..... | 17 |

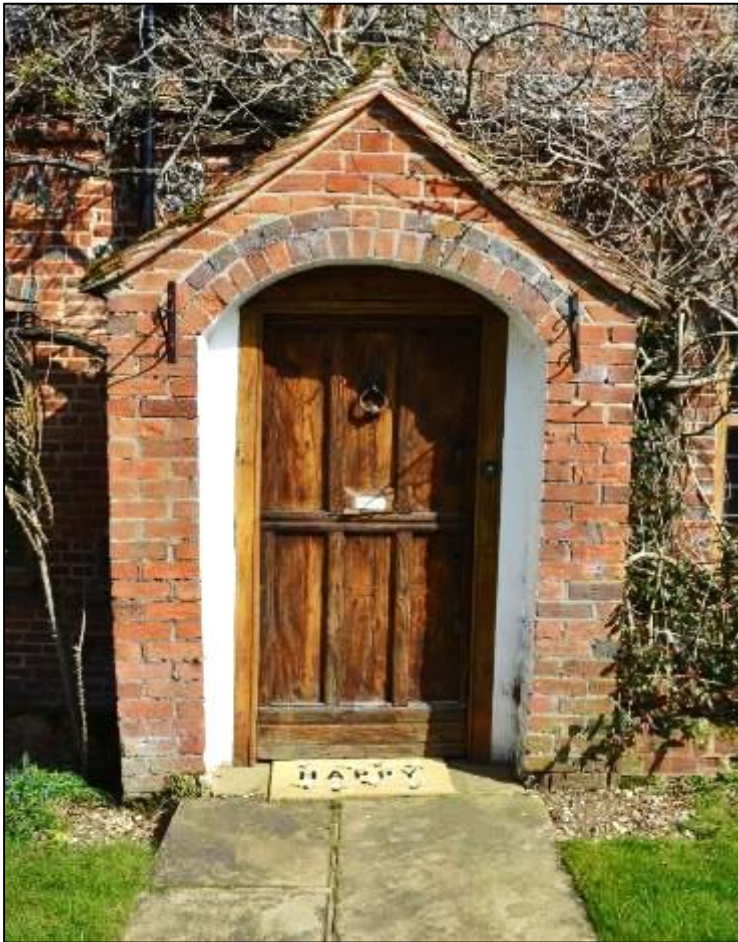
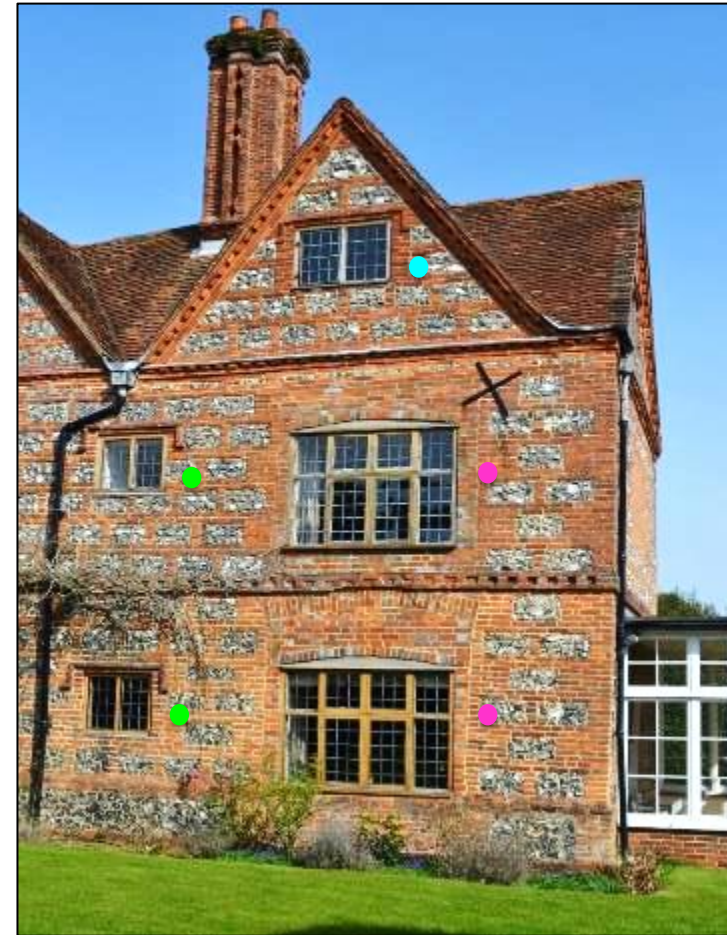
Figure 17: Details of the west elevation- (left) 20<sup>th</sup> century porch inset with 17<sup>th</sup> century door, (right) when compared to **Figure 16** the fenestration alterations become clear, the inserted two light casement windows under hood mouldings (highlighted in green), and the 4 light mullion and transom windows which have been increased in size from the early 20<sup>th</sup> century

The windows throughout the property have been replaced in the late 20<sup>th</sup>-21<sup>st</sup> Century with modern timber frame units. Across the west elevation the windows are a mix of mullion and transom 4 light casement windows in segmental relieving arches (which have been raised to incorporate wider and taller casements- see **Figure 16** where the windows are smaller) and 2 light casements under hood mouldings (**Figure 17**). There appears to be one surviving original single glazed leaded window which can be seen in the wine cellar (**Figure 32**). There is also a 17<sup>th</sup> century 6 panel door to the left of the centre of the building set within a modern porch (**Figure 17 & Figure 25**).

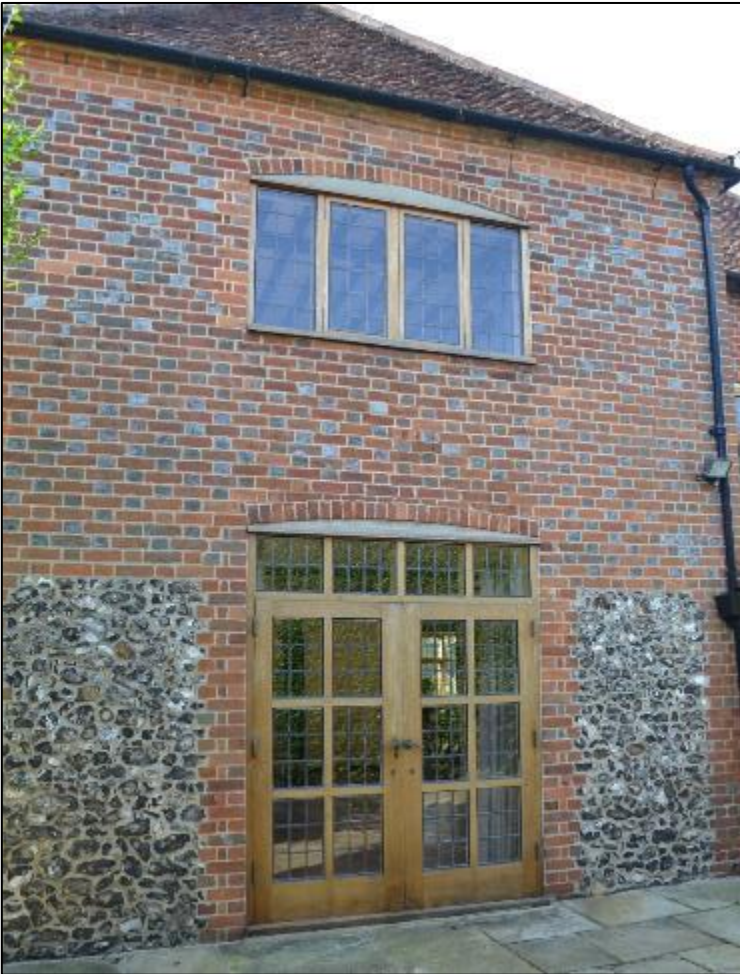
*Figure 18: East elevation- (left) view of the 19<sup>th</sup> century extension , it was once in line with the two adjacent projecting gables but curiously was extended eastwards by a small amount in the Victorian period*

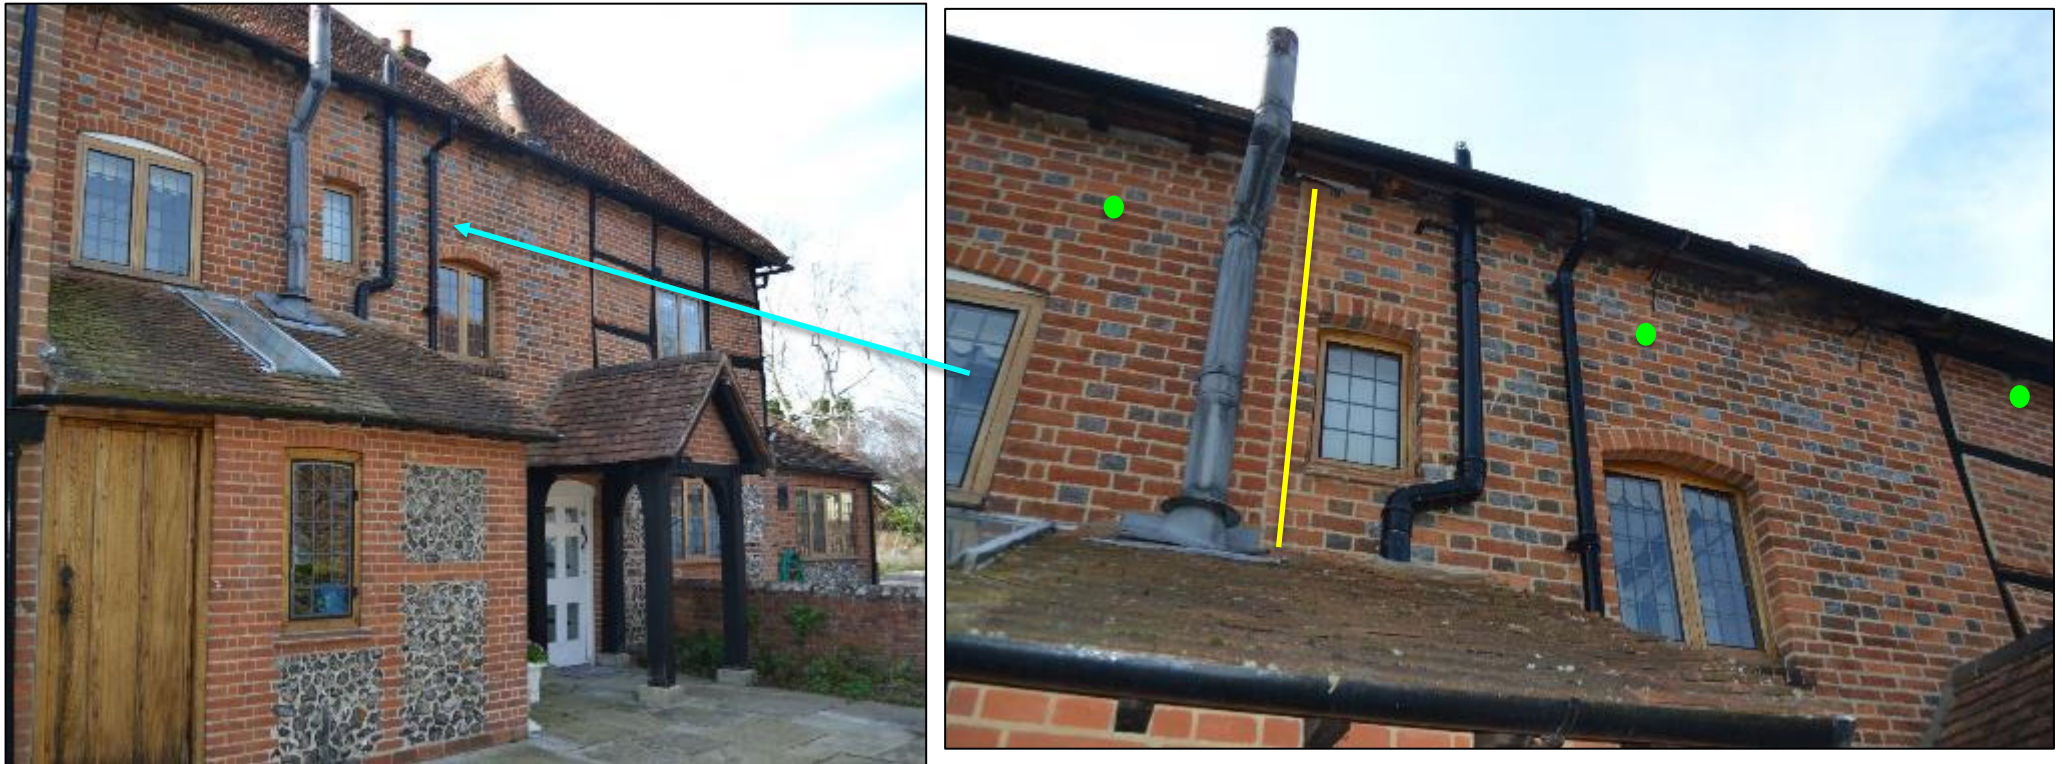
*Figure 19: Details of east elevation-the variation in brick work along this elevation suggests contemporary alterations- it is clear that the first floor brick work can be divided into three distinct sections (highlighted in green), the central section does not tie into the neighbouring section suggesting a late 20<sup>th</sup>/21<sup>st</sup> century alteration/repair-possibly when the windows were altered (highlighted in yellow)*

| Figure 19: Details of east elevation-the variation in brick work along this elevation suggests contemporary alterations- it is clear that the first floor brick work can be divided into three distinct sections (highlighted in green), the central section does not tie into the neighbouring section suggesting a late 20 <sup>th</sup> /21 <sup>st</sup> century alteration/repair-possibly when the windows were altered (highlighted in yellow) ..... | 20 |

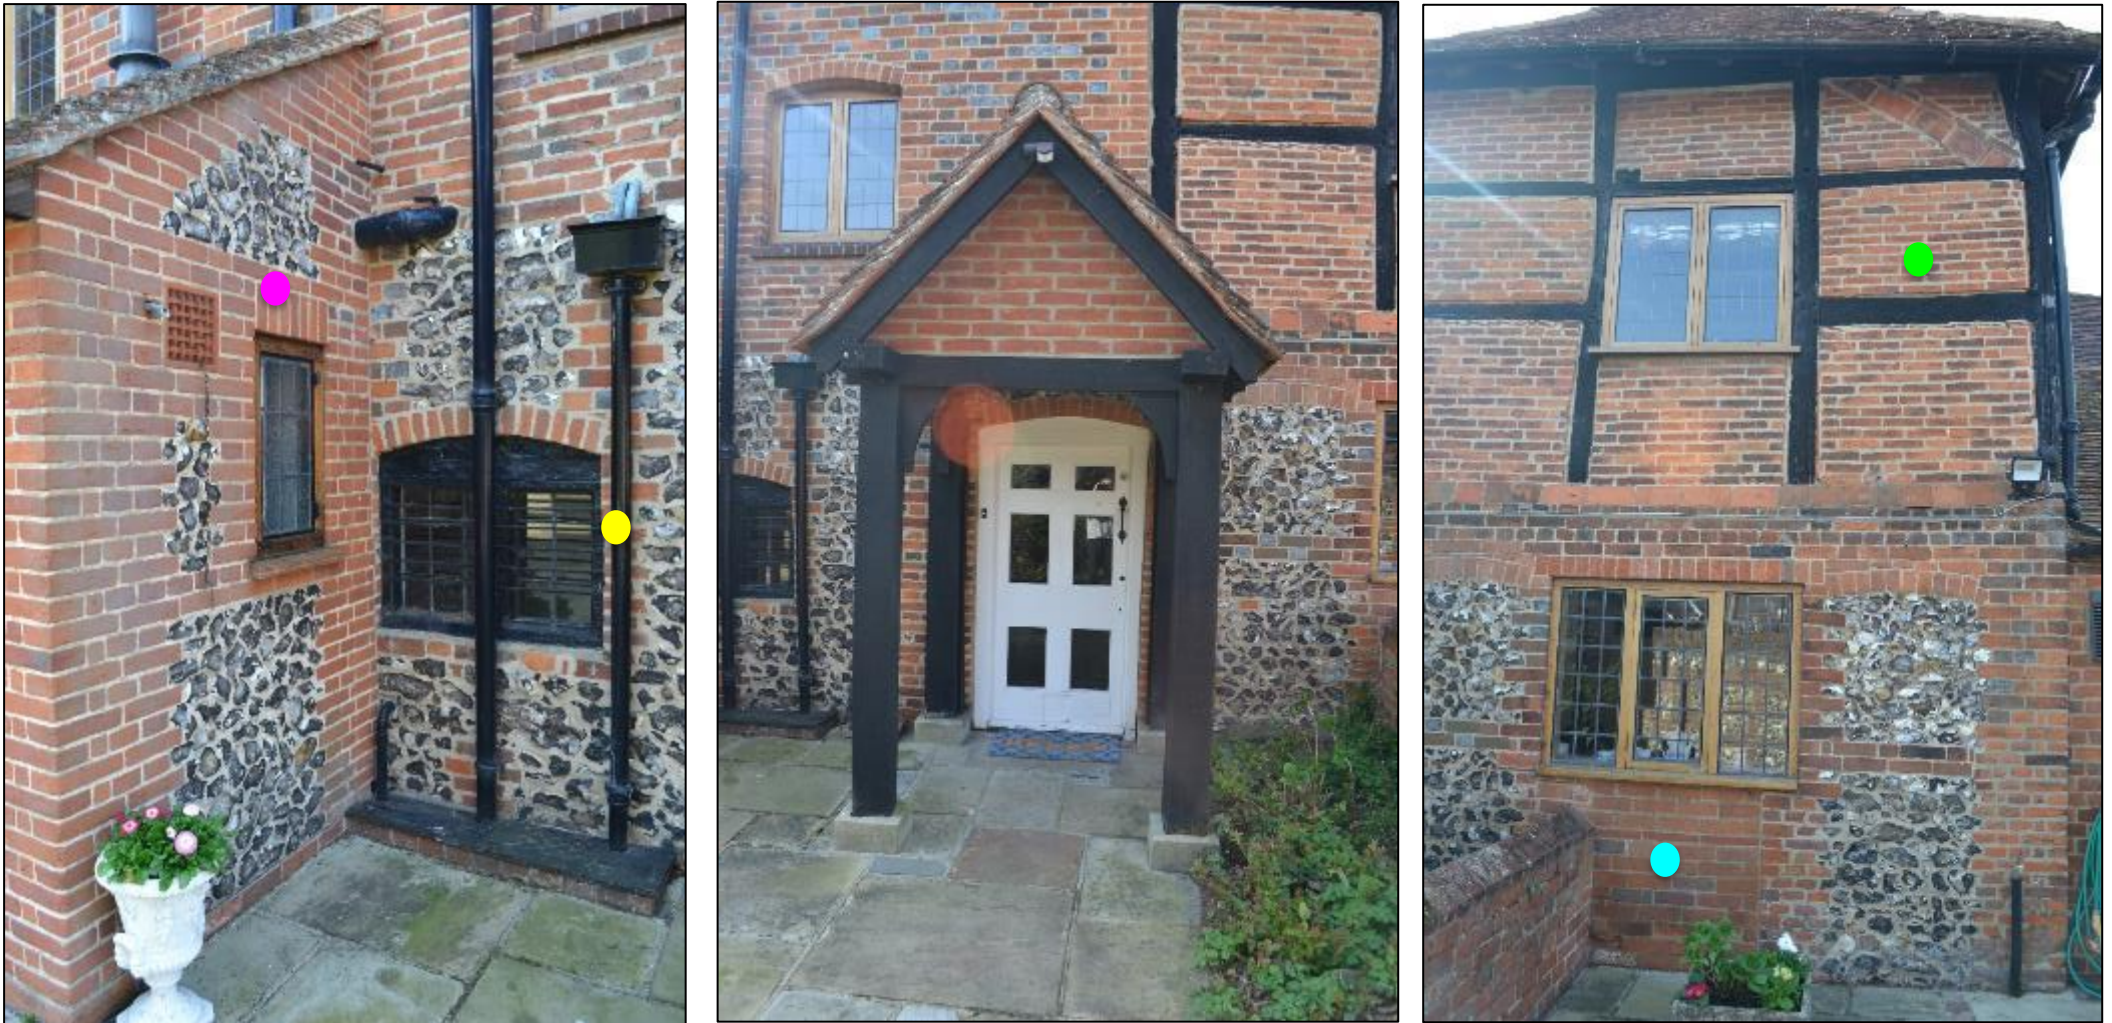
Figure 20: Details of east elevation- (left) 20<sup>th</sup> century extension now boiler room (highlighted in pink), surviving single glazed leaded window (highlighted in yellow), (centre) details of 20<sup>th</sup> century porch, (right) evidence of potential location of former doorway (highlighted in blue), exposed timber framing thought to be contemporaneous to the adjacent kitchen extension (highlighted in green)

The east elevation has been noted as being 'irregular' in the Historic England listing (see [Appendix A](#)). It consists of 3 hipped gables which, as discussed above, are thought to be later 17<sup>th</sup> century additions to the property; the irregular brick work across the façade (**Figure 19**) and internal roof timbers suggests this (**Figure 51**). The ground floor boiler room and projecting porch are 20<sup>th</sup> century additions (**Figure 15** & **Figure 20**). The timber framed and brick infilled northern section of the east elevation appears to be part of a later refacing contemporaneous with the hipped gable single storey extension to the left of it (**Figure 20**).
