**Heritage Statement & Impact Assessment**

Old Grove House  
St Barnabas Road  
Reading  
RG4 8RA

July 2022

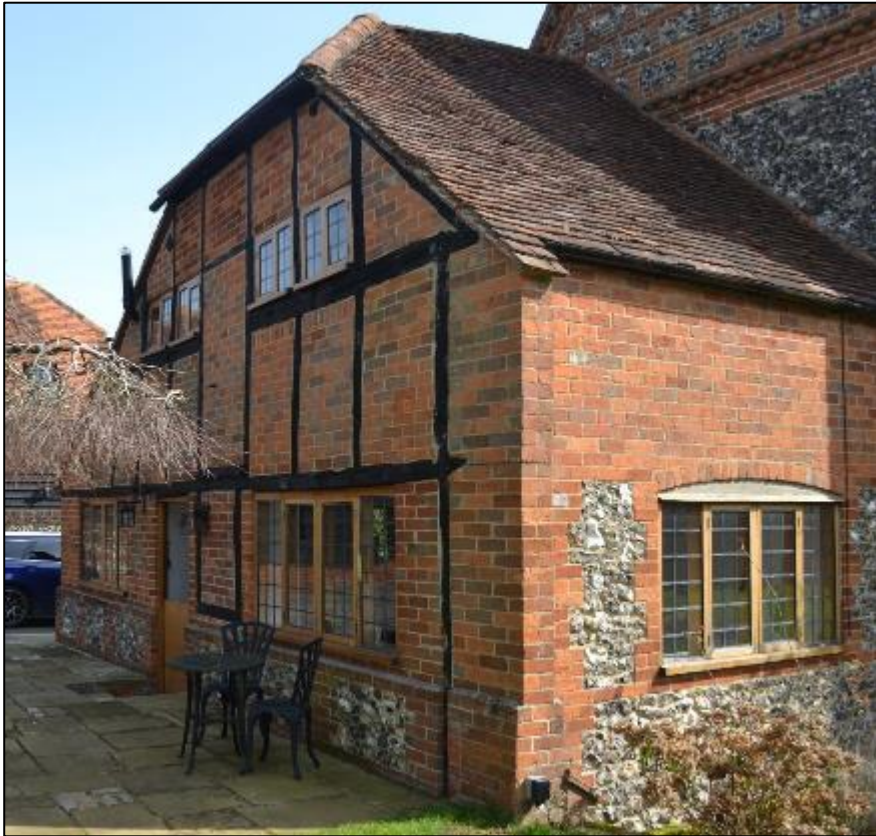
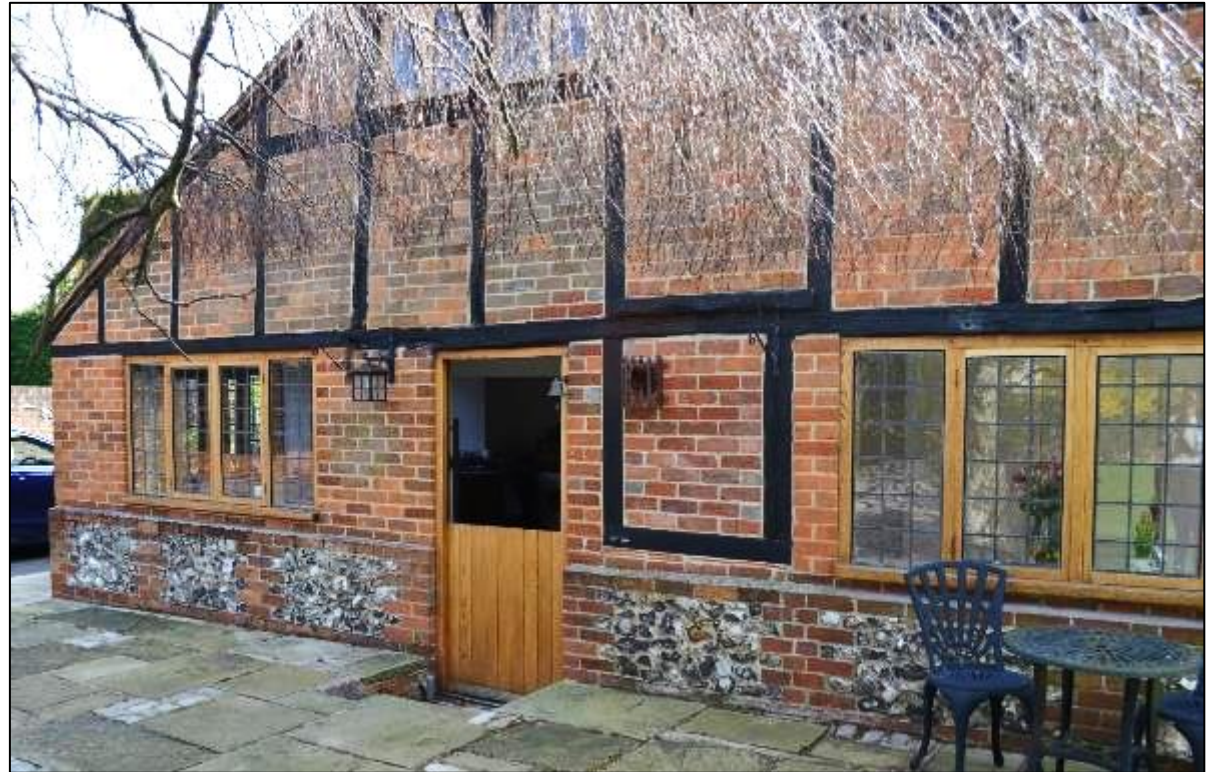
*Figure 21: Details of north elevation- 20<sup>th</sup> century kitchen extension thought to have replaced a smaller structure previously in that location*

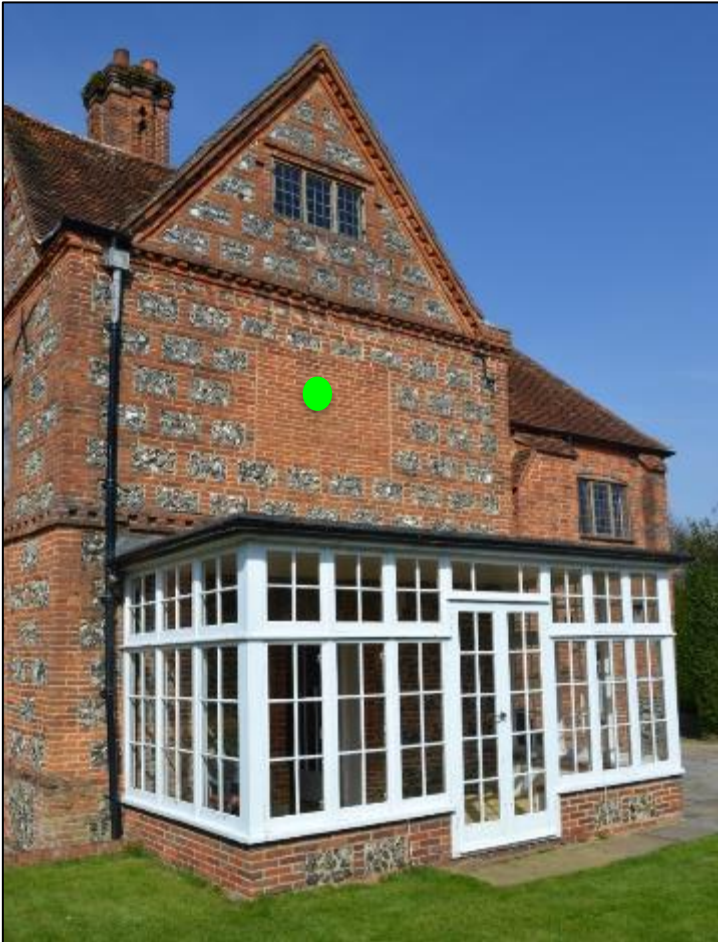
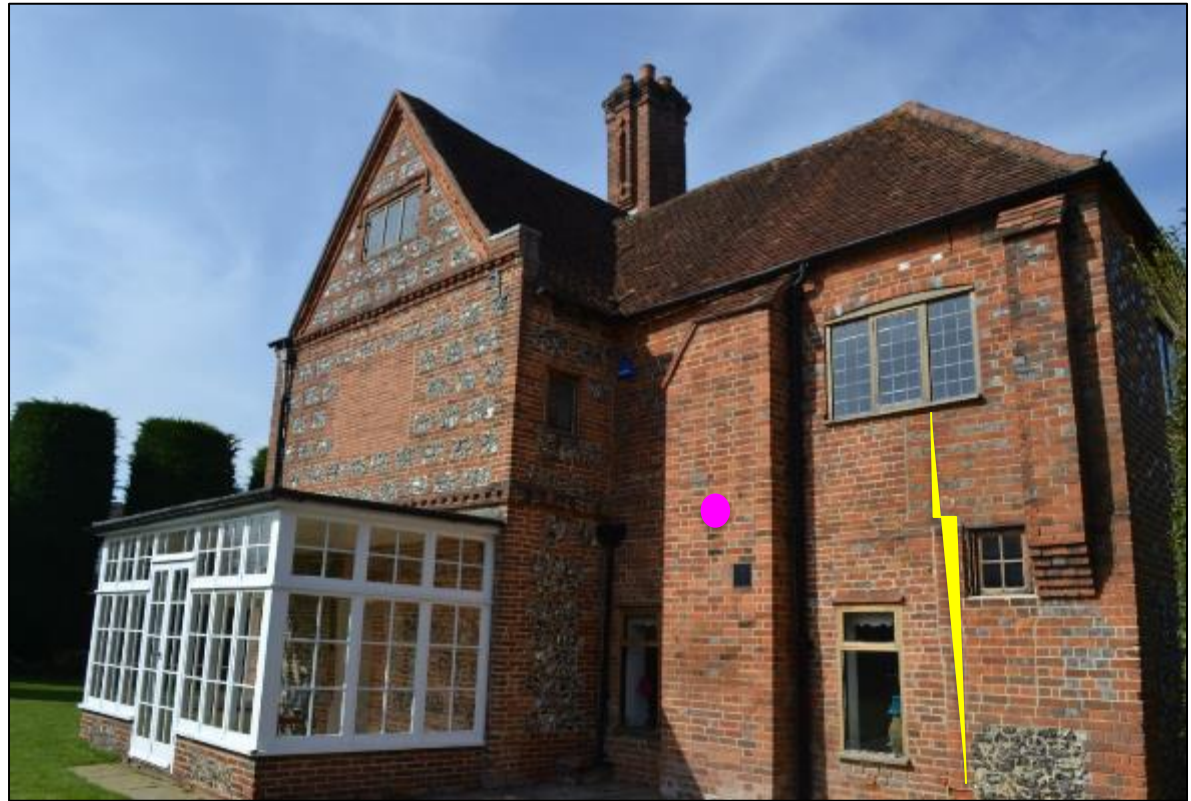
*Figure 22: Details of south elevation- (left) note the 1930s garden room/conservatory and blocked off window (highlighted in green), (right) note the remains of a chimney stack that would have been wider than it is at present (highlighted in purple), and 'seam' of where the small 19<sup>th</sup> century extension was added (highlighted in yellow)*

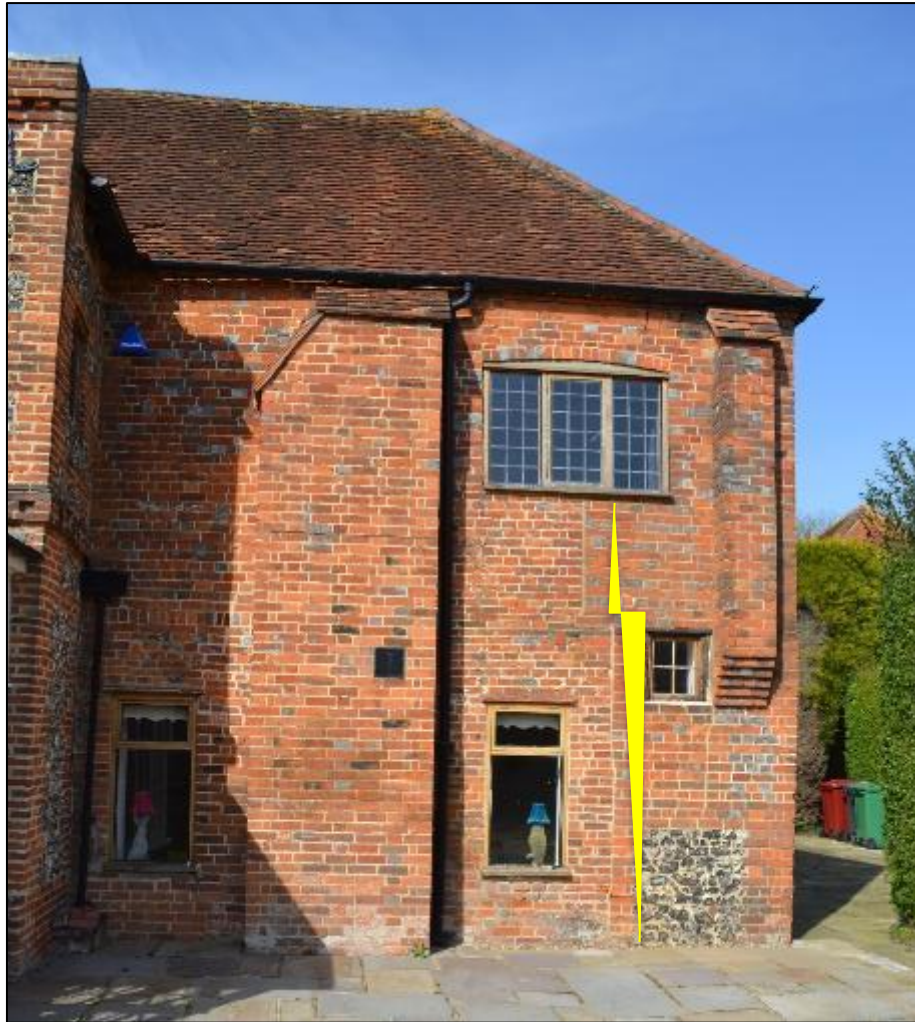
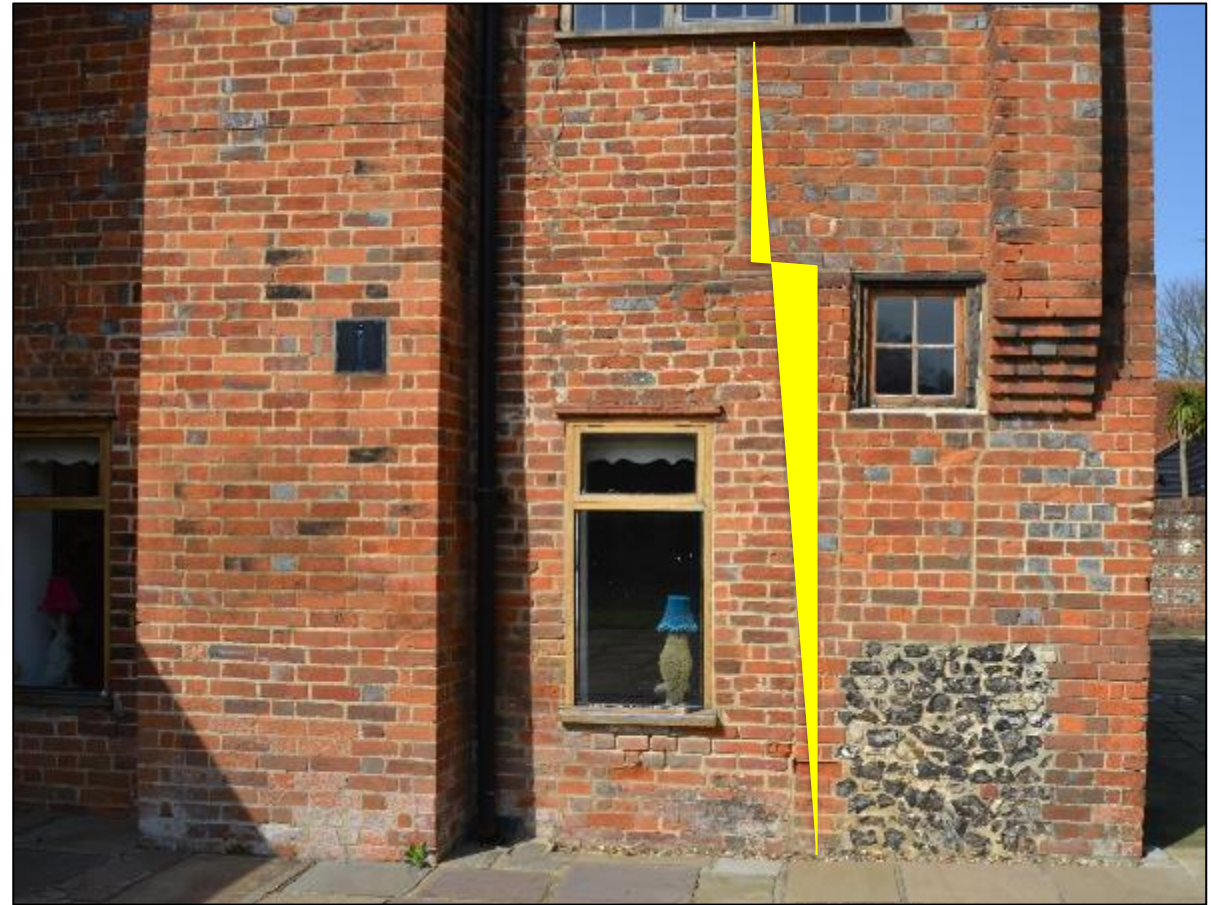
*Figure 23: Details of south elevation- it is not entirely clear why the building was extended by such a small amount in the 19<sup>th</sup> century (highlighted in yellow)- however it is likely that the chimney stack would have served a further 'service room' before being part removed.*

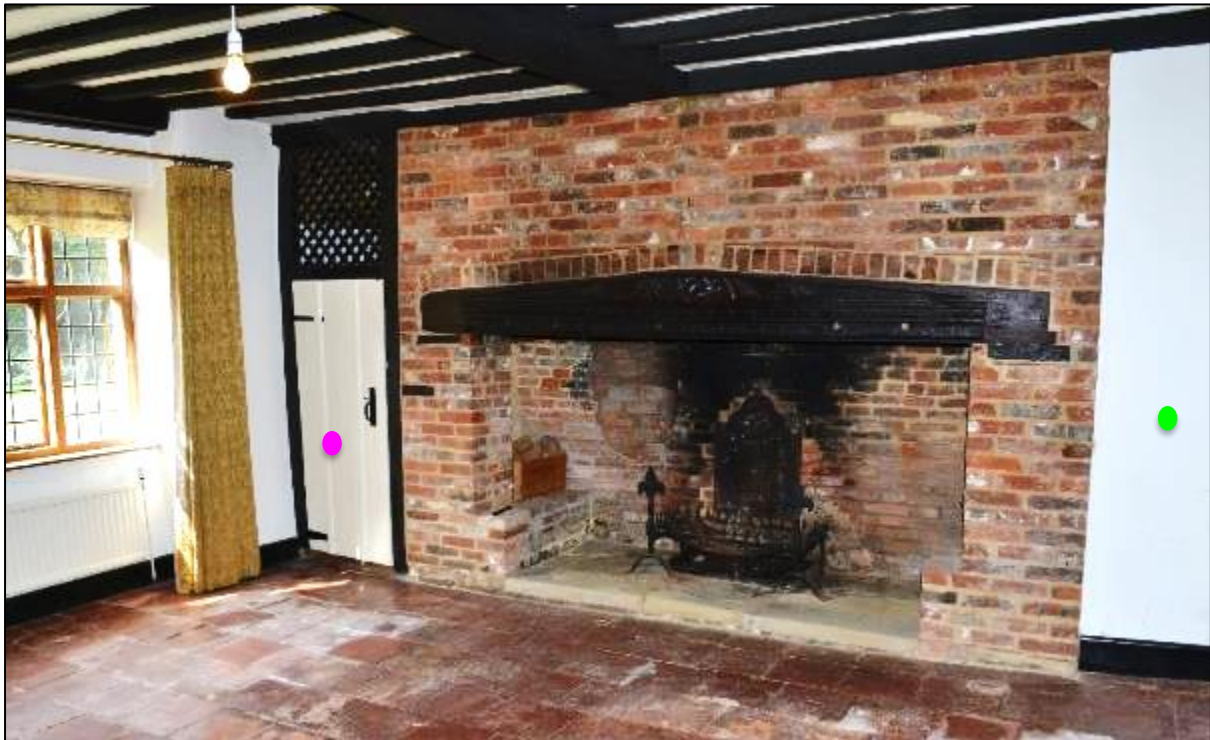
*Figure 24: Tudor fireplace in reception hall with moulded timber lintel- note the cupboard to the left (highlighted in pink) and the location of a former door to the right-now blocked (highlighted in green)*

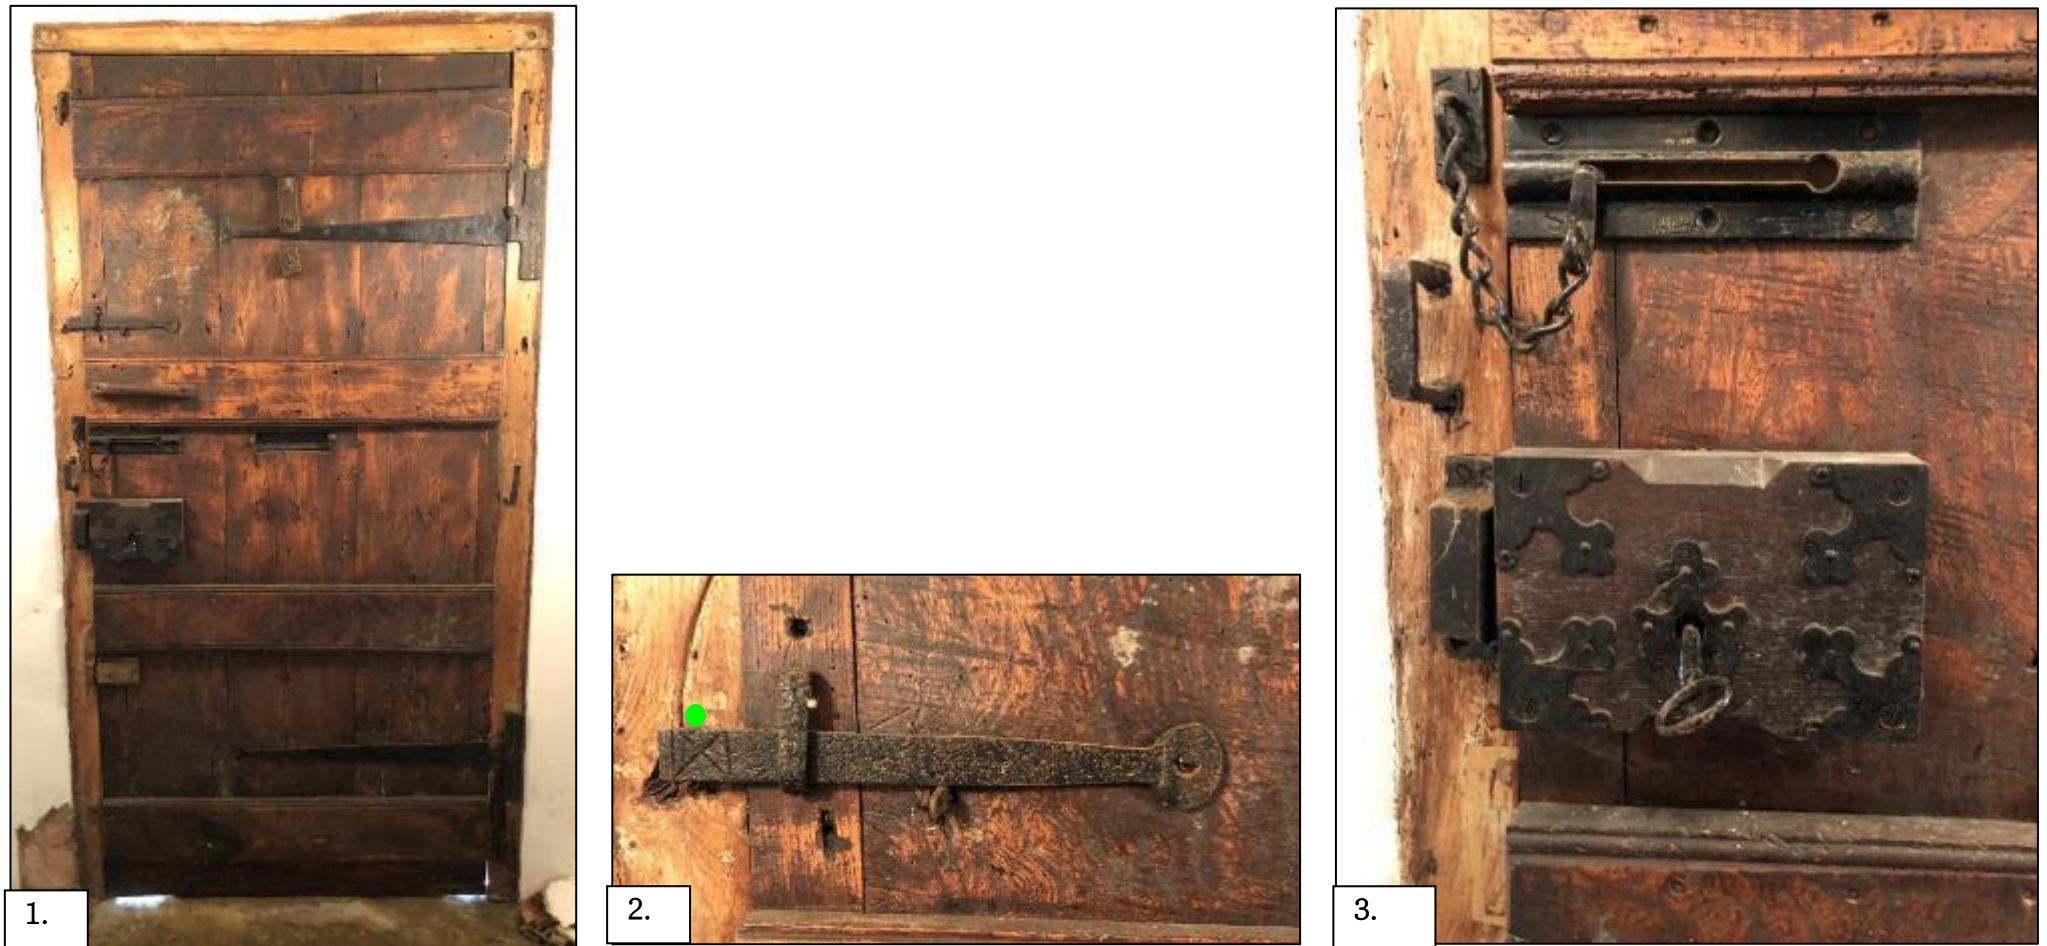
Figure 25: Detail of porch door- 1. 17<sup>th</sup> century plank timber door, 2. Detail of iron latch on door-interestingly this design with a 'X' is seen throughout the house on other latches, 3. Detail of further ironwork on the door

The windows throughout the property have been replaced in the late 20<sup>th</sup>-21<sup>st</sup> Century with modern timber frame units. Across the west elevation the windows are a mix of mullion and transom 4 light casement windows in segmental relieving arches (which have been raised to incorporate wider and taller casements- see **Figure 16** where the windows are smaller) and 2 light casements under hood mouldings (**Figure 17**). There appears to be one surviving original single glazed leaded window which can be seen in the wine cellar (**Figure 32**). There is also a 17<sup>th</sup> century 6 panel door to the left of the centre of the building set within a modern porch (**Figure 17 & Figure 25**).

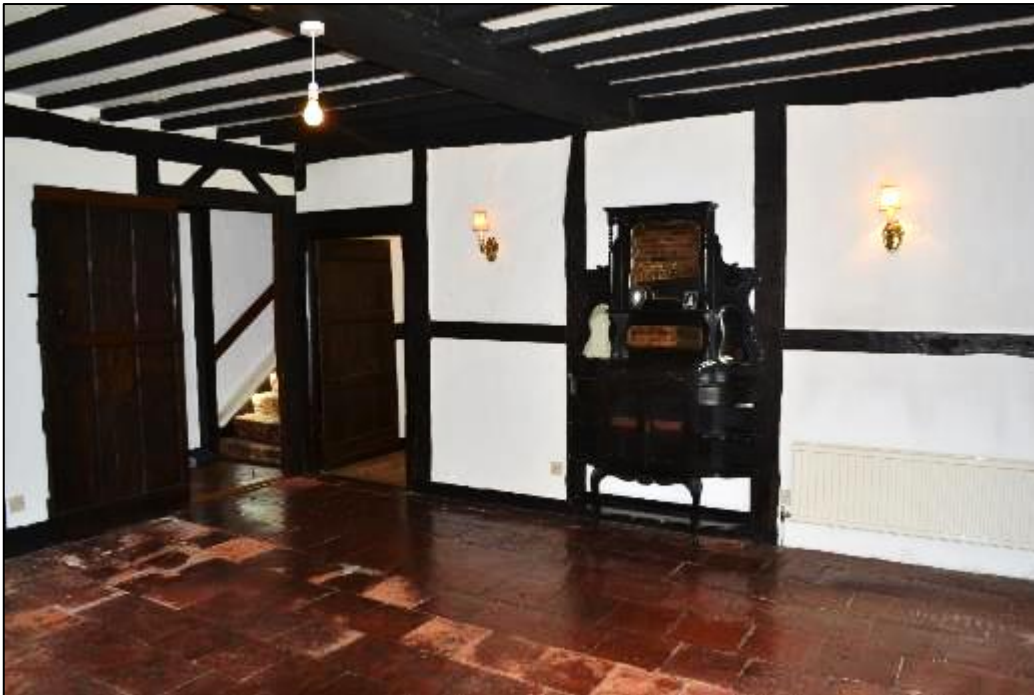
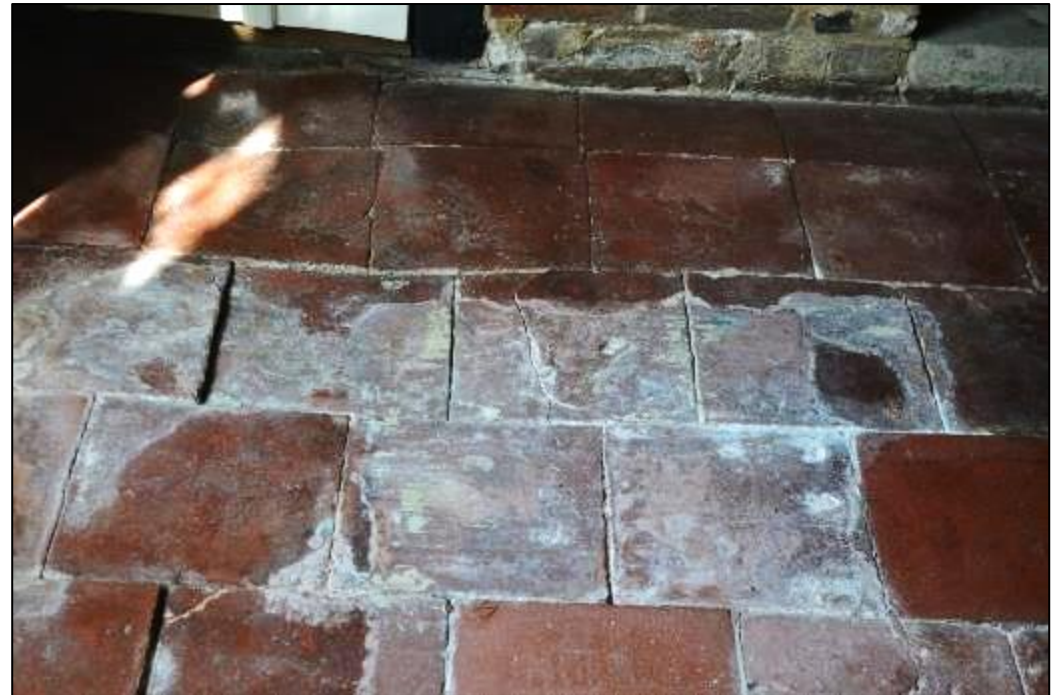
*Figure 26: Exposed timber framing and panels are evident throughout the reception room, (right) detail of salt efflorescence – which in itself is a sign of excessive ground water*

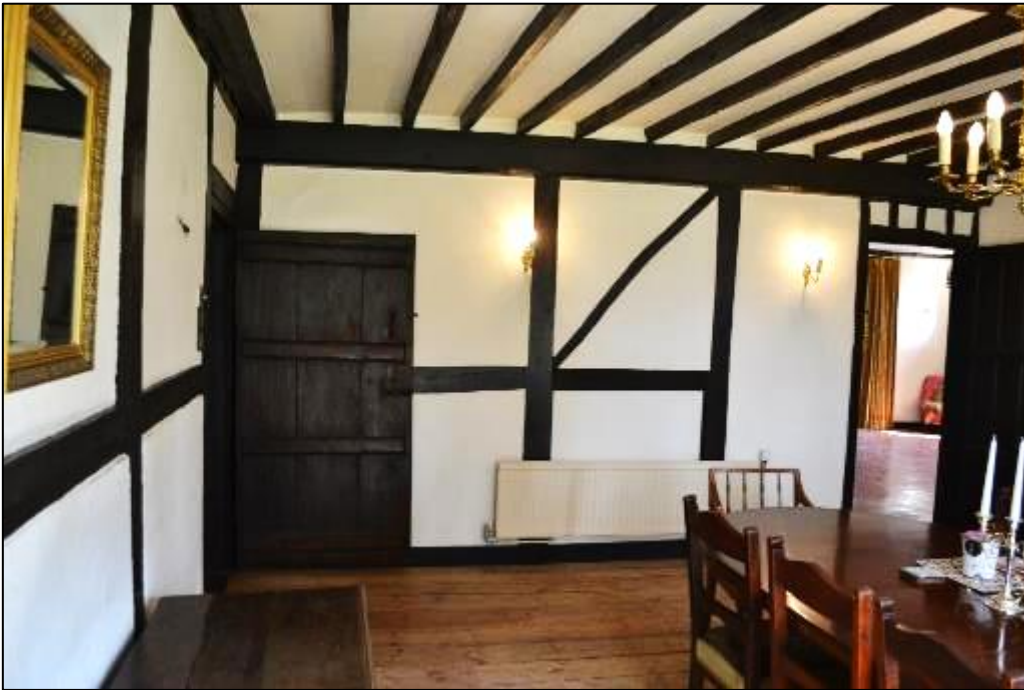
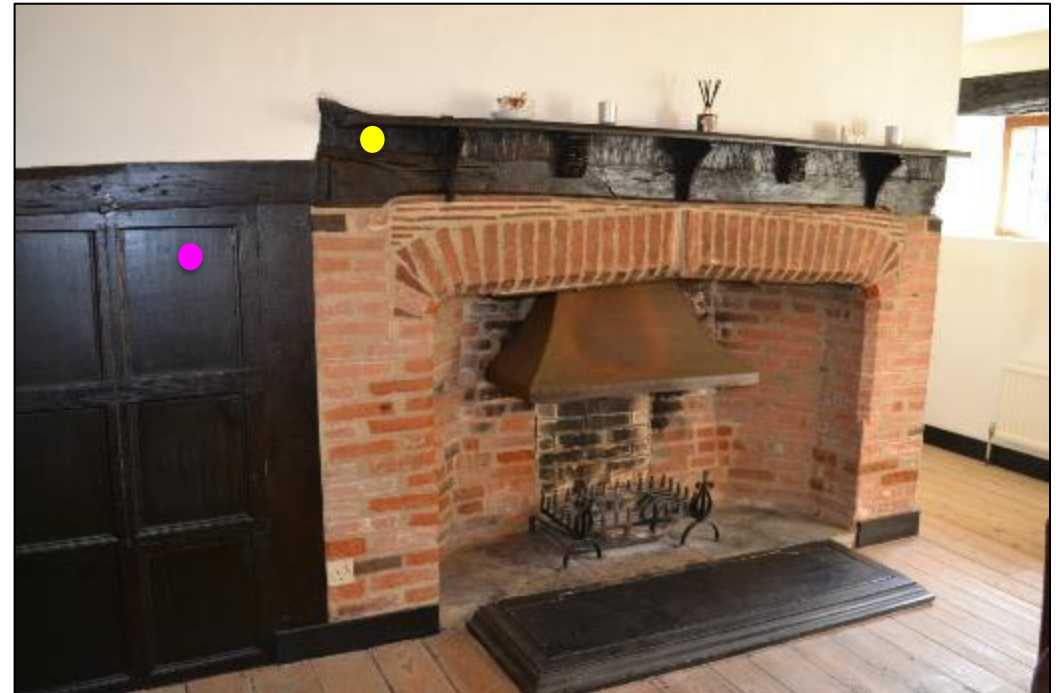
*Figure 27: Exposed timber framing throughout, (right) remains of 17<sup>th</sup> century timber panelling (highlighted in pink) and large Tudor depressed brick arch fireplace and moulded mantel with masked brackets (highlighted in yellow)*

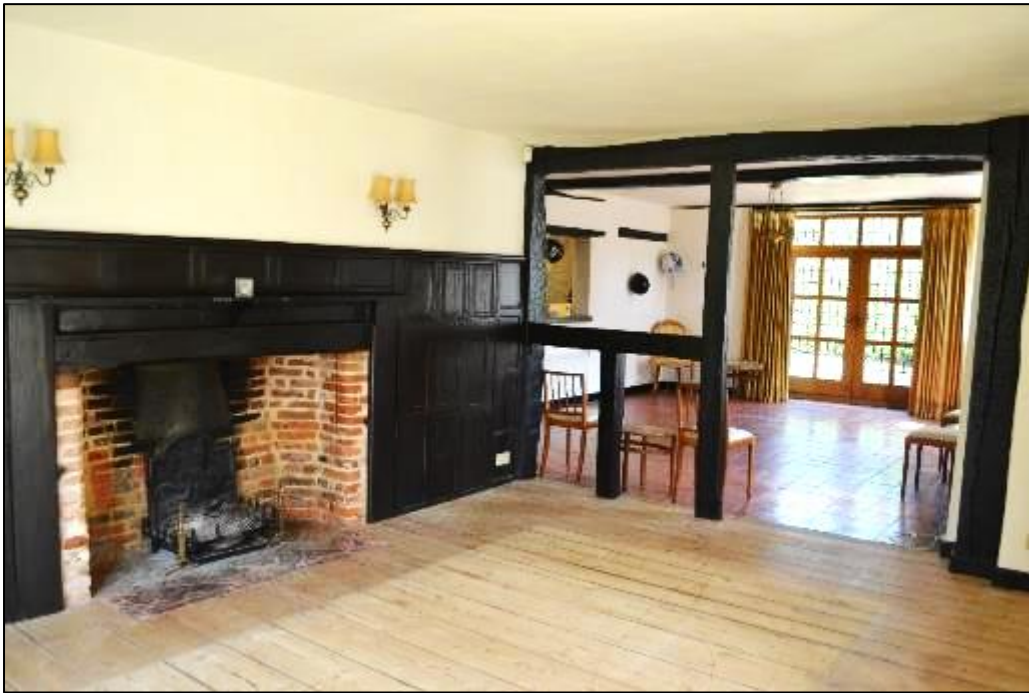
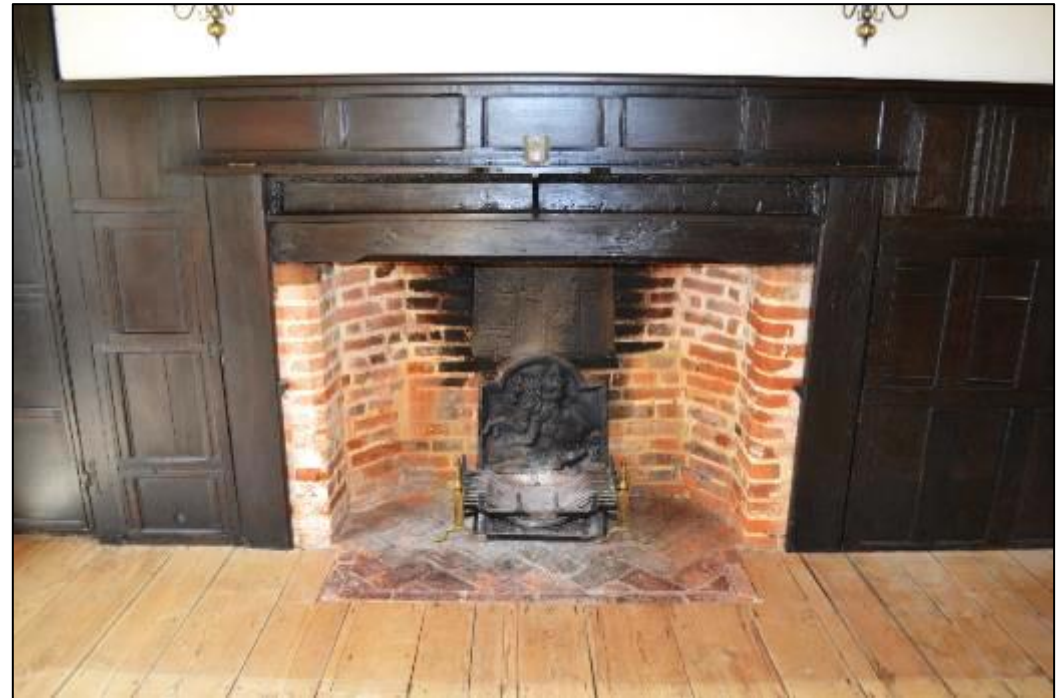
*Figure 28: Exposed open timber framing, (right) detail of brick lined fireplace surrounded by the remains of 17<sup>th</sup> century timber panelling- interestingly parts of this panelling have been re-used elsewhere within the house*

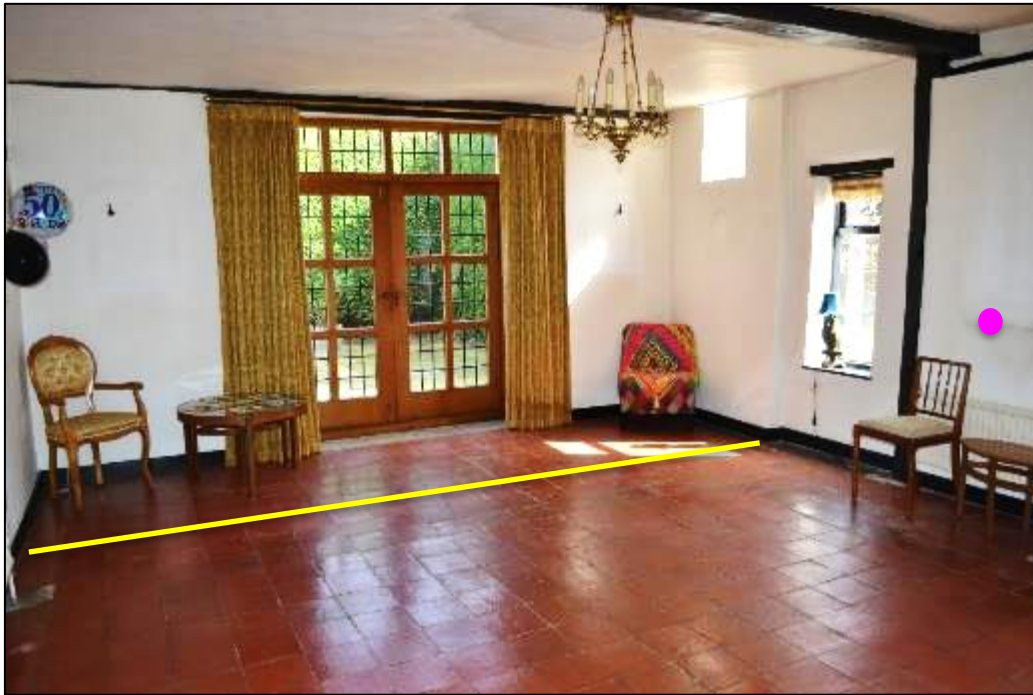
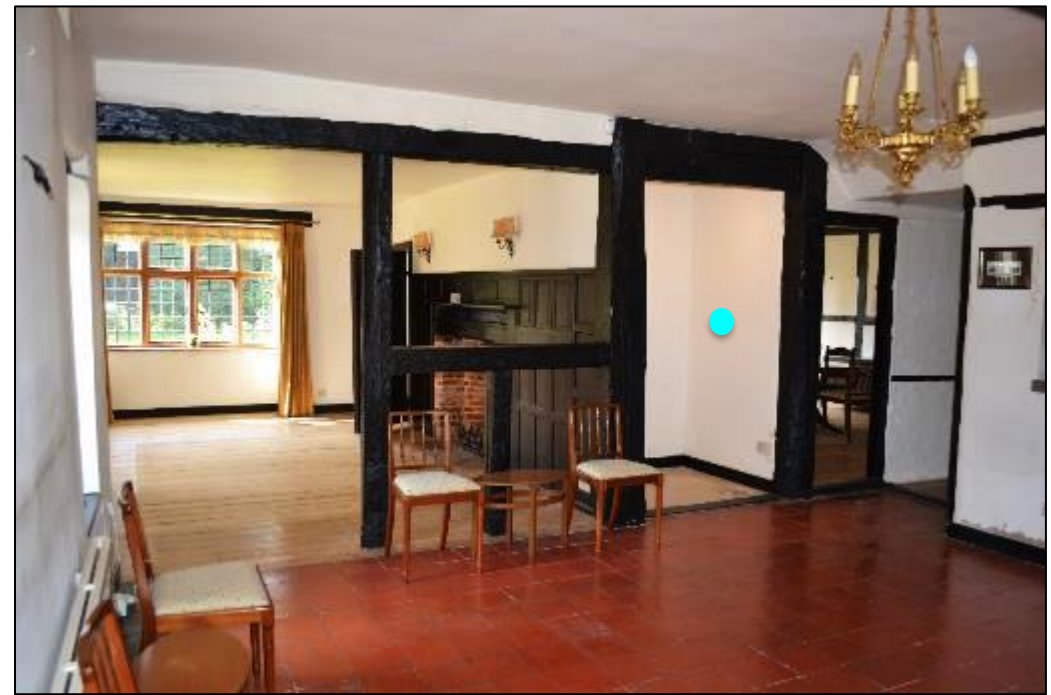
Figure 29: (left) Extended in the 19<sup>th</sup> century (limit of extension highlighted in yellow), (right) location of former fireplace (highlighted in pink), potential location of original stair when the property was a lobby entrance plan form (highlighted in blue)

The original early 17<sup>th</sup> century dwelling may have consisted of an attic, 2 units at ground floor and two units at first floor with a separate unit, likely to be a service area, to the north of the property (likely to be the current main reception room and part of the current kitchen). This would also be replicated at first floor level. Entrance to the property may have been where the two casement window is to the right of the porch (Error! Reference source not found.) with a lobby present directly on entry with doors leading both left and right, as is typical for a baffle / lobby entry house (**Figure 14**). The staircase to the property may have been located to the side rear side of the fireplace, evidence of which could be read in the space/void behind the fireplace where there is high ceilings within which could have facilitated the necessary head height (**Figure 29 & Figure 30**).

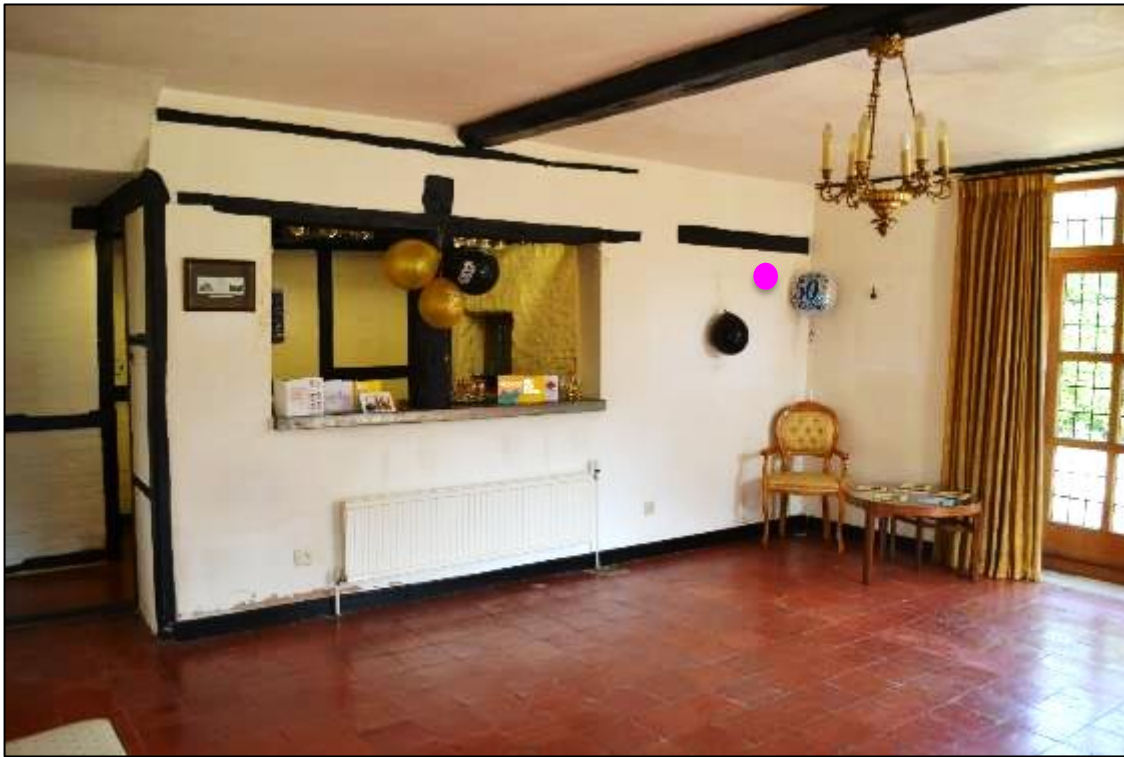
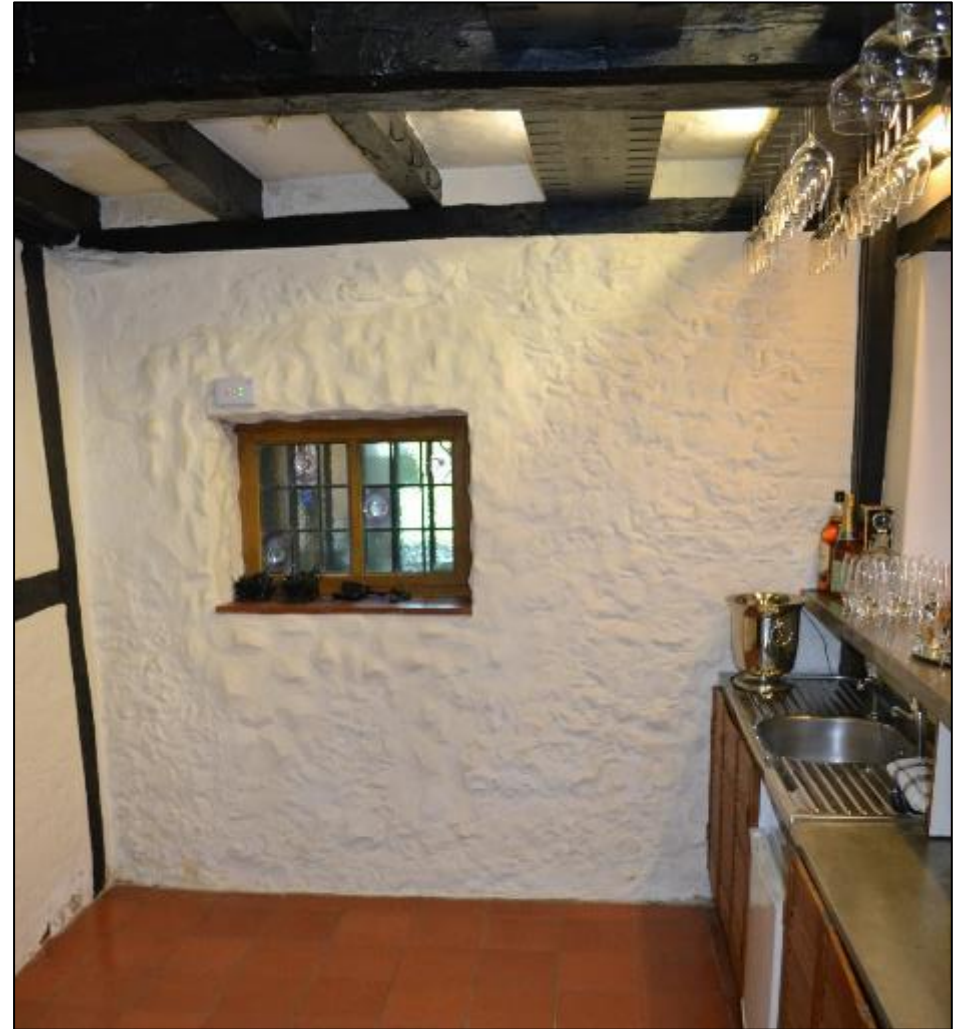
Figure 30: Bar located within the family room, blocked off doorway (highlighted in pink) which would have led out to what is now the location of the boiler room

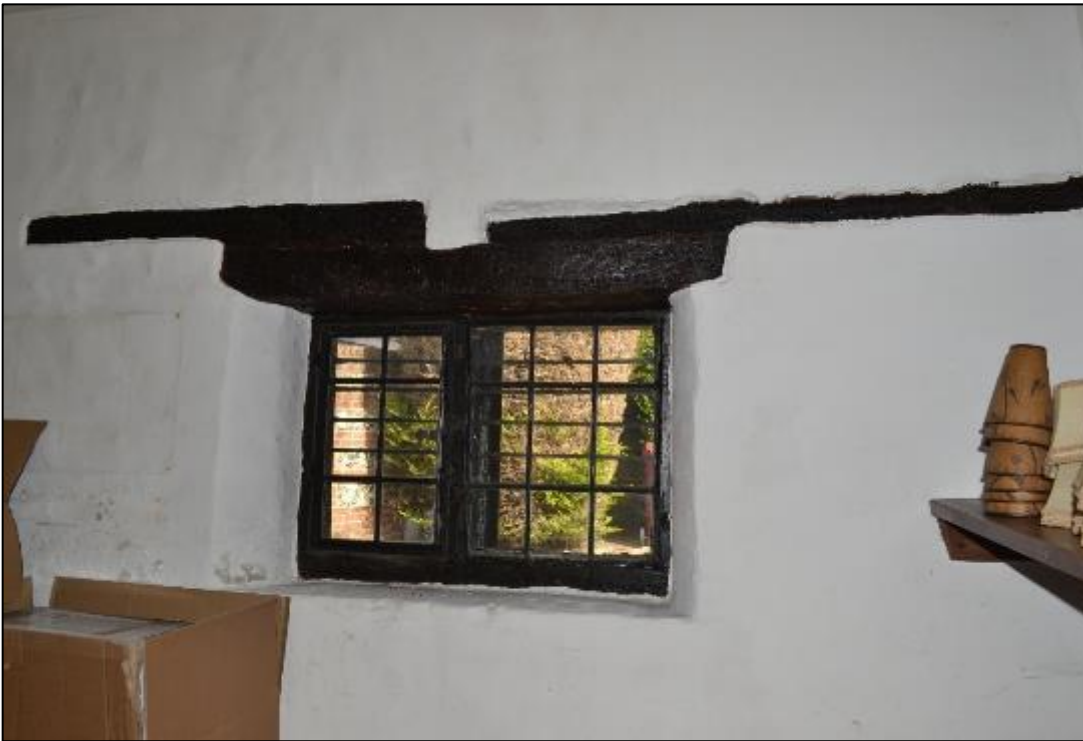
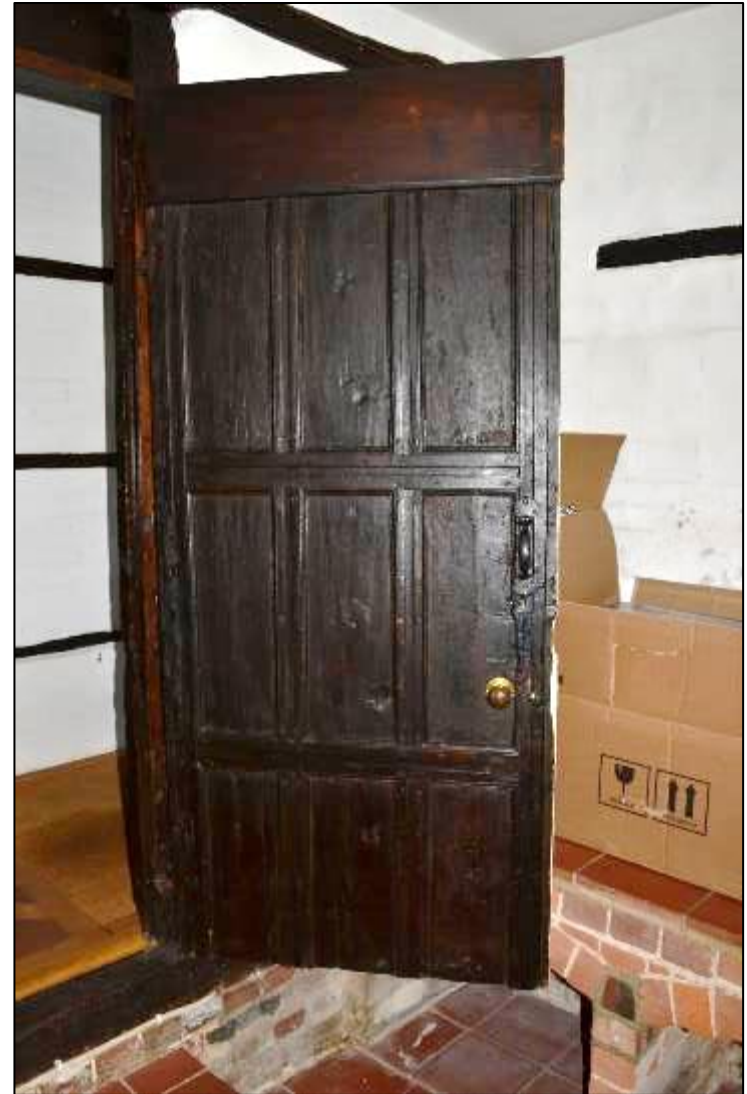
*Figure 32: (left) Original timber single glazed leaded window, (right) example of one of the many timber panelled doors within Old Grove House*

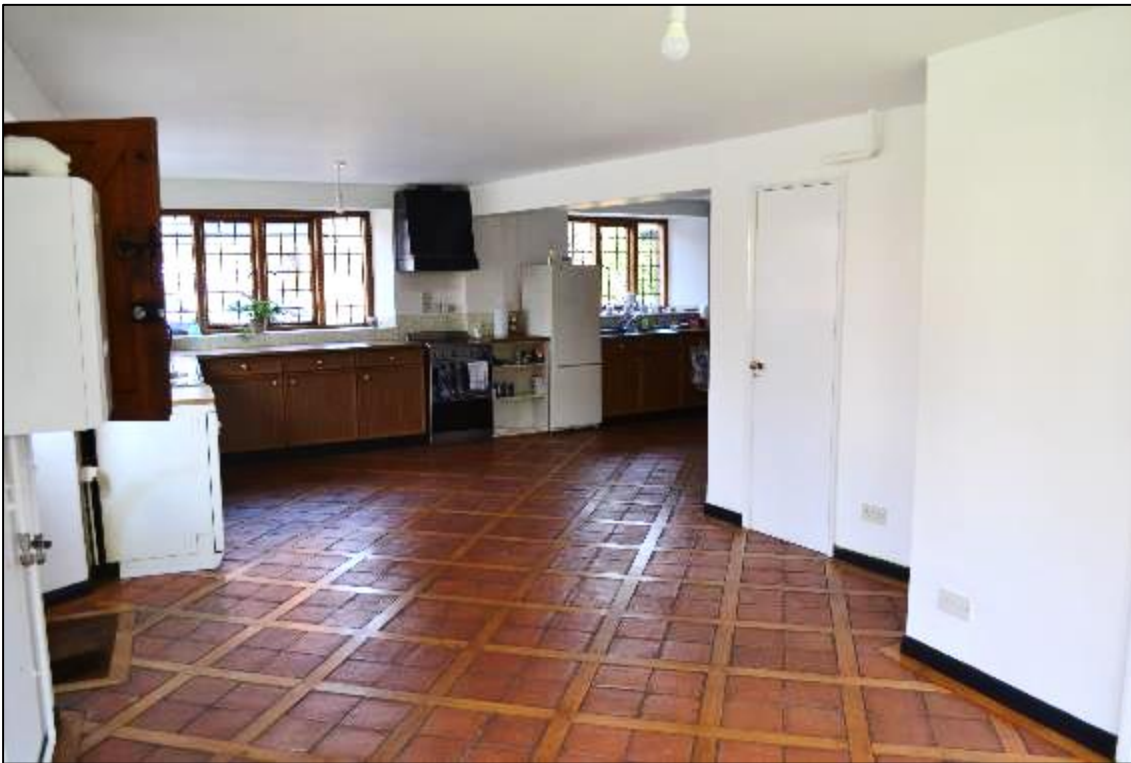
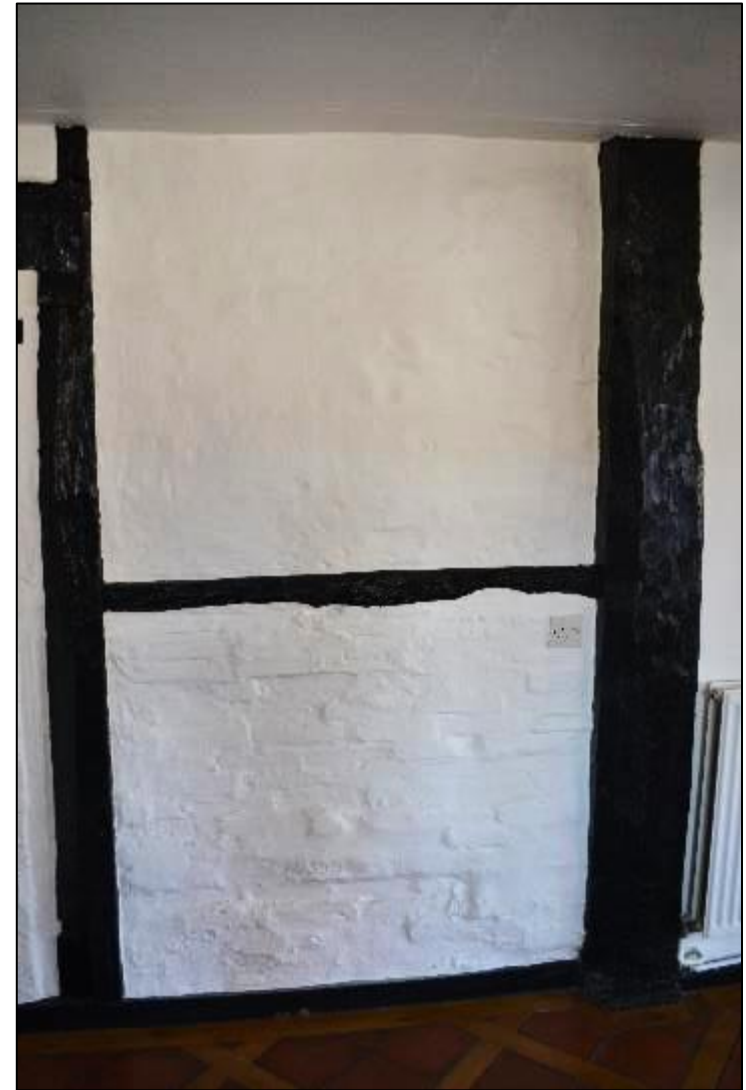
*Figure 33: (left) View of kitchen from north-western corner of the room, (right) timber panelling and brick infill along wall shared with the reception room*

The kitchen is part of the later 20<sup>th</sup> century extension which appears to have replaced a similar structure in that location- evidenced by the exposed beam that runs just inside the doorway upon entering (**Figure 33**).

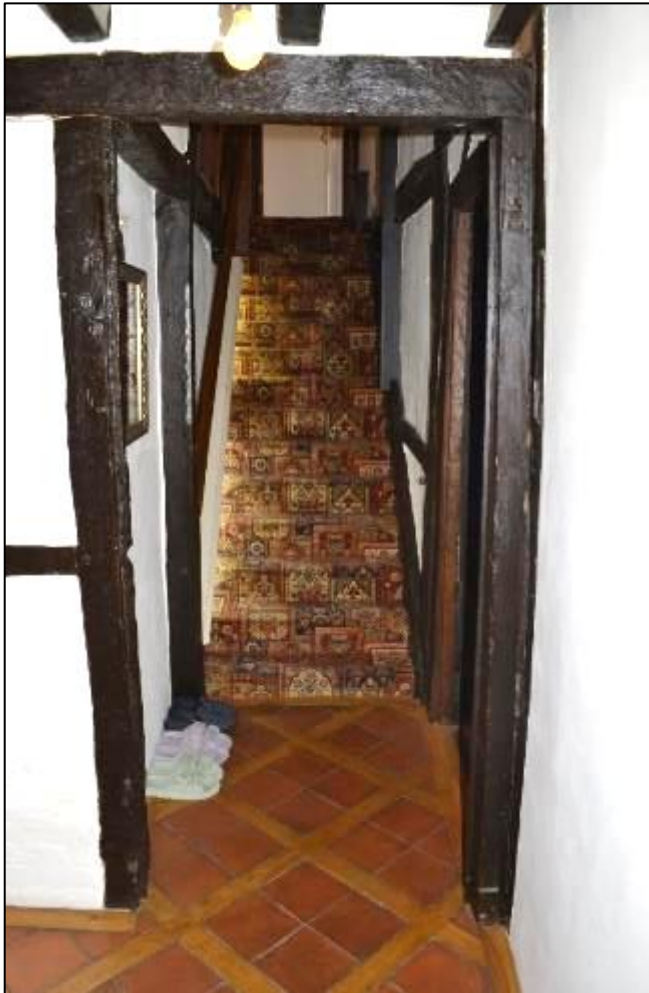
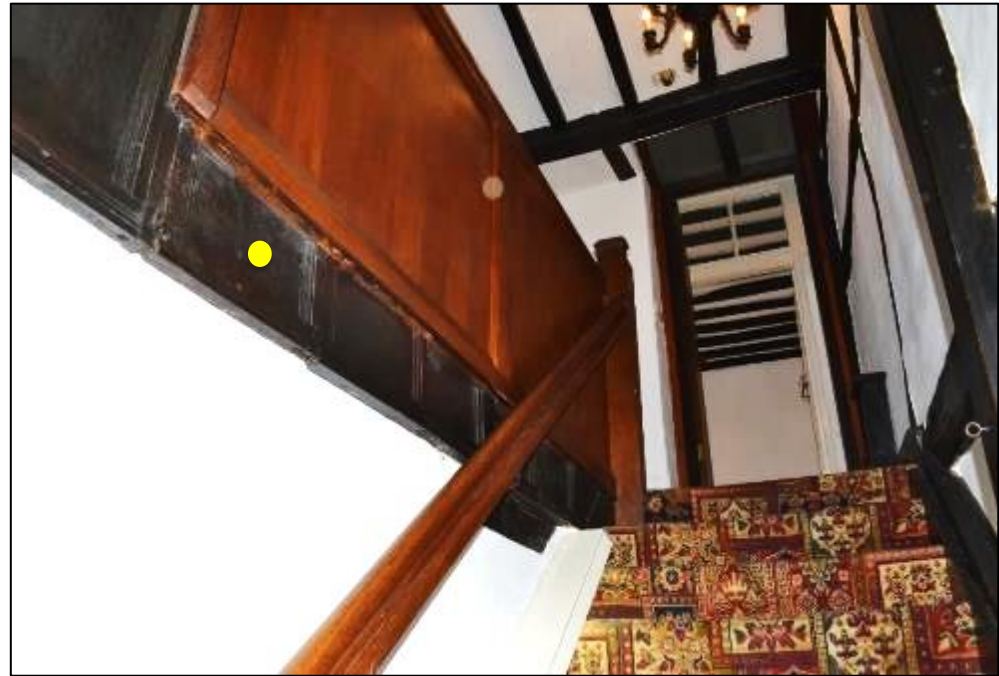
*Figure 34: (left) View of hallway leading to the main central staircase which is thought to have potentially replaced an earlier one thought to have been located in the family room, (right) detail of timber wall panelling reused along the staircase as some of the panels are now drawers (highlighted in yellow)*

| Figure 34: (left) View of hallway leading to the main central staircase which is thought to have potentially replaced an earlier one thought to have been located in the family room, (right) detail of timber wall panelling reused along the staircase as some of the panels are now drawers (highlighted in yellow) ..... | 36 |
