**Heritage Statement & Impact Assessment**

Old Grove House  
St Barnabas Road  
Reading  
RG4 8RA

July 2022

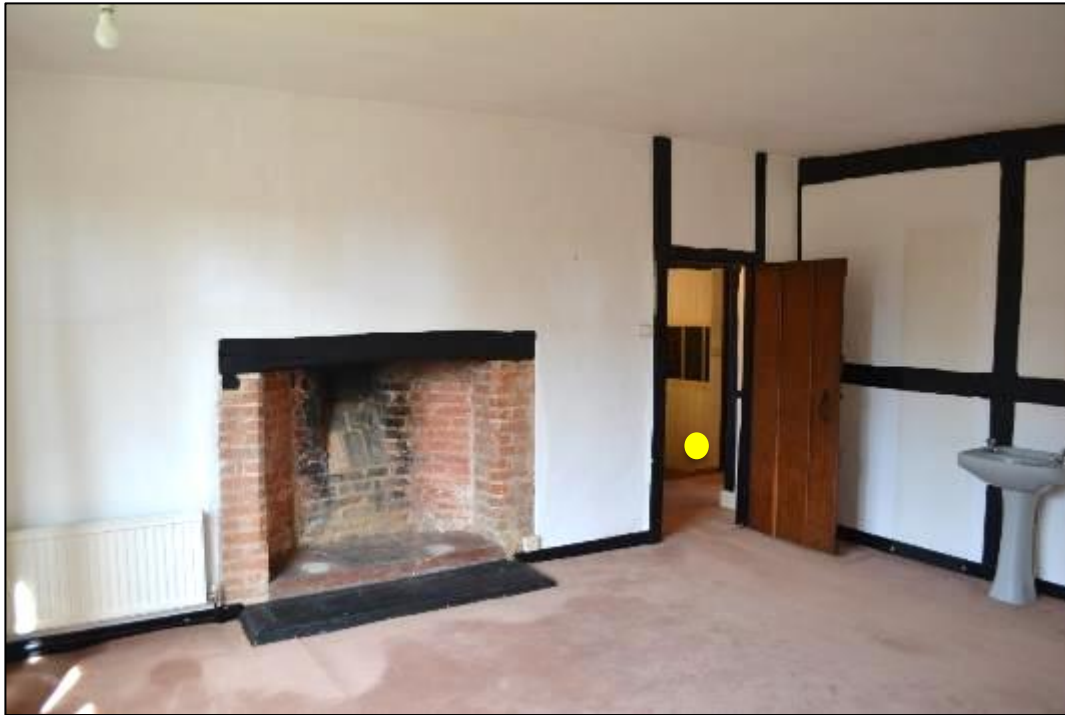
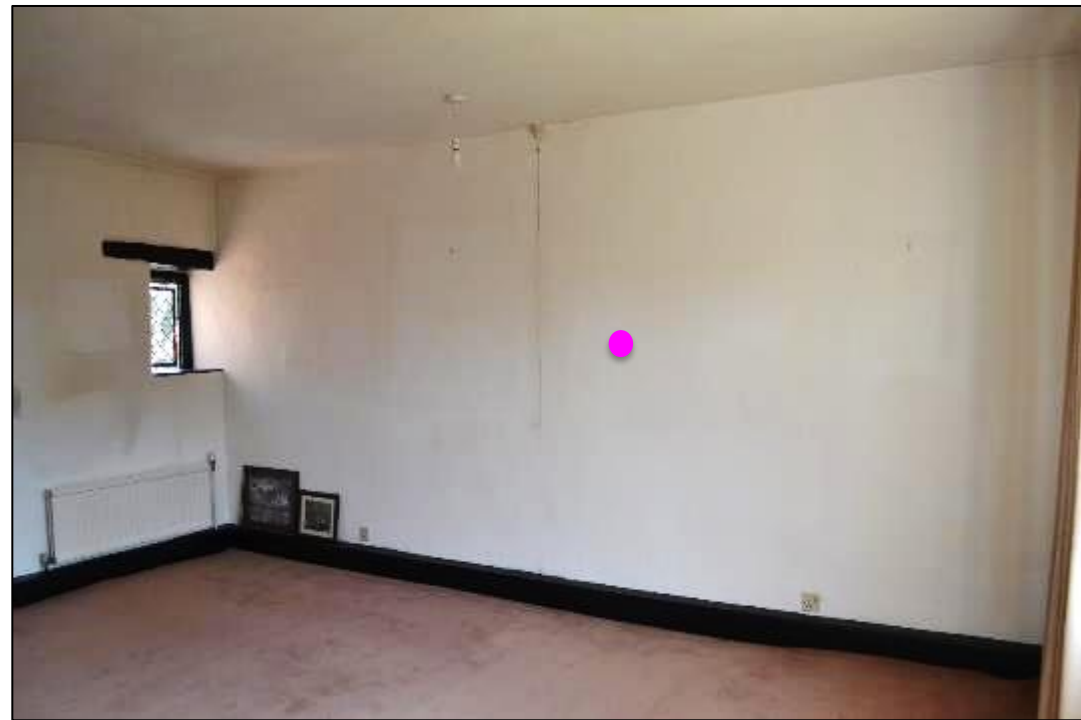
*Figure 37: (left) Exposed brick lined fireplace, location of where the original stair would have emerged (highlighted in yellow), (right) internal wall of where the blocked off window on the southern elevation is located (highlighted in pink)*

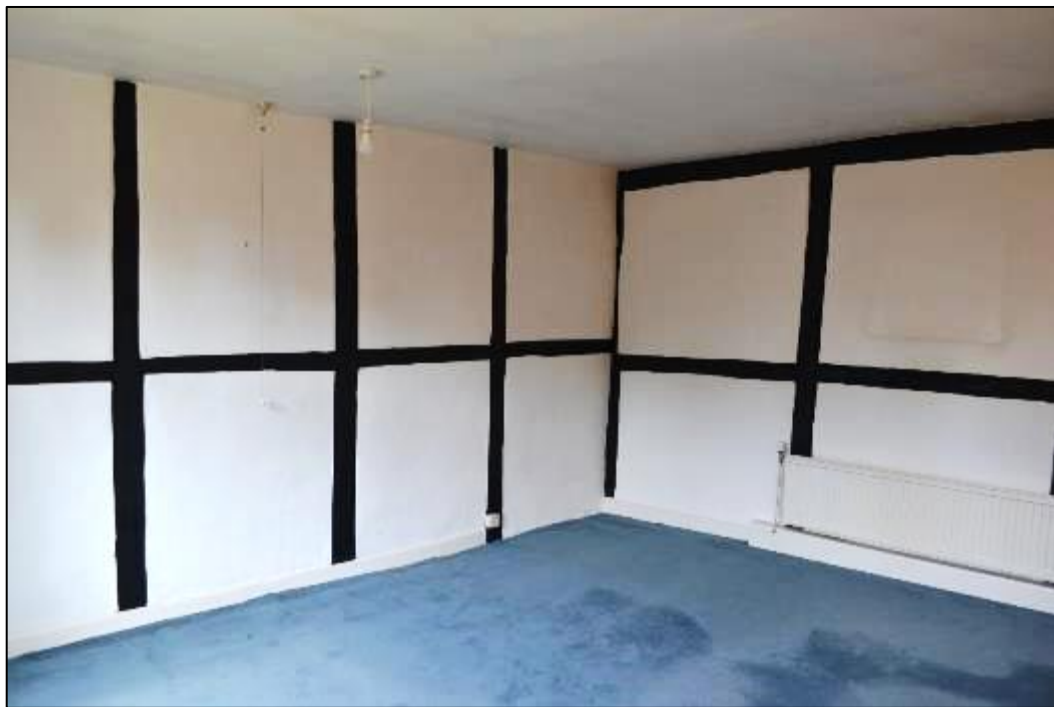
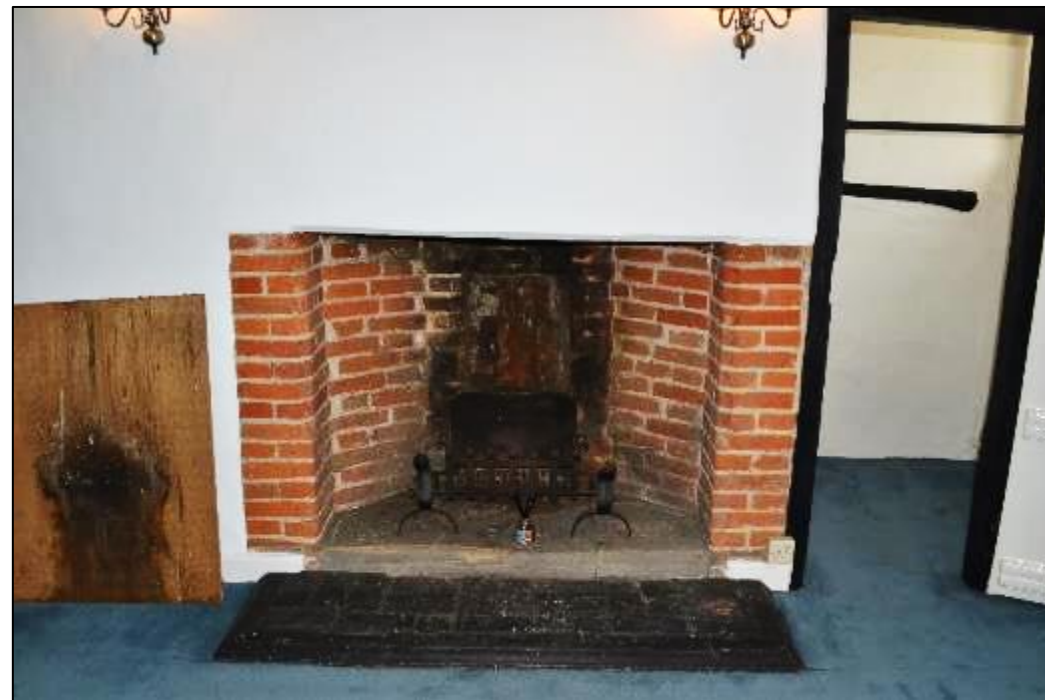
*Figure 38: (left) Exposed timber framing and panelling- it is within this room that original timber floorboards were discovered under the carpet, (right) exposed brick lined fireplace and adjacent cupboard*

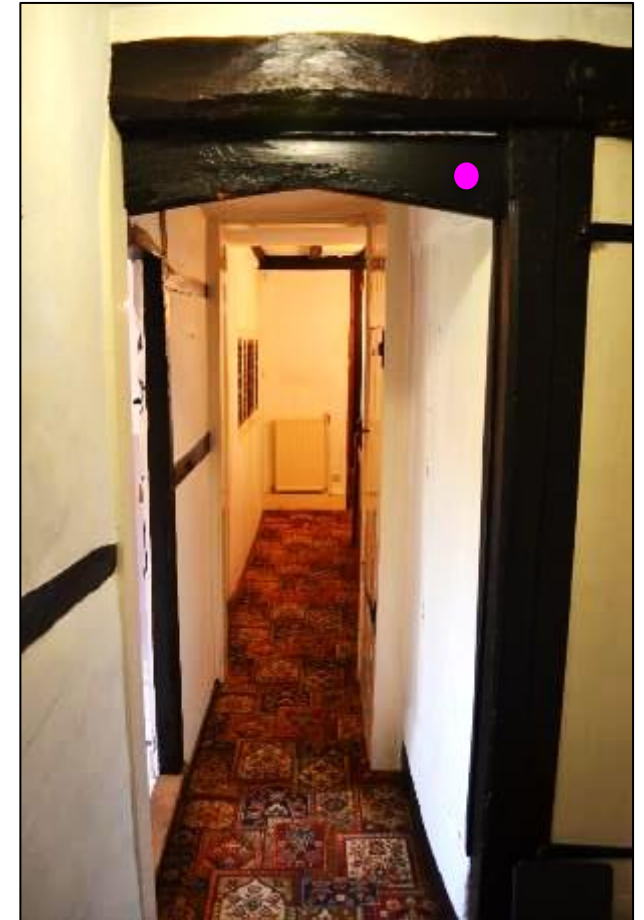
*Figure 39: (left & centre) The family bathrooms located just off the main hallway, (right) interesting four centre timber arch located at the end of the hallway (highlighted in pink)*

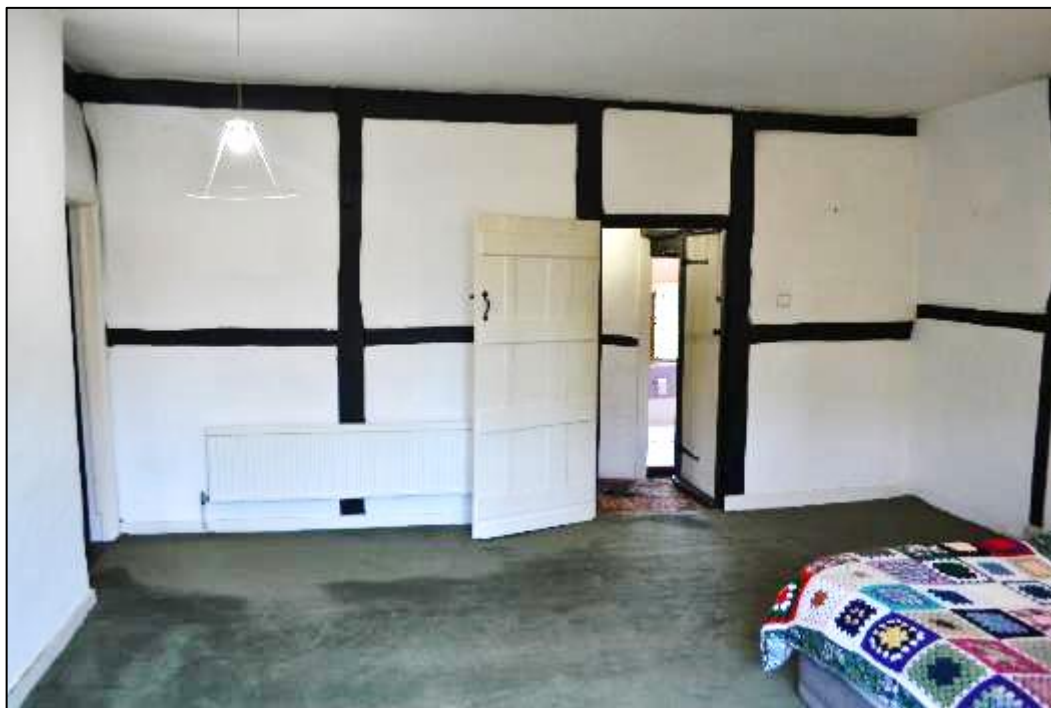
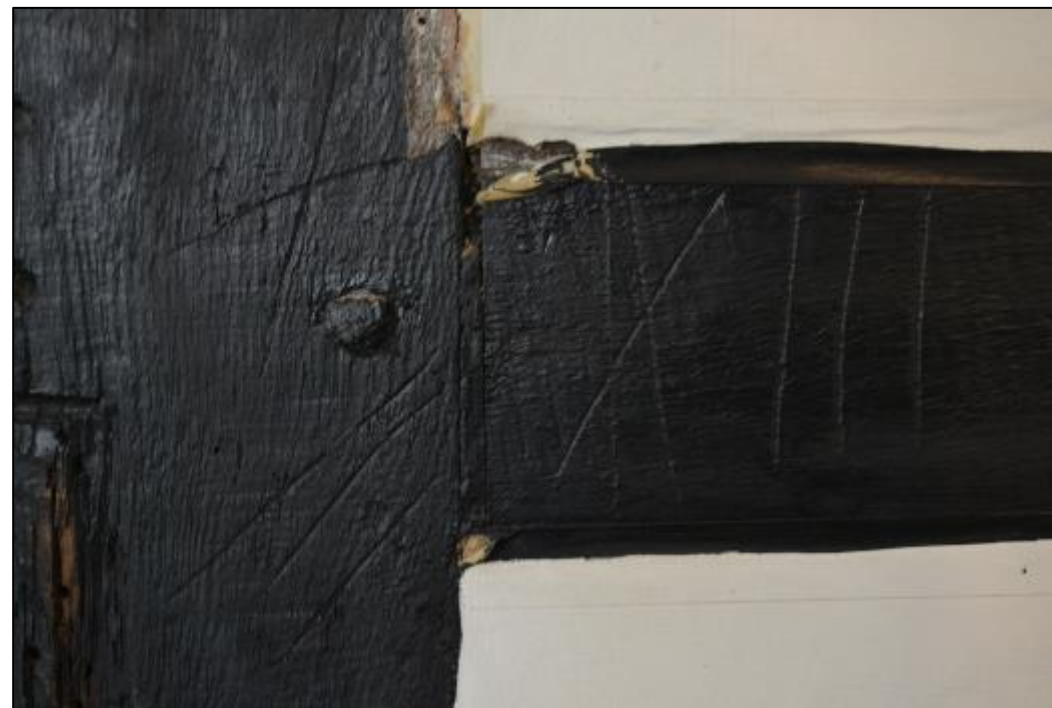
*Figure 41: (left) Exposed timber framing and panelling, (right) example of carpenters marks found on timbers throughout the house*

| Figure 41: (left) Exposed timber framing and panelling, (right) example of carpenters marks found on timbers throughout the house ..... | 43 |

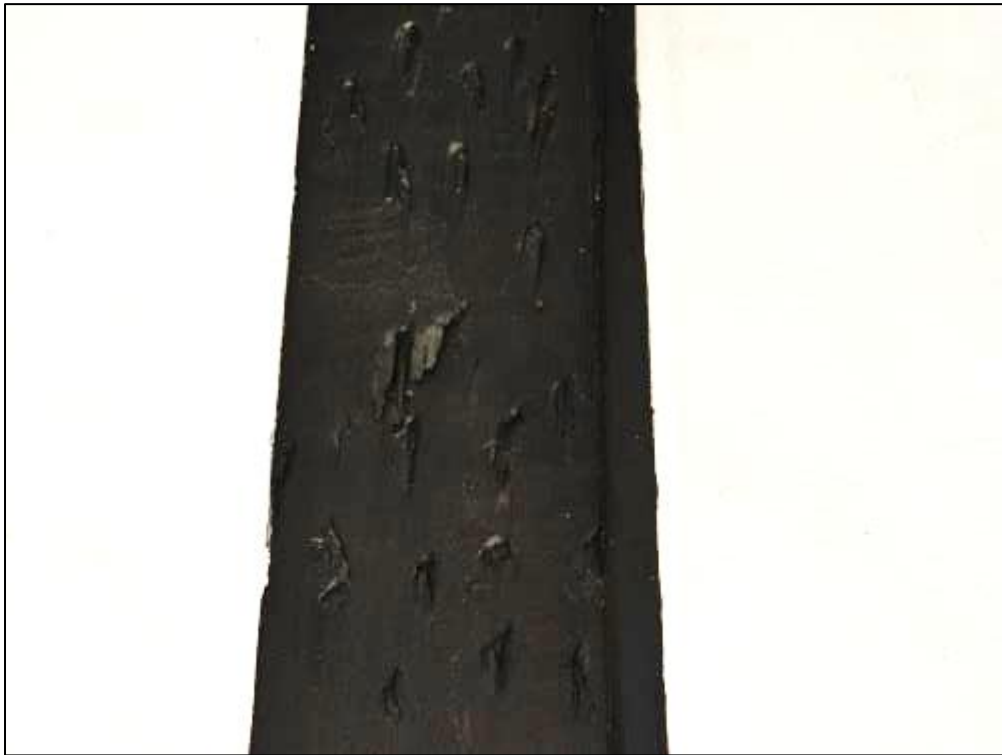
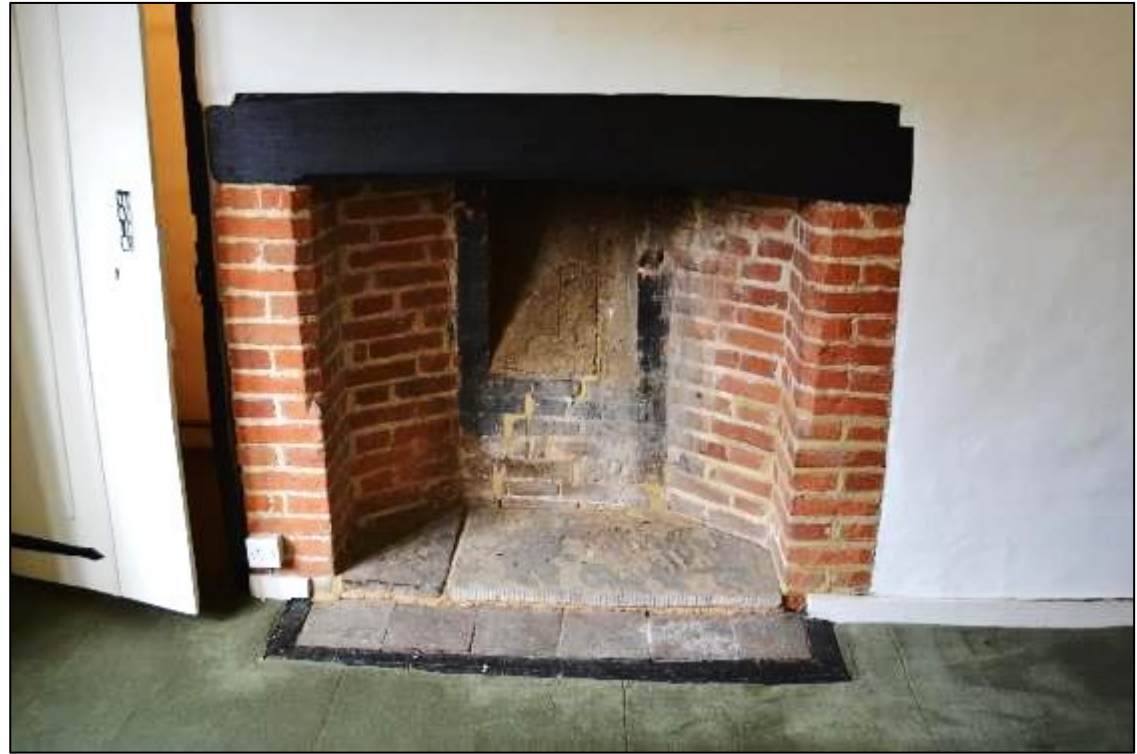
*Figure 42: (left) Example of plaster notches found on some of the timber framing throughout the house, (right) brick lined fireplace with timber lintel and adjacent cupboard.*

| Figure 42: (left) Example of plaster notches found on some of the timber framing throughout the house, (right) brick lined fireplace with timber lintel and adjacent cupboard. .... | 44 |

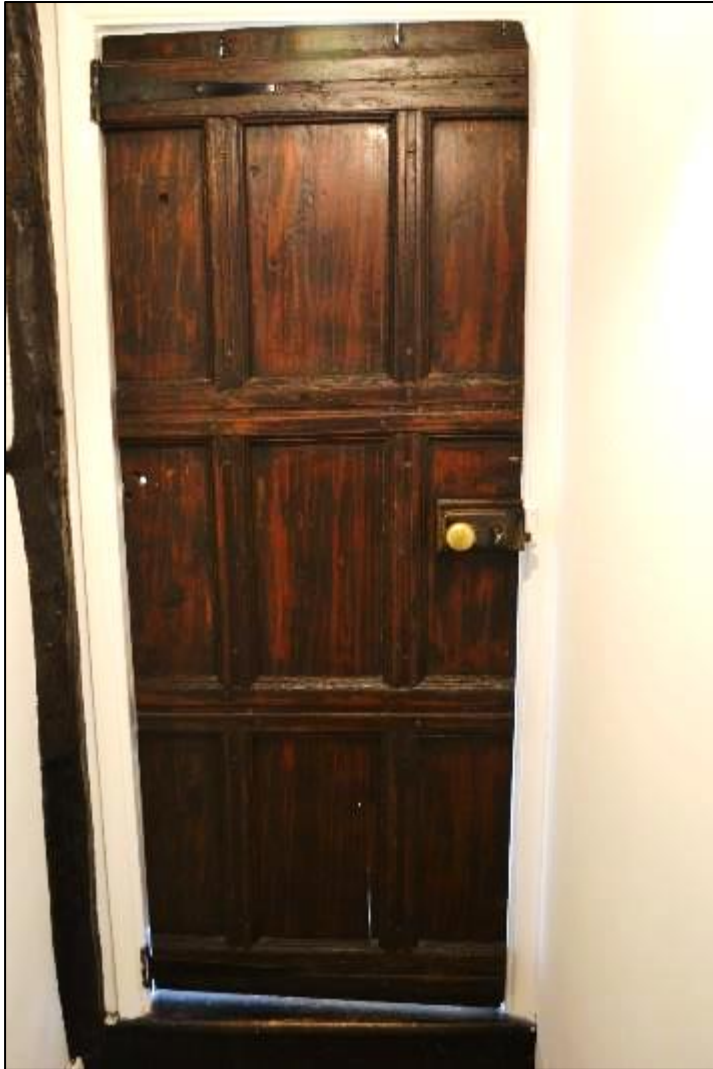
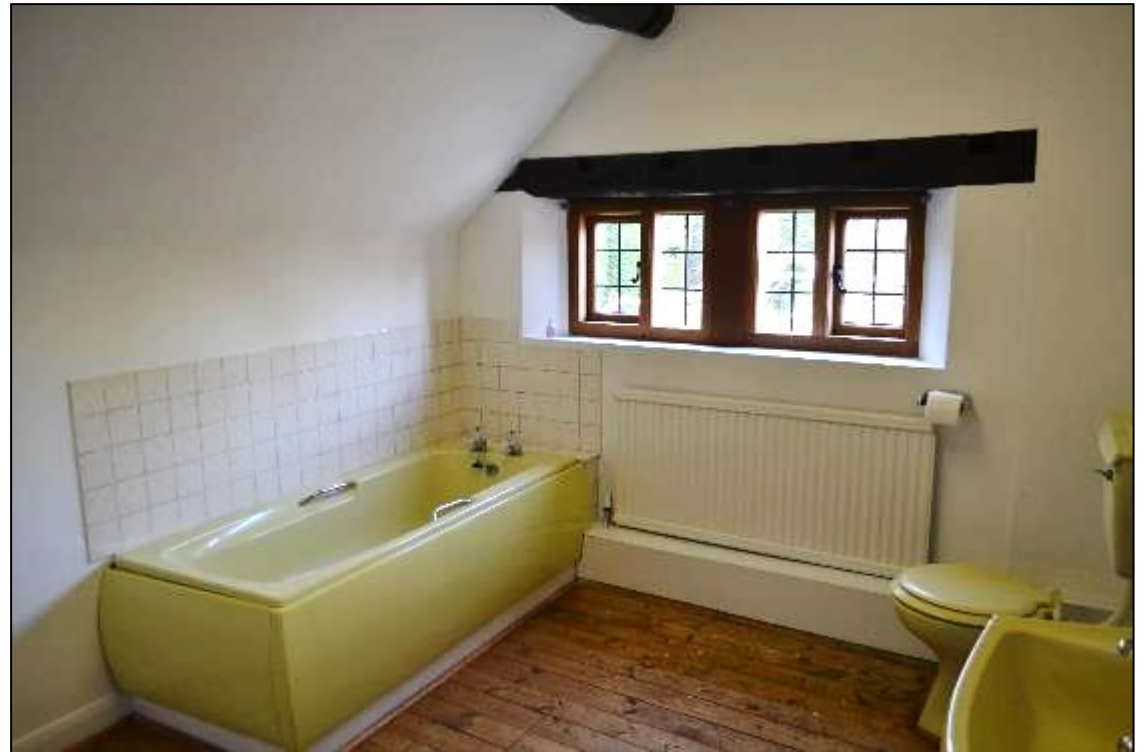
*Figure 43: (left) Door separating bedroom 2 from the en-suite- note the door appears to be re-used timber panelling, (right) ensuite bathroom located above 20<sup>th</sup> century kitchen extension*

As mentioned above, the stairs may be a later insertion and have been lined with parts of the early 17<sup>th</sup> century panelling from the sitting room (**Figure 34**). On the first floor bedrooms 2,4 and 5 all have exposed fireplaces and timber plank floors under the carpet. Bedroom 2 appears to have a door also made out of decorative wood panelling (**Figure 43**) whilst in bedroom 5 there is no visible evidence of the blocked off window in the plaster work (**Figure 37**). All the rooms, including bedroom 3 have exposed timber framing. The master bedroom, which is adjacent to bedrooms 4 and 5, is located in the south eastern gable that was extended in the late 19<sup>th</sup> century (**Figure 36**). Curiously the en-suite to the bedroom has 5 leaded coloured stained glass panels which look out onto the central hallway (**Figure 35**).

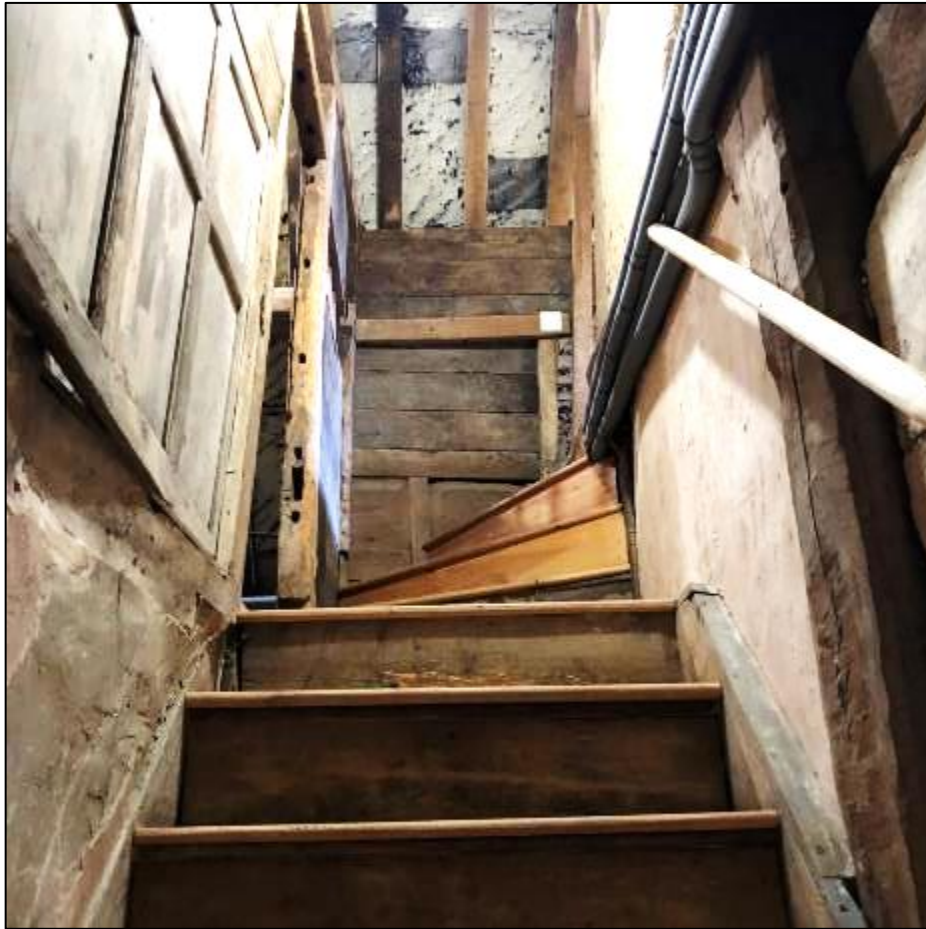
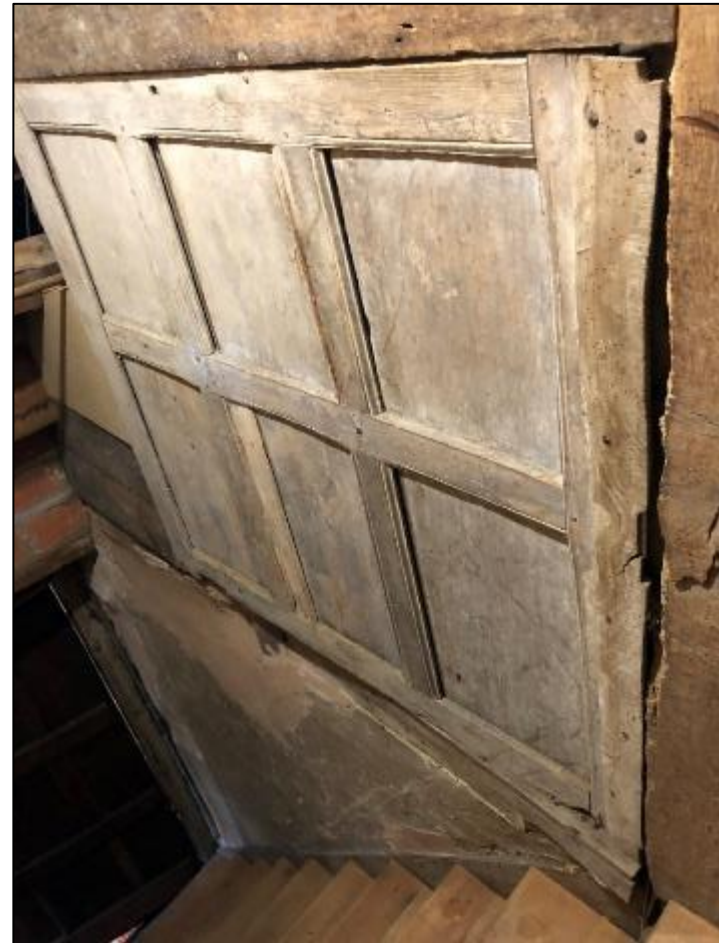
*Figure 44: (left) Stairs leading up to attic rooms, (right) example of 17<sup>th</sup> century timber panelling (similar to that found downstairs in the principal rooms) being used as a partition*

The attic is accessed by a timber stair, that as discussed earlier, utilises unexpected timber elements such as 17<sup>th</sup> century panelling and what appears to be part of an agricultural partition (**Figure 44 & Figure 45**). All of the timber roof structure is exposed- with some infilling both historic and modern in certain sections (**Figure 48 & Figure 49**). The historic plaster appears to have been laid upon willow lathes which is interesting to note. There is also evidence of some of the roof timbers having been repaired in the 20<sup>th</sup> century (**Figure 46**) whilst the floor has been completely covered in 20<sup>th</sup> century timber boards and mdf.

| Figure 44: (left) Stairs leading up to attic rooms, (right) example of 17 <sup>th</sup> century timber panelling (similar to that found downstairs in the principal rooms) being used as a partition ..... | 46 |

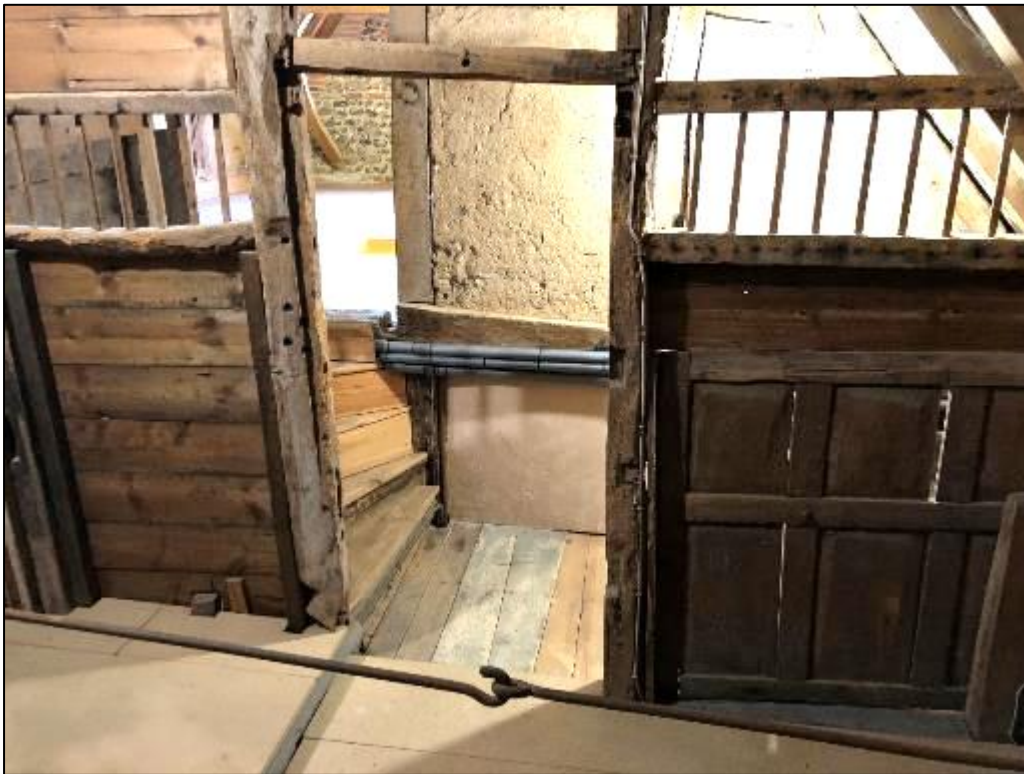
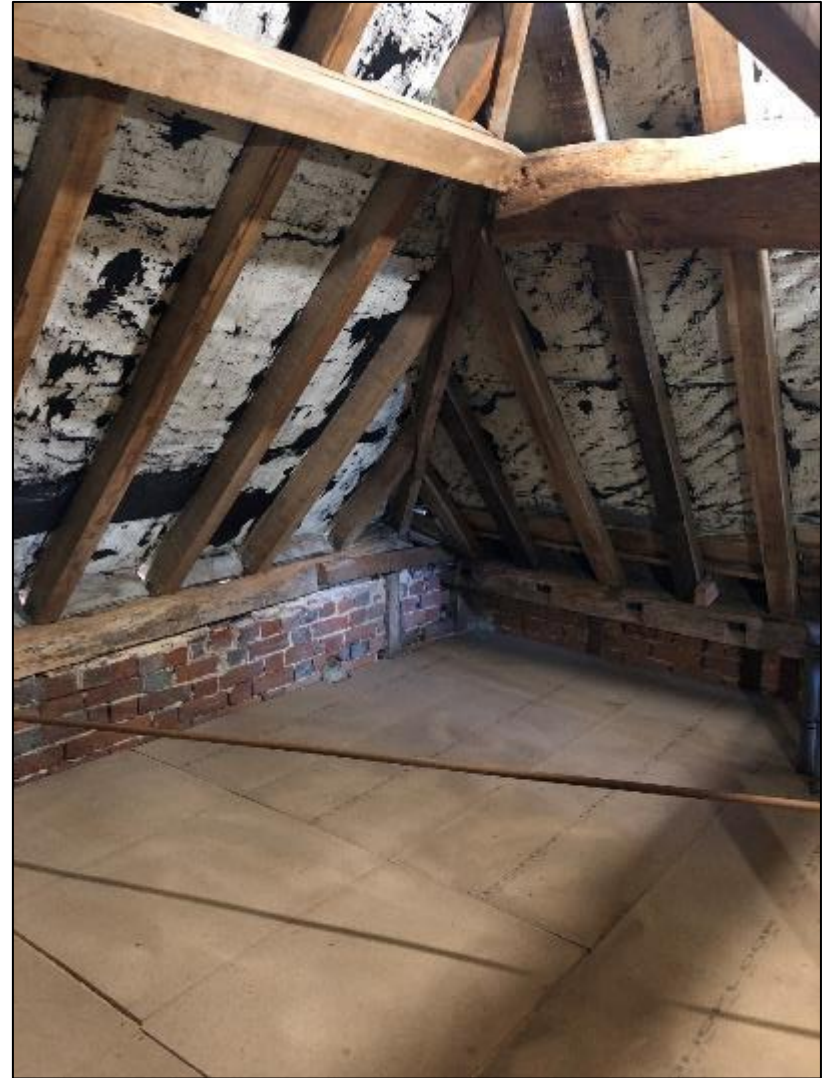
*Figure 45: (left) Note the different elements- agricultural and formal- that create the timber partition, (right) view of internal roof structure of central gable along the eastern elevation*

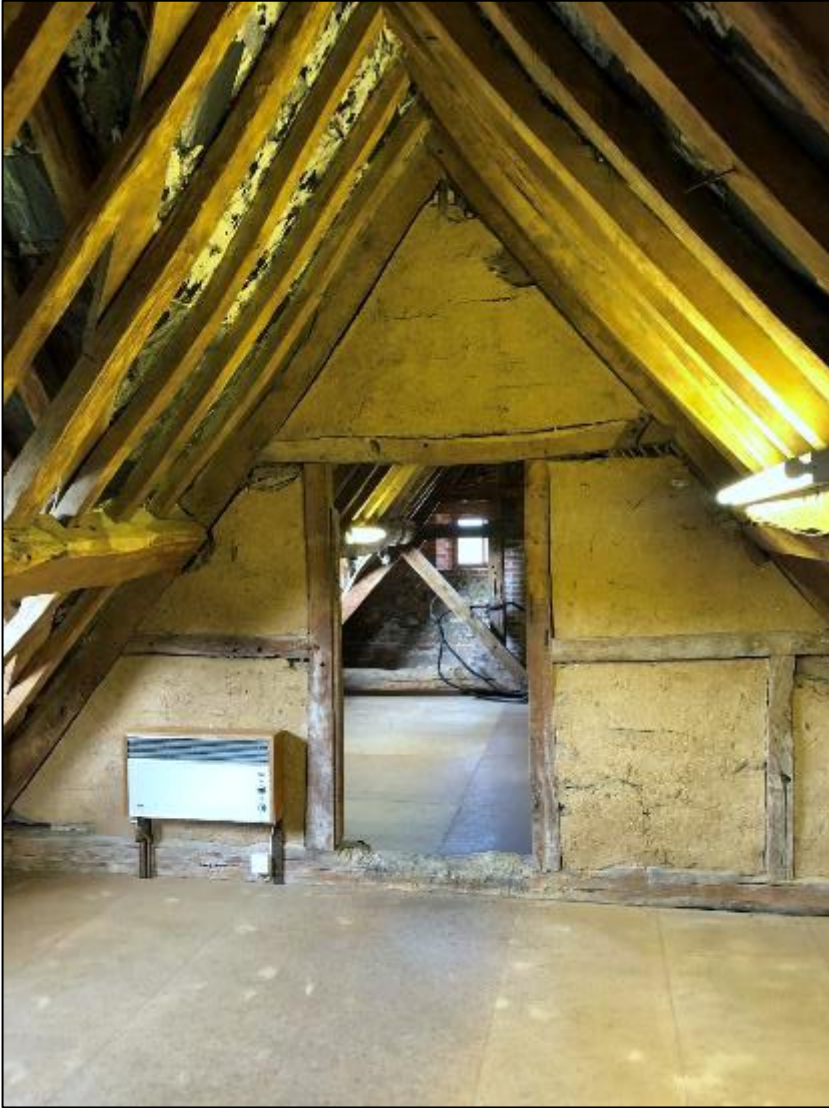
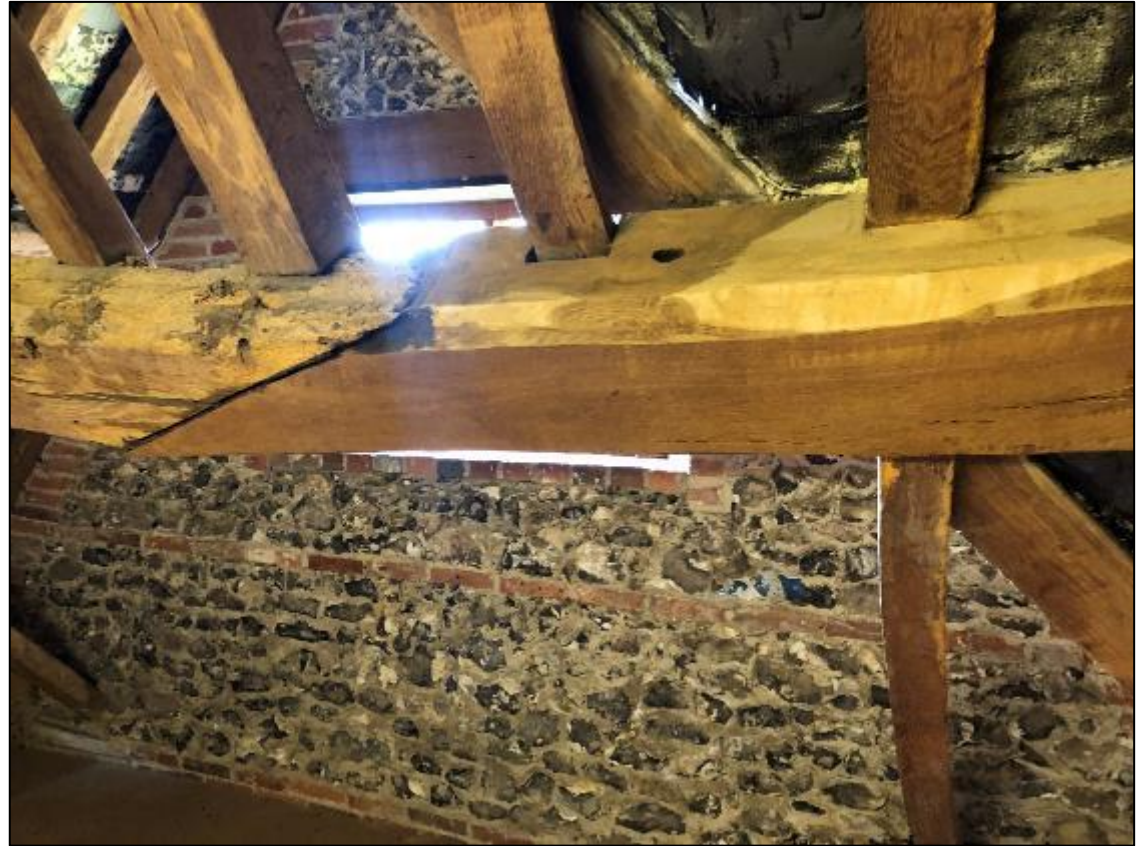
*Figure 46: (left) Internal view of central roof space- note the original plaster infill panels, (right) example of where the roof structure has been repaired and new timbers spliced in*

| Figure 46: (left) Internal view of central roof space- note the original plaster infill panels, (right) example of where the roof structure has been repaired and new timbers spliced in..... | 48 |

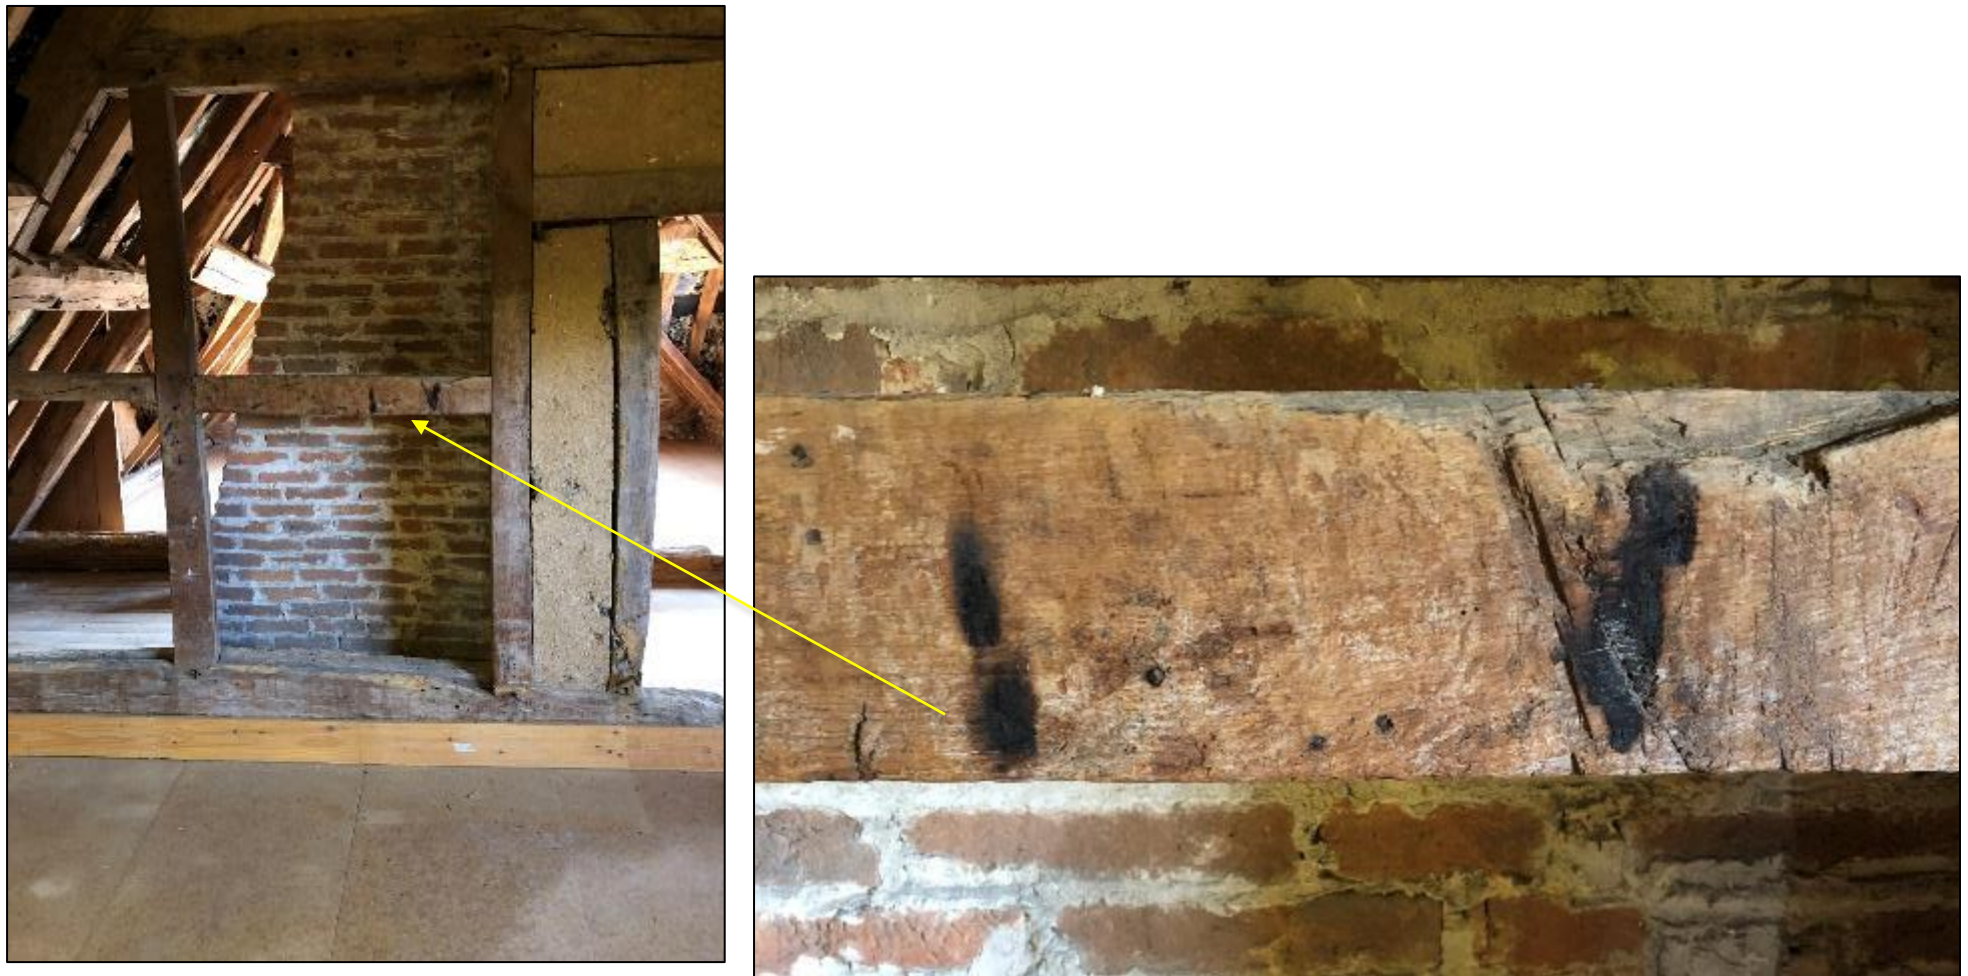
*Figure 47: (left) View of timber framing and original infill around the central chimney stack, (right) example of apotropaic burn marks found throughout the attic space*

The most fascinating features of the attic however are the apotropaic burn marks found on the timbers closest to the two chimney breasts (**Figure 47 & Figure 53**). Apotropaic marks are most often inscribed on buildings. The markings are believed to have turned away evil, providing protection to the building and those who lived or worked within it. The evil that was being 'turned away' may have been demons, witches or the then ever present evil eye. These burn marks are commonly misinterpreted as accidental candle burns.

Recent studies have shown that these purposeful markings are to be found all over the timbers of many early houses, and often in places where there is little chance of a candle having been left alone, such as high up in roof timbers, on joists under the floor boards or even on furniture. The very distinctive tear-drop shaped burns have a very specific purpose, that being to protect the dwelling and its occupants from the devastating rages of fire, a very real and destructive threat in times past when building materials were highly flammable and heating, lighting and cooking within the home all had to be achieved with a naked flame. Which would explain why the burn marks found with Old Grove House are all located around the chimney breasts.

| Figure 47: (left) View of timber framing and original infill around the central chimney stack, (right) example of apotropaic burn marks found throughout the attic space ..... | 49 |

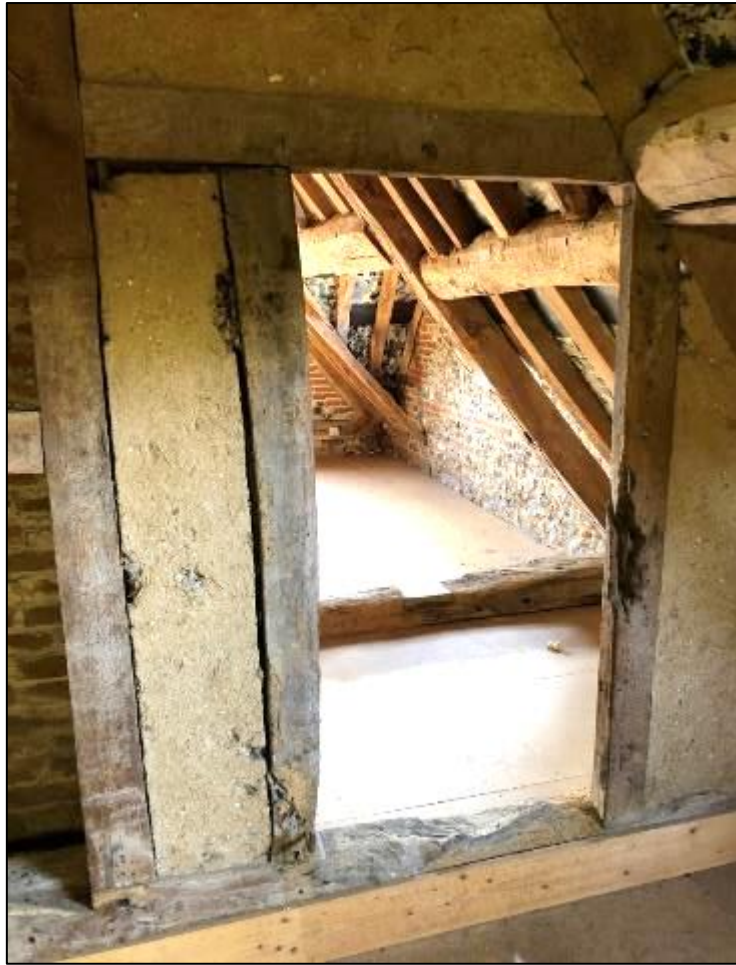
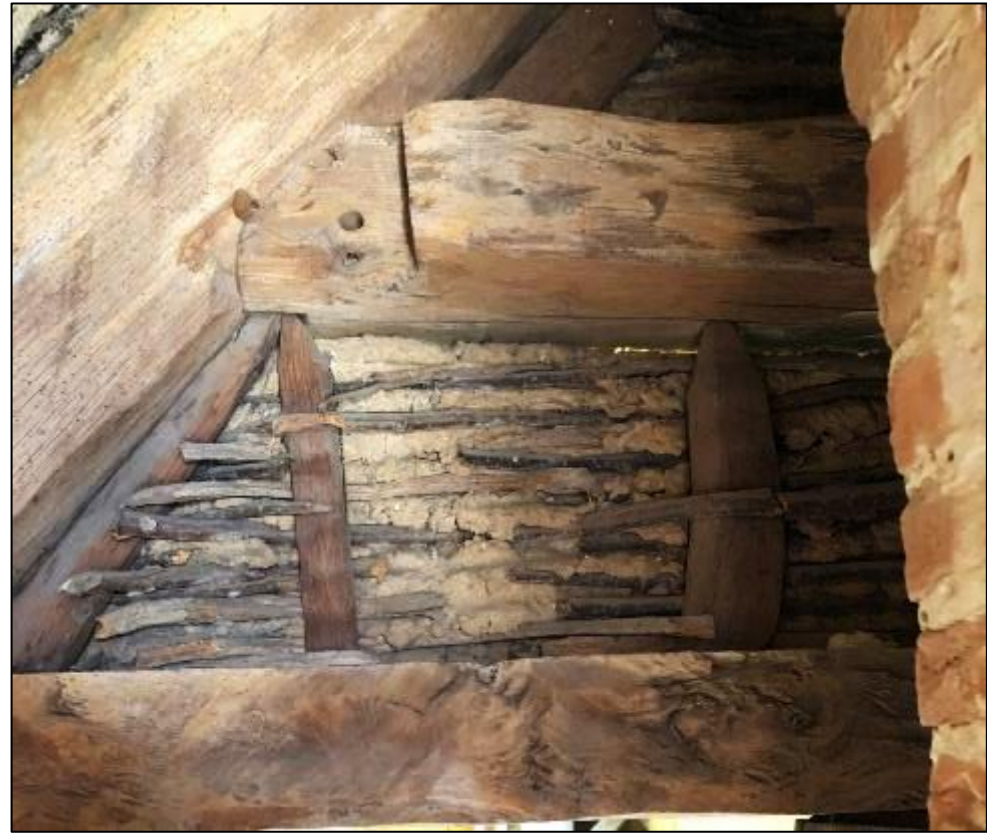
*Figure 48: (left) Further examples of historic plaster panels, (right) detail of the lathes thought to be made out of willow upon which the plaster has been applied*

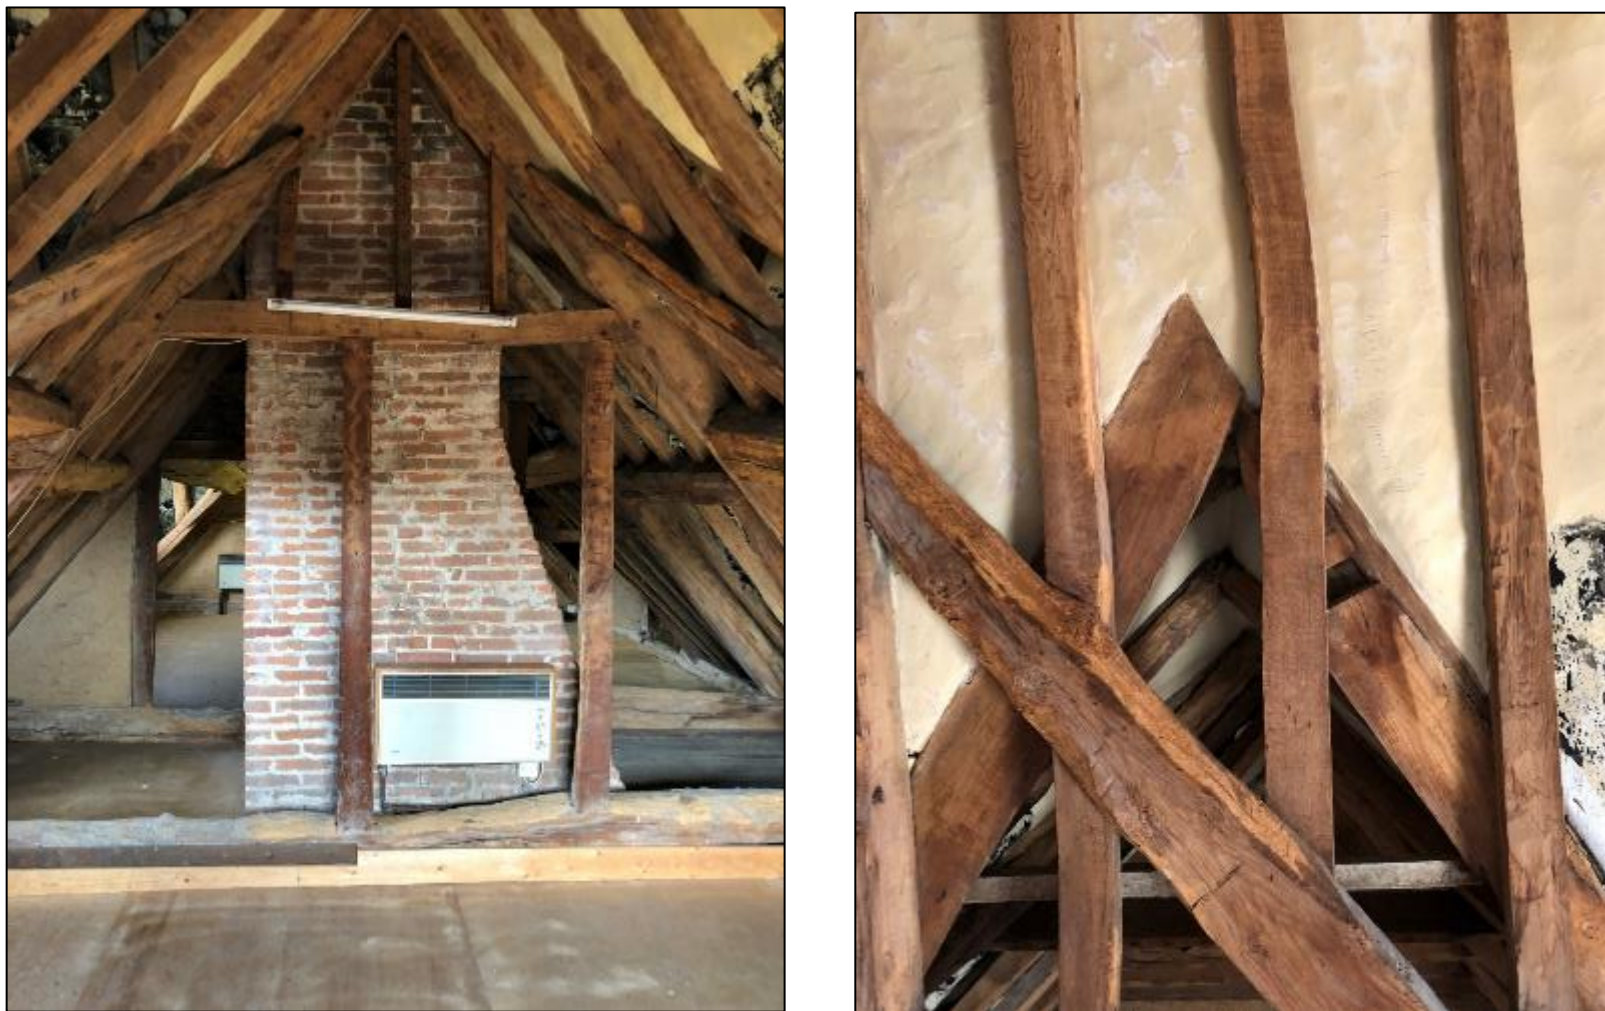
*Figure 49: (left) View of internal roof space and central chimney stack, (right) example of modern infill plaster which has been attempted in various locations within the attic*

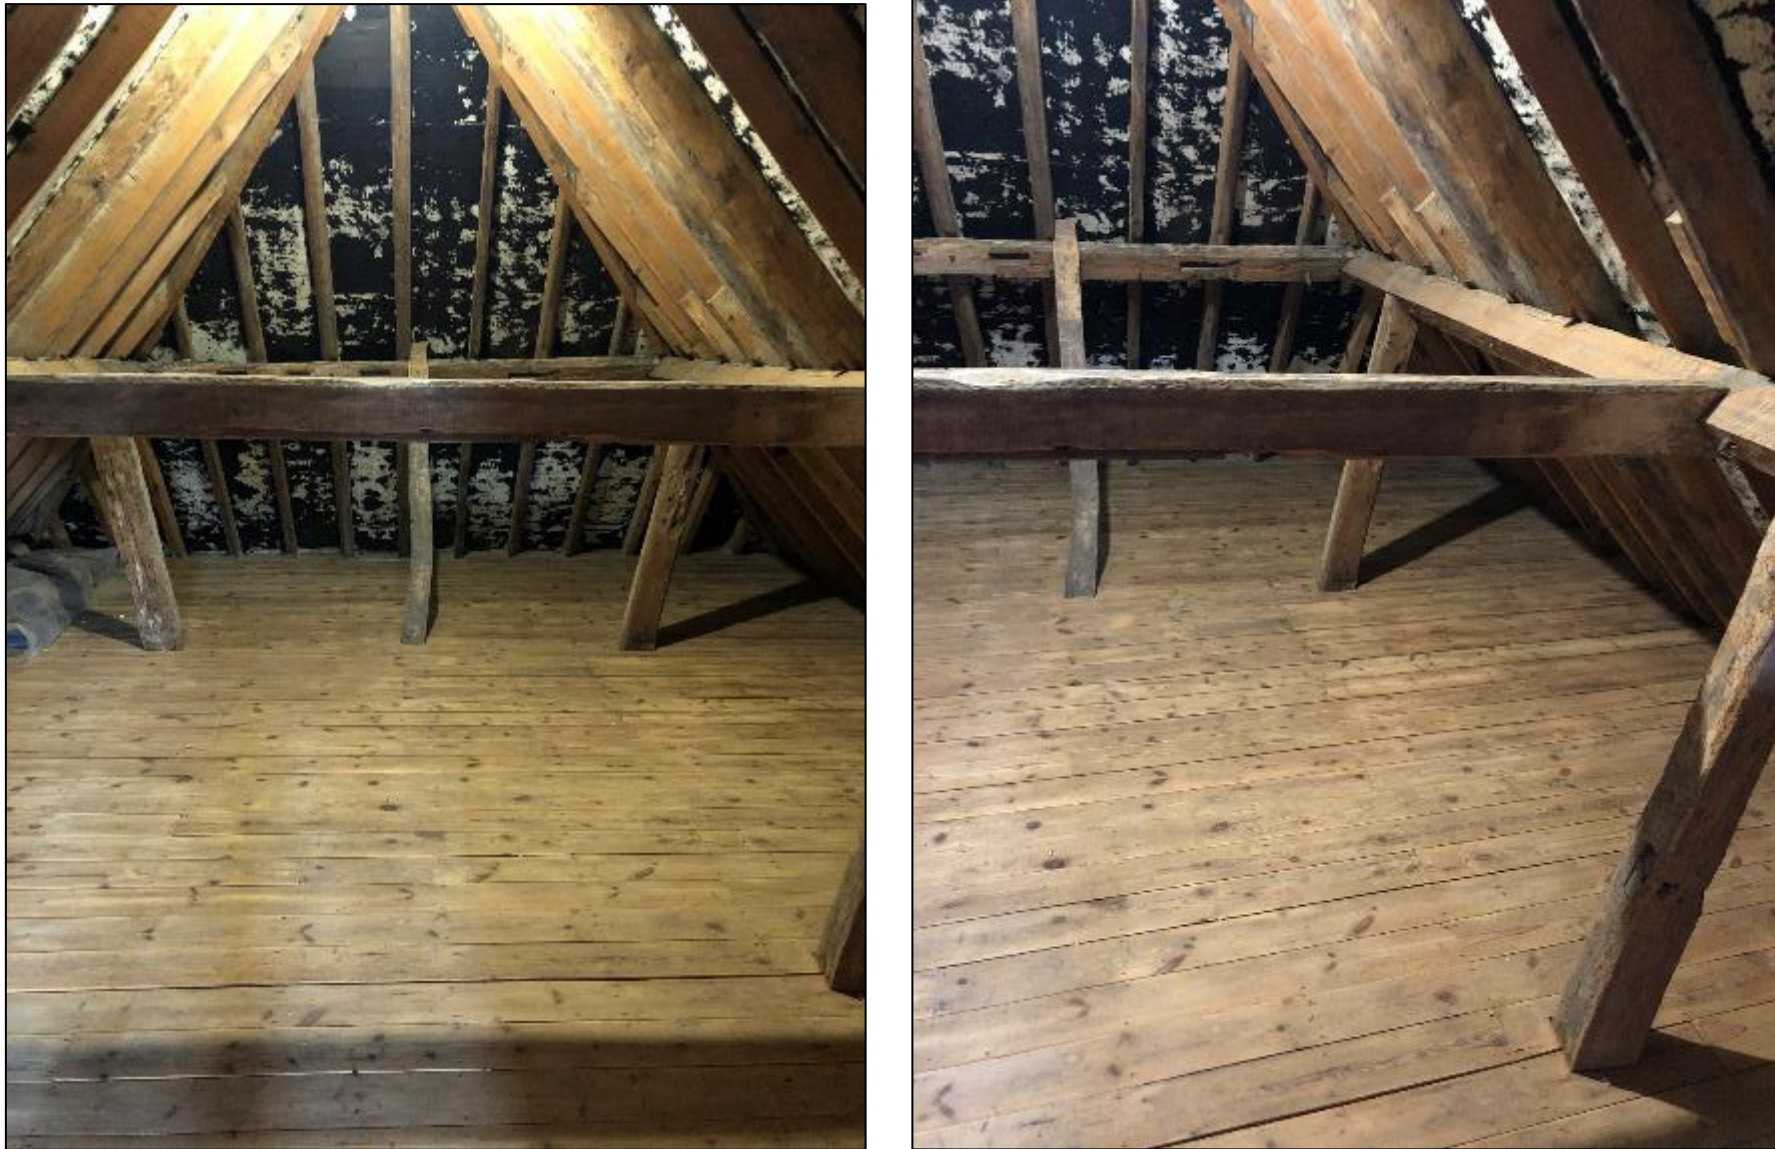
*Figure 50: View inside the southernmost gable along the east elevation- note that this has been extended in the 19<sup>th</sup> century*
