**Heritage Statement & Impact Assessment**

Old Grove House  
St Barnabas Road  
Reading  
RG4 8RA

July 2022

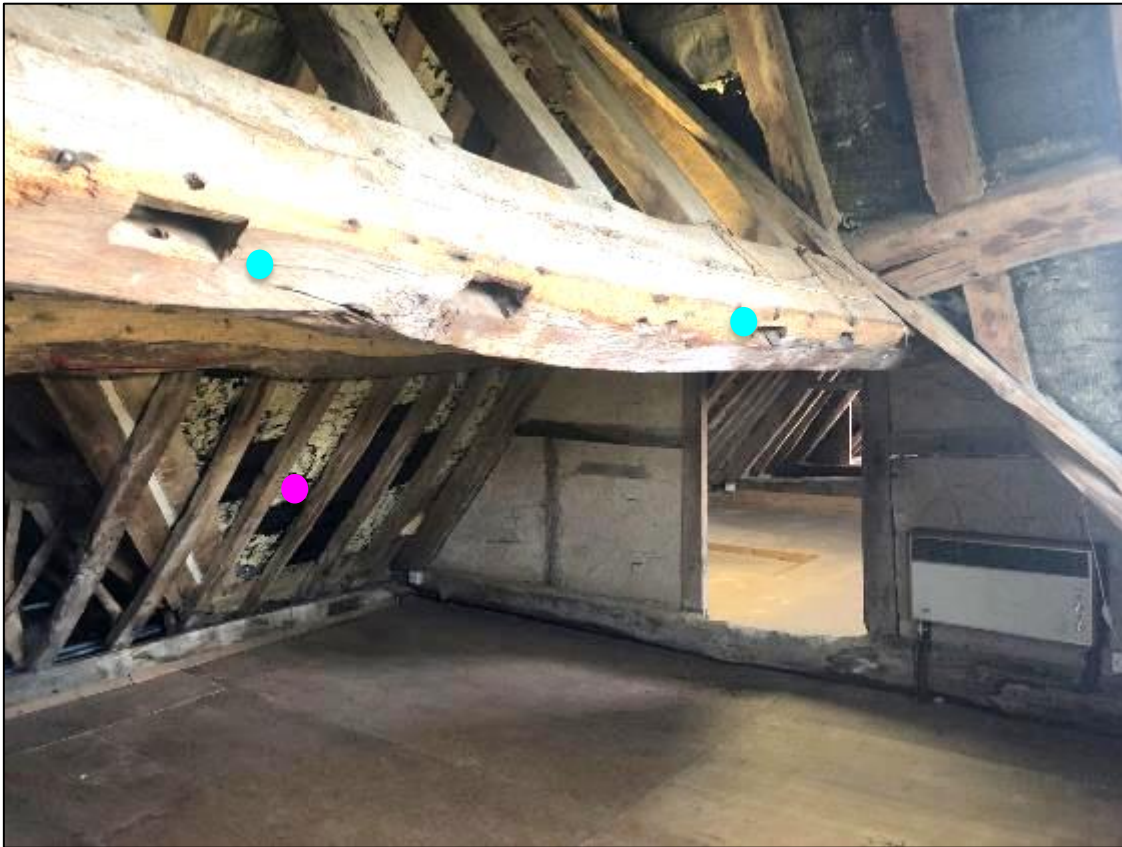
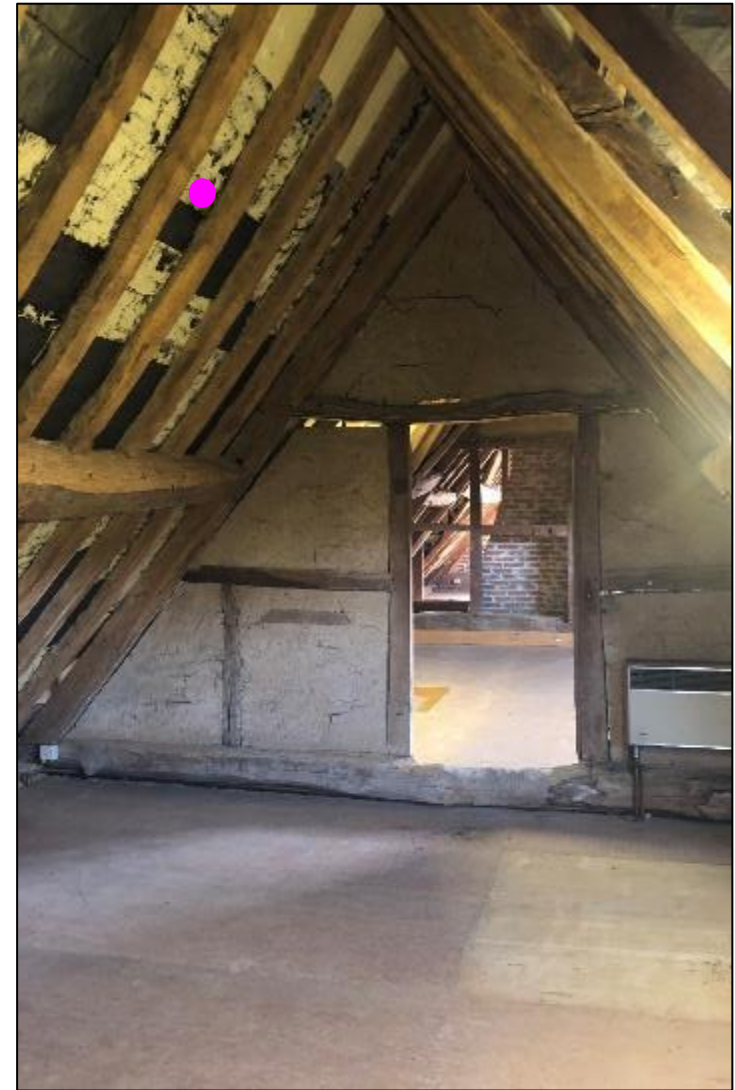
*Figure 51: View inside the internal roof void- note the historic plaster panels and 20<sup>th</sup> century sarking (highlighted in pink). The details highlighted in blue are evidence to suggest that parts of the timber frame (throughout the entire building-not just the attic) may have been reused from a different building*

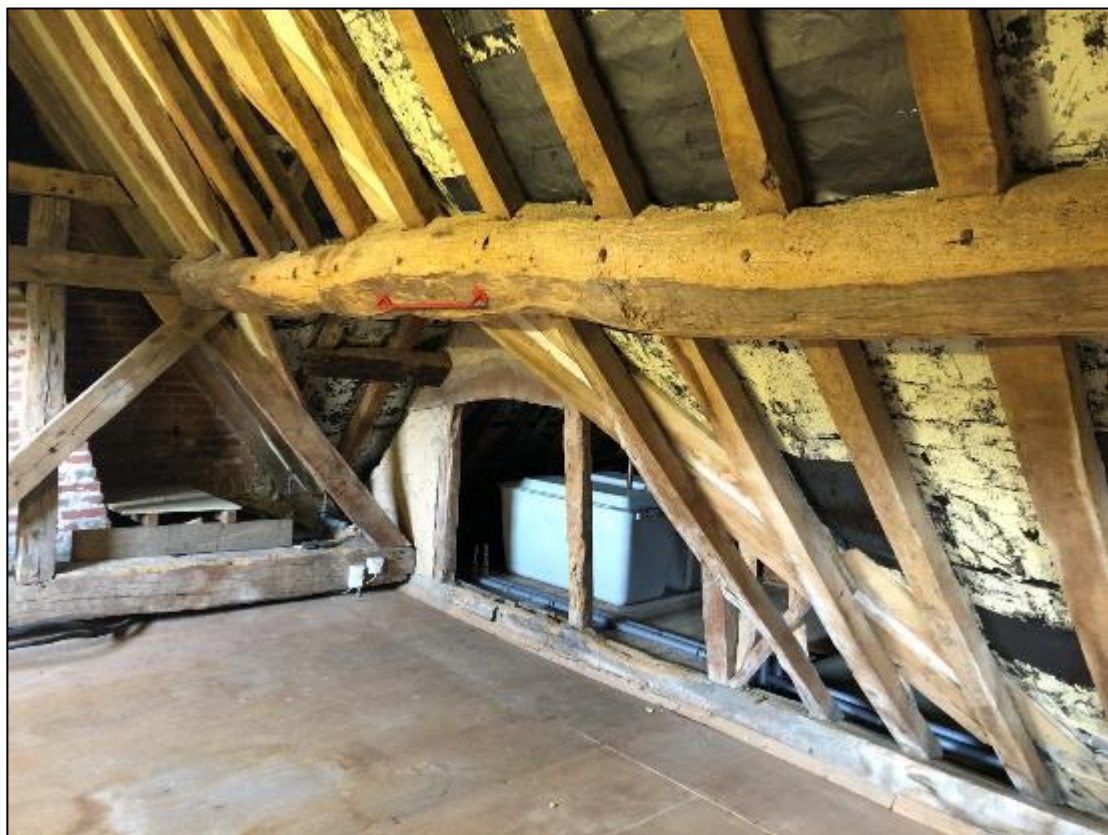
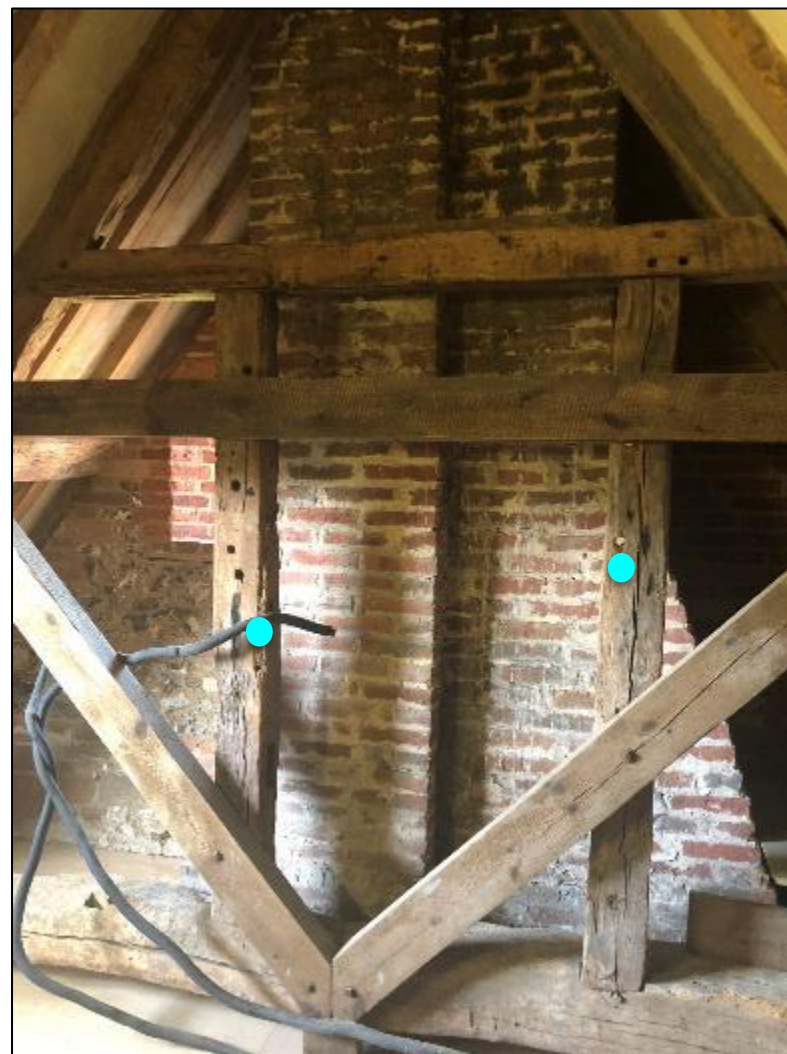
*Figure 52: View of internal attic space, (right) evidence of apotropaic marks (highlighted in blue)*

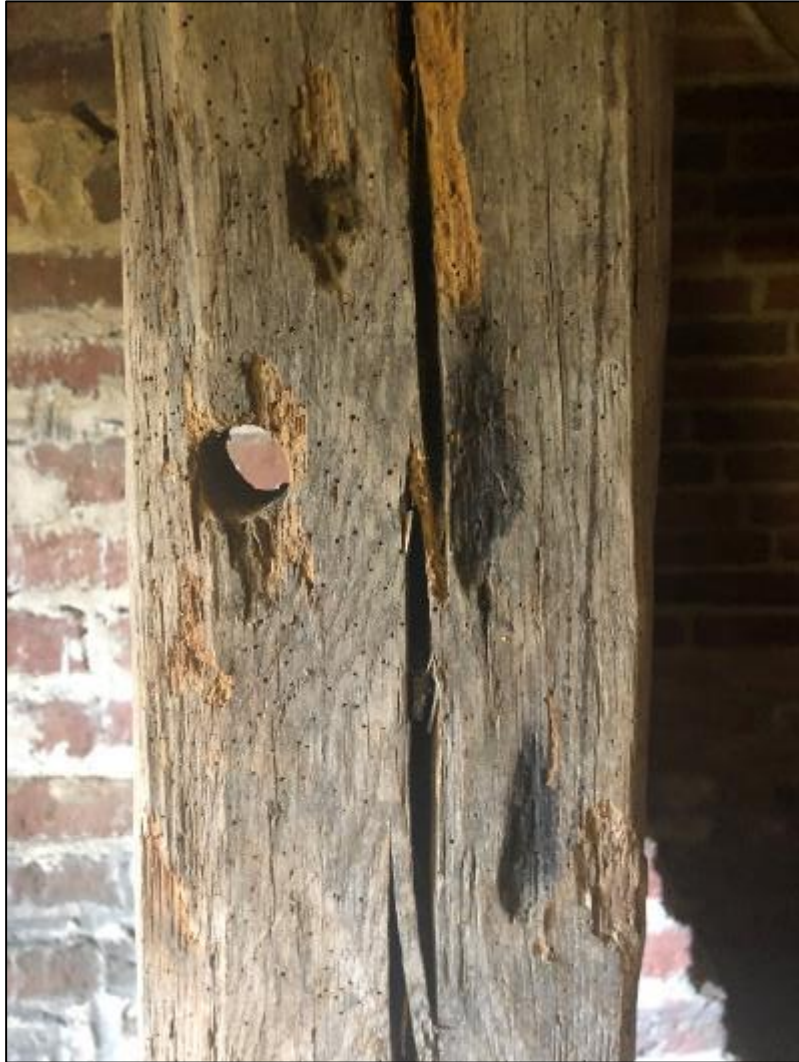
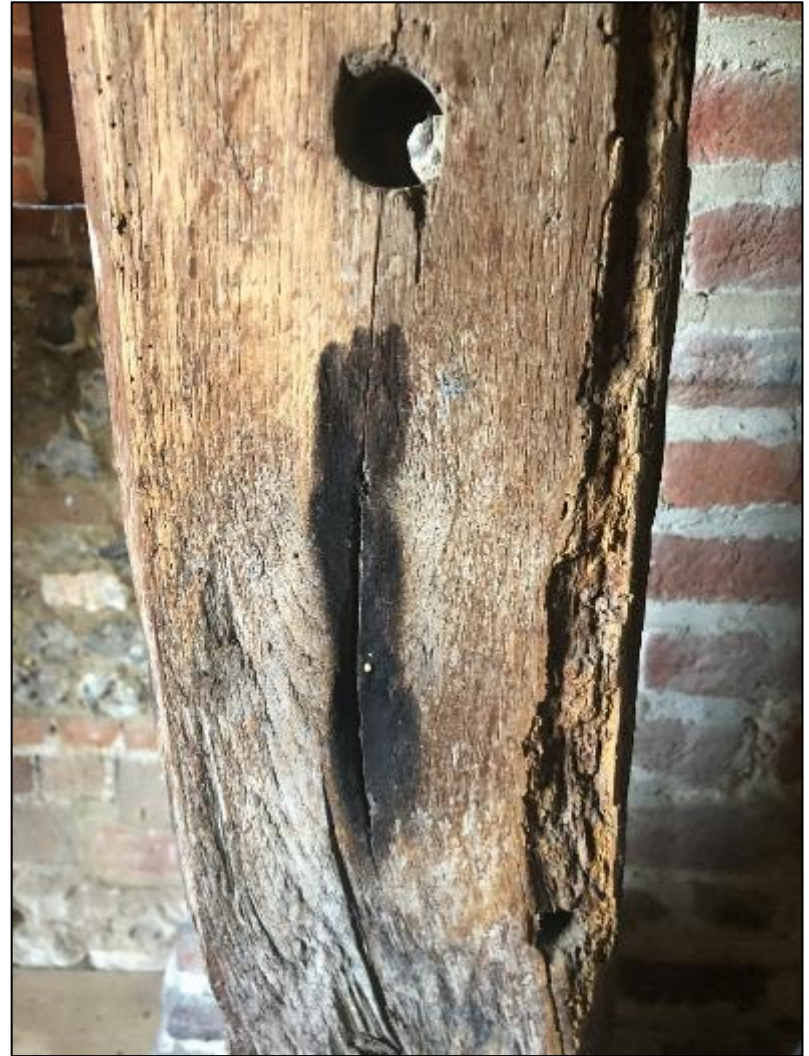
*Figure 53: Detail of the apotropaic marks identified above*

The most fascinating features of the attic however are the apotropaic burn marks found on the timbers closest to the two chimney breasts (**Figure 47 & Figure 53**). Apotropaic marks are most often inscribed on buildings. The markings are believed to have turned away evil, providing protection to the building and those who lived or worked within it. The evil that was being 'turned away' may have been demons, witches or the then ever present evil eye. These burn marks are commonly misinterpreted as accidental candle burns.

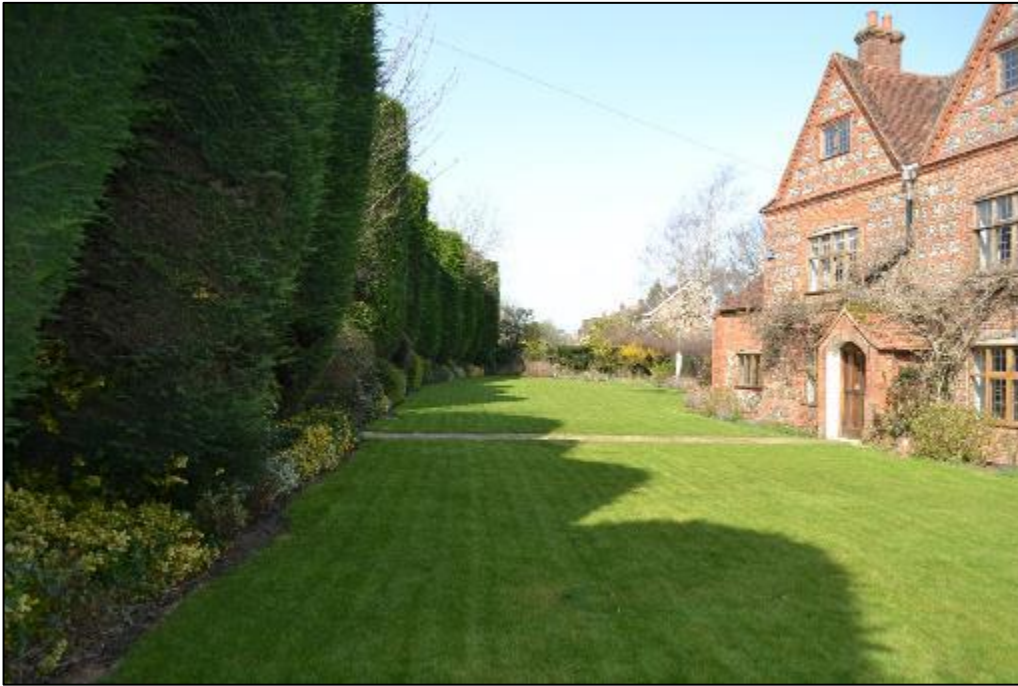
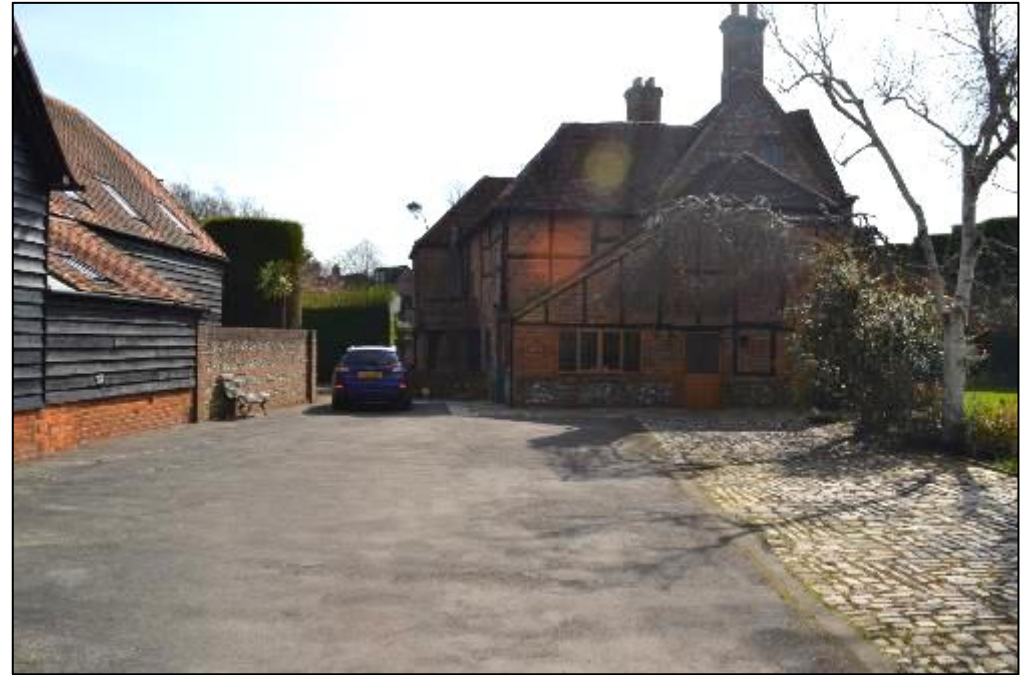
*Figure 54: (left) View looking northwards across the garden which is located to the west of the house, (right) view of northern elevation and driveway- historically an enclosed courtyard (see [OS Maps](#))*

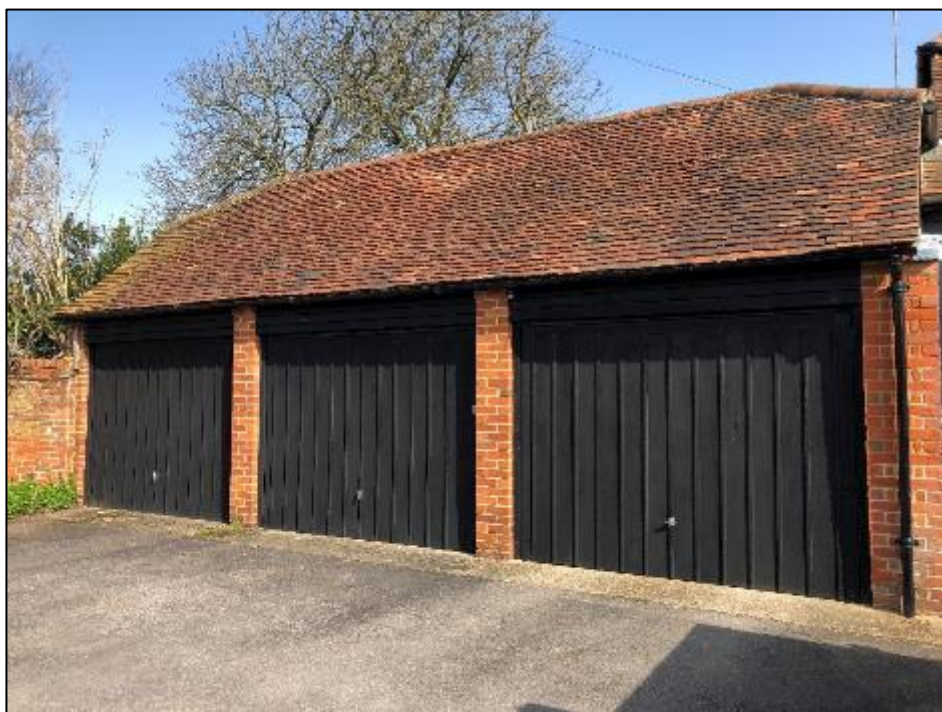
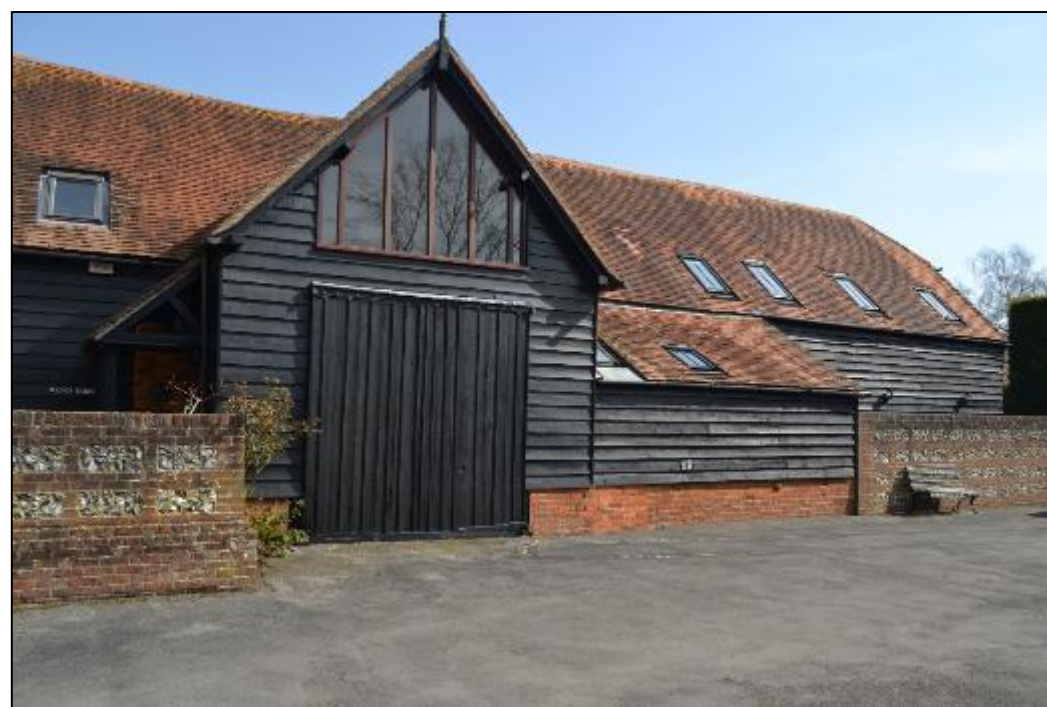
*Figure 55: (left) View of shared garage- 2 are owned by Old Grove House, (right) view of the 17<sup>th</sup> century Old Barn historically associated with Old Grove House, now in separate private ownership*
