# LEIGHTON PARK SCHOOL

## DEMOLITION AND REFURBISHMENT AT GROVE HOUSE

### BUILDING INSPECTION REPORT (PROTECTED SPECIES)

Document Ref: E22108001 Doc 01 – 28 February 2022

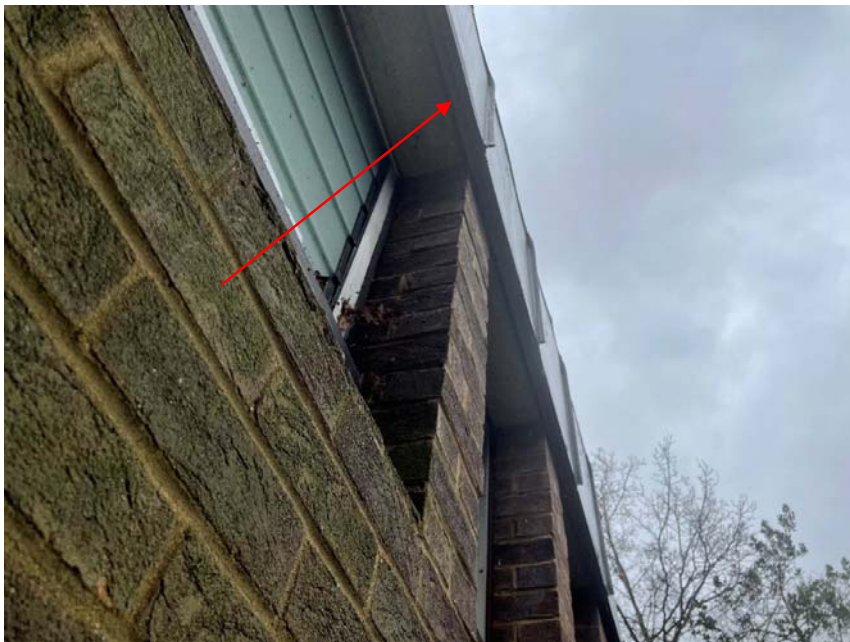
**Plate 1 Gap behind overhang of lead cladding, single storey Changing Rooms**

- 3.9 The internal check of the Changing Rooms in the north east of the site found no features suitable for use by birds or bats and no evidence of either group. The door and windows are all sound although a shallow gap was noted on both the eastern and northern elevation where the overhang of the lead cladding meets to brick/blockwork wall (Plate 1). No external evidence of bats was found on walls, windows or sills below this gap although occasional use during the active part of the year (April – October) by individual or small number of bats could not be ruled out. This gap was also present on the two storey structure in the north, fronting onto Pepper Lane. The features identified at the Changing Rooms, adjoining 2 storey extension and on the eastern gable end of Grove House were considered of **Low bat potential**, and further survey of these features would be recommended to inform the demolition/refurbishment works

- 5.2 The features associated with the Changing Rooms (proposed for demolition); adjoining two-storey structure (retained but lead cladding replaced/repared) and eastern gable end of Grove House (retained with internal refurbishment undertaken) were considered of Low bat potential and use by individual or small numbers of bats during the active season could not be precluded. Similarly, use by nesting birds (March – August) of the vertical openings at the eastern gable end of Grove House could not be ruled out on the basis of the current survey.

- Removal or repair of lead cladding to be undertaken using hand-held tools (crowbars, claw hammers etc.). Access for these works is likely to require use of scaffold and/or a Cherry picker;

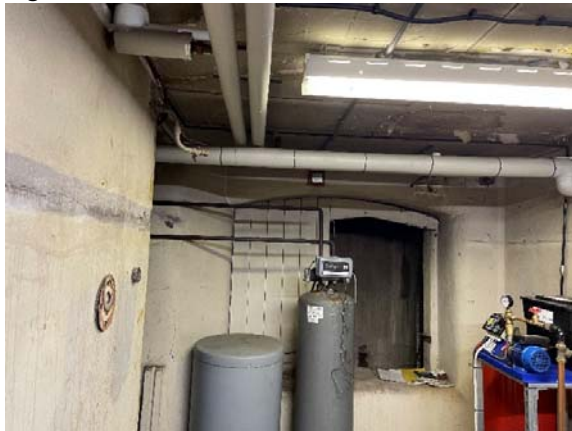
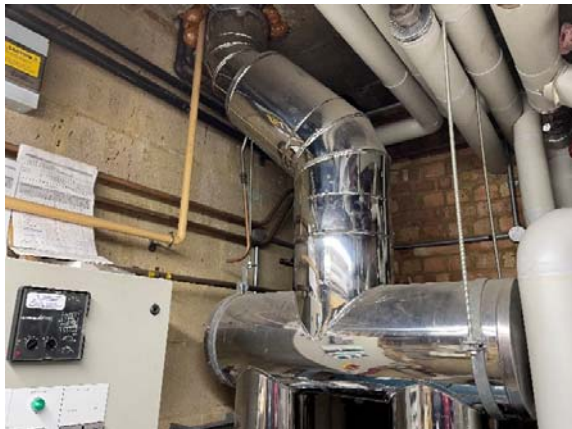
| Target Note | Description/comment |
|---|---|
| <p><b>Interior Rooms – Main Building</b></p> | <p>Internal inspection of ground floor and basement boiler rooms of main building. Both are accessed via locked, interior doors – no means of access from outside. No evidence of bats found in either location and no obvious light or draught ingress or means of access.</p> |

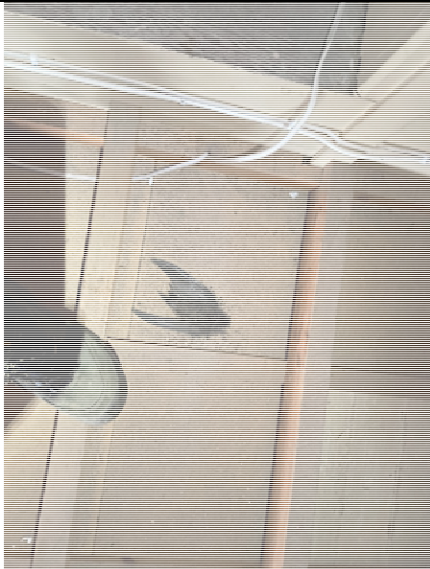
| Target Note | Description/comment |
|---|---|
| <p><b>Rood Void – Main building</b></p> | <p>Single accessible roof space present in eastern part of building – roof space oriented east/west. Accessed via first floor room which overlooks flat roofed structure to north east corner.</p> <p>Rood space has been partitioned with internal walls and papered ceiling such that it does not connect to any other roof space. Damage to ceiling in south east corner exposed the original roof space above with timber planks visible to underside of tiled roof – no direct access into this void.</p> |

| Target Note | Description/comment |
|---|---|
| | <div data-bbox="378 195 948 621" data-label="Image"> </div> <p data-bbox="378 657 1230 720">Accessible space is relatively light due to window in eastern gable end – this window is sound with glass intact.</p> <div data-bbox="378 720 948 1146" data-label="Image"> </div> <div data-bbox="378 1178 948 1604" data-label="Image"> </div> <p data-bbox="378 1640 1284 1799">Dead Swift found inside space which suggests window may have been left open (and been blown shut). Old bird splashing (droppings) also present to roof timbers alongside the window. No features in accessible space for use by bats and no evidence found. Similarly, no evidence on floors or walls below damaged section of ceiling.</p> |

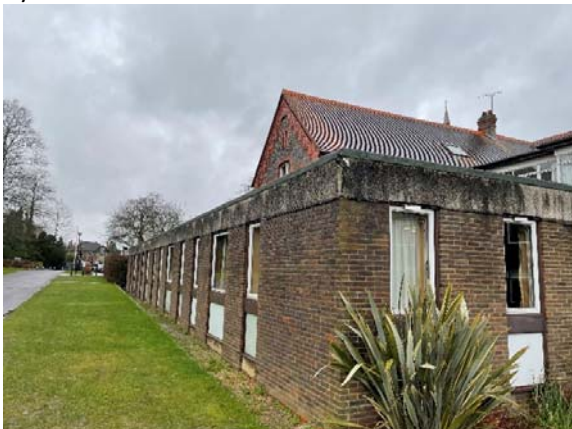
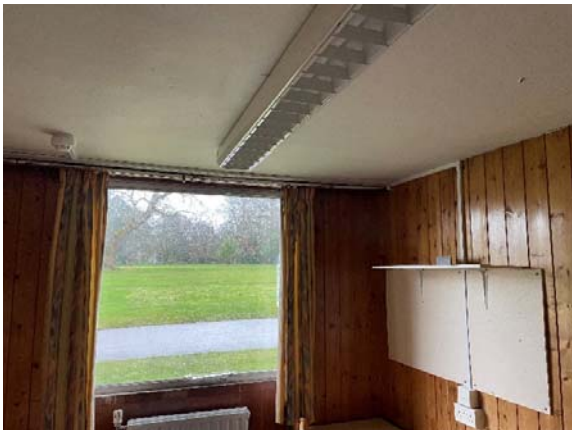
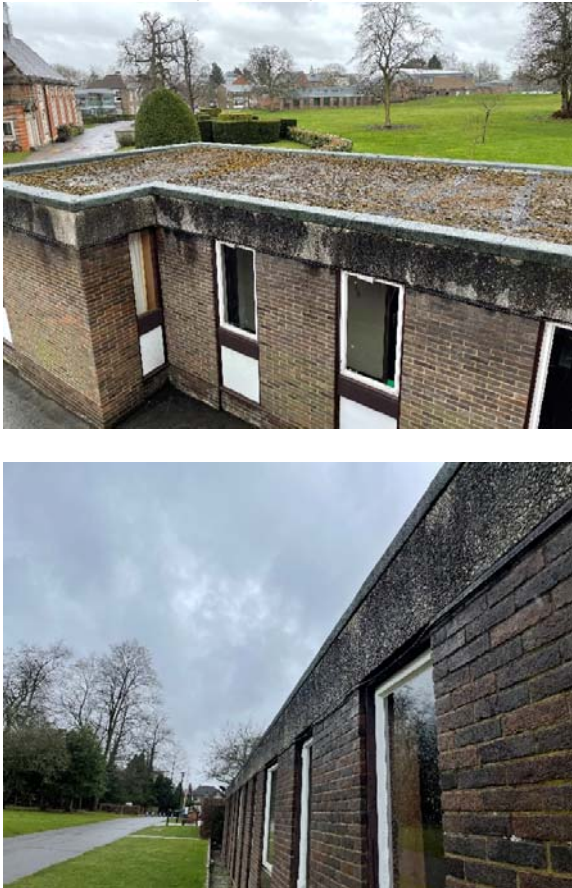
| Target Note | Description/comment |
|---|---|
| <p><b>Single Storey extension to south ('carbuncle')</b></p> | <p>Single storey brick with concrete roof plinth and flat felt roof. Doors and windows are all sound and no obvious means of access to interior noted. Building subdivided into a number of small exam rooms – no internal features suitable for use by bats and no evidence found.</p> <p>Felt roof as visible from fire escape of adjacent main building is sound as is felt</p> |

| Target Note | Description/comment |
|---|---|
| | <p data-bbox="380 201 1252 264">overlap to concrete roof plinth – no obvious gaps and no external evidence of bats noted on any window panes, sills or frames.</p> <p data-bbox="380 1182 756 1213"><b>Overall: Negligible Bat Potential.</b></p> |

- 5.1 The combination of desk study & site inspection surveys have established that there was no evidence of current or historical use by bats at any of the surveyed locations at Grove House. The flat roofed southern extension was considered of Negligible roost potential and similarly did not support features that could be used by nesting birds – no further surveys would be required for this structure prior to demolition.

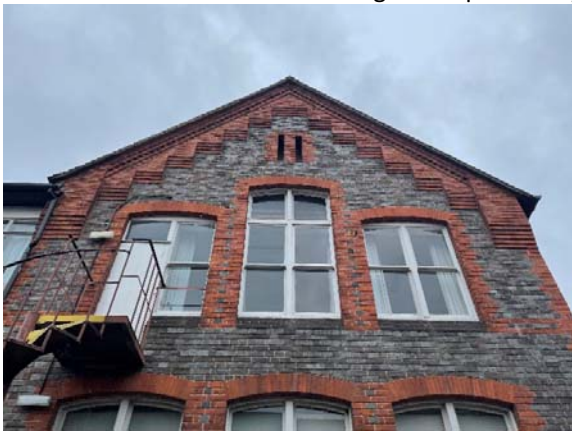
| Target Note | Description/comment |
|---|---|
| <b>Eastern Gable – main Building</b> | <p data-bbox="380 1251 1284 1381">Vertical brick-lined openings above window – not possible to establish if there is an opening or cavity at the top of the opening. No droppings (bird or bat) visible from ground level using binoculars. If top of the channel is ‘open’ would allow access into roof void above ceiling noted previously.</p> |

- 5.3 An application for the demolition and refurbishment works will be submitted to the local authority (Reading Borough Council) and, subject to planning approval, works are likely to commence from summer/autumn 2022. The current report would be sufficient to allow an application to be made and validated although further survey to establish the likely presence/absence of roosting bats would be recommended – the results of this survey would be needed to allow determination of an application. Best practice guidelines for structures of Low potential require a single emergence or re-entry survey and this could be achieved using a team of up to 3 surveyors at the eastern/north eastern elevation of the building. The optimal timing for this type of survey would be between May and August.

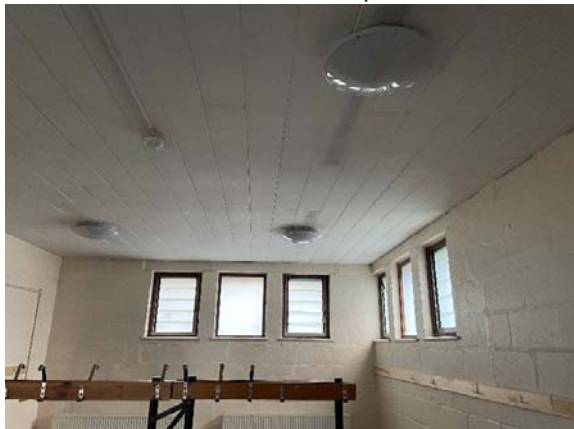
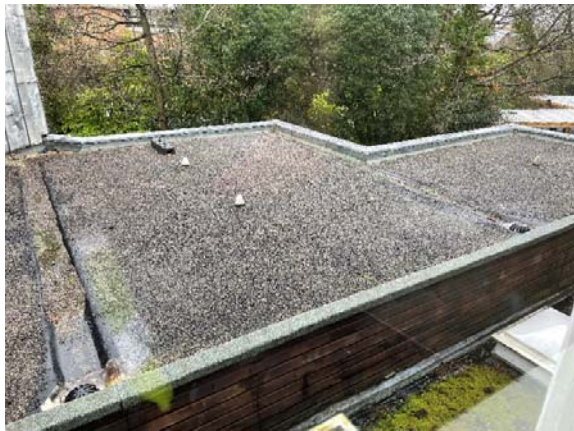
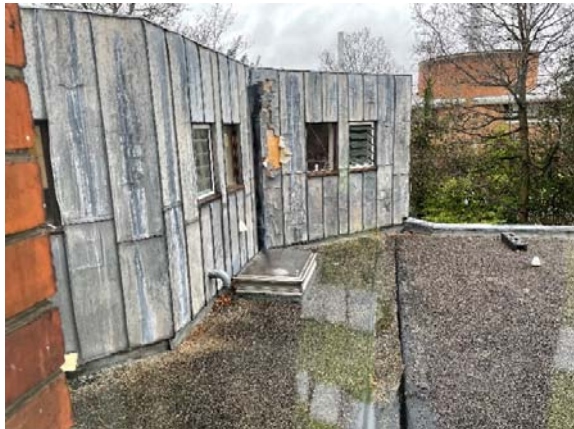
| Target Note | Description/comment |
|---|---|
| <b>Single storey</b> | Single storey extension to north east with door and windows all intact – several |

| Target Note | Description/comment |
|---|---|
| <p><b>building<br/>(Changing Rooms)</b></p> | <p>windows are slatted to allow ventilation of sports changing rooms – no internal evidence of bats or birds found (rooms are clean and in use).</p> <p>Flat roof and cladding to two -storey building visible from first floor or main building. Roof is generally sound (including timber cladding to lower level) and while lead cladding is peeling in places, no obvious features for bats identified.</p> <p>Covered porch to entrance door on eastern side is sound – no damage or gaps around plywood ceiling and no droppings/evidence of bats on floors, walls or door. Light fitting present – likely to limit any potential use by bats if this is on at</p> |

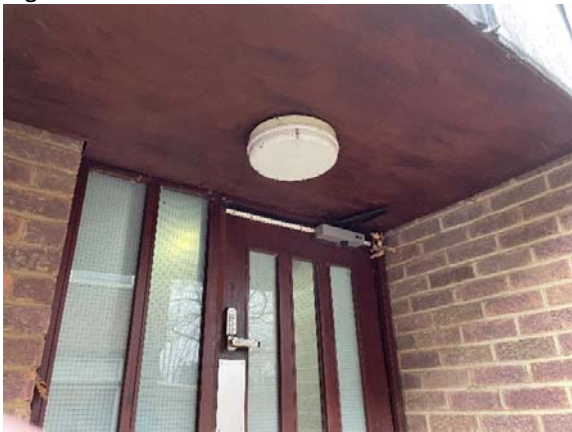
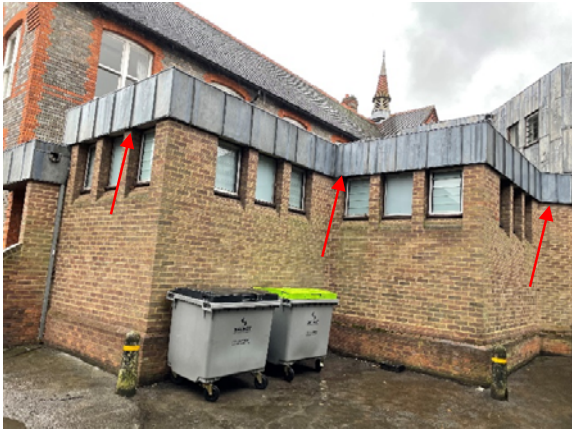
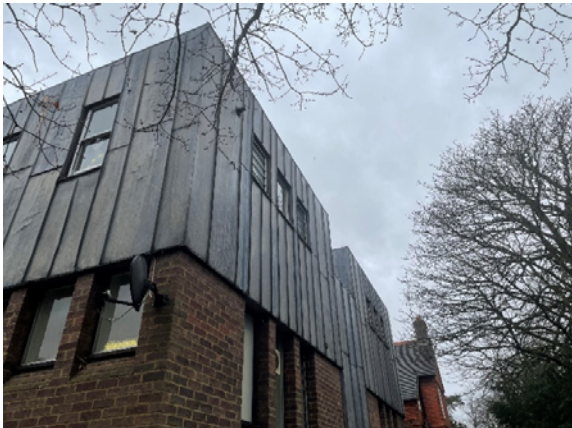
| Target Note | Description/comment |
|---|---|
| | <p data-bbox="380 201 448 231">night.</p> <p data-bbox="380 690 1273 821">Eastern and northern elevations of changing rooms with narrow gap behind the lead cladding where this overlaps with brick/blockwork wall – cavity approximately 20 – 30mm wide and to a height of ca. 100mm. No external evidence at any location on windows, walls or sills</p> <p data-bbox="380 1316 1273 1446">Two-storey, lead clad structure adjoining changing rooms to be retained but cladding likely to be removed/repaired. Gap behind overhang present at top of ground floor level as noted for Changing Rooms. No external evidence of bats noted.</p> |

| Target Note | Description/comment |
|---|---|
| | <p><i>North eastern extension and eastern gable of Main Building</i> - No external or internal evidence of bats was found although features identified offer possible access and could support use on an occasional/irregular basis by individual or small numbers of bats during the active period of the year (April – Sept). Site is located in residential area but with scattered trees within the school grounds and tree/scrub corridors to north and west providing local habitat connectivity.</p> <p><b><i>Overall these parts of the building were considered to be of Low potential.</i></b></p> |

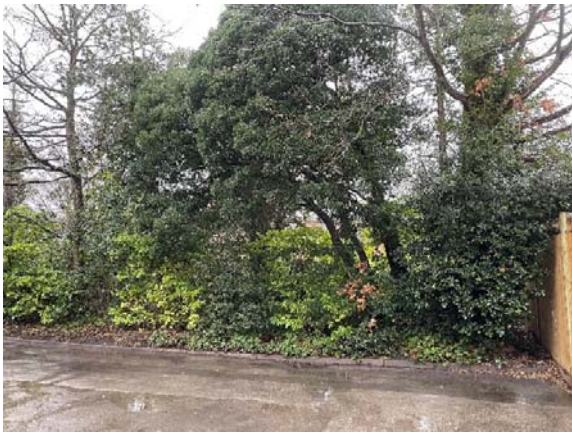
| Target Note | Description/comment |
|---|---|
| <p><b>Trees and Scrub to Pepper Lane</b></p> | <p>Linear belt of trees and scrub along Pepper Lane – likely to be used as corridor for movement by bats or birds in immediate local area.</p> |
