**2-4 Kings Road, Reading, Berkshire, RG1 3AA- Roost Assessment.**

EHM Ltd has been commissioned to carry out a preliminary bat roost assessment at a property; 2-4 Kings Road in Reading RG1 3AA. This letter report will provide an assessment of the buildings on site potential to support a bat roost.

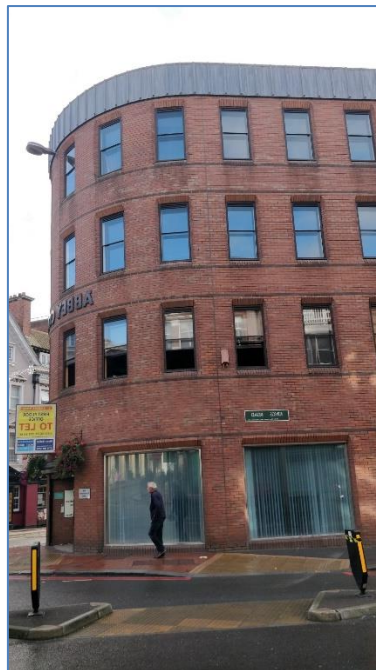
The site contains a large red brick building over 4 levels (photo 1). The building is currently being converted into residential flats and had formerly been granted permission to demolish the plant room at the top, but due to changes in the planning application a bat assessment was then requested.

The site is in a highly built up area near the centre of Reading (grid ref SU717733) and sits on the corner of Kings Road and High Street. The roof area is mostly flat, however there is a large circular plant room due for demolition, with a pitched tiled roof. For the most part the structure and tiles are in good, well-maintained condition. Internally the roof is lined with a thick layer of fibreglass, which is covered in a layer of plastic sheeting. This plant room is currently being used as storage and is in daily use during the construction works. Therefore it is highly disturbed by noise and light.

**Photo 1:** Exterior of the main building

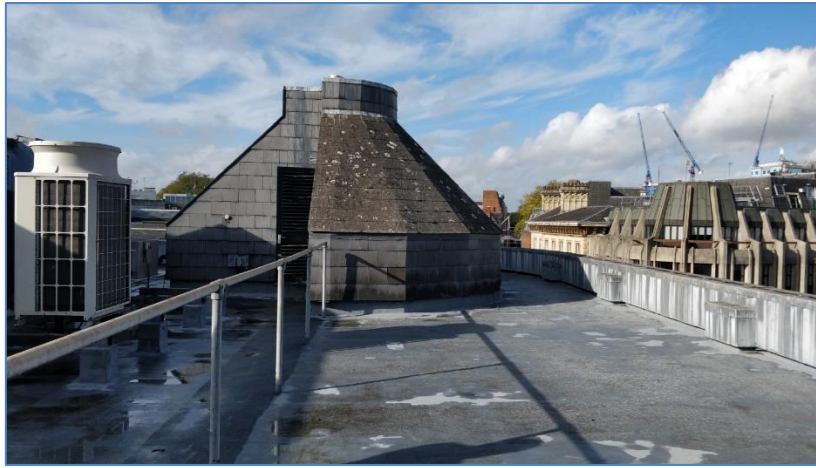
An external and internal inspection was carried out searching for any potential crevices or gaps that might provide a roosting opportunity. This was an Oval shaped building with a section cut into it where the entrance door is for the plant room (Photo 2). The sides are covered in tiles, as is the pitched roof. The tiles were all in good condition and tight to each other except above the doorway where there was a single missing tile (Photo 3). This feature did not appear to provide a suitable roost feature and there was no evidence of bats.

**Photo 2:** Exterior of the plant room on flat roof of main building

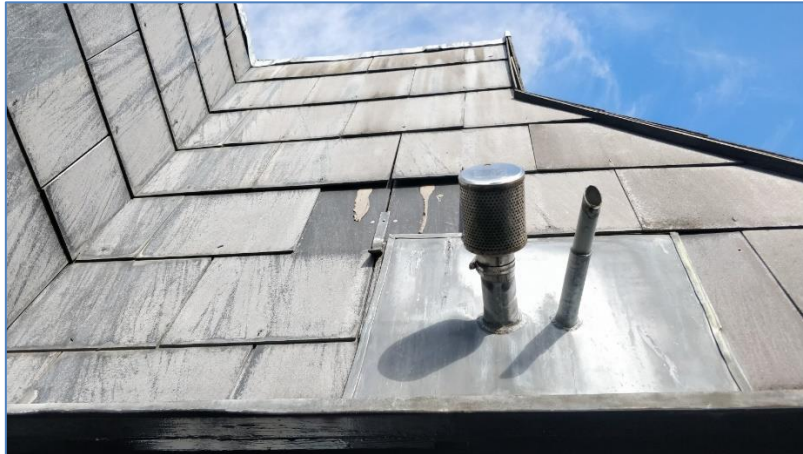
**Photo 3:** Possible feature above door investigated and found not to be a likely roost site

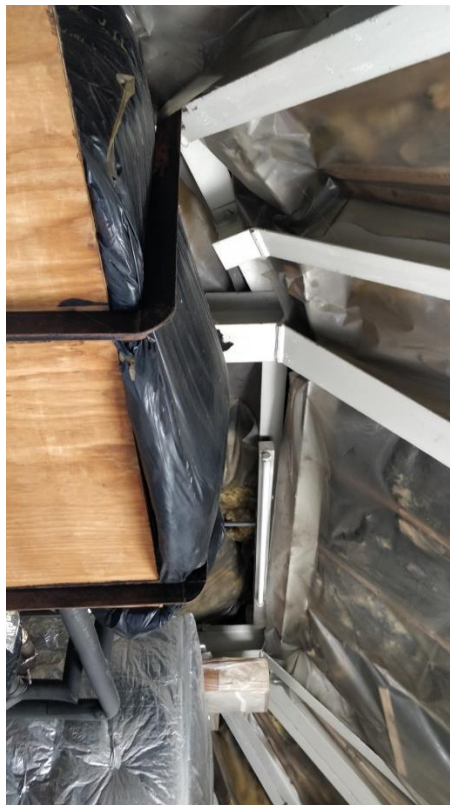
**Photo 4:** Interior of plant room

The interior of the plant room did not contain any evidence of bats. There were no potential entry points into the interior with dense insulation backing the exterior tiles (photo 4). Plastic sheeting was also located over the insulation.
