## 16 Tower Close, Emmer Green, RG4 8UU

### Preliminary Bat Roost Assessment

June 2022

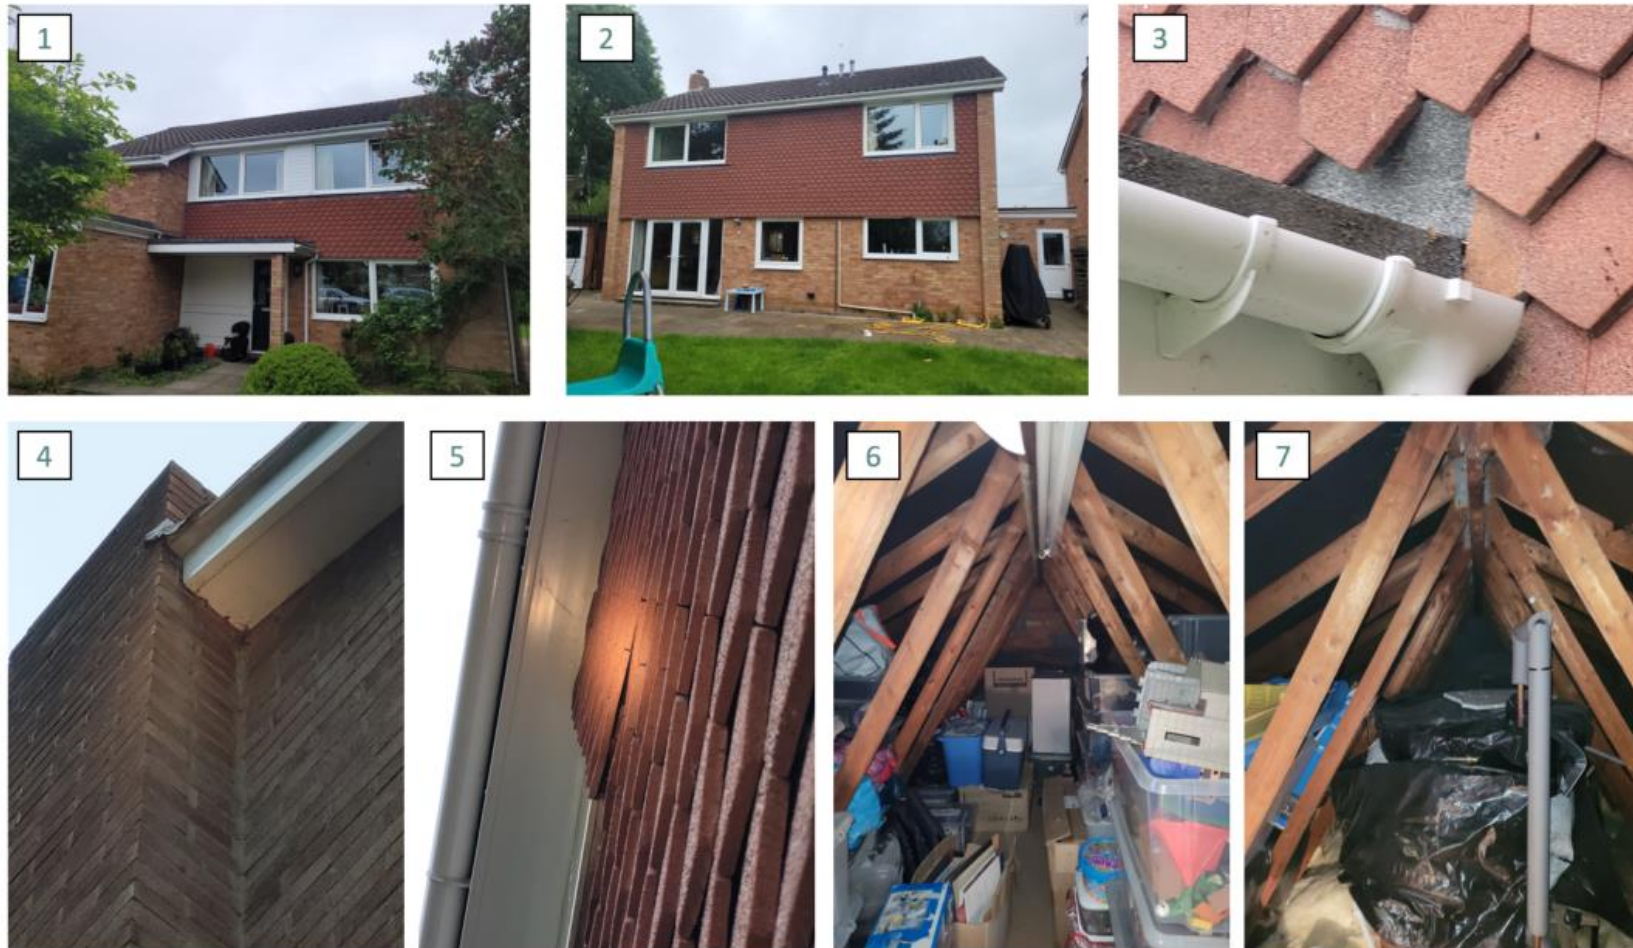
Figure 3: Photos of the site

This is a red brick and brown concrete tiled house with red hanging tiles present on the entire rear elevation with a smaller area on the front of the property. The soffits were replaced five years ago and are tight in general, however gaps were noted where the soffits meet the chimney breast on the eastern gable end. The lead flashing on the chimney has raised at this gable end also. The roof and ridge tiles are tight. A handful of hanging tiles on the rear of the house have cobweb free gaps.

Loft: This is lined with bitumen and partially boarded on the floor, the un-boarded areas have rockwool insulation. There are some tears in the bitumen lining and therefore some light ingress was noted. The space is entirely filled with storage (to apex) with modern truss making the space very

cramped. Some cobweb shrouding was noted throughout, but the space is used frequently by the homeowners.

Evidence: None found.

1: Front view of the house. 2: Rear view of the house. 3: Example of a gap under the hanging tiles. 4: Gap where soffit meets the chimney  
5: More gaps at the hanging tiles 6: Loft view facing east 7: Loft view facing west

No evidence of bats was found at 16 Tower Close, Emmer Green. However, there are hanging tiles present on both the rear and front of the house, many of which have lifted in places, revealing cobweb-free gaps. The lead flashing around the chimney has also lifted, and there are some gaps between the chimney and soffits providing potential crawl space for bats to utilise space between the tiles and wall beneath and within the soffits themselves.

Following standard guidance (see appendix 1), the building should be subjected to further scrutiny, therefore a single bat activity survey is recommended on 16 Tower Close between May – September (inclusive). This will enable surveyors to determine if bats are using the buildings and if so, the species, nature, and character of the roosts present. Should roosting bats be observed then two further activity surveys will be required to provide information on the size and nature of the roosts present to help inform a European Protected Species license or Bat Mitigation Class license application (if required) prior to any development works being undertaken. Three surveyors, augmented with thermal and/or infra-red cameras will be required to adequately observe all aspects of the building for each activity survey required.
