**Residential Refurbishment & Alterations**

**Carlisle House,  
118 Oxford Road,  
Reading  
RG1 7NG**

**Design, Access & Heritage  
Statement**

**18009.9.1\_22.07.29\_DAS**

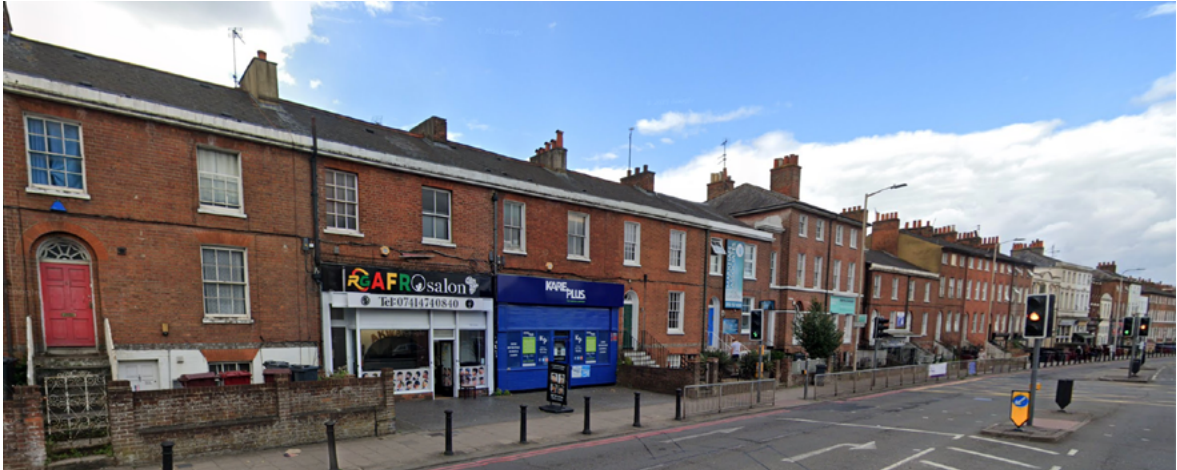
Fig.4: View of Oxford Road's Georgian Terraces to the South of the site

The character of Oxford Road adjacent to the application site is generally defined by the Georgian and Victorian terraced buildings containing a mix of uses often with commercial active frontages at street level. The character of the site is very different with significant 50-metre and 11-metre building setback away from Oxford Road and Trinity Place respectively. The spacious southern and eastern portions of the site provide the existing green shared amenity space which is proposed to be enhanced with a high-quality, more formal landscaped garden appropriate to the grandeur of the listed building.

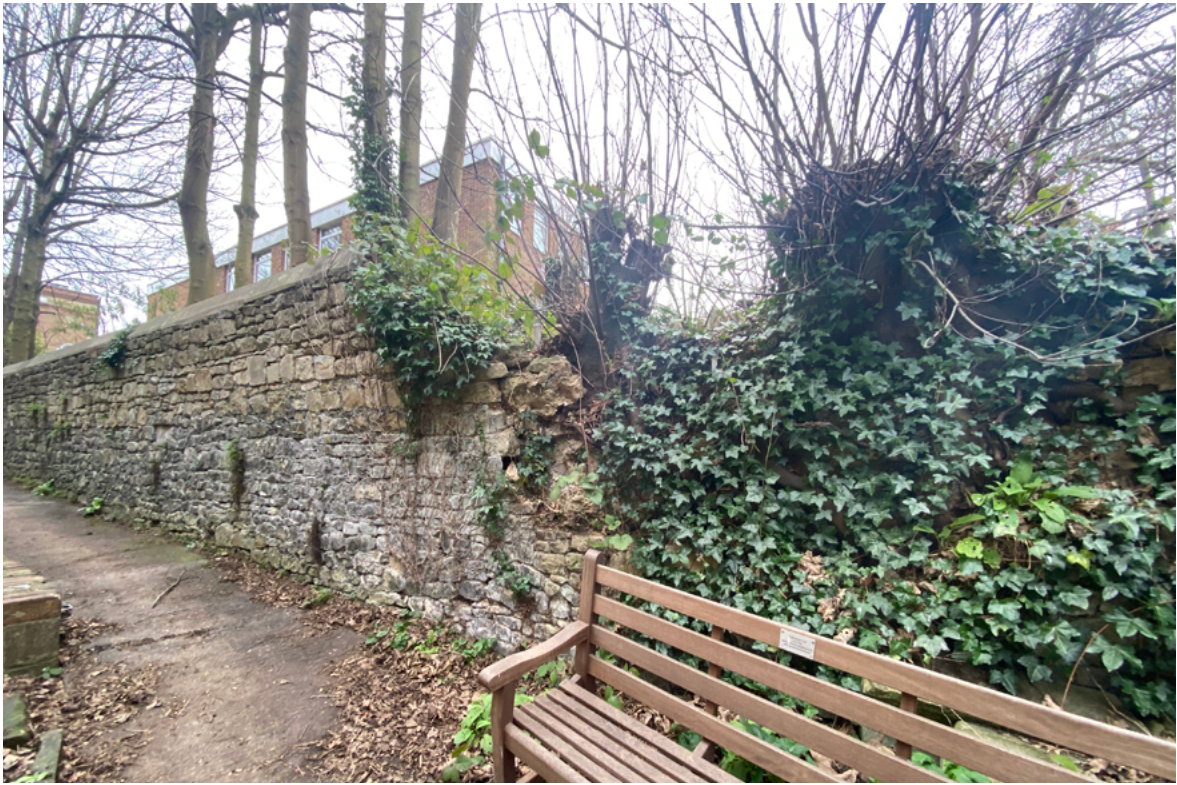
Fig.5: View of self-seeded sycamore trees causing partial collapse to boundary retaining wall

The grade II listed Church of the Holy Trinity is located to the south east of Carlisle House on the neighbouring plot, fronting onto Oxford Road. The majority of the shared boundary in this location is defined by a stone retaining wall creating the ramped access from the church's Oxford Road frontage down to the crypt beneath the church. Along the retaining wall boundary within the Carlisle House site are located several self-seeded sycamore trees which have been allowed to grow un-restrained and are now causing significant damage to the retaining boundary wall between the two listed buildings. These large sycamore trees, when in leaf, also block out very significant amounts of daylight to the south and east facing rooms at Carlisle House. As part of the application, it is proposed for the sycamore trees to be removed and replaced with other more appropriate tree planting on the site.

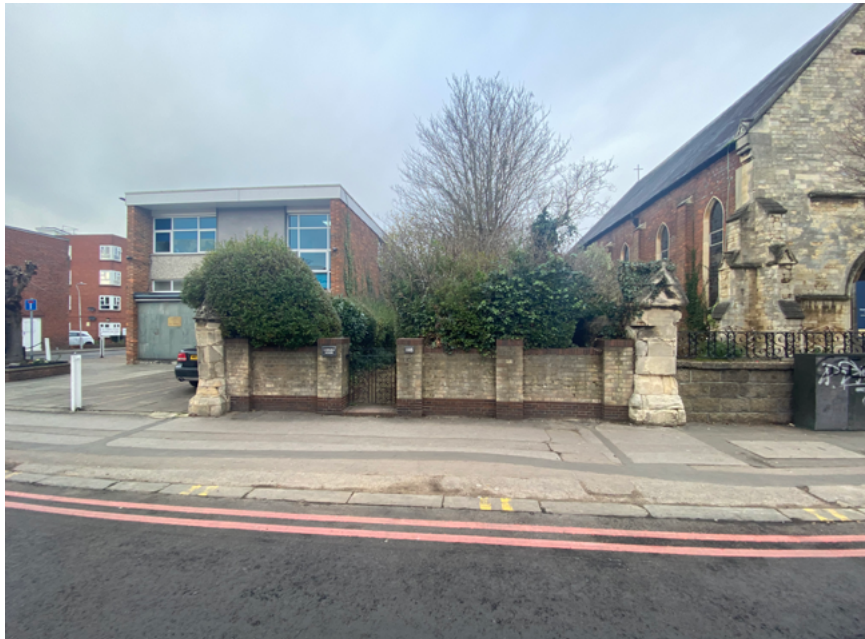
Fig.6: View of Carlisle House Oxford Road frontage between the Oddfellows Hall (L) and Holy Trinity Church (R)

The neighbouring plot which cuts into the south western corner of the application site accommodates the modern Oddfellows Hall building which houses the Reading branch of the Oddfellows community support charity. In between the Oddfellows Hall and Holy Trinity Church plots is located the 7.5-metre-long Oxford Road street frontage of the Carlisle House site which offers pedestrian and cycle access. The current brickwork and steel railed gate boundary treatment is not original and is proposed to be replaced as part of the application with a higher quality solution more congruous with the status of Carlisle House.

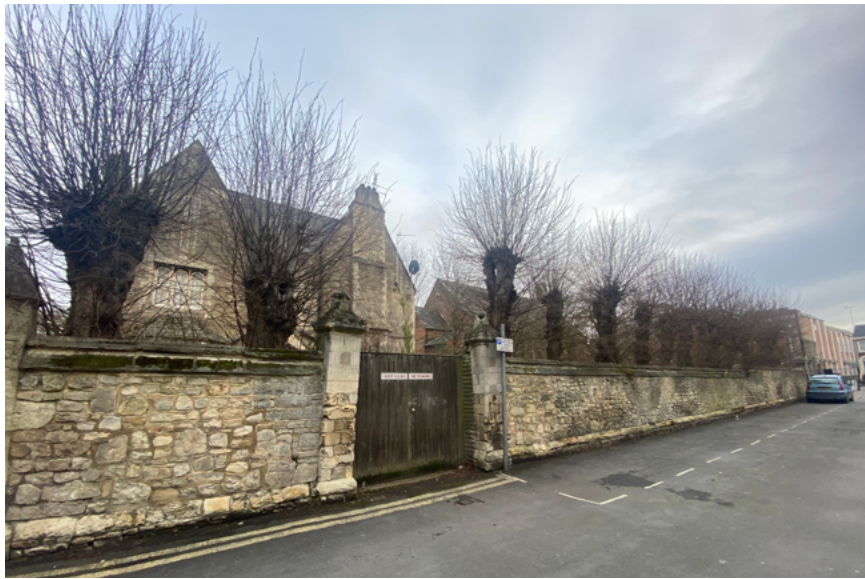
Fig.7: View of western boundary with Trinity Place and vehicle access gates which are to be replaced.

The existing vehicle access to the application site is located within the western boundary providing access directly to the resident's car parking area. Along the western boundary with Trinity Place there are regular pollarded Lime trees within the site abutting the attractive original stone boundary wall. The existing vehicle access gates are of relatively poor quality and are proposed to be replaced with a more appropriate solution.

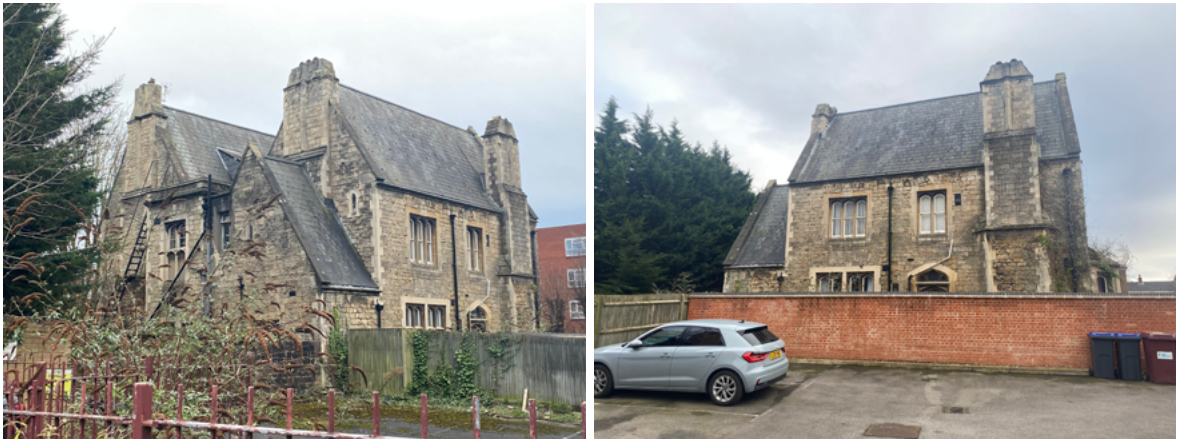
Fig.8-9: View of Carlisle House from the north east (L) and the north (R), illustrating the inherently awkward relationship between the listed building and it's north and eastern boundaries.

Due to an historic significant reduction to the Carlisle House plot size to the north and east there are only small building set-backs from the boundaries ranging between 2 and 5 metres. There are modern housing blocks located to the west and north west of the site, car parking to the north, a dilapidated and vacant office building to the north east and night club building located to the east.

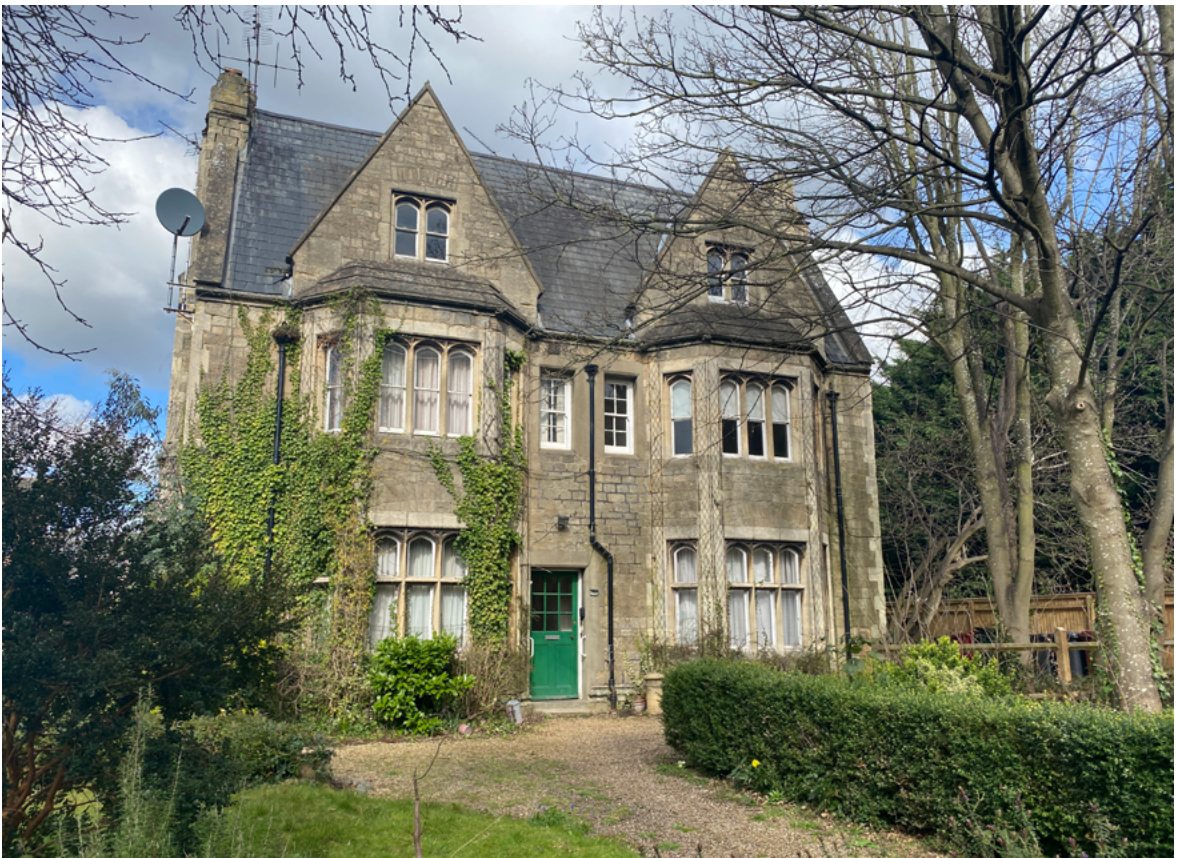
Fig.12: View of south elevation with non-original central entrance door and windows

Carlisle House itself was originally built as a grand house for the clergy serving Trinity Church in the Victorian era which was then subsequently subdivided into 4no. flats during the 1930s. The change of use to separate flats fundamentally altered the internal layout principle and was not carried out in a sensitive manner resulting in fairly significant harm to the appearance and arrangement of the building. Additional information describing the historic and current arrangement of the site and building is provided within the Heritage and Layout sections of this statement. Additional clarifications describing how improvements to the site and building are proposed are provided within the Layout, Appearance and Landscaping sections of this statement.

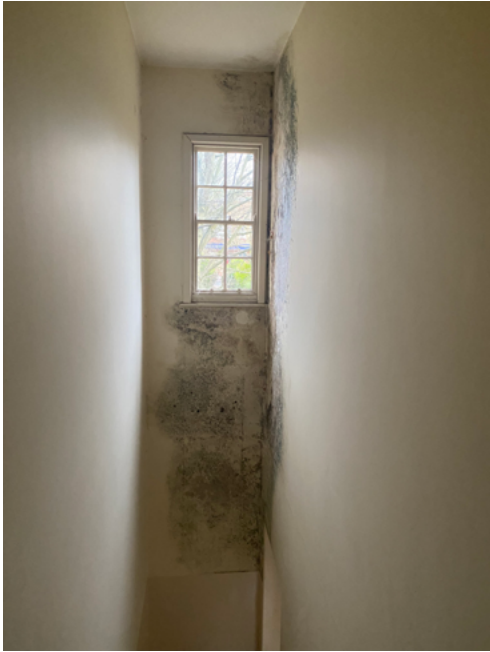
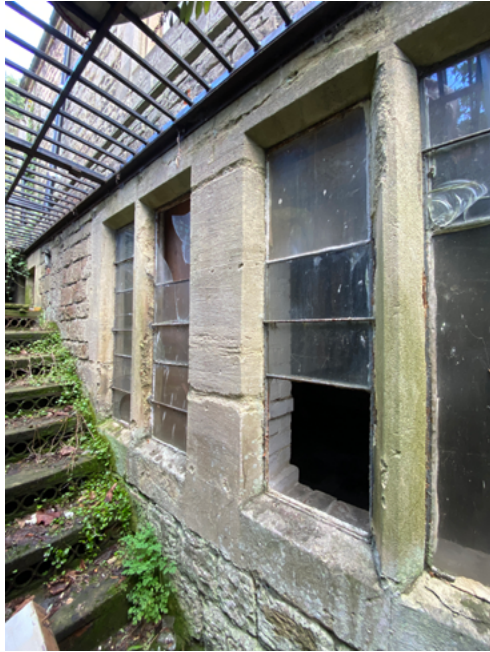
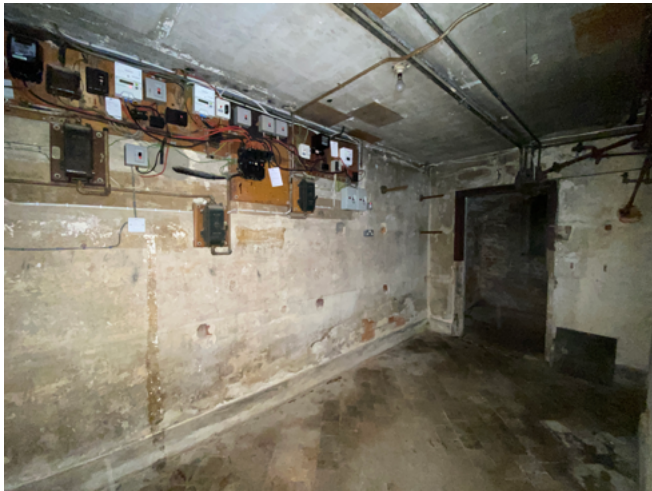
Fig. 13-15: Photographs of building dilapidations

- Significant electrical safety issues which require all electrical wiring installation to be replaced
- No central heating to the flats
- Significant damp issues
- Structural issues particularly relating to the ground floor

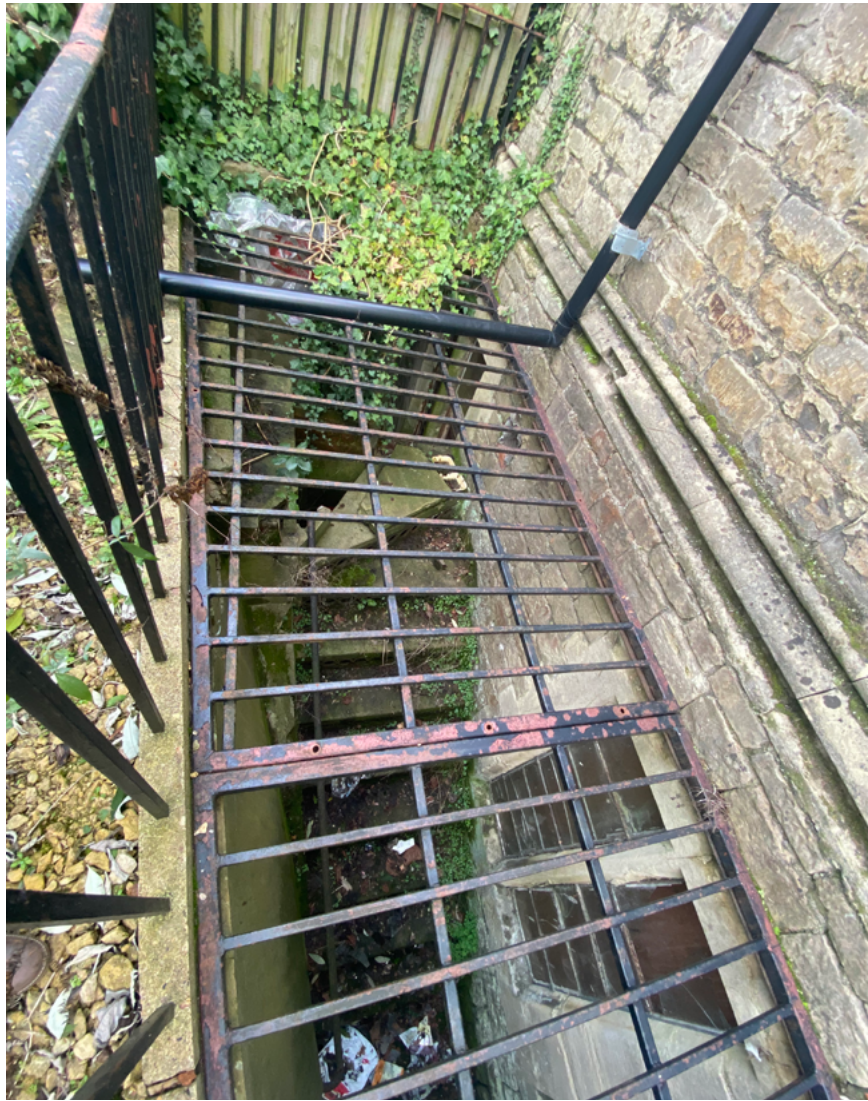
Fig. 17: Photograph of stepped access lightwell owned by Reading Borough Council

We consider that this situation has arisen due to a possible historic conveyancing error when land to the north of Carlisle House has been carved-up and sold for development. The Applicant seeks to use this planning application to enable discussion with the relevant Reading Borough Council department in order to better resolve this issue and return this small isolated parcel of land to the Carlisle House ownership Title.
