## 23 Kidmore Road, Caversham RG4 7LR

### Preliminary Bat Roost Assessment

September 2021

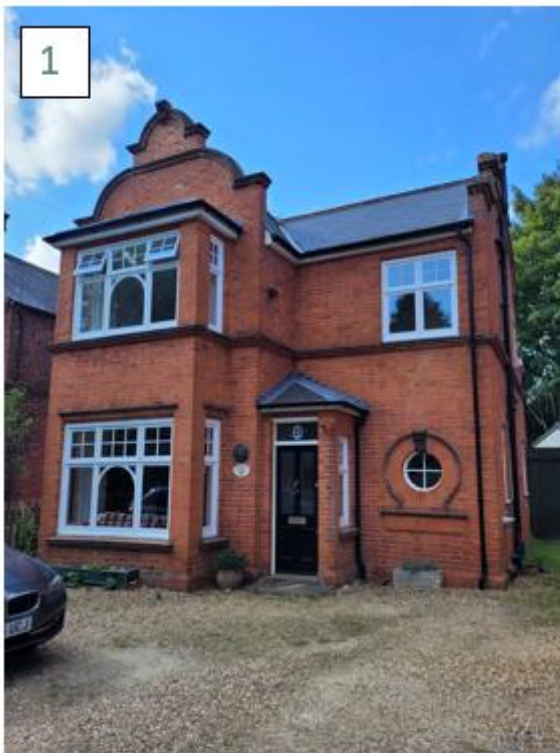
This is a three-storey residential dwelling built with red brick walls and grey slate tiles. There are parapet ends on the front and side gables. There is a single storey mono-pitch rear extension.

The brickwork, window frames and plastic soffits are tight. The roof and ridge tiles are tight as the building was re-roofed around five years ago. A few slipped tiles were noted on the mono-pitch rear extension. Gaps were noted in the walls, but the house is single skin with no internal cavity.

1: Front view of the house. 2: Rear view of the house. 3: Garage. 4: View of the roof and ridgeline from a skylight window in the previously converted loft.

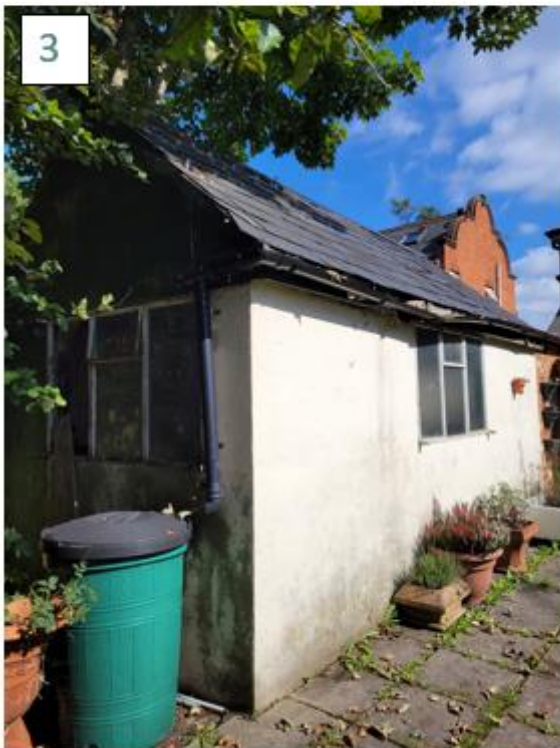
This is a small garage with grey slate roof tiles. Both the ridge and roof tiles have slipped. There is wooden shiplap on the western gable end, but this was covered in cobwebs

**Trigger Index: 0.46 Negligible**

However, it is recommended that the rear extension roof and the detached garage of 23 Kidmore Road is soft stripped prior to full demolition to ensure in the unlikely event bats are present they are not harmed.

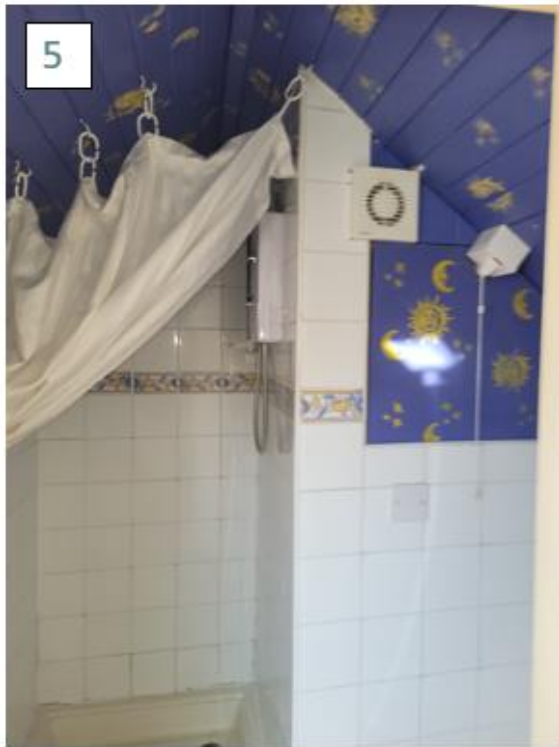
5: Internal view of the shower room in the converted loft. 6: Internal view of the converted loft.  
7: Internal view of the eaves storage space showing second access door. 8: Internal view of detached garage.

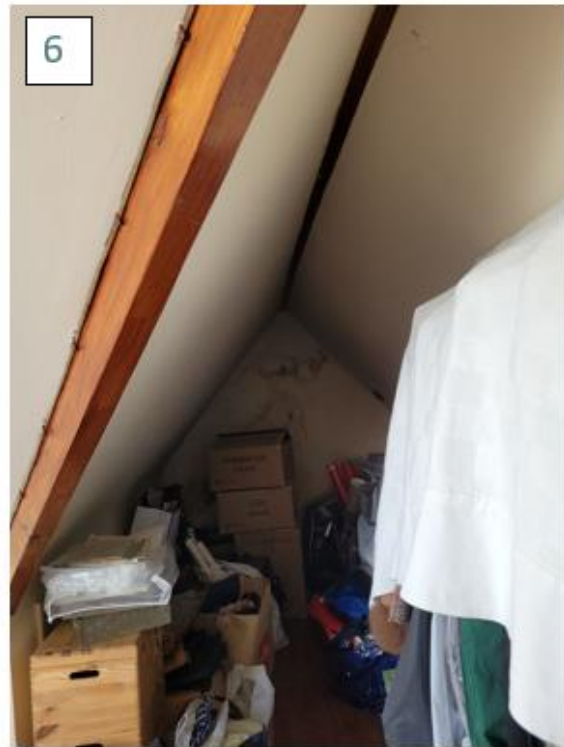
The house has one large loft which has been converted to living accommodation. Small loft spaces are found within the eaves which have small doors accessing this cramped space. All of these spaces have MDF boarding on the floor and roof with some cupboards being used as storage

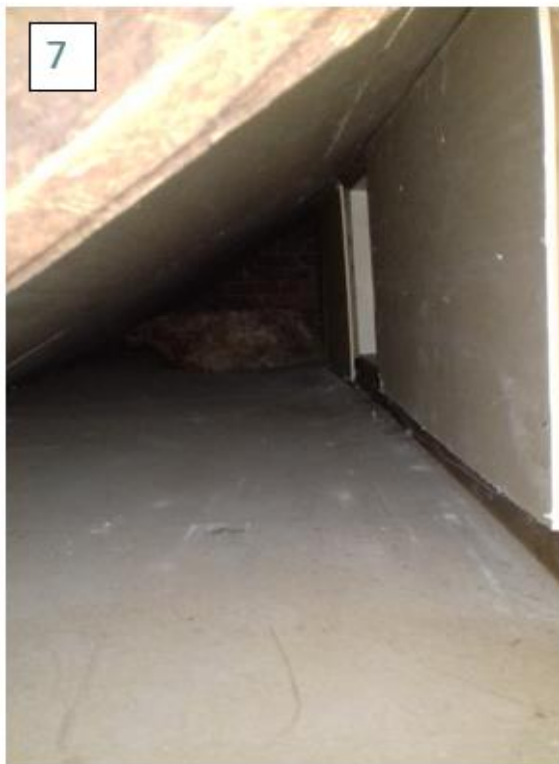
No bat droppings were found within the eaves spaces inspected.

**Trigger Index: 0.48 Negligible**

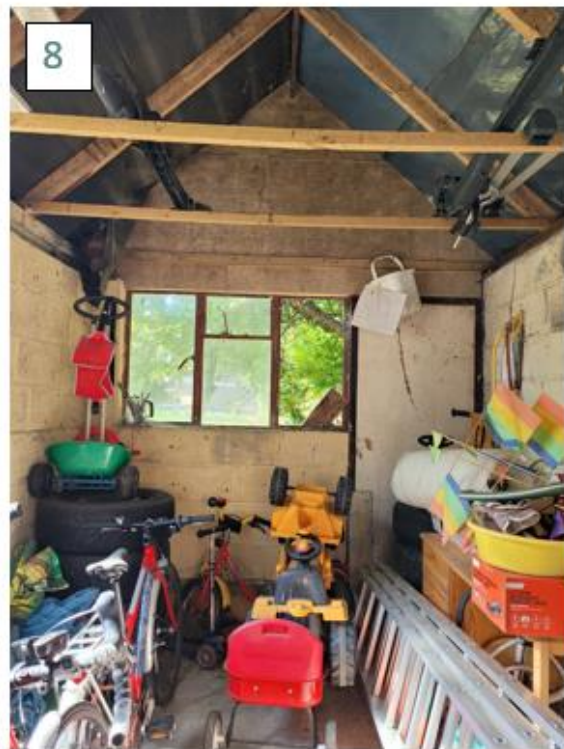
The Garage: This is open from floor to unlined roof above with the garage door being open at the time of the survey, there is also a broken window. No evidence of bats was found
