## Ground Investigation Report

Proposed Residential Development

Curzon Street, Reading

Document no.: STU5697-R01 Rev A

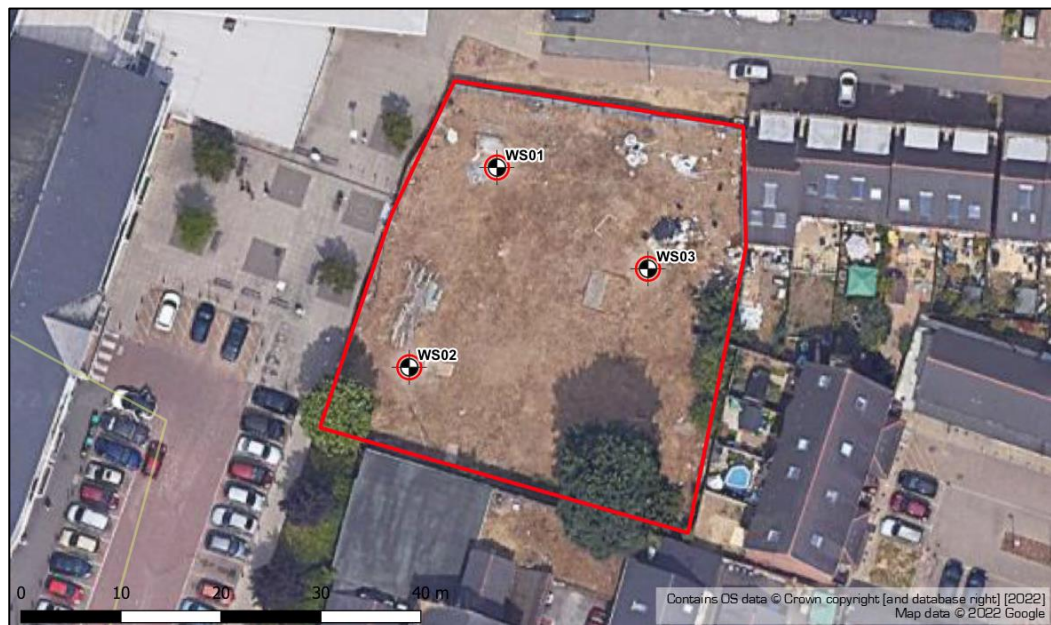
*Figure 2: Approximate Exploratory Hole Location Plan*

3.2.3 An exploratory hole location plan is presented below.
