## Re Weldale Street Reading, Application Number 220617

Many thanks for reviewing the Fairhurst Validation Report (112990, R9, April 2022). We are in receipt of the memorandum to Jonathan Markwell dated 10 May 2022 (ref EP/735289).

I am writing to address the concerns raised in the memorandum, to set out the wider context of the validation report and more specifically regarding the cover layer thicknesses encountered across the site.

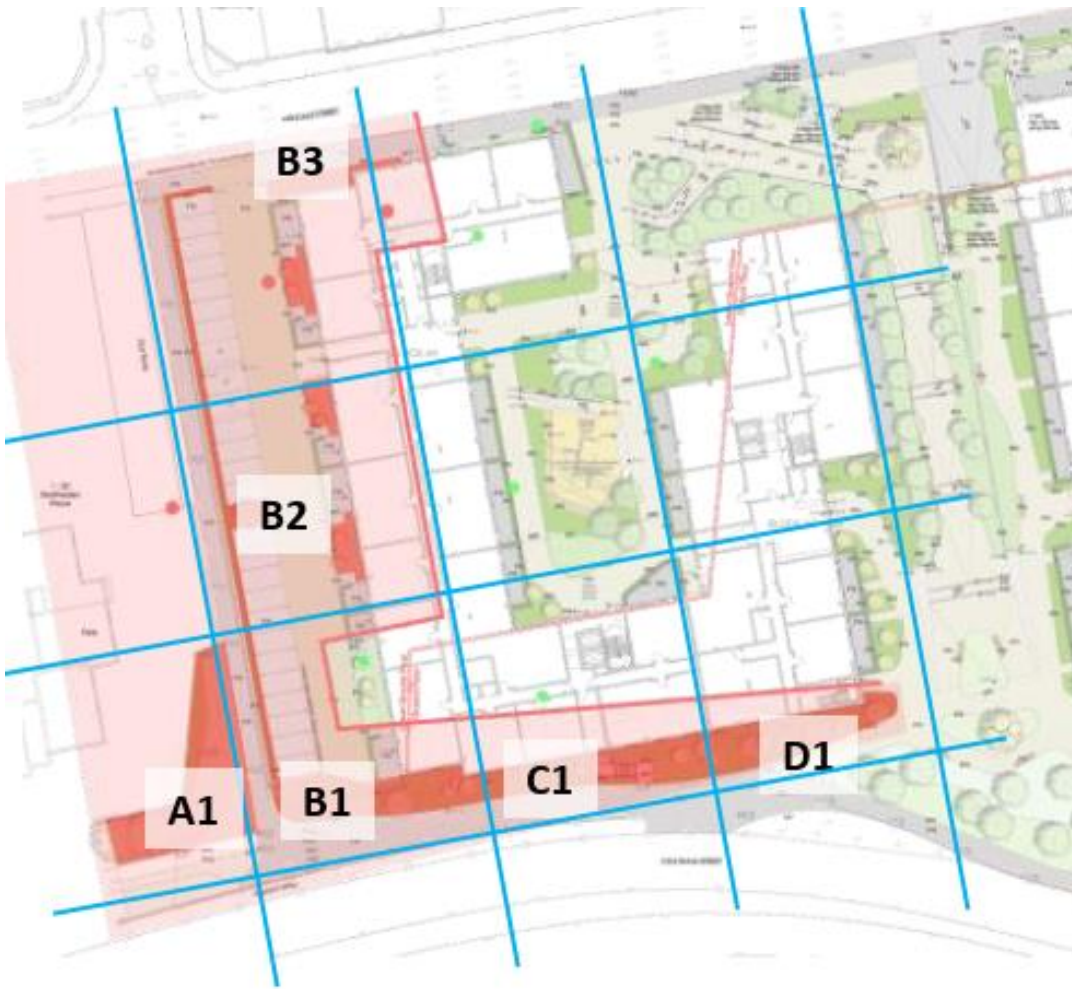
Original cover layer verification pit locations

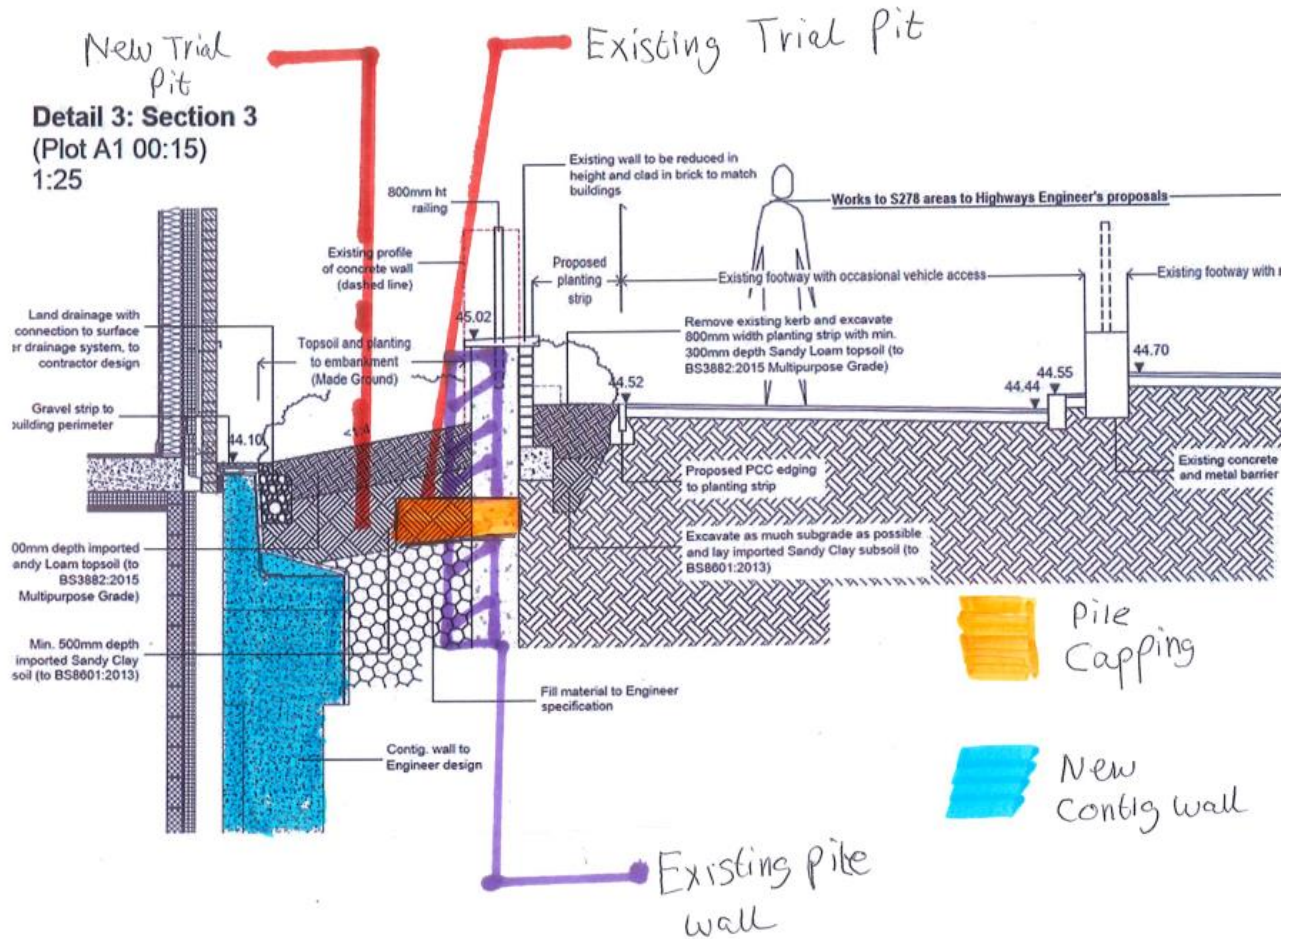
The trial pits excavated in the southern area of the site in squares B1 and C1 showed the specified thicknesses were not achieved. To add context, please see attached a cross section of this area of the site.

The original trial pits excavated by Fairhurst were located above the pile capping of the existing pile wall extending into the soft landscaped area. The required depth of excavation in these locations could not be achieved due to concrete piles and subsequently the topsoil/subsoil thicknesses were not achieved. Therefore, in this case, the pile cap acts as a barrier to human health, coupled with the presence of the orange geo-textile membrane, risks to the end users in these locations are mitigated.

Cross-section of the southern boundary and location with areas of B1 and C1.

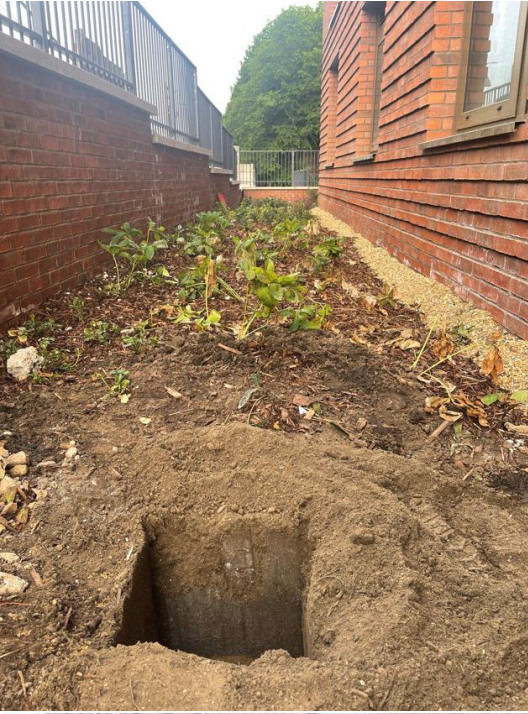
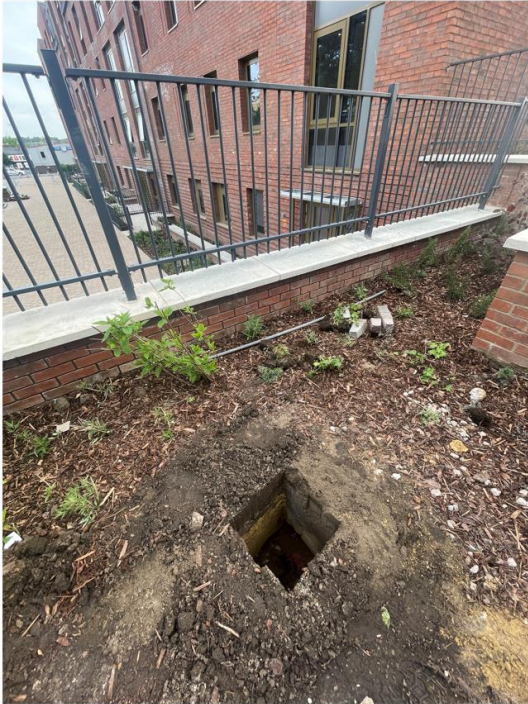
### New trial pit locations

To demonstrate compliance with the strategy in the wider areas, the contractor has excavated three more trial pits in areas of B1, C1 and D1, please see the photographs appended to this letter. Trial pit location B2 encountered 300mm of topsoil over 150mm subsoil and locations C1 and D1 encountered 300mm topsoil over a minimum of 300mm subsoil. All three locations were underlain by the orange geotextile membrane.

Additional Trial pit excavation at locations B1 and C1 where trial pits met the specification

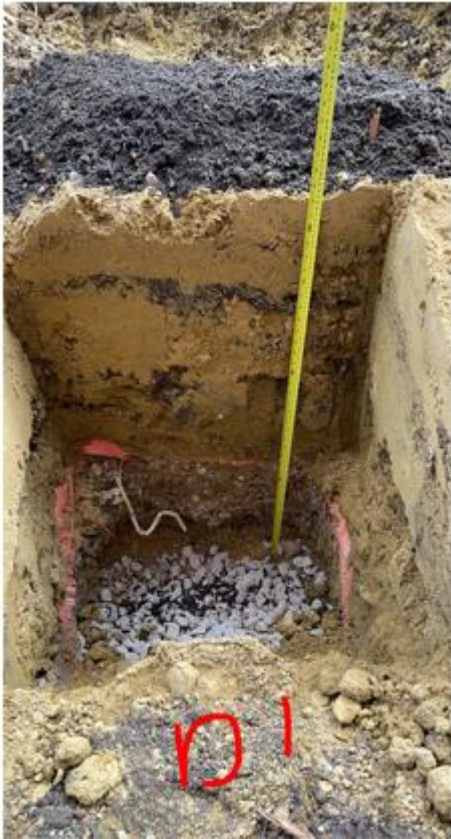
It should be noted that during the excavation, the orange geotextile membrane was damaged (see photo of location D1 below). Where this happened, the contractor has reinstated the membrane prior to backfilling.

Trial pit in location D1. The contractor has reinstated the geotextile membrane on backfilling.

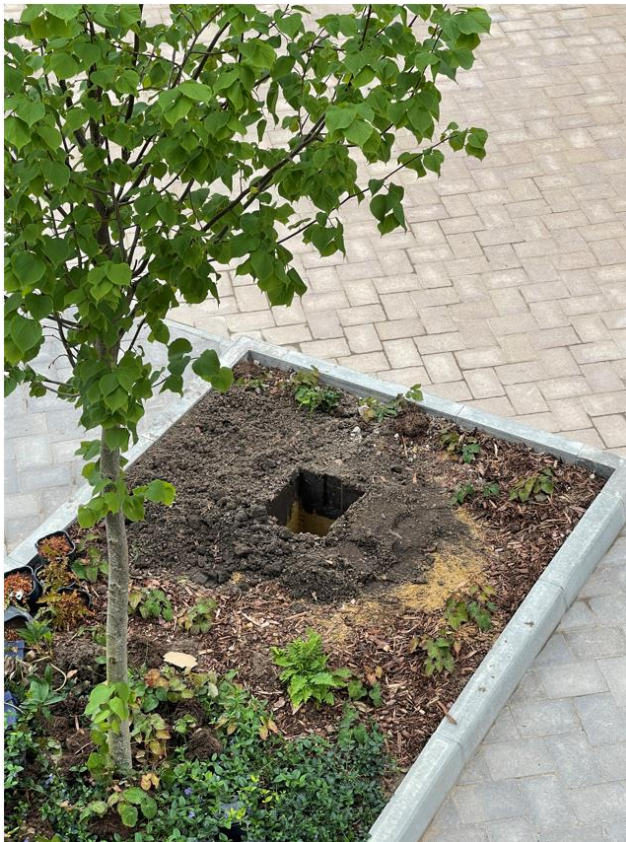
A trial pit was excavated near the original location within square B2 and demonstrates compliance with the Remediation Strategy. Some variation in cover layer thicknesses can be expected throughout site partially due to the location of services, as was the case here, and partially due to settlement. The second trial pit excavated by the Contractor within this area showed 300mm topsoil over 150mm subsoil and 150mm reject stone underlain by the orange geo-textile membrane.

Trial pit location in square B2, demonstrating compliance with the specification.
