**GEO-ENVIRONMENTAL & GEOTECHNICAL ASSESSMENT  
(GROUND INVESTIGATION)  
REPORT**

**199-207 HENLEY ROAD,  
READING,  
RG4 6LJ**

**Report Title:** Geo-environmental & Geotechnical Assessment Ground Investigation Report for 199-207 Henley Road, Reading, RG4 6LJ

**Job No:** P9413J811/PS

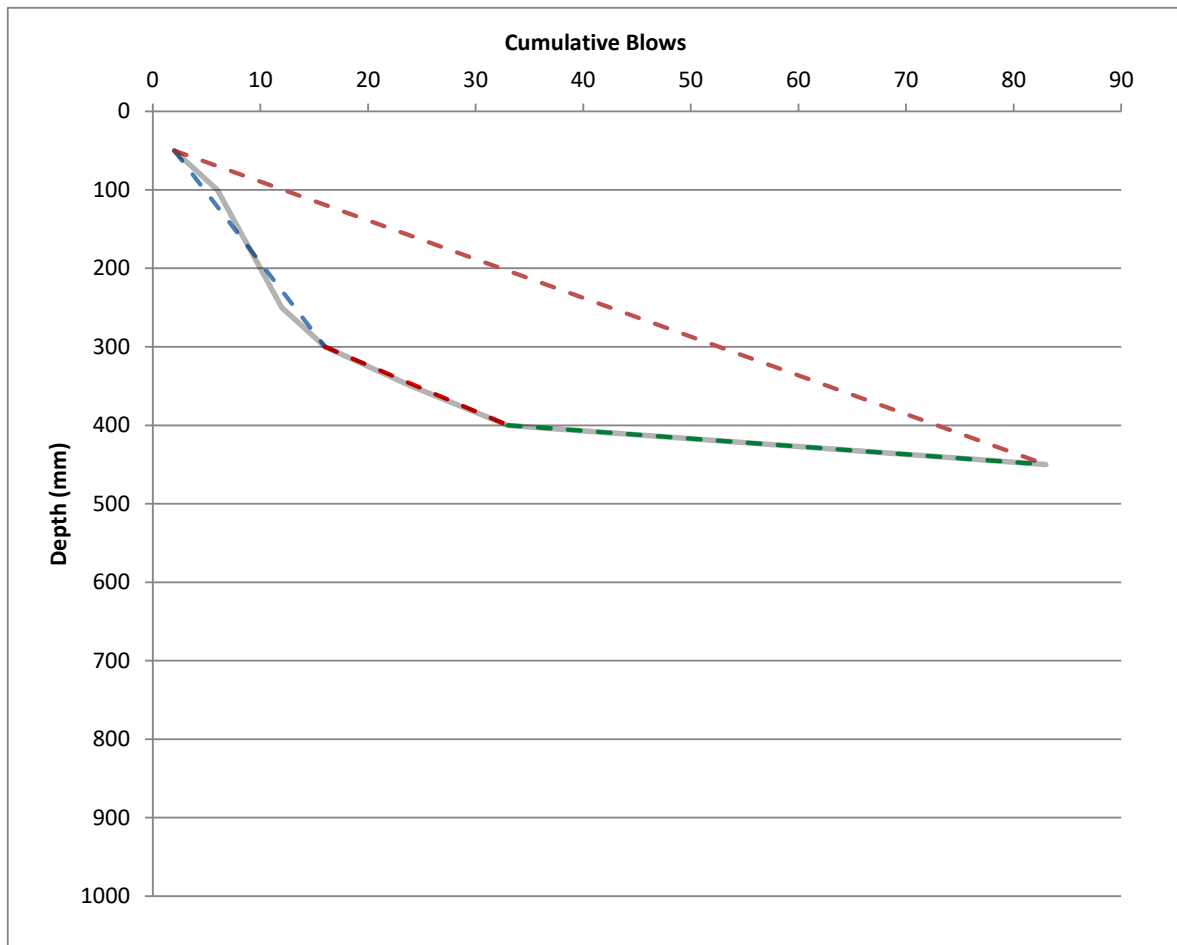
Test carried out using a Perth Probe type dynamic cone probe consisting of a 8 kg free fall hammer lifted and dropped through a height of 575mm  
 Colour of text refers to the modelled gradient on graph below  
 No recovery
