| <b>Project:</b> | Reading Golf Course | | | <b>Title</b> | Exploratory Hole Location Plan | | |
| <b>Ref No:</b> | GE20079 | <b>Revision:</b> | 1.0 | | | | |

**Geophysical Survey Report  
Former Reading Golf Club  
Berkshire**

**Magnitude Surveys Ref: MSSU986**

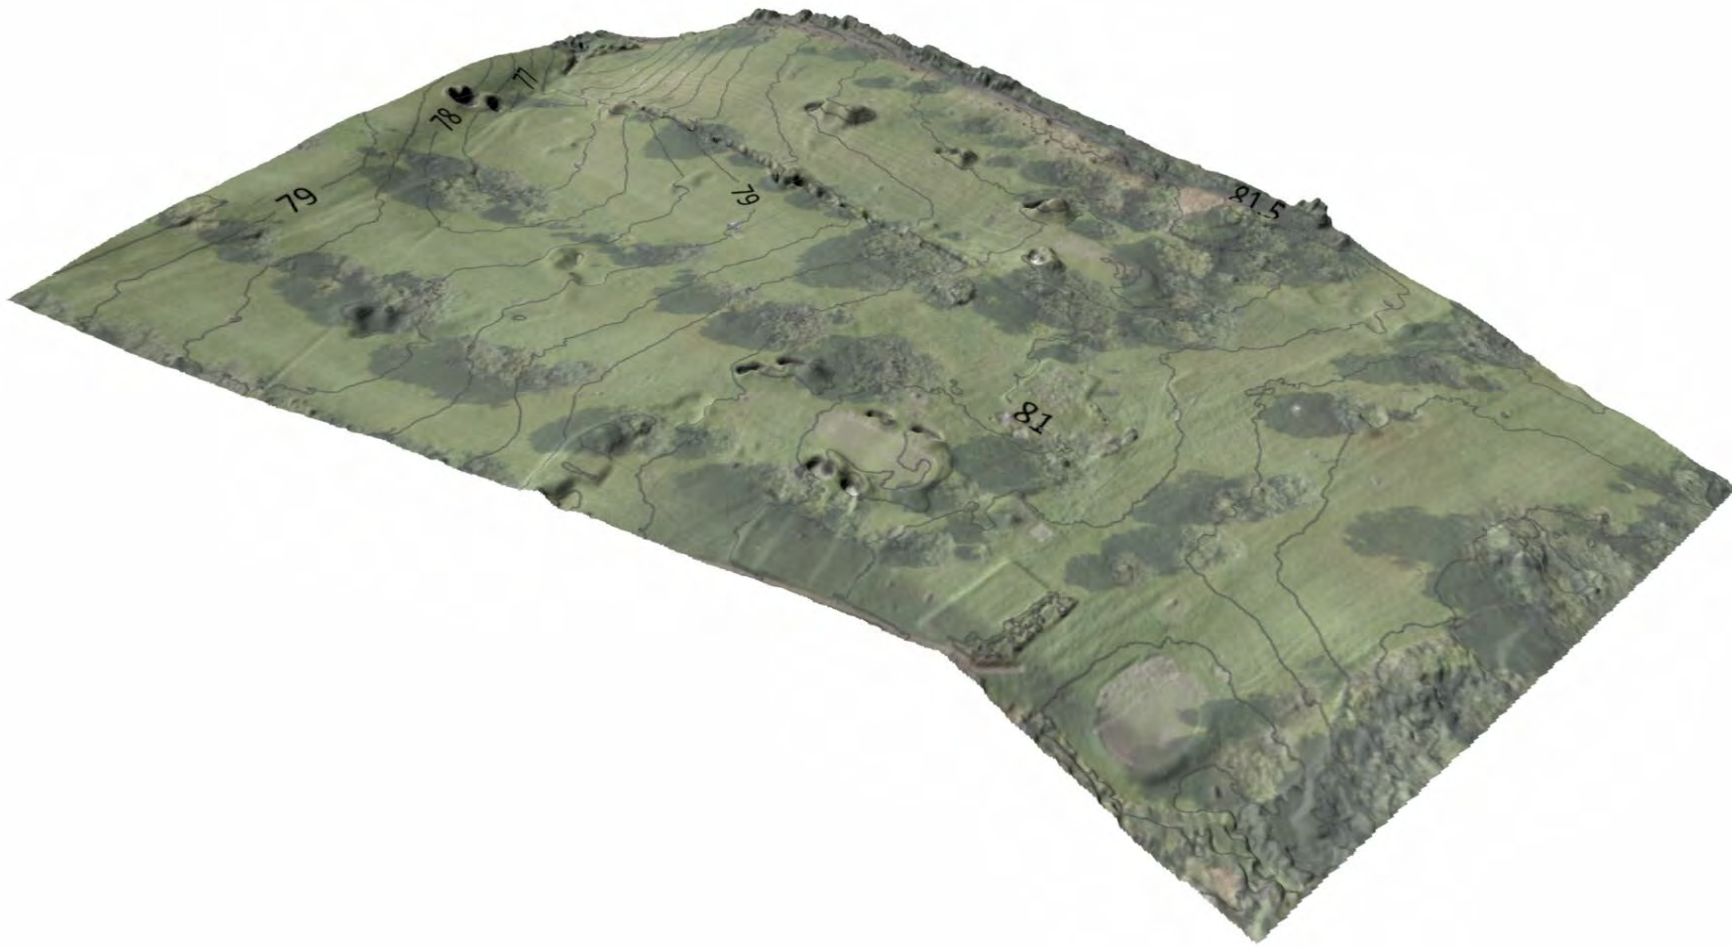
NOTE: This 3D model surface is for illustrative purposes and includes a 5x vertical exaggeration

| <b>Project:</b> | Reading Golf Course | | | <b>Title</b> | Digital Terrain Model (3D) | |

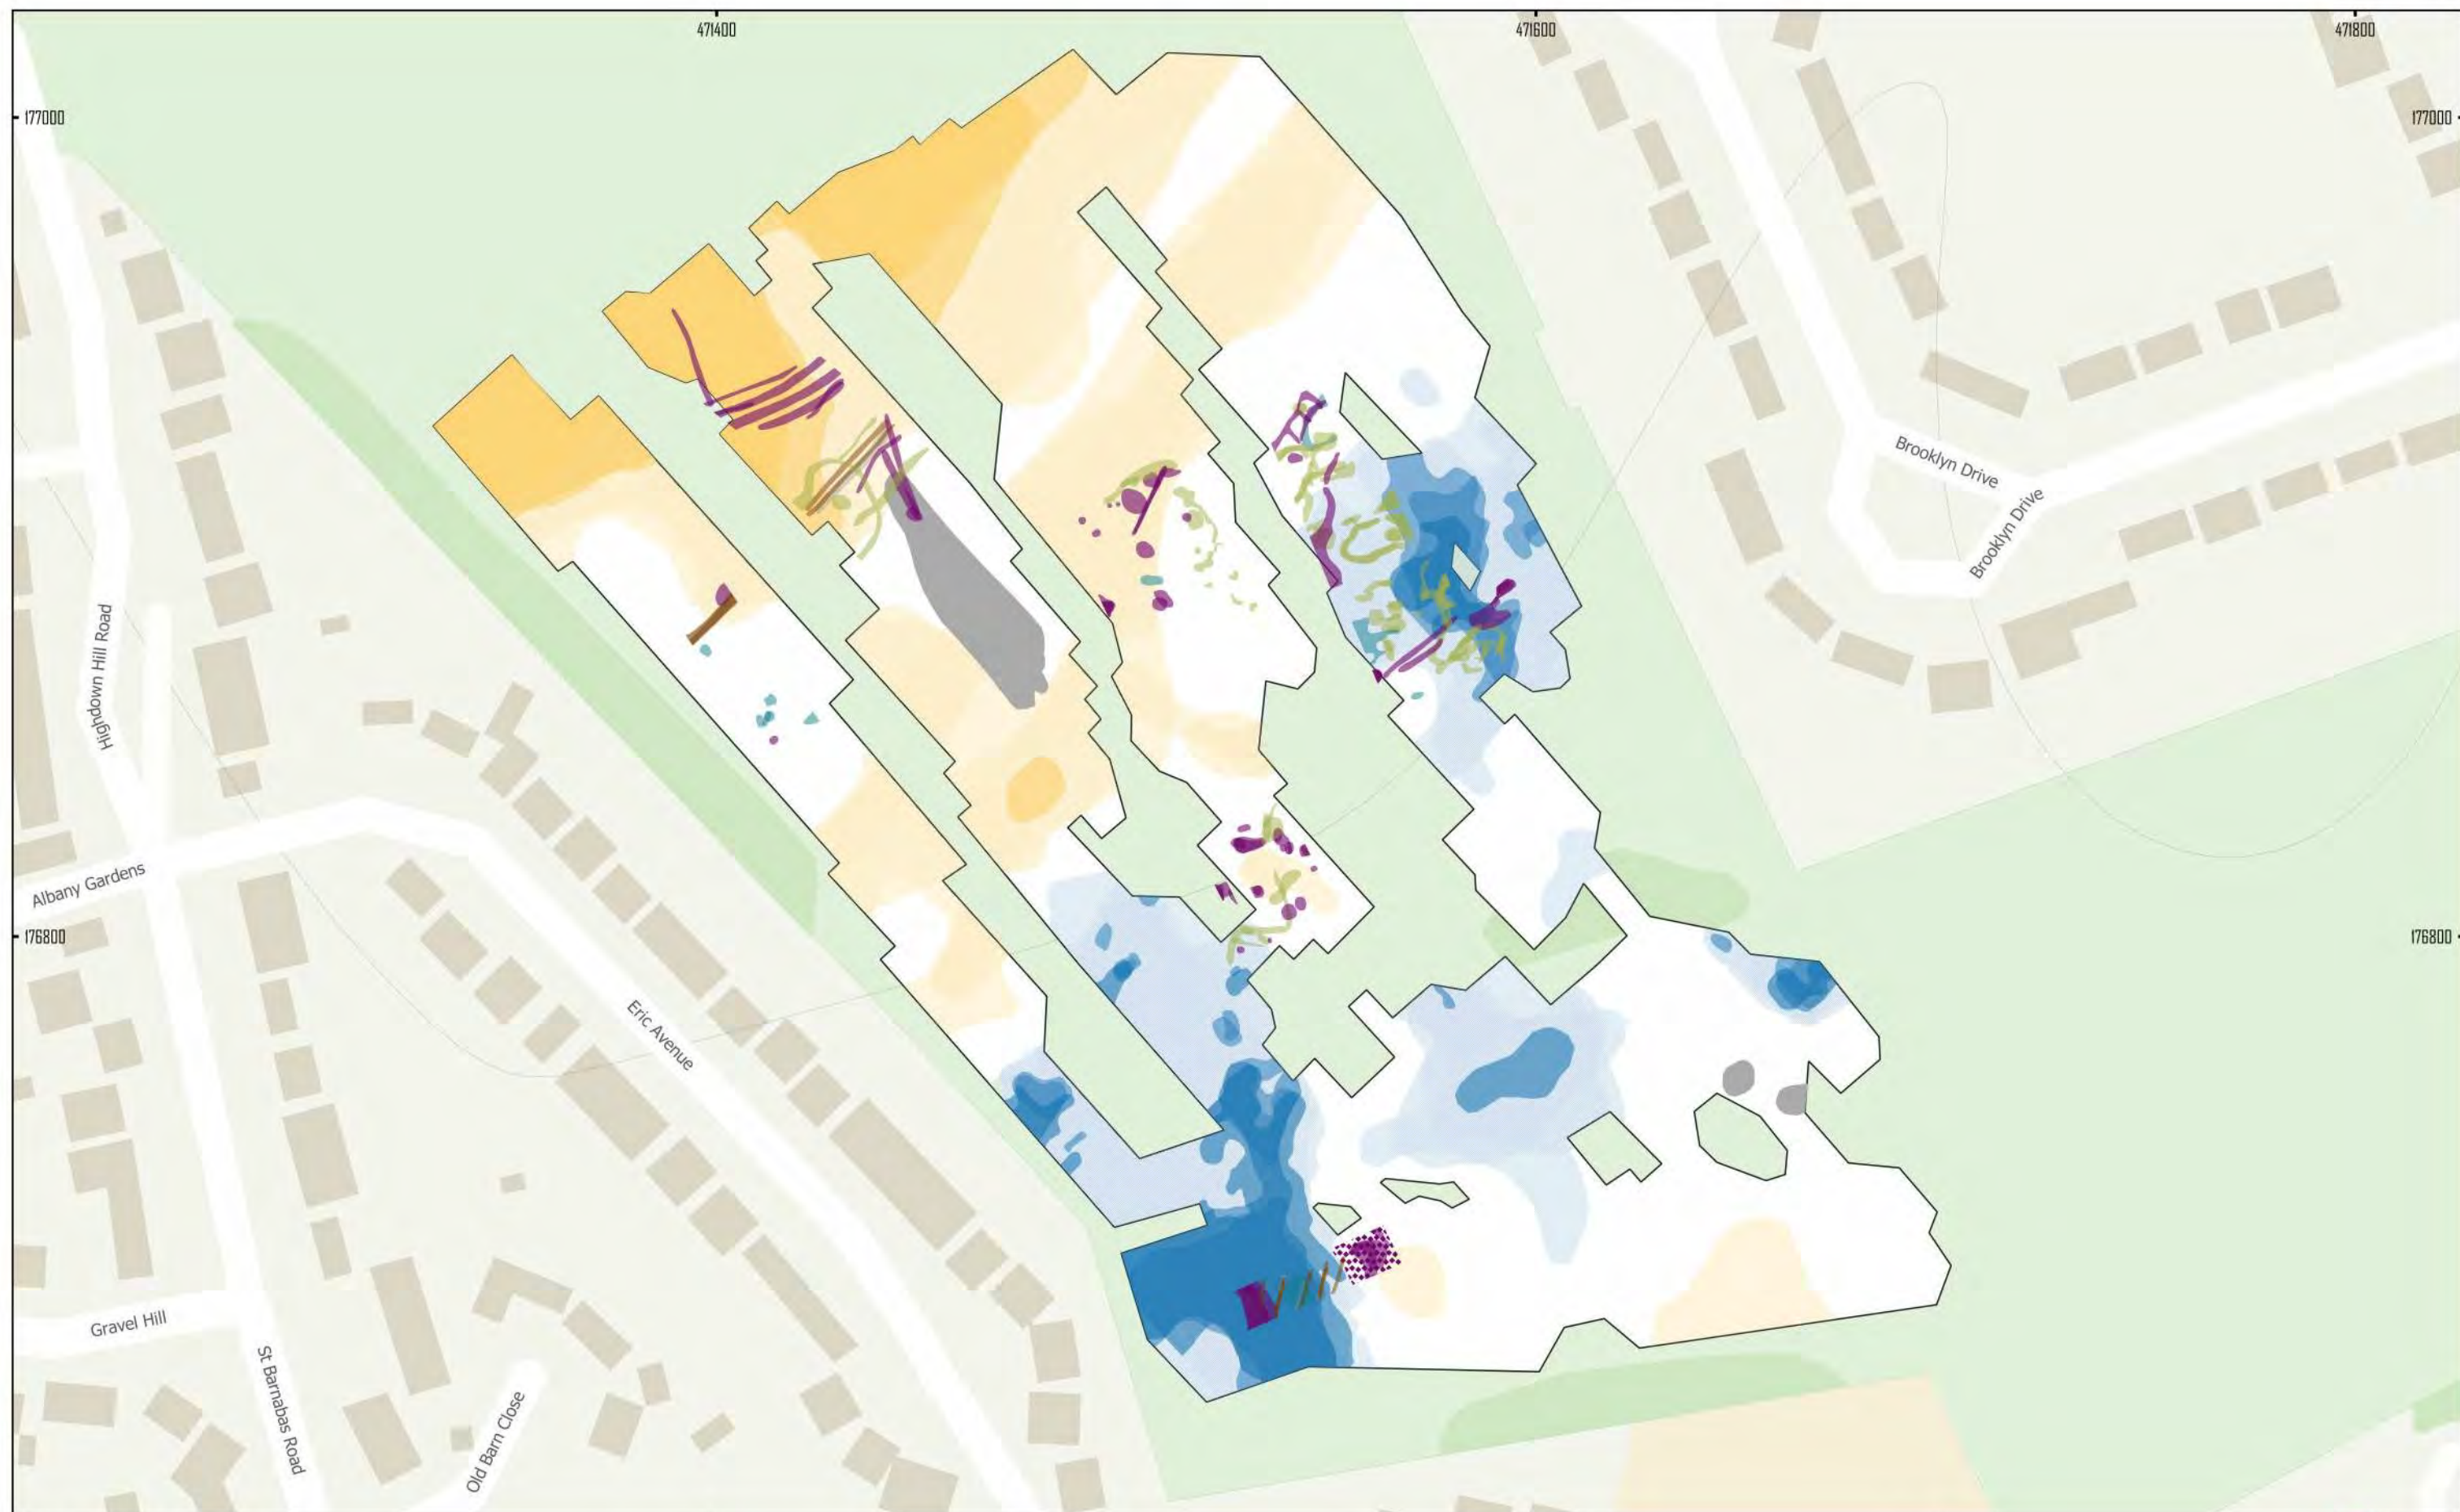
MSSU986 - Reading Golf Club  
 Figure 15 - Composite Interpretation EM & GPR  
 1:1,500 @ A3  
 Copyright Magnitude Surveys Ltd 2021  
 Contains Ordnance Survey data © Crown Copyright and database right 2021
