## Heritage Statement & Assessment of Significance

Site: 3 Gravel Hill Cottages, Blagrove Lane, Caversham, Reading, RG4 7DY  
Client: The Mapledurham Estate

Date: April 2022

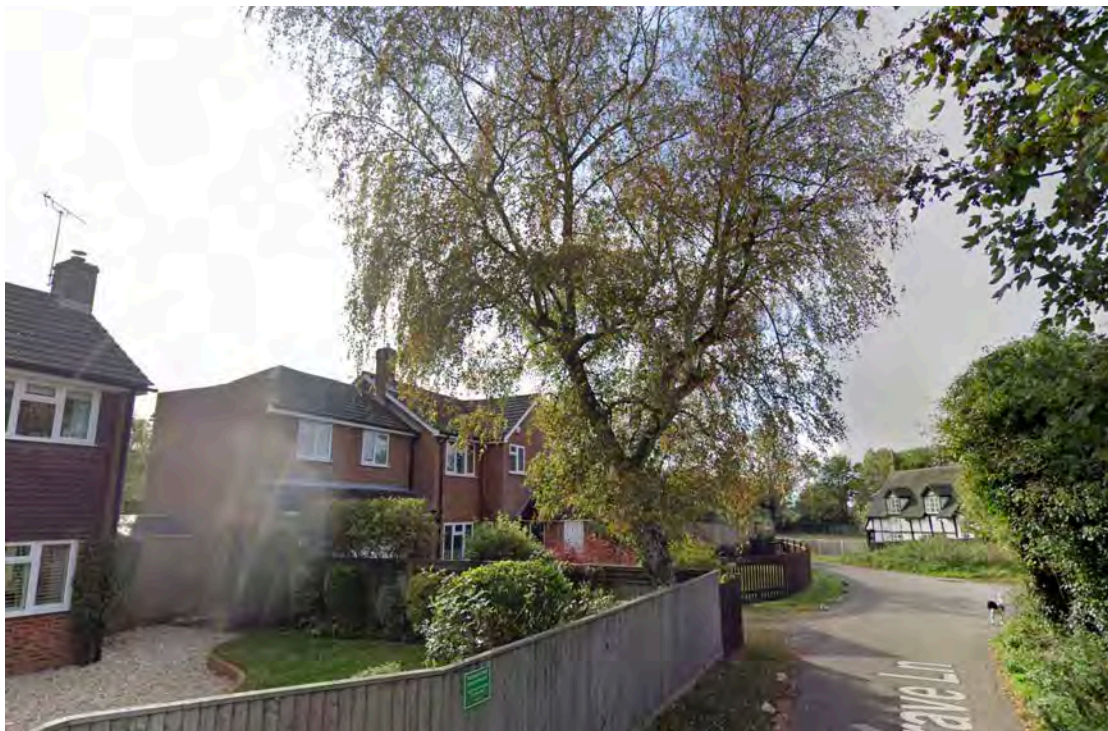
Fig 4: Image above from Google Maps. View South along Blagrove Lane, with 3 Gravel Hill Cottages in the background on the right, and the modern housing on the left-hand side.

The properties directly to the opposite side of Blagrove Lane are from the latter part of the 20<sup>th</sup> century and of indifferent quality. However, the narrow and tightly bounded nature of Blagrove Lane, with high hedges and curving road, do maintain something of a rural feel which is to the benefit of the setting of 3 Gravel Hill Cottages (3GHC).

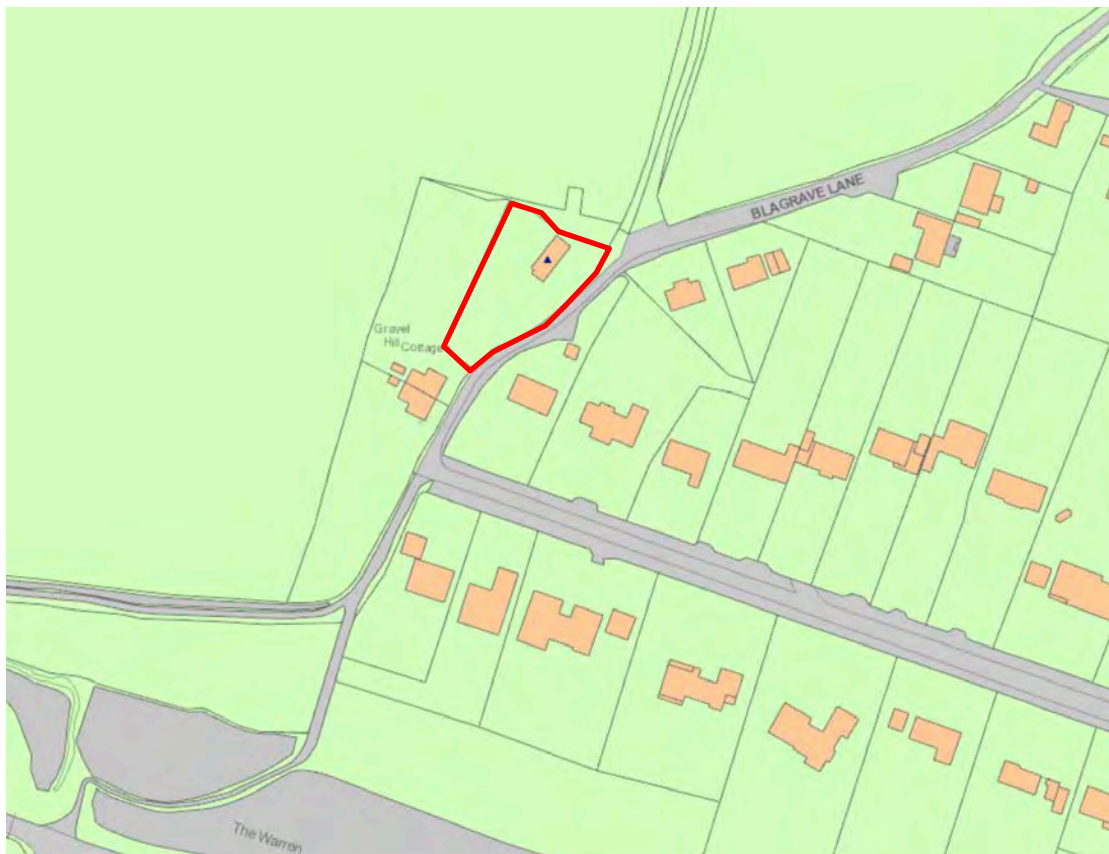
Fig 6: Image above from Historic England mapping. Site indicated in red.

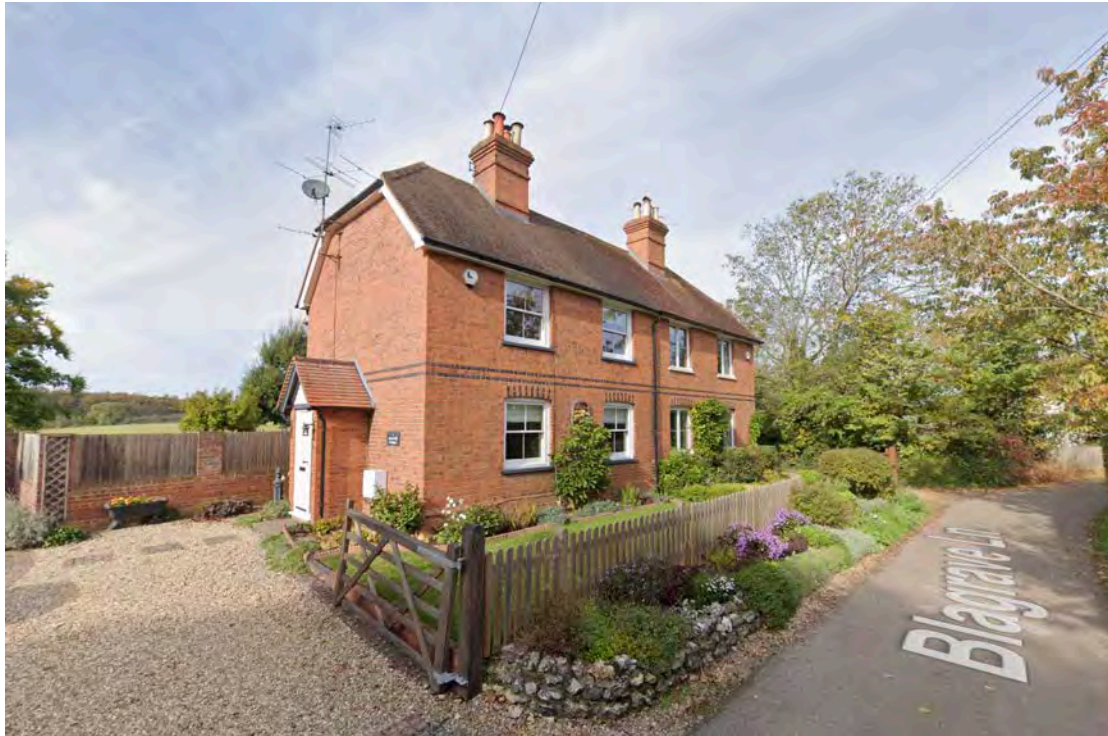
Fig 7: Image above from Google Maps. View of 1&2 Gravel Hill Cottages from Blagrove Lane.

To the South of 3GHC, the only traditional buildings are a pair of attractive late Victorian or early Edwardian cottages, known as 1&2 Gravel Hill Cottages as shown in Figure 7, below. Due to the planting to the gardens and boundary between 3GHC and these two properties, there is no strong visual relationship between them. It is likely that both these and 3GHC were all originally inhabited by agricultural workers, in what then would have been a significantly more rural landscape.

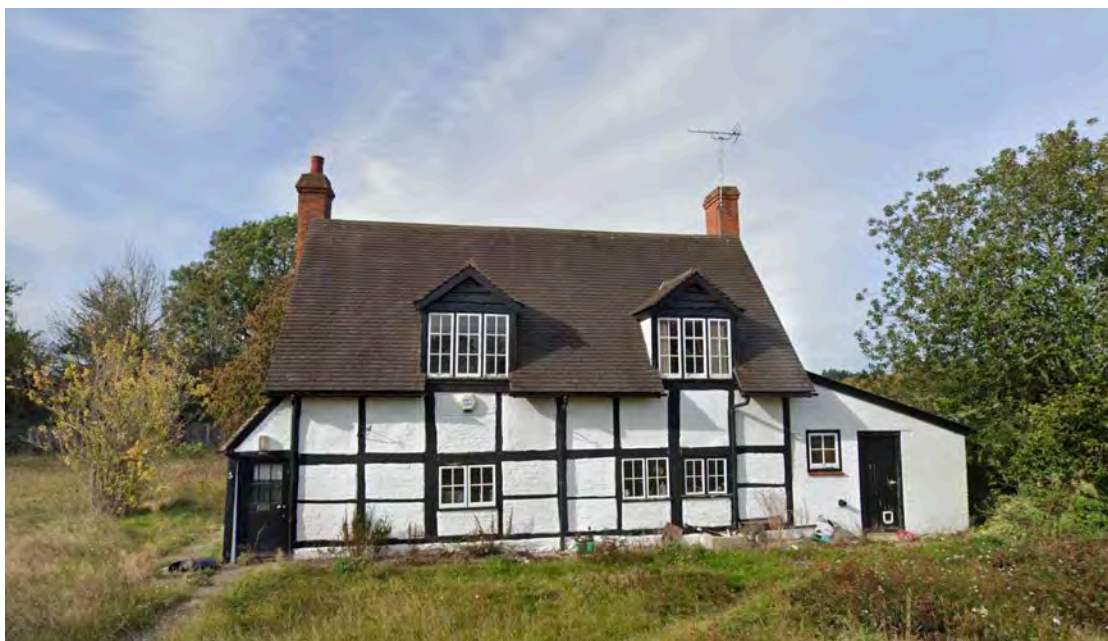
Fig 8: The South-East elevation of 3 Gravel Hill Cottages, viewed from Blagrove Lane.

As seen in figure 8 above, the cottage is on one and a half stories in height, with a lean-to extension added to each end. That at the South-Western (left hand in figure 8) end is a modest projection to accommodate the large fireplace with a baffle entry porch to the roadside. The extension to the North-Eastern end (right hand side, figure 8) is a later twentieth century lean-to extension, which provides some sanitary accommodation. This is of a rather utilitarian quality.

The other notable feature of the building is the pair of prominent dormers. These are quite large and almost certainly represent additions from the time when the building was altered from thatch to a tiled roof, probably replacing earlier, lower, dormers in the same location.

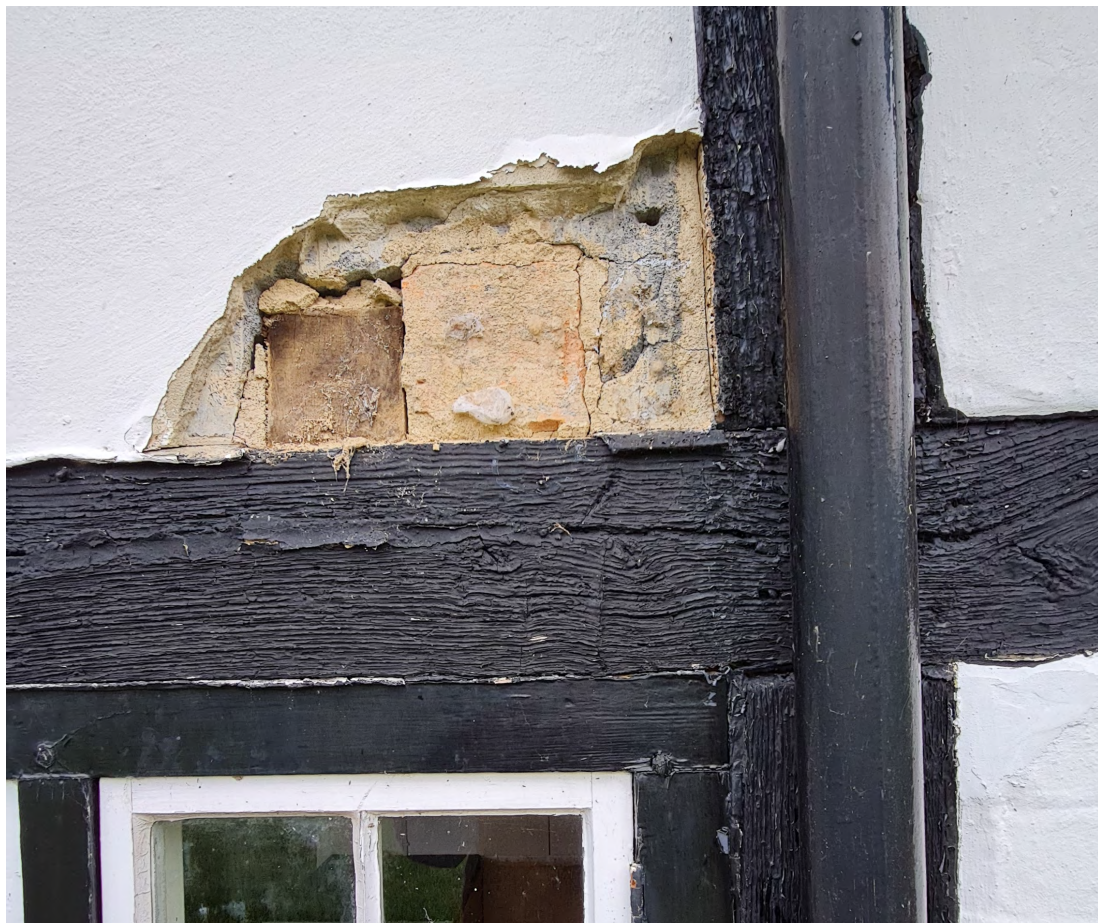
The frame appears to be in reasonable condition, and there is a mixture of infill panels, some of which are brickwork, and some rendered. All are painted. The render is at least in part sand-cement, which is not breathable and not sympathetic to the timber frame. Some areas have become cracked or broken away, as shown in figure 9 below.

Fig 9: Section of blown render to the South-East elevation. Note modern masonry infill and the end of the first-floor joist behind.

- Repair of failing joinery, predominantly window casements, on a like-for-like basis.
- Installation of secondary glazing to improve thermal performance.

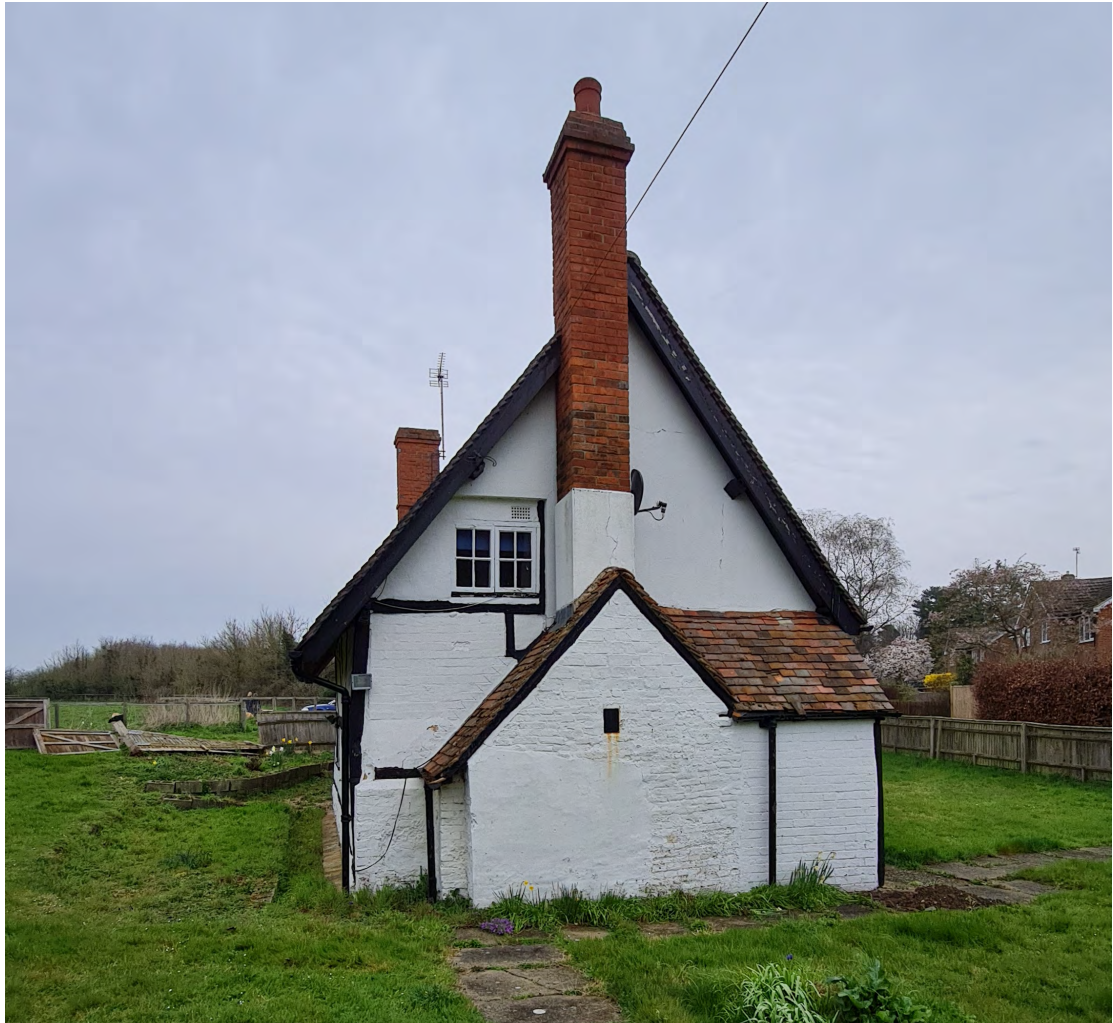
Fig 10: South-West end elevation. Note the projection for the fireplace, with chimney above built as a separate stack against, but not attached to, the gable. The projection continues as the porch to the right-hand side. Above this the wall has been packed out and rendered.

It is considered likely that the chimneys were added at different times, with the larger external fireplace and stack to the South-Western elevation certainly being older than the small stack at the North-Eastern end, and if not original to the cottage then not being much later.

The South-Western stack has been closed down as is typical and now has a small fireplace opening, and a detracting C20 fire surround in decorative stone cladding. The upper section of the chimney has been rebuilt.

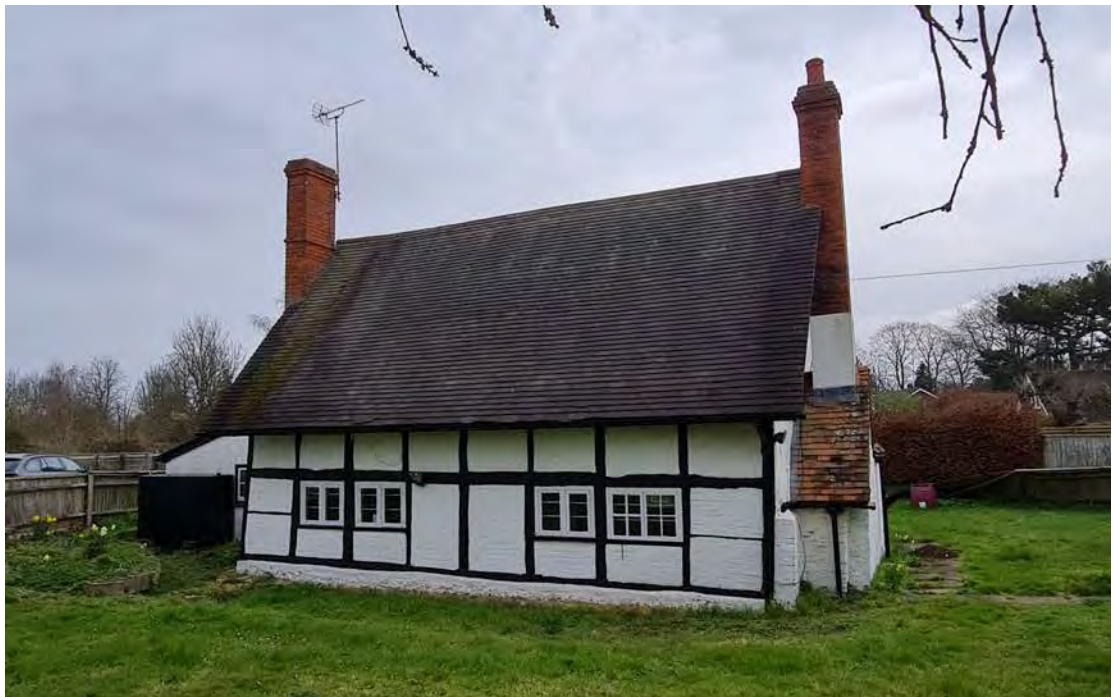
Fig 11: North-West (rear) elevation.

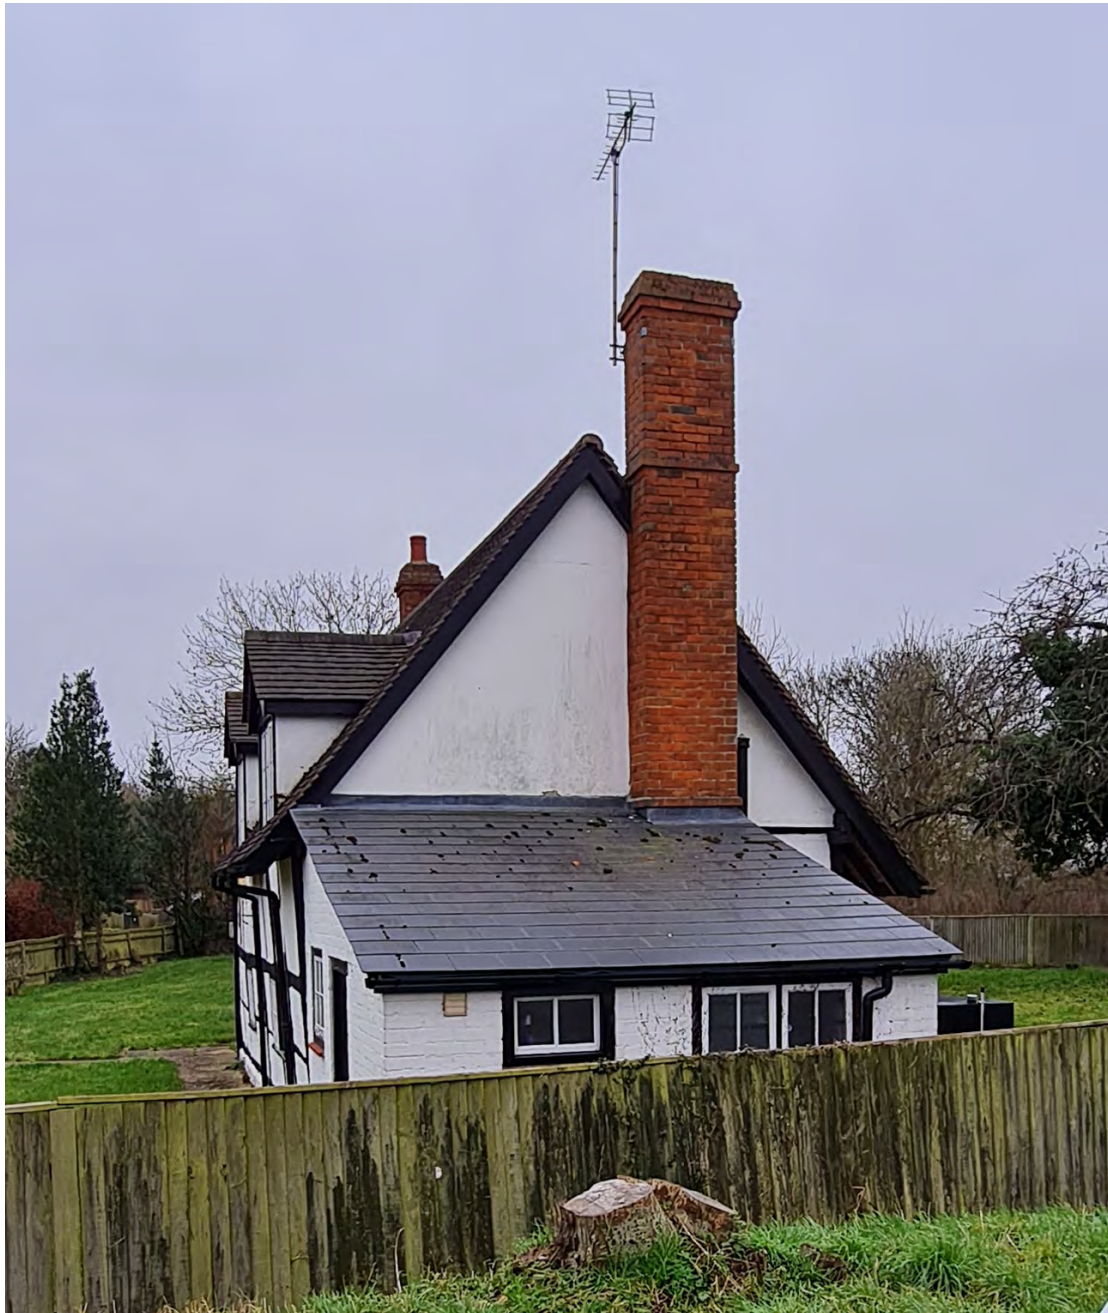
Fig 12: North-East elevation. Note again the packing-off and rendering of the gable.

The North-Eastern stack is small in plan from the ground floor up, which suggests it is Victorian at the earliest.

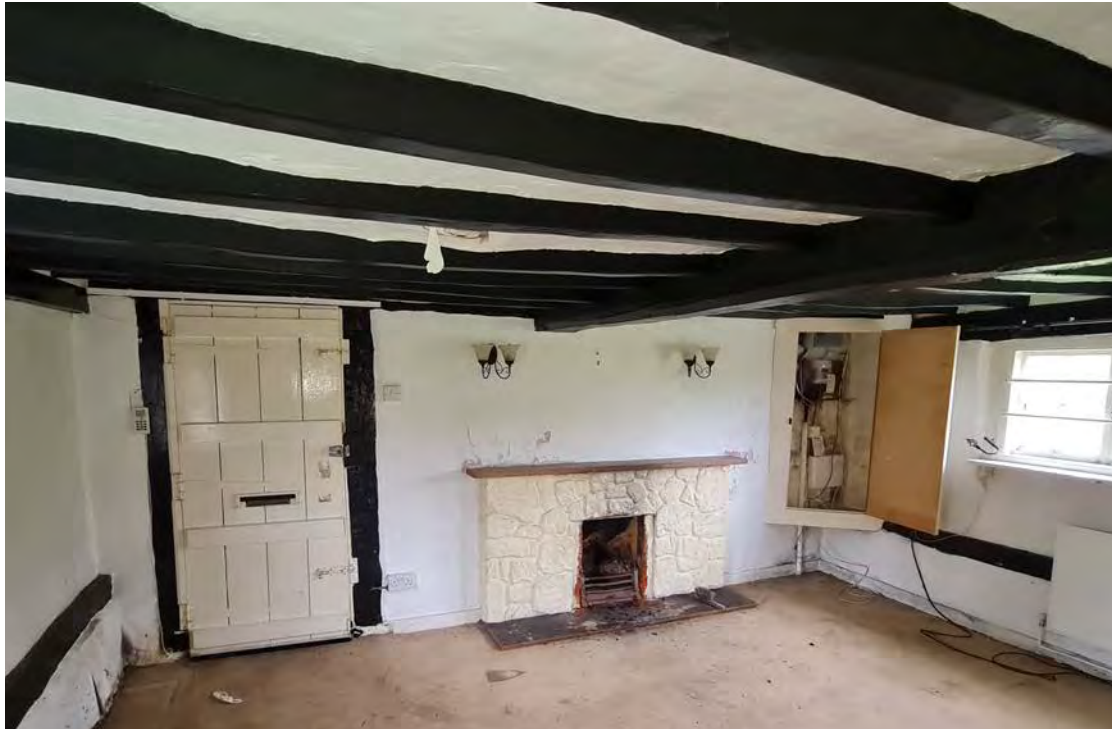
Fig 14: Internal view of the Living Room and North-Eastern fireplace. Note also the exposed floor beam and joists to the first floor.

- Removal of the unattractive stone-clad fireplace to the Living Room, and the opening up of the original fireplace in order to install a wood burner.
- Renewal of services.

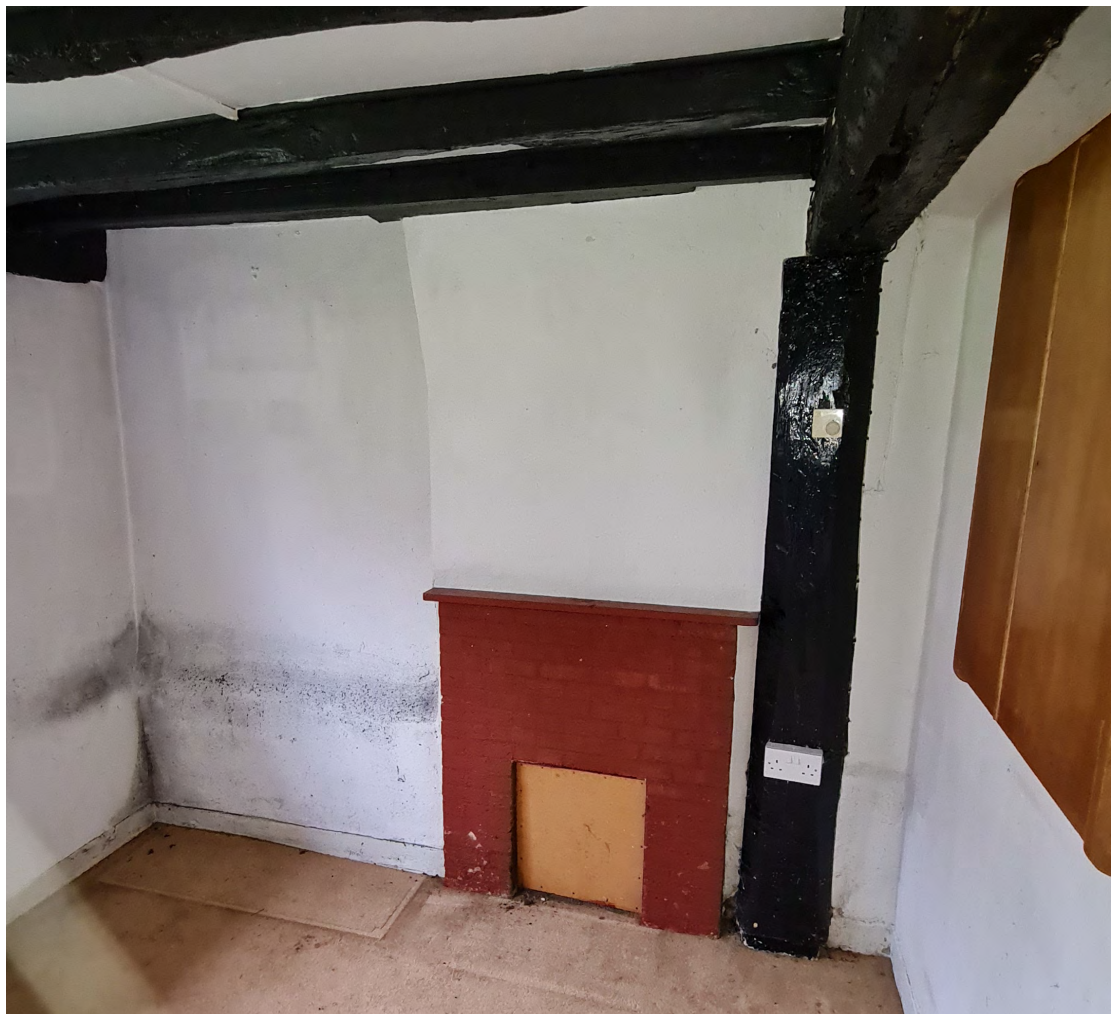
Fig 15: Internal view of the Dining Room and South-Western fireplace. Note damp to wall on left-hand side.

- Removal of the existing concrete path against the building and the installation of a French drain.
- Lowering of high ground level externally to reduce damp.

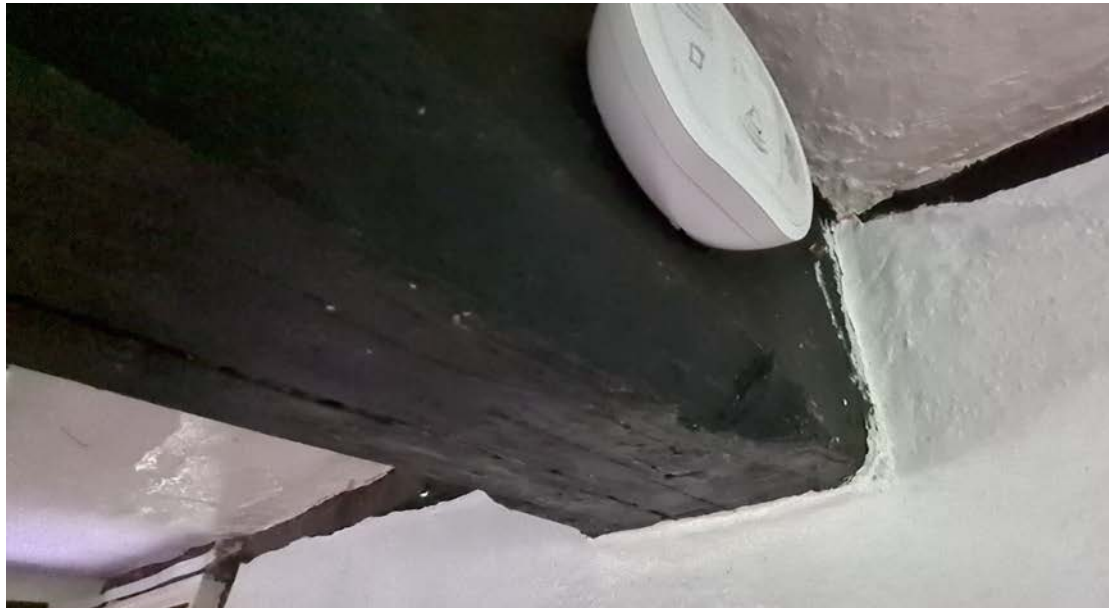
The axial, or bridging, beams to the first floor include chamfers and stops to their underside, indicating that they were always designed to be visible. The stops are of a type known as a 'step-stop' which was prevalent in the 16<sup>th</sup> and early 17<sup>th</sup> centuries.

Fig 16: View of step-stop to end of axial beam in Living Room.

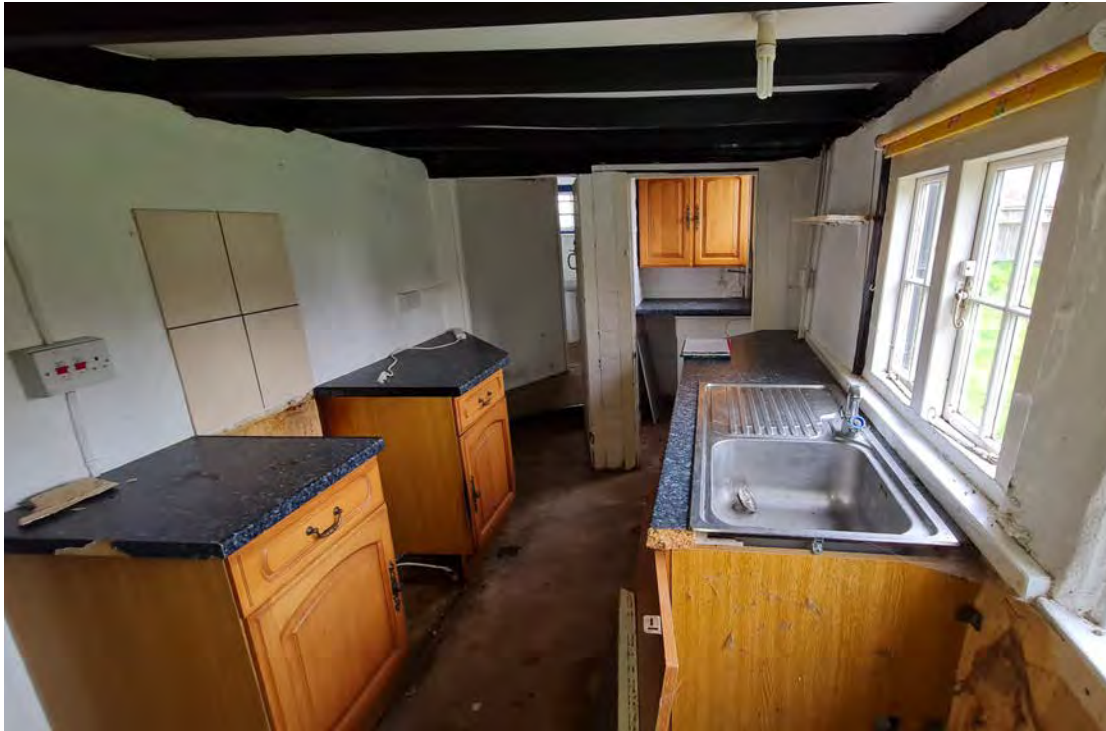
Fig 18: View of Kitchen. Note modern dividing wall on left-hand side.

- The Removal of the modern partition wall between the Kitchen and Dining Room in order to create a single Kitchen-Diner within the larger, original, space.

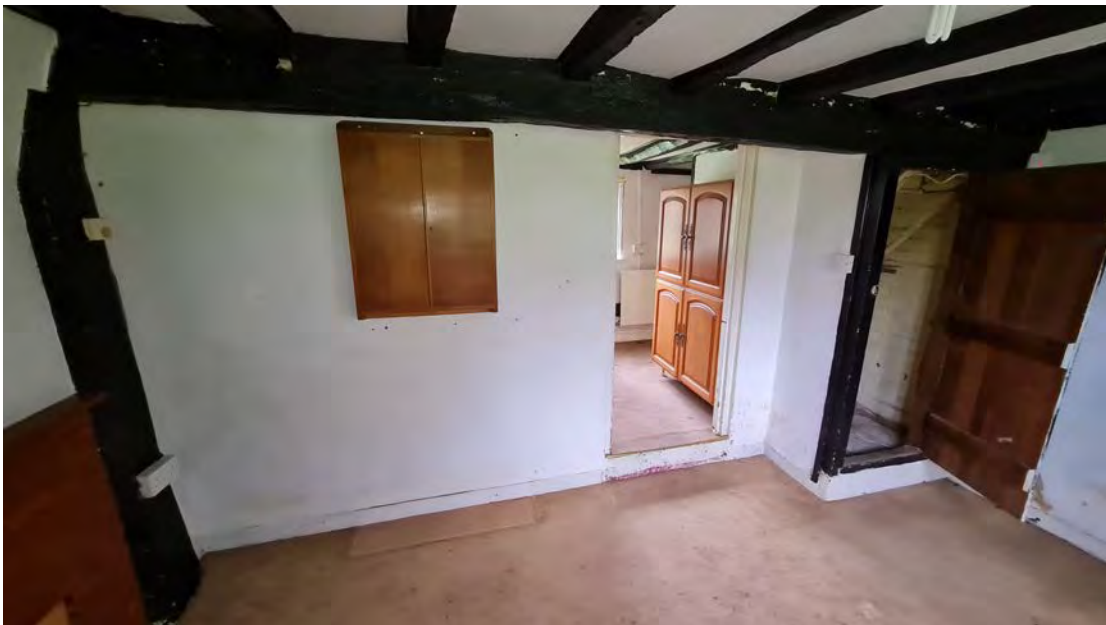
Fig 19: View of wall between Kitchen and Dining Room from Dining Room side. Note raised floor to Kitchen, which is one step higher than the rest of the ground floor.

- Internal alterations to the 20<sup>th</sup> century single storey lean-to extension to provide improved bathroom and utility spaces.
- Lowering of the raised floor to the Kitchen back to its original level, so as to improve the headroom.

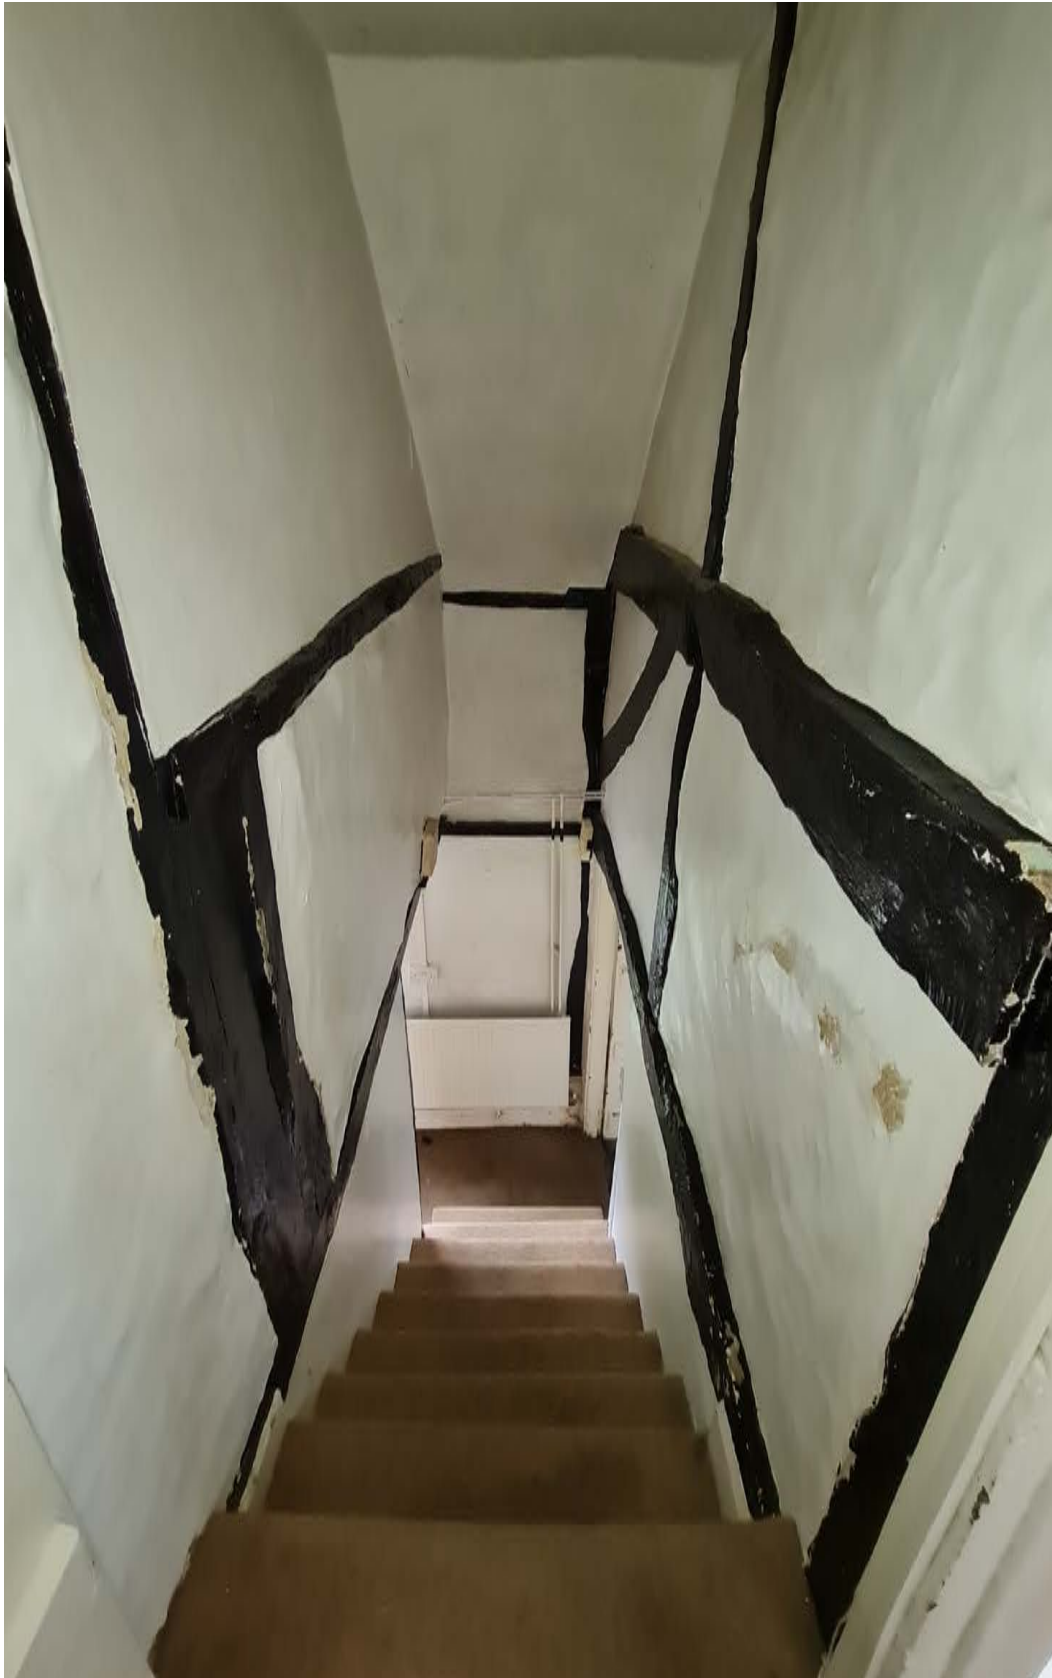
The staircase is likely to be 18<sup>th</sup> century, although it rises between two narrowly spaced frames in a narrow bay, with the original timber frame elements visible. This is shown in figure 20 on the following page.

Fig 20: View of stair rising between two narrowly spaced frames.

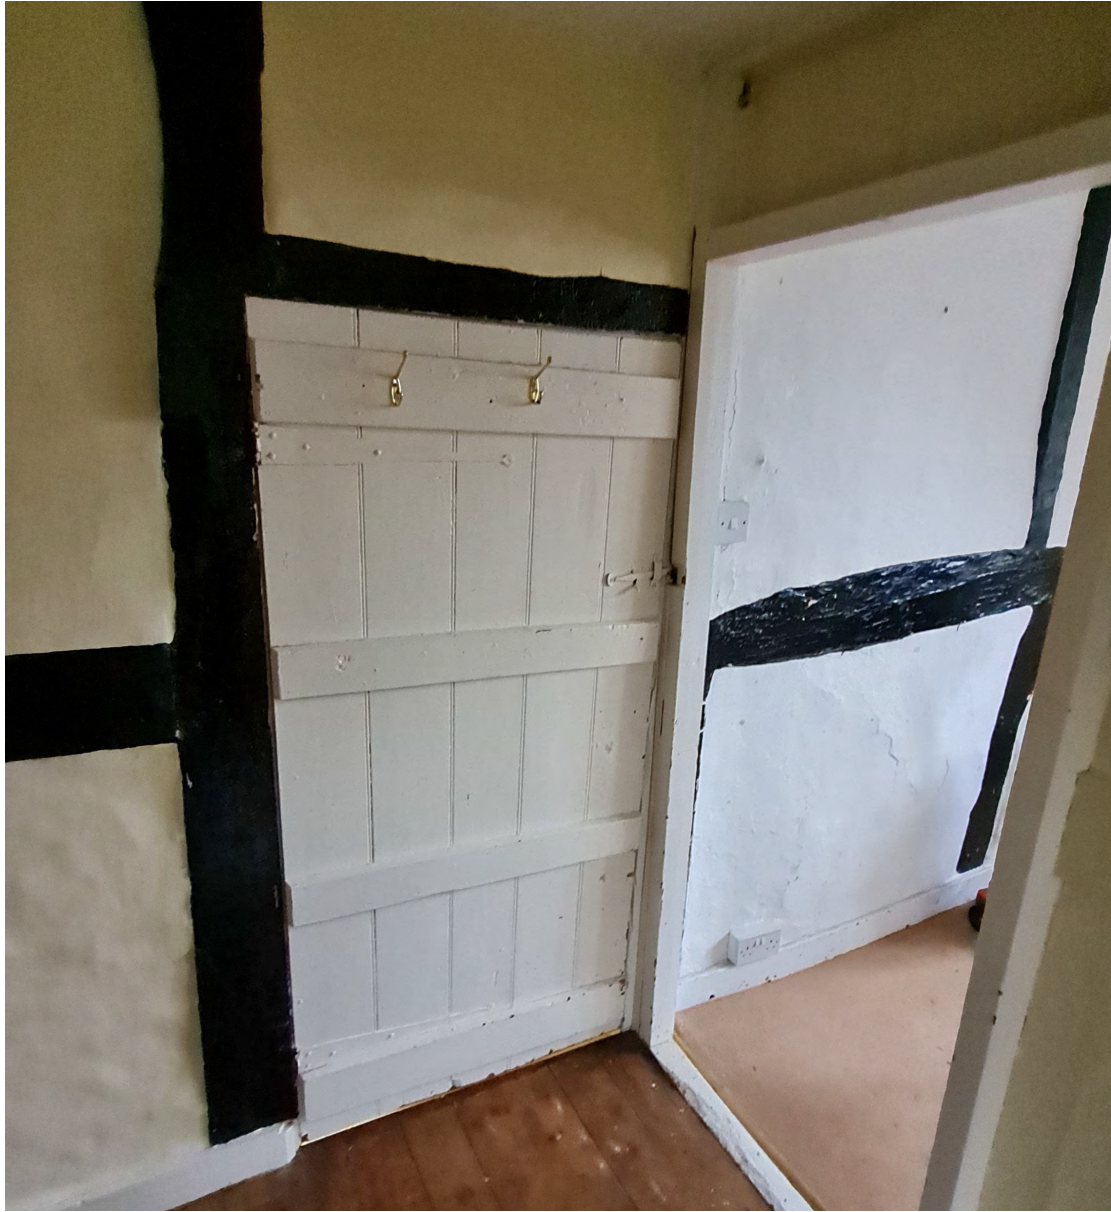
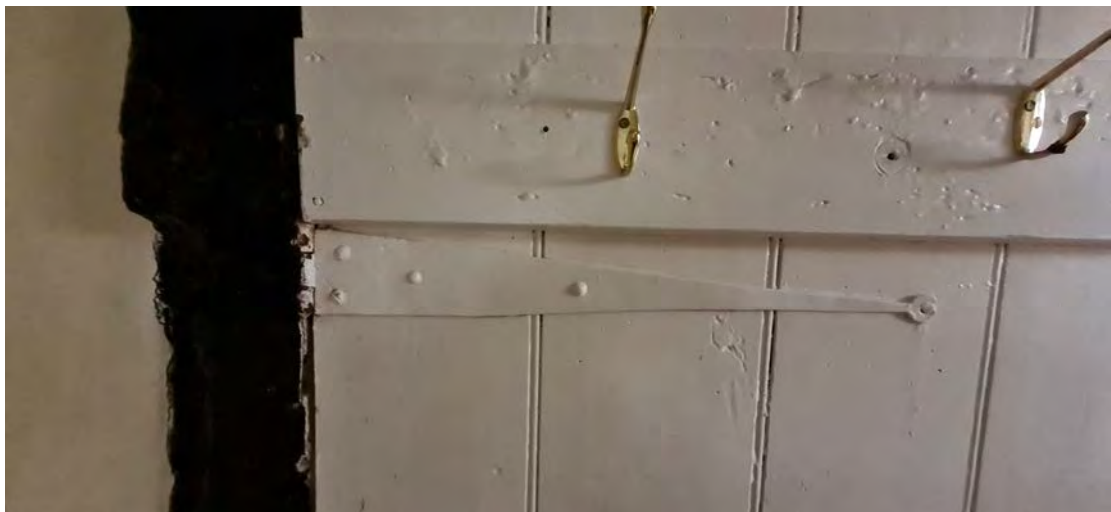
Also of interest, several doors within the property have ironmongery which dates to around the 18<sup>th</sup> century. Hinges in particular can be dated in general terms by their slenderness and strap ends. These are shown in figures 21 and 22 below.

Figs 21 & 22: View of bedroom door illustrating 18<sup>th</sup> century hinges.

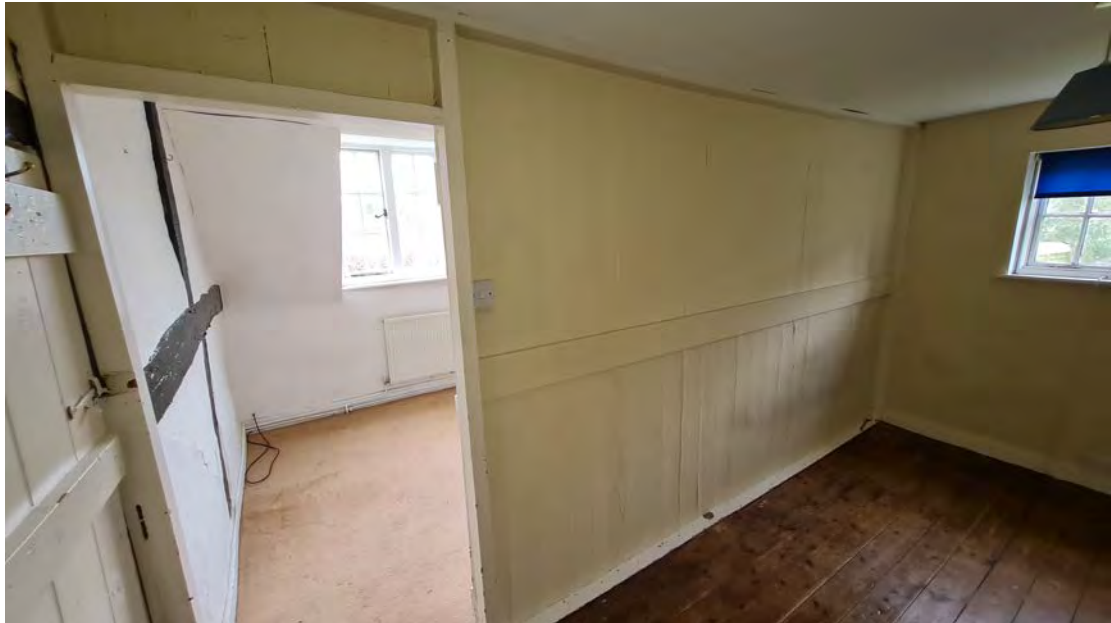
The wall which divides one of the original first floor rooms into two is constructed of boards and rails, probably dating from the late Victorian or Edwardian period.

Fig 23: View of the later dividing wall between the two first floor bedrooms.

- The removal of the poor quality relatively modern first-floor partition between the two bedrooms, to remove the 'inner room' condition which does not comply with Building Regulations.

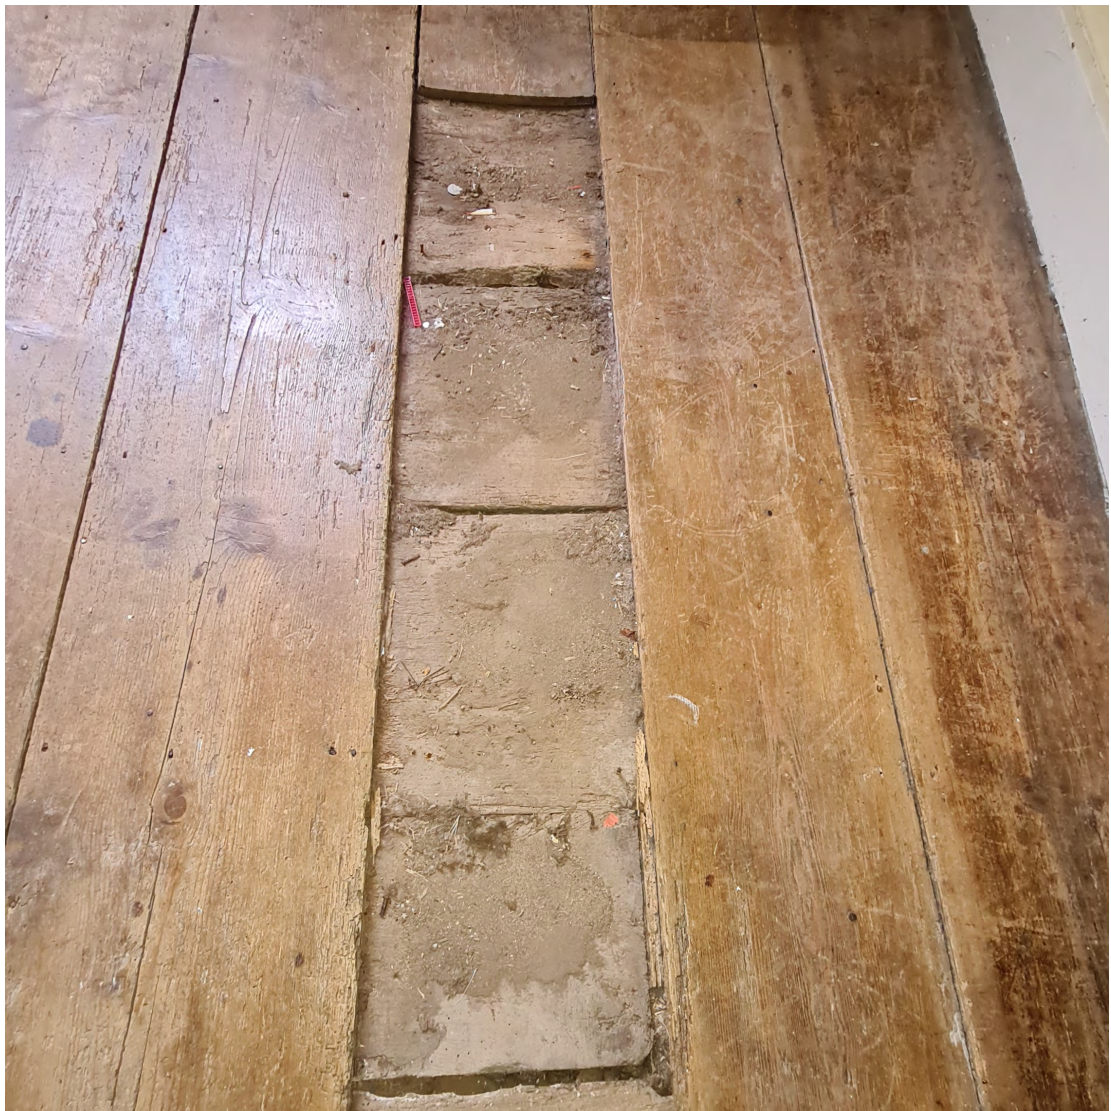
The first floor is supported on very slender joists, the majority of which have been replaced with new hardwood joists in relatively recent times. A substantial number of the remainder are in a very poor condition and the first floor is extremely 'live' when walking on it. This floor has been considered unfit for use by a structural engineer.

Fig 24: View of the underlying older floorboards to the first floor.

As shown in figure 24, the first floor within the larger bedroom has been over-boarded with a thin board. Beneath this are an older layer of hardwood boards which may be original.

- Replacement of failing first-floor joists together with over-boardings to ensure safety of the floor for use, as recommended by the Structural Engineer.
