## Technical Note

Project: 816 Oxford Road, Reading

Subject: Surface Water Drainage Strategy & Statement Doc Ref. 6799 – DSTN Issue 02

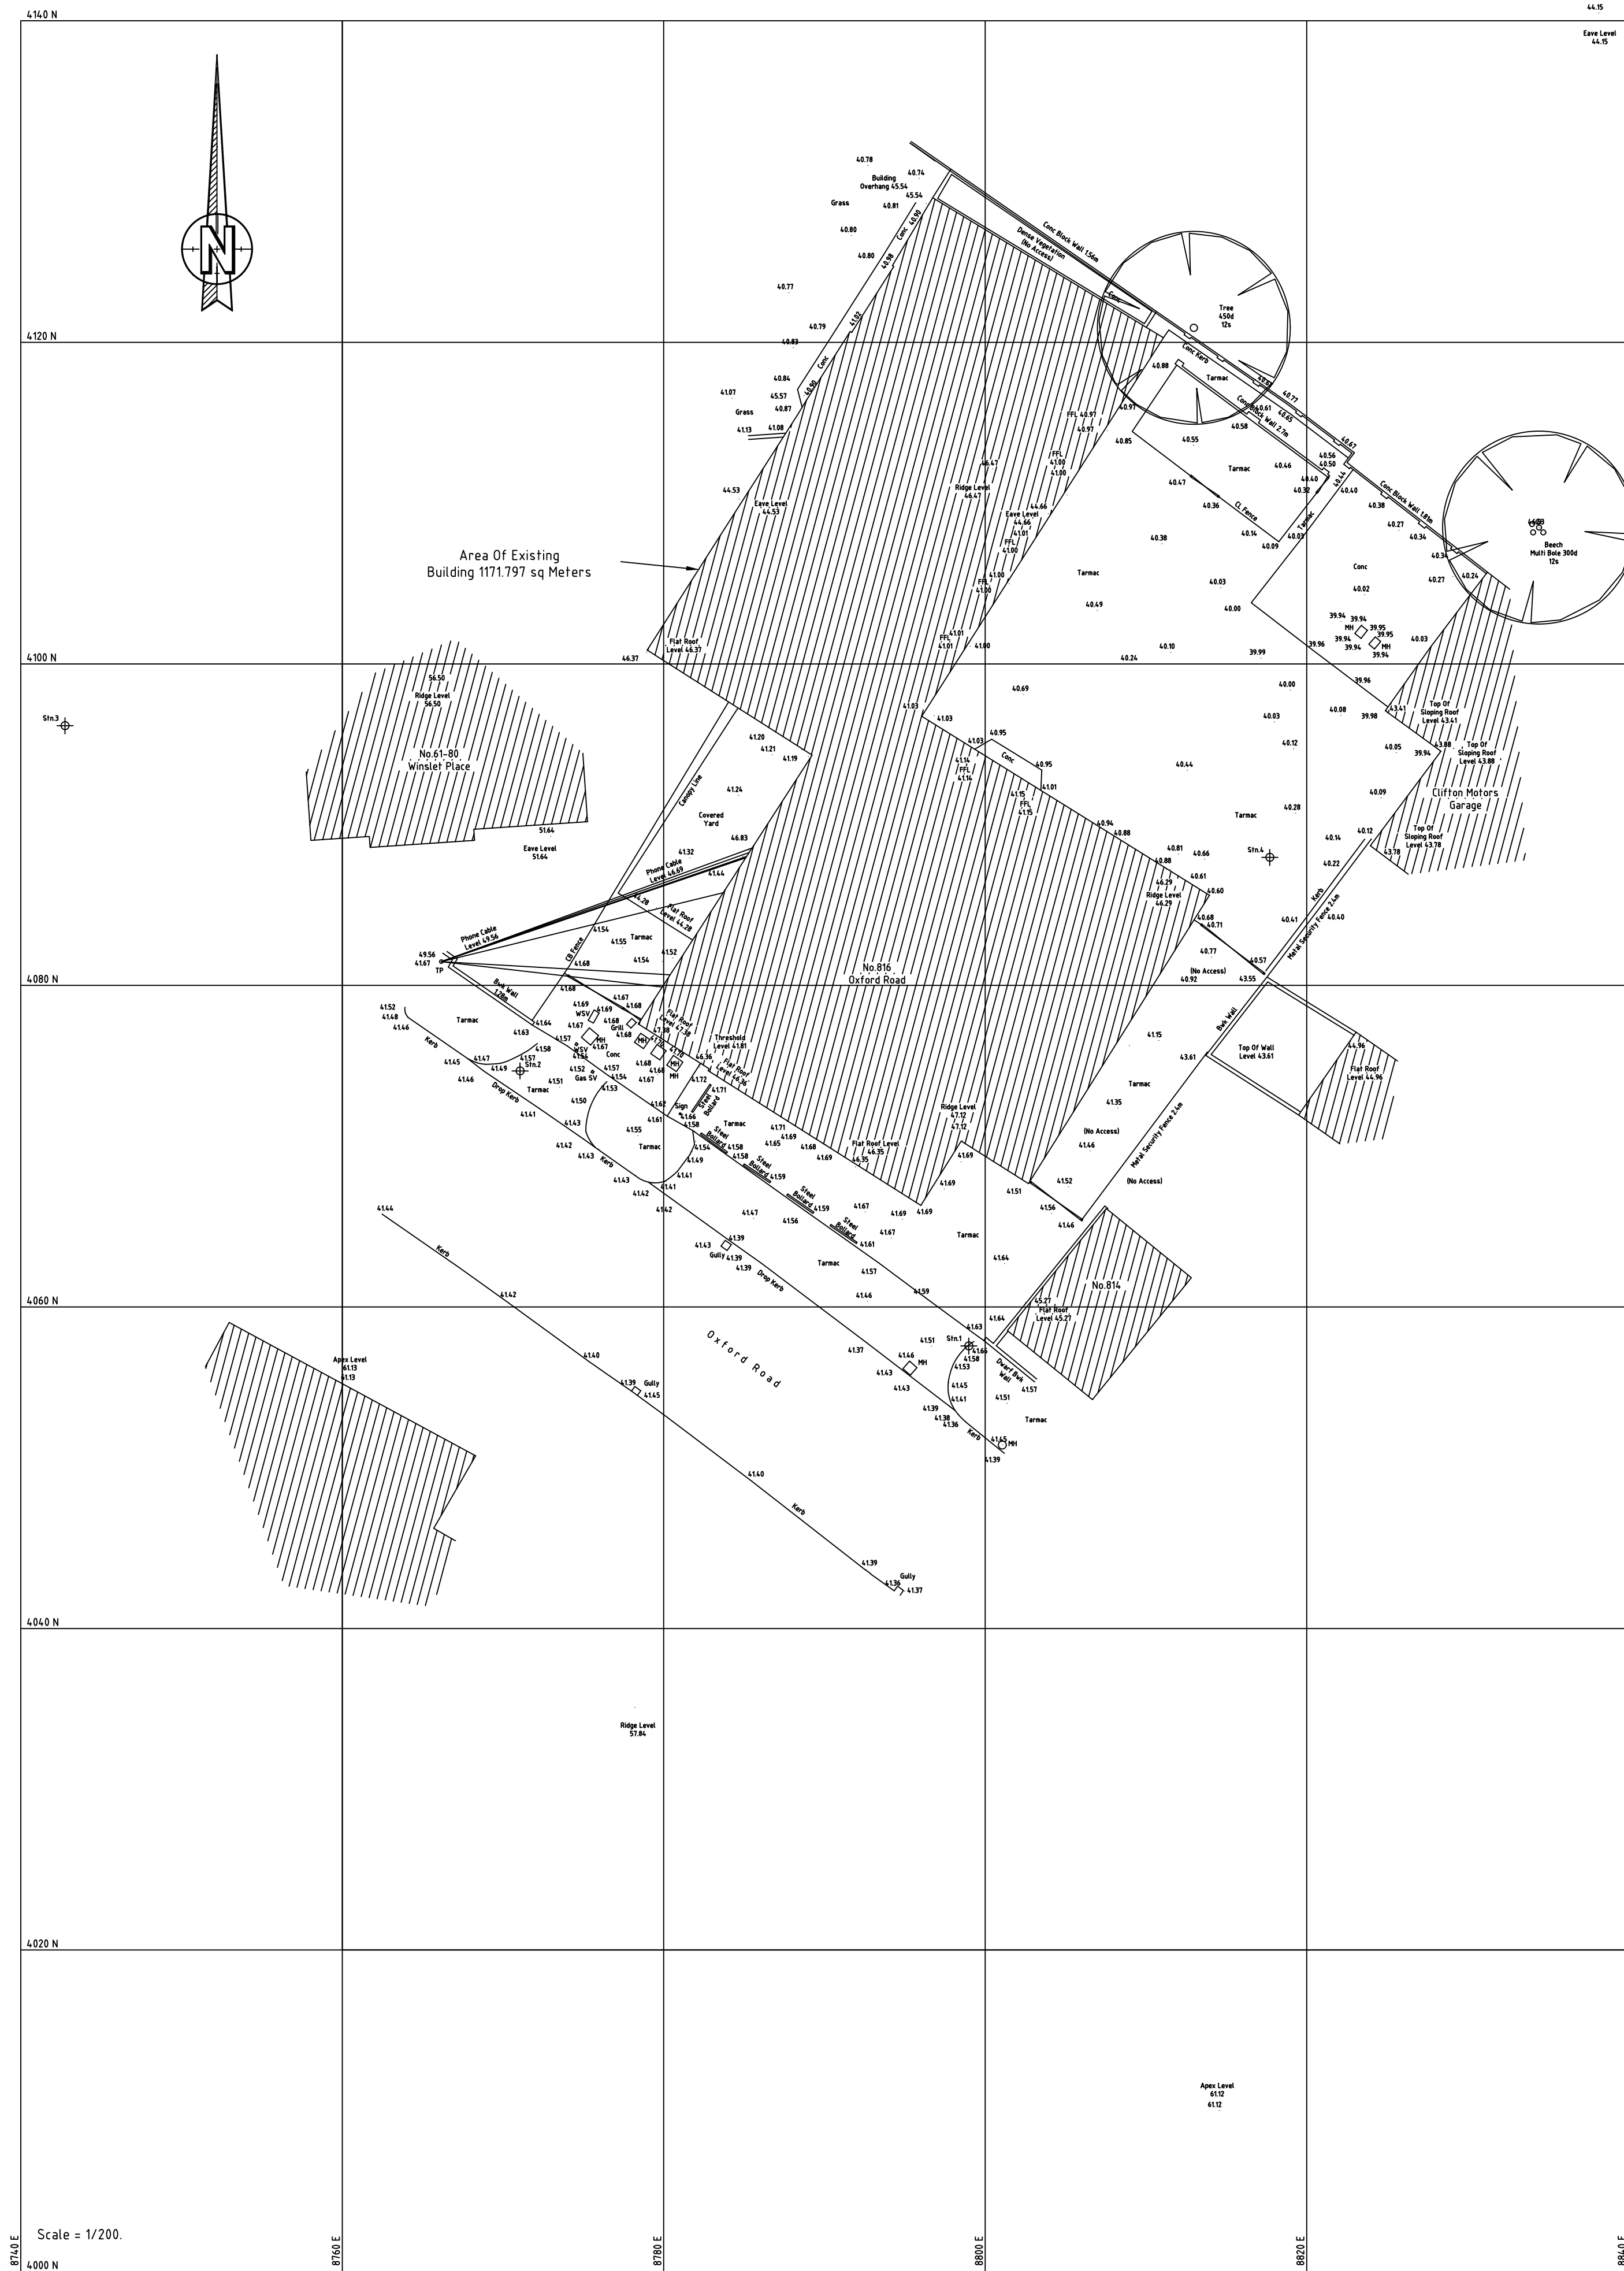
**Topographical Survey**

Survey Notes  
Insertion Point to OS  
Stn.1 468798.977 174057.569

Survey Co-Ords  
 Stn.1 8798.977 4057.569 41.603  
 Stn.2 8771.057 4074.682 41.493  
 Stn.3 8742.750 4096.150 41.344  
 Stn.4 8817.706 4087.962 40.469

- 2.1. The topographical survey indicates a number of existing manhole covers to the front and back of the site.
- 2.2. The topographical survey undertaken by Peter J.H.Roberts and Associates is included as **Appendix B**.

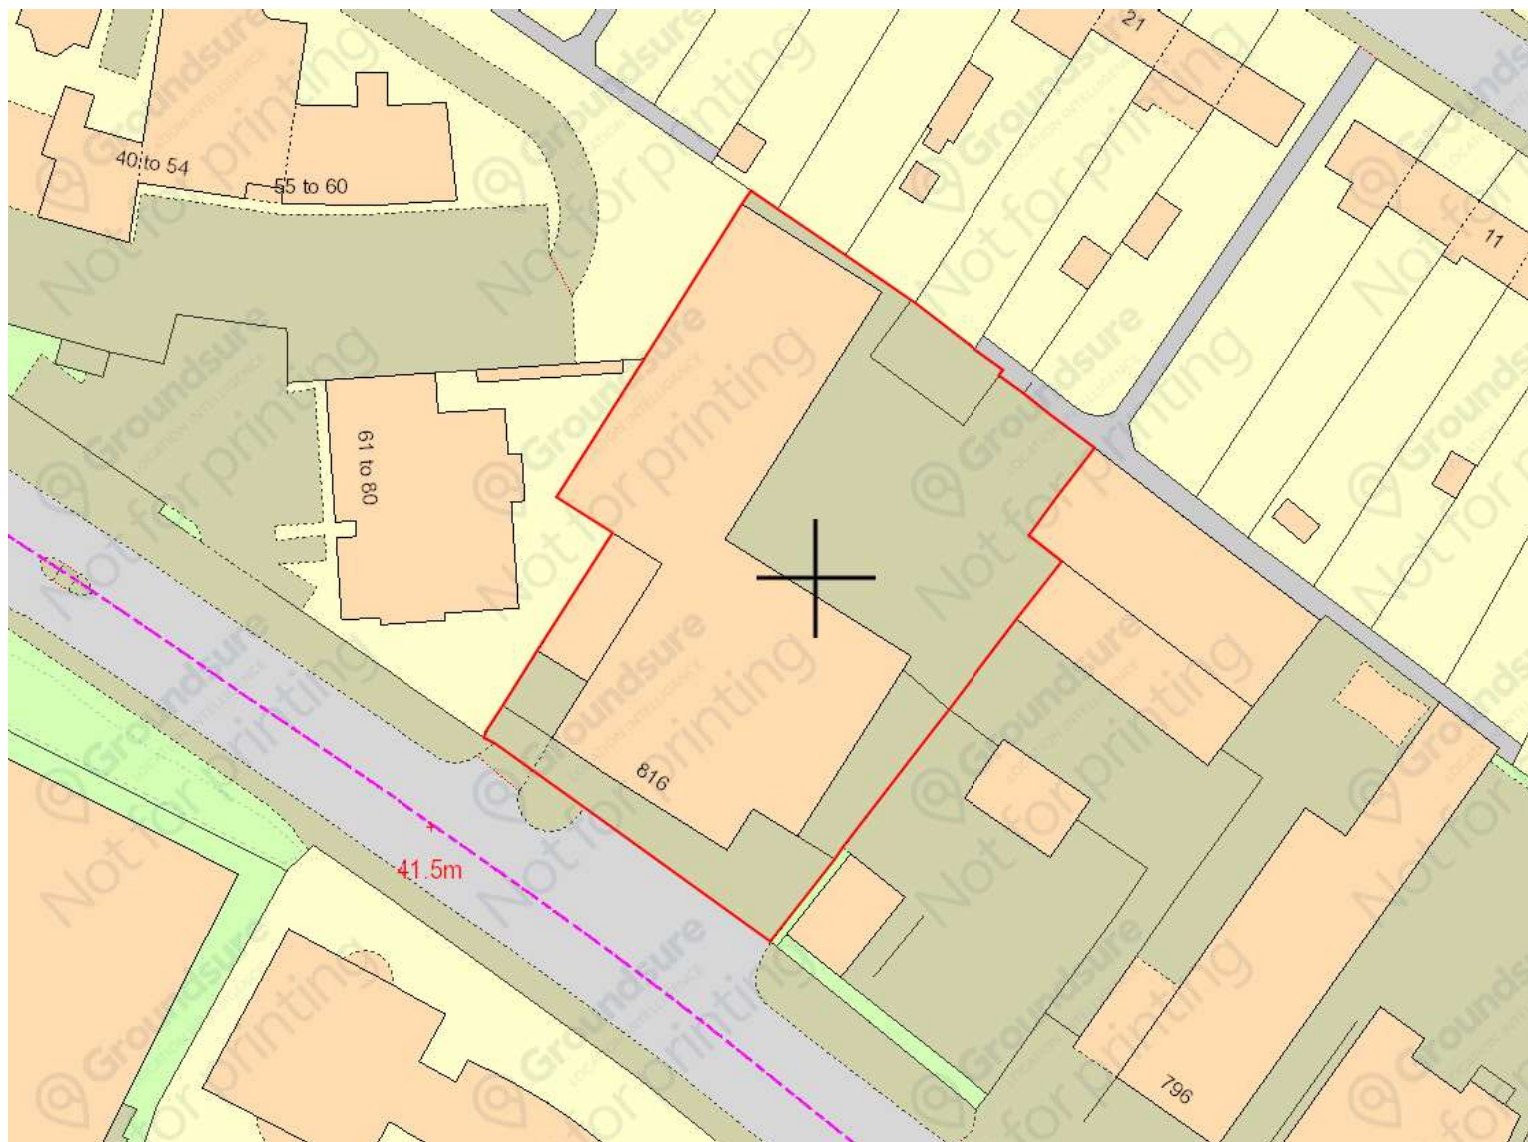
**Figure 2 – Site Development Area**

The national grid reference for the centre of the site was approximately SU 68804 74093. A site location plan is given within Figure 1. A plan showing the site area is given within Figure 2.

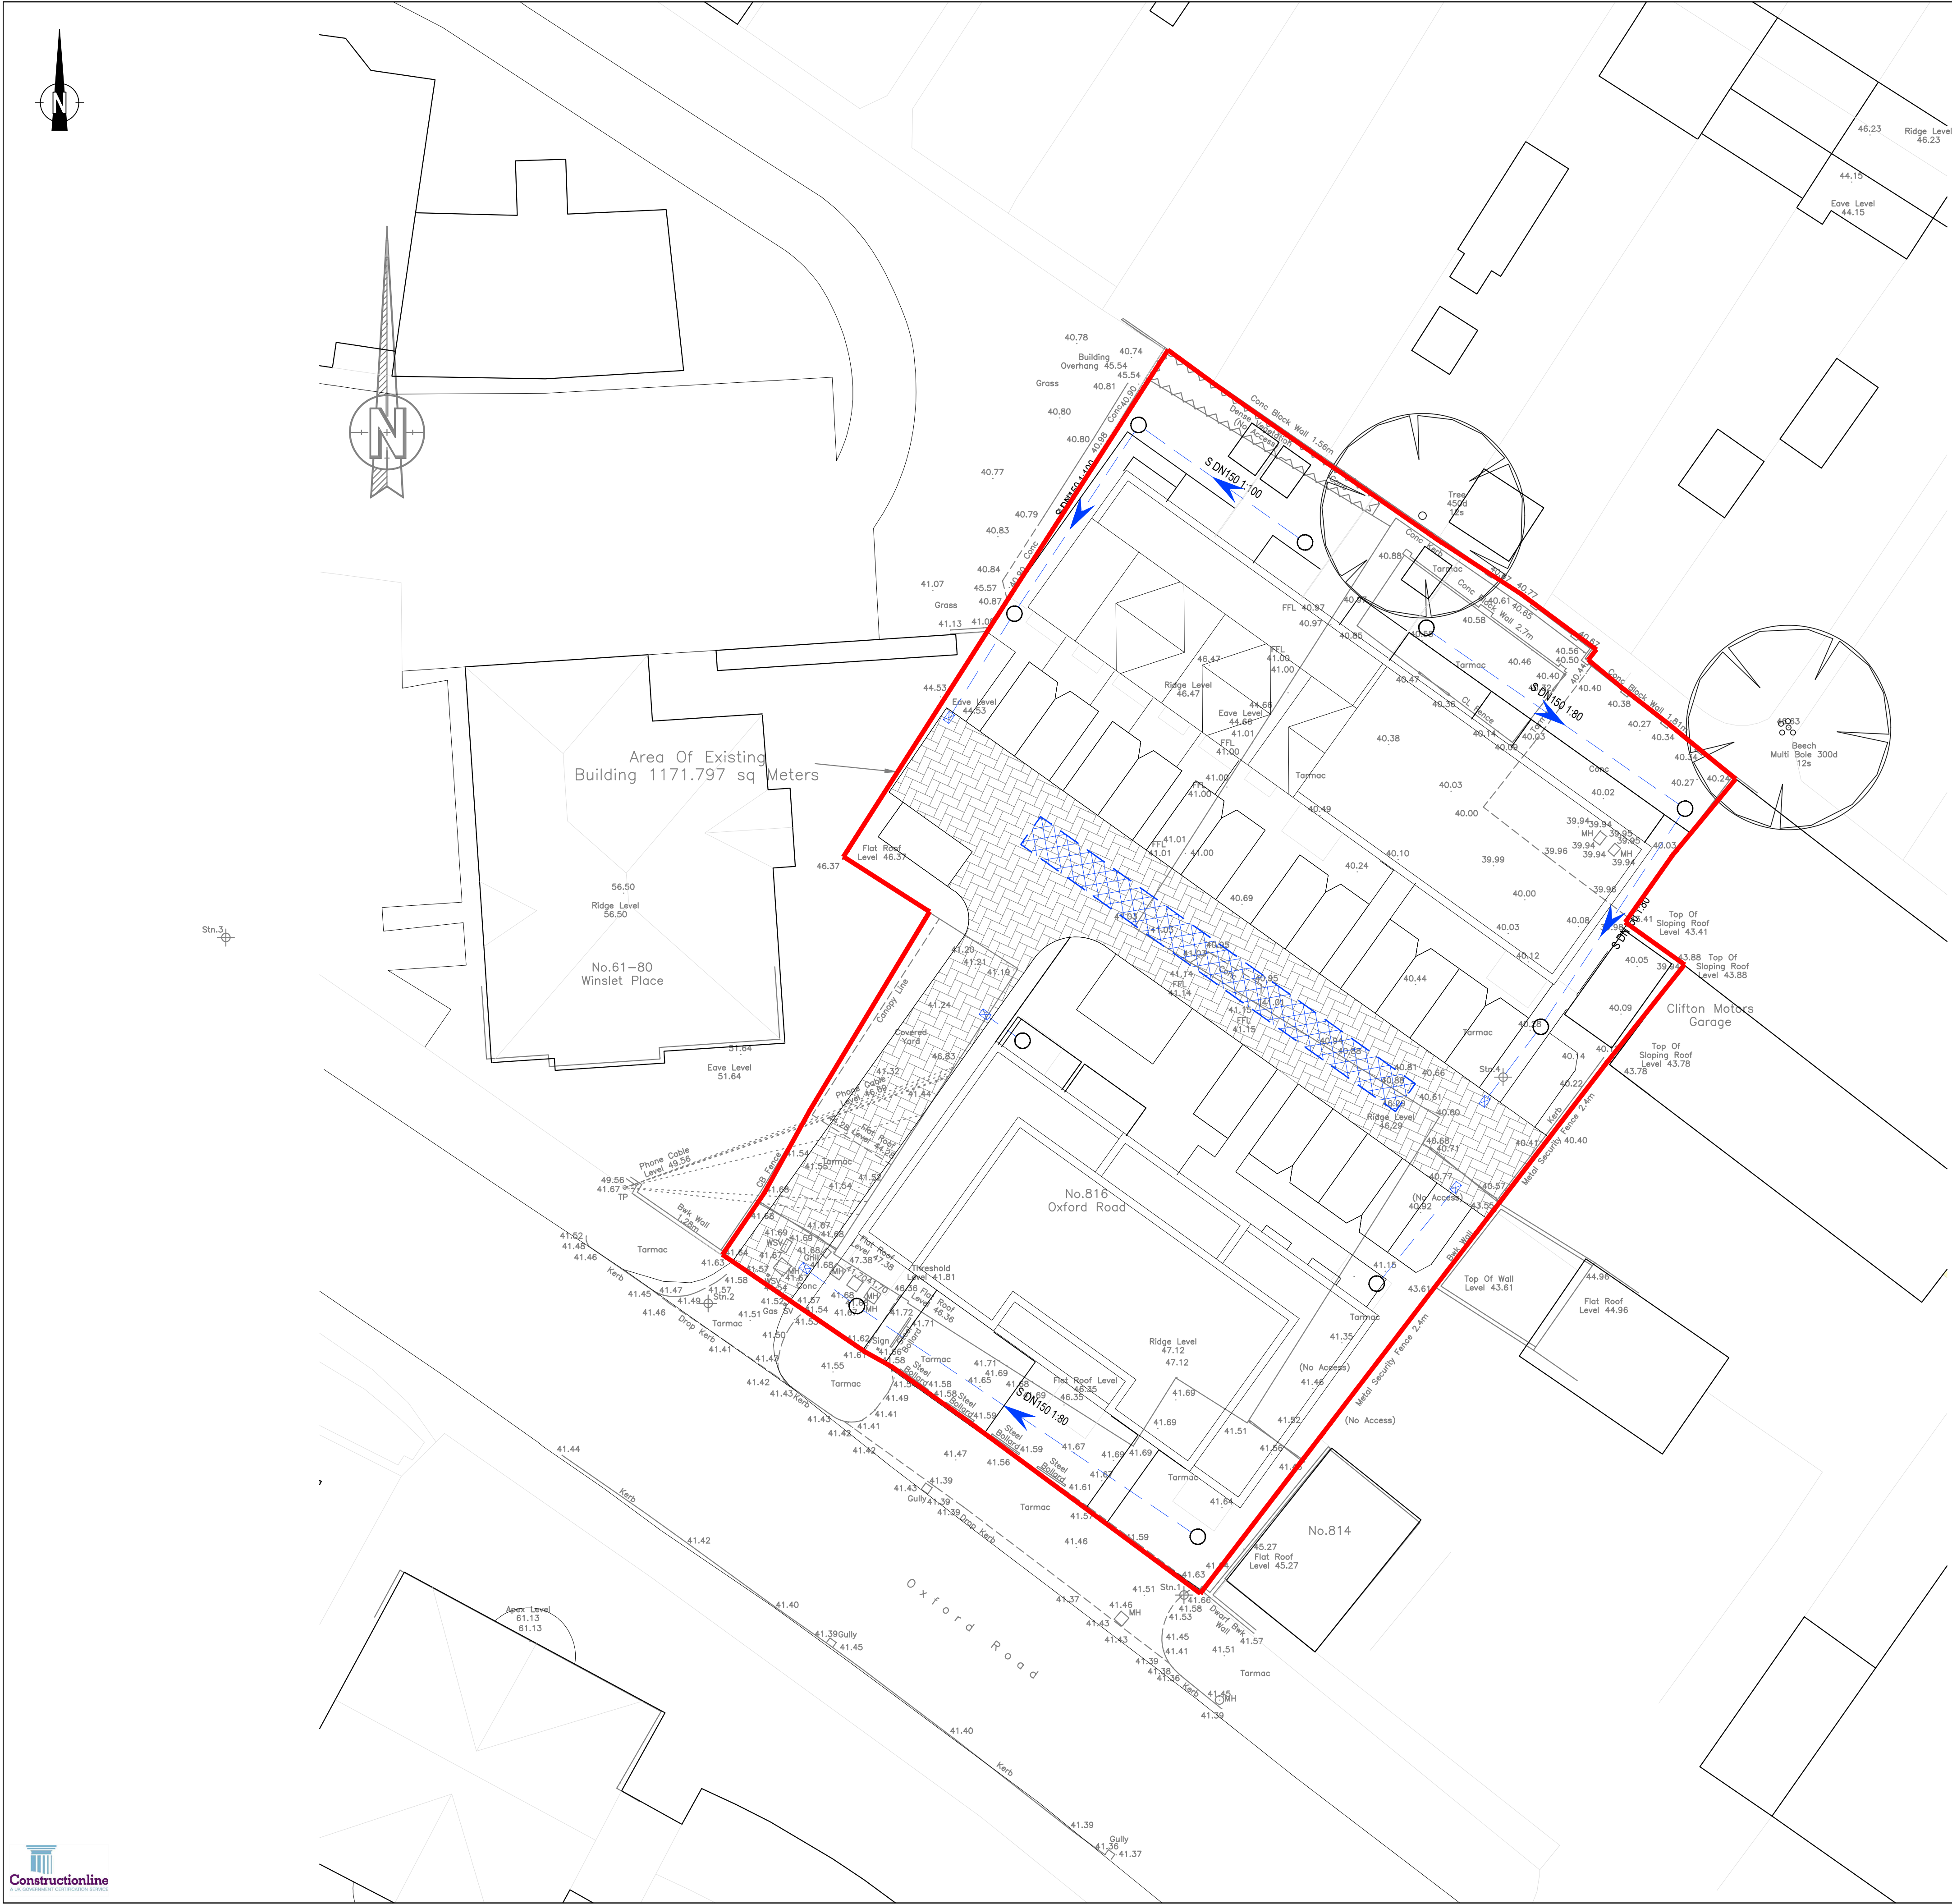
**Drainage Strategy**

- SURFACE WATER DRAINAGE STRATEGY**
- INFILTRATION TESTING SHOWED INFILTRATION POTENTIAL FOR THE SITE FOR SURFACE WATER DISCHARGE.
  - ALL SURFACE WATER RUNOFF FROM SITE TO DISCHARGE INTO THE GROUND VIA THE POROUS PAVED ACCESS.
  - INFILTRATION RATE USED FOR THE PERMEABLE PAVING AND CRATE SOAKAWAY IS 1.077x10<sup>-6</sup>m/s, BASED ON TESTING IN TRIAL PIT TP2.
  - GRATE SOAKAWAY TO BE LOCATED UNDERNEATH FORMATION OF PERMEABLE PAVING AND PROVIDE EXTRA STORAGE AT DEPTH.
  - PERMEABLE PAVING DESIGNED A 1.1m DEEP AND CRATE SOAKAWAY DESIGNED AT 0.4m DEEP FOR A TOTAL DEPTH OF 1.5m
  - MICRO DRAINAGE CALCULATIONS SHOW THAT ALL STORAGE REQUIREMENTS FOR THE SITE CAN BE ACCOMMODATED WITHIN THE PROPOSED PERMEABLE PAVING AND CRATES FOR ALL STORM EVENTS UP TO AND INCLUDING THE 1 IN 100 YEAR PLUS 40% CC EVENT.

- 3.14. It is proposed that all surface water from the redevelopment will infiltrate into the ground through porous pavements in the access road. Crate soakaways are proposed to be provided beneath a section of the pervious pavement to provide further storage of surface water runoff before infiltration into the ground.

- 3.15. Surface water runoff from hardstanding areas will run towards the permeable paving and infiltrate into the ground, and runoff from roof areas will be collected by surface water drains and discharged into the sub-base of the pervious paving, where all surface water will infiltrate into the ground.
