Thank you for your e-mail dated 7<sup>th</sup> April 2022 relating to my application at 31 Northcourt Avenue, and the comments from ecology. They consider that “the house may host roosting bats”, and so state that there is a requirement for a bat survey to confirm if this is the case. I understand that this is the case if there is a ‘reasonable likelihood’ of bats being present at the property. The following outlines why I do not believe this to be the case at the property being developed, and submit this statement in response, as per the guidance given on p.23 of the Reading Borough Council “*Validation Requirements For Planning Applications November 2021 Edition*”, referenced below:

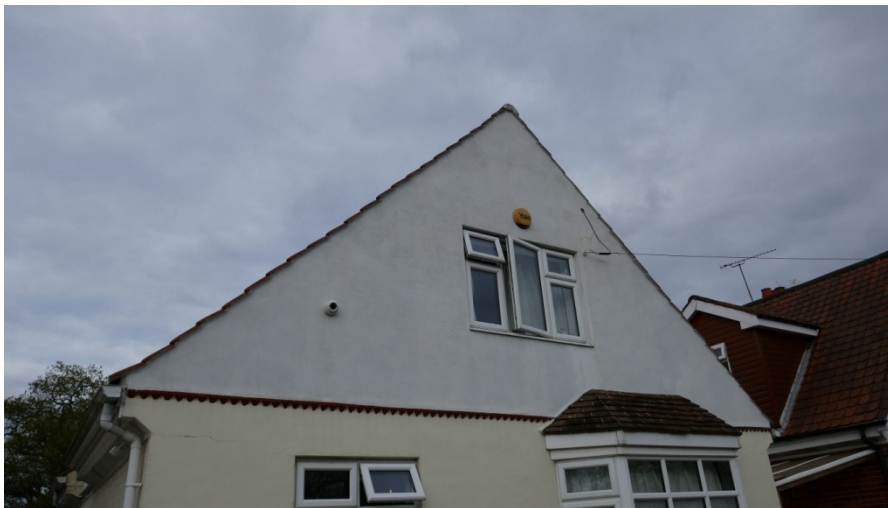
Diagram.2

- Unlike other properties on the street, the chimney has historically been removed from the property and covered up with tiles and so there are no openings. See diagram.2.

- All soffits and fascia are sealed with straight edge timber against straight edge brick. The do not even contain pre-cut ventilation holes which could potentially be used as access. The render to both the front and rear gable ends goes directly up to the tile edge, with no overhanging soffit or fascia to create a gap for access. The existing half dormer over the staircase has minimal side edges of whole sheet lead flashing. This is fitted to be flush to the roof tiles on the main roof slope, with no holes or gaps. Due to the small size the lead face it also appears to have a single joint/ or a repair, which has been sealed to avoid openings. To the roof of this half dormer the tiles also do not overhang the sides, and mortar fills the resulting joint. None of these 'joints' are directly attached to the main loft space, with the eaves being 4m away from the main loft, and any space between the roof rafters is considered to be insulated. See diagrams.2-6
