43A CHURCH ROAD,  
CAVERSHAM,  
BERKSHIRE

## **Bat Survey Report**

June 2021  
9548.BatReport.vf

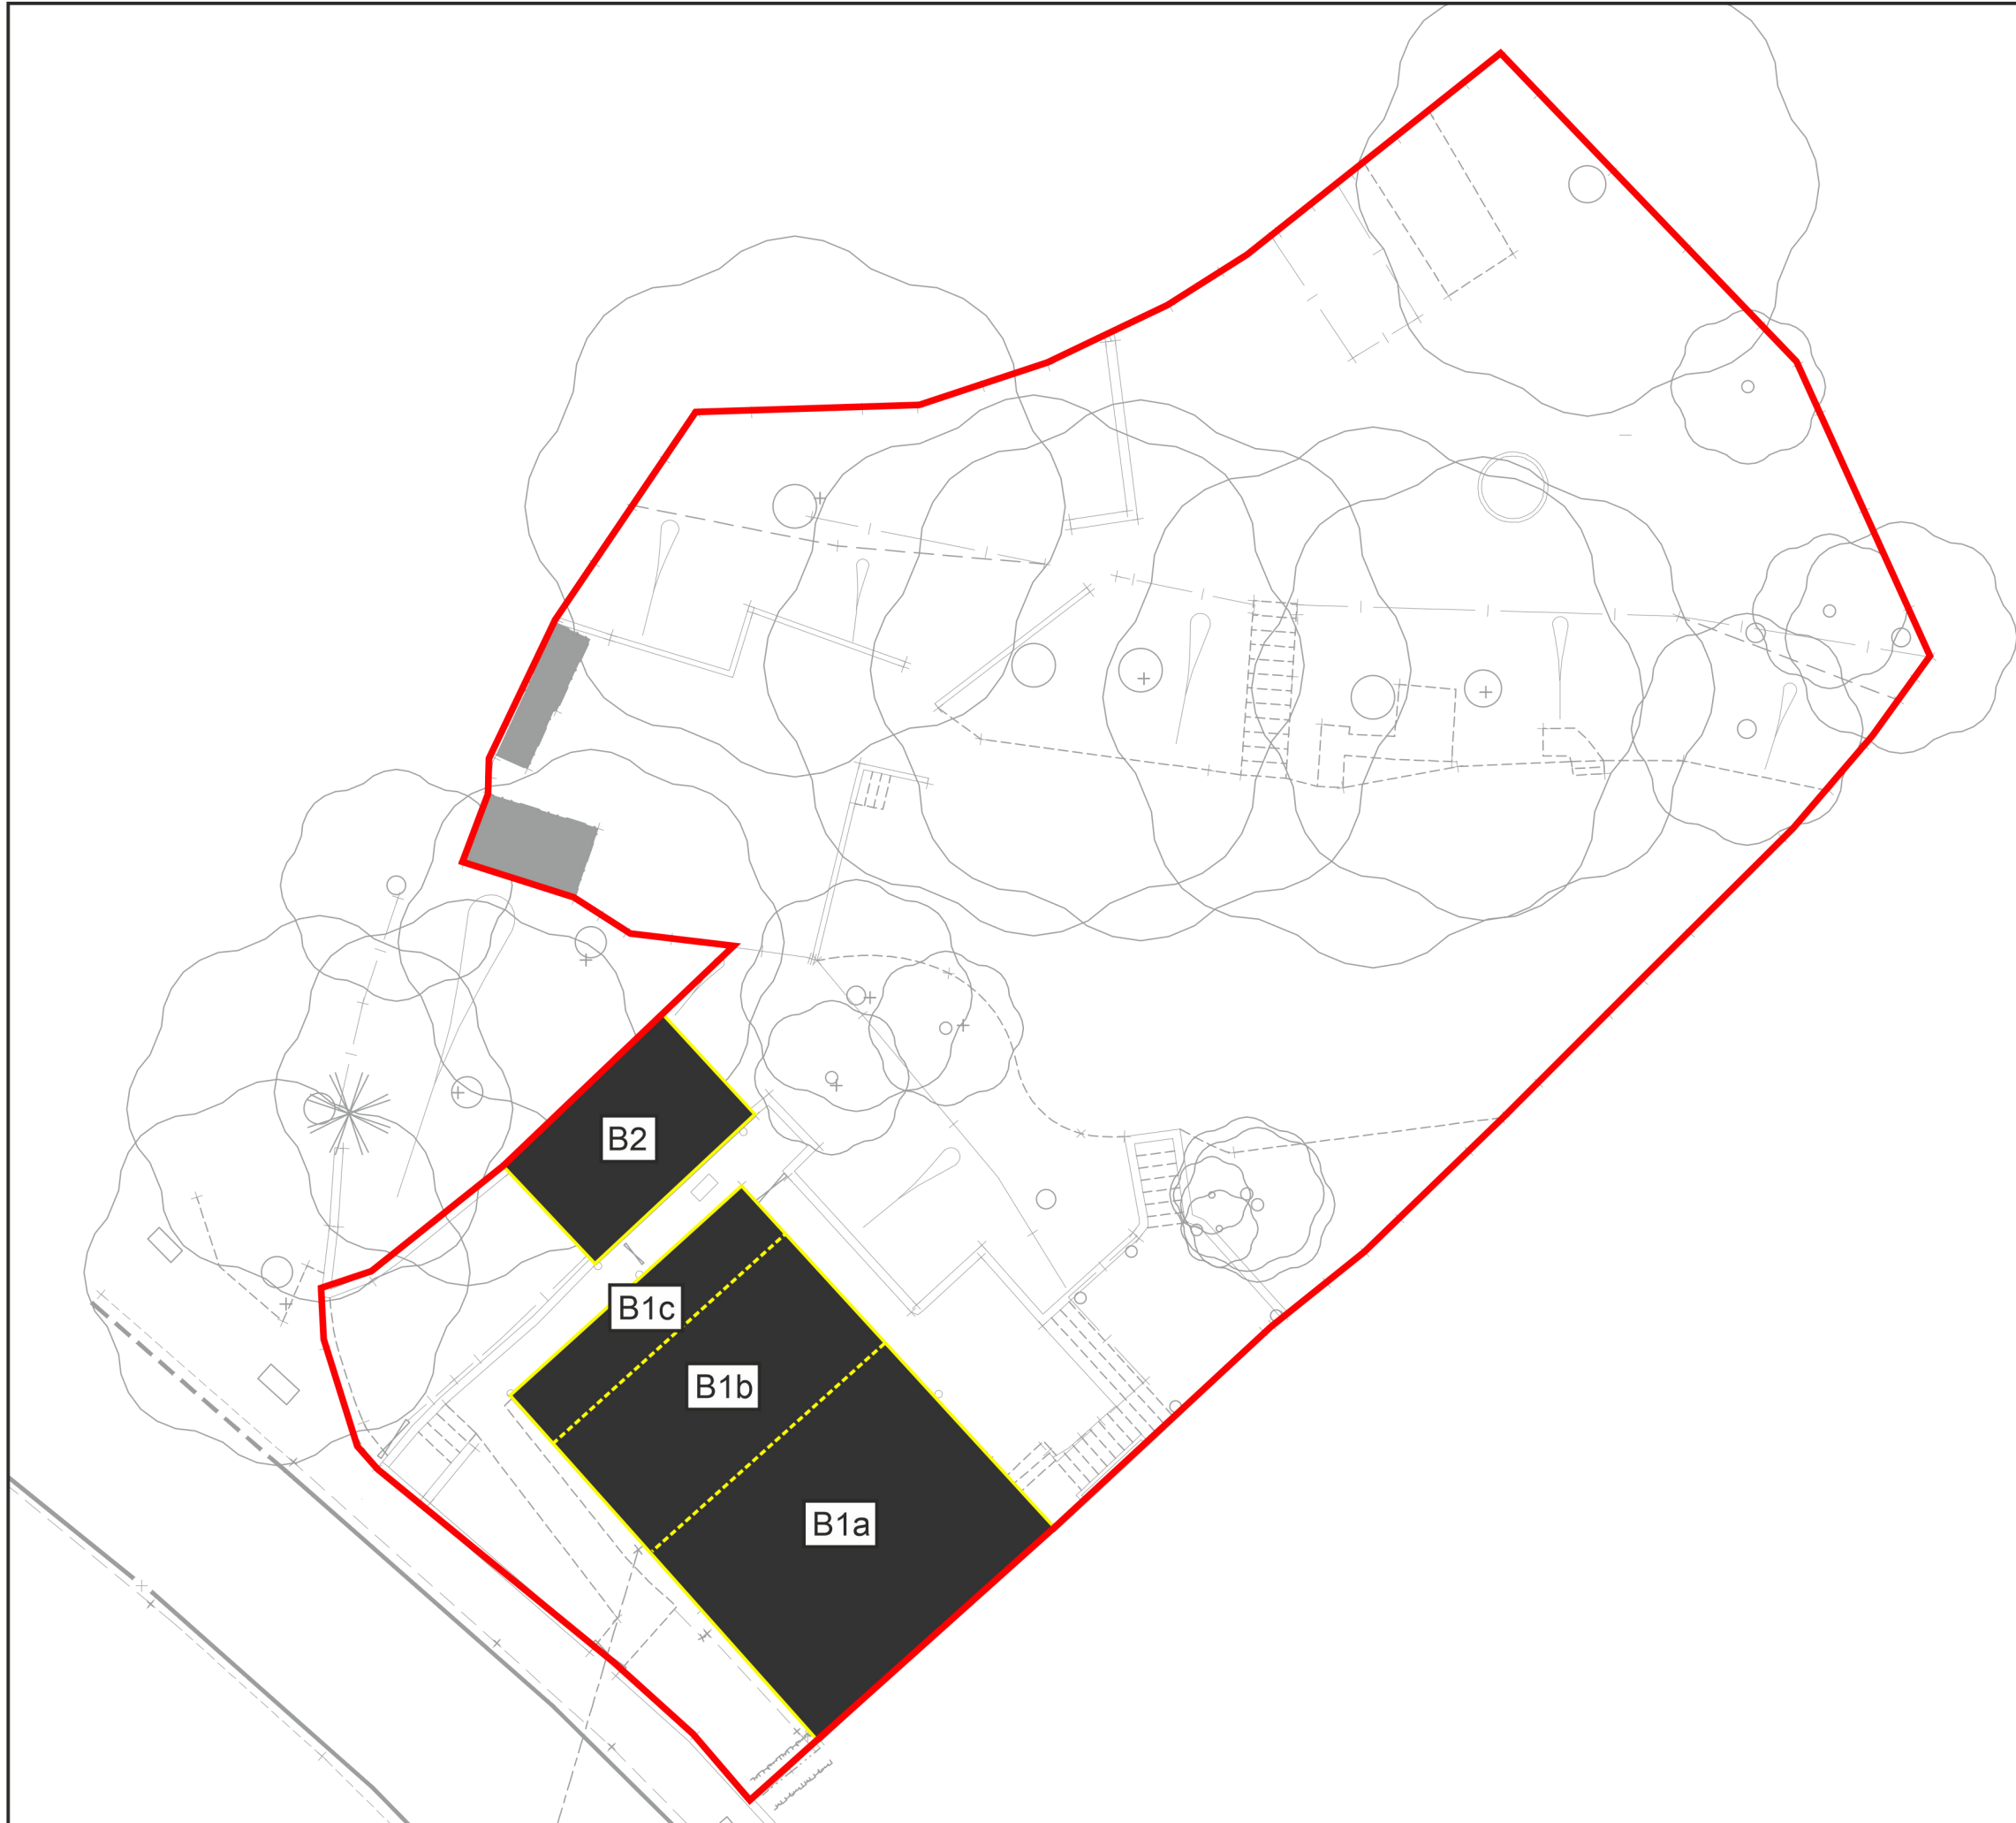
PLAN ECO2:  
BUILDING LOCATIONS

- 1.2.1. The site comprises two buildings. Building B1 is a Grade II listed residential property divided into three sections: B1a, B1b and B1c. Building B2 is a single storey garage.
- 1.2.2. The proposals for the site are to demolish the garage (Building B2) and to construct a two-storey extension on Building B1.

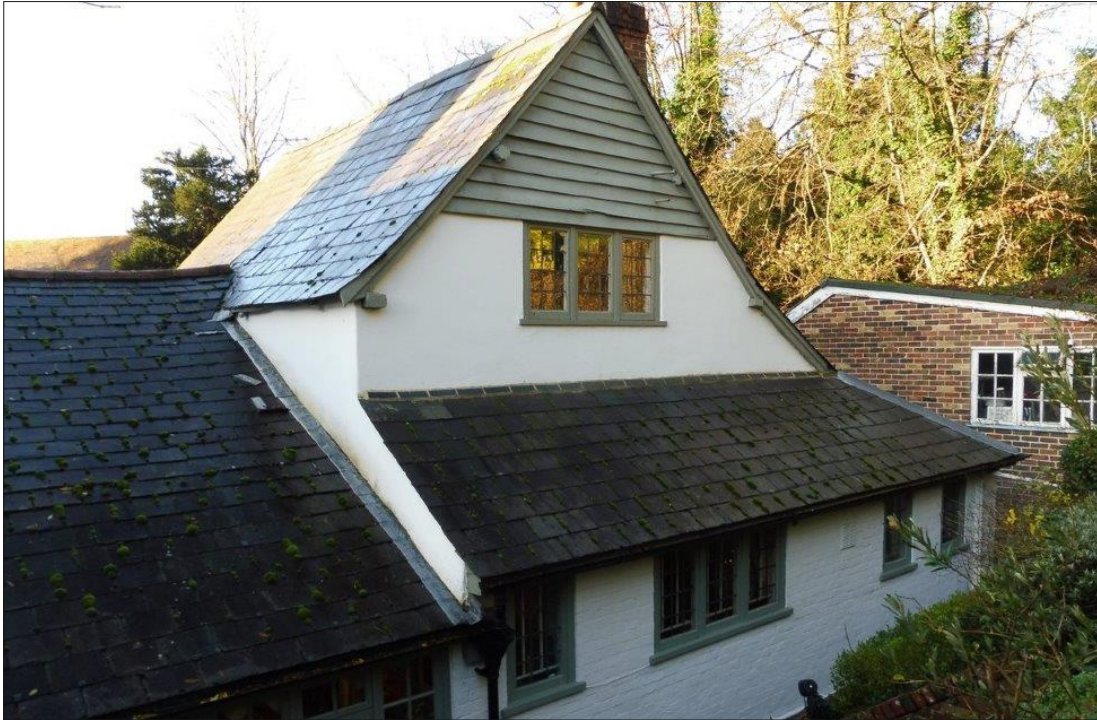
PHOTOGRAPH 1: Building B1

- 4.1.1. The site is located in the suburb of Caversham in Reading, Berkshire (see Plan ECO1).
- 4.1.2. Building B1 is a Grade II listed brick-built residential property (see Photograph 1). There are three sections, each containing a separate loft void. B1a is a single storey section with a pitched slate tile roof with ridge tiles. The roof is in good condition with only a few gaps under the slate tiles and ridge tiles. The void of section B1a is small with a wooden frame and sarking boards (see Photograph 2). The height is approximately 1m at the apex. It is 2.5m wide and approximately 5m long. Half of the space is in use as miscellaneous storage. No access points were recorded.

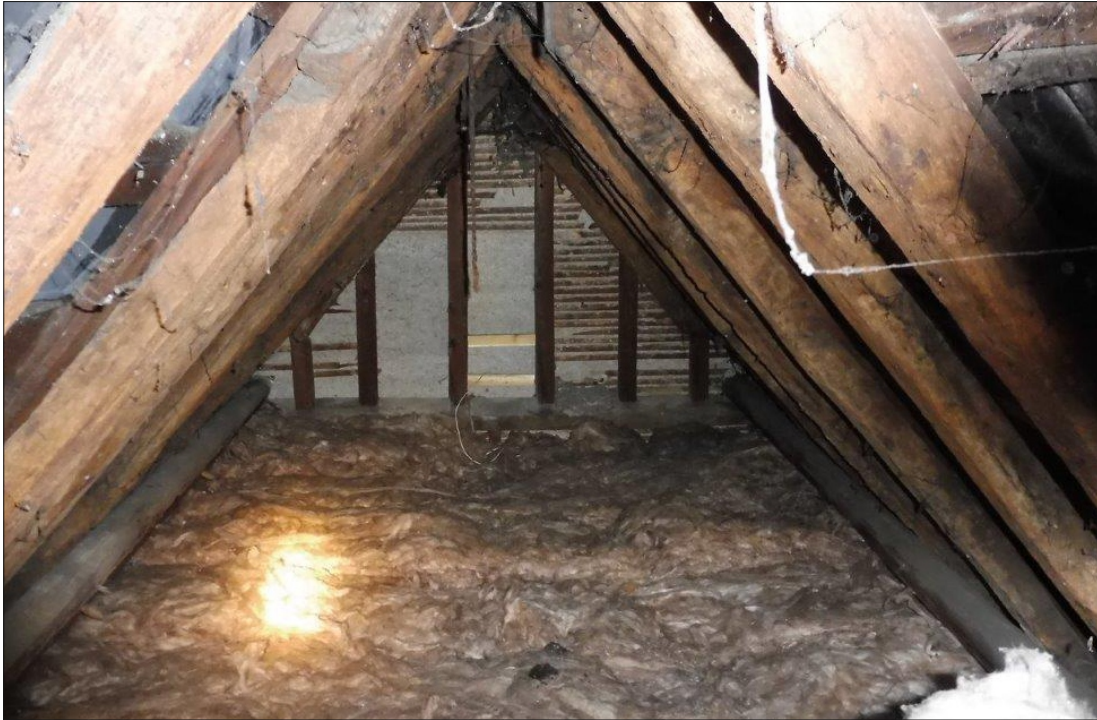
PHOTOGRAPH 3: Loft Void within Building B1b

- 4.1.3. B1b is the two-storey section with a pitched slate tile roof and ridge tiles. The majority of the roof is in good condition with a few gaps under the slate tiles and ridge tiles. Lead flashing is present at the join with B1a and surrounding the chimney. Good condition wood cladding is present in the gable at the rear of the building. The void of section B1b is larger with access to the southwestern end blocked by the water tank (see Photograph 3). The remainder of the void is used for miscellaneous storage. The void is approximately 2m at the apex, with a width of 2m and length of 8m. The loft has a wooden frame and no lining which provides access to the slate tiles. A number of potential access points are present.

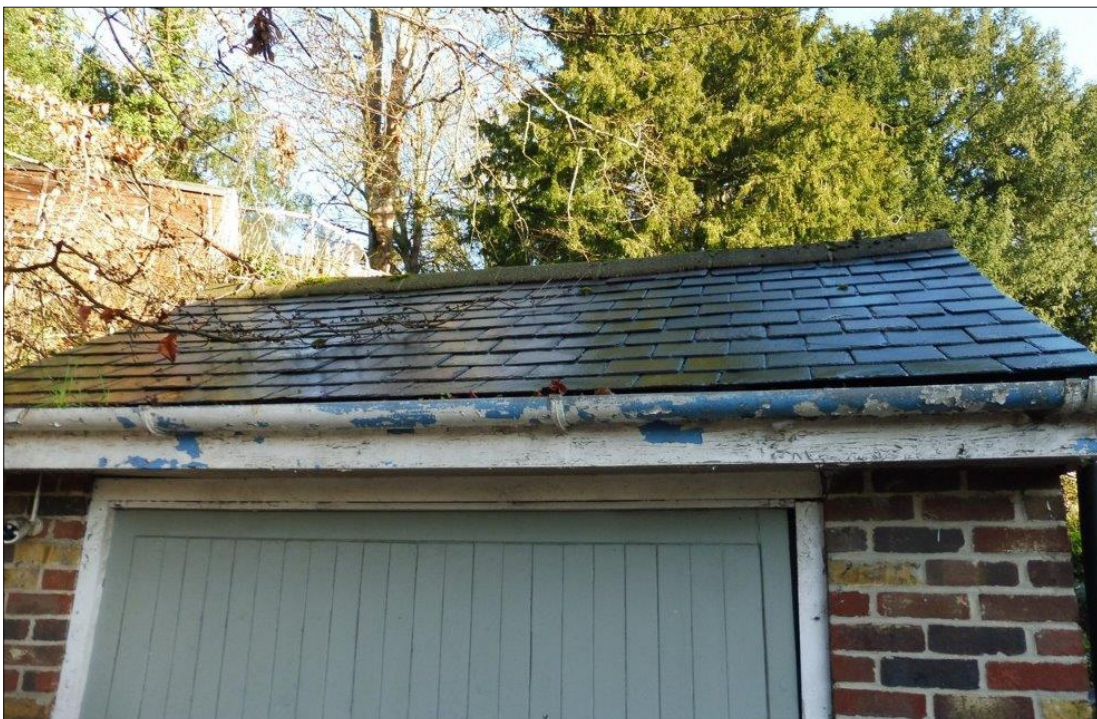
PHOTOGRAPH 4: Building B2

- 4.1.5. Building B2 is a single storey garage with a pitched roof (see Photograph 4). The front of the roof has slate tiles and ridge tiles whereas the rear comprises a shallower bitumen felt section of roof. A wooden soffit is present at the front of the garage. Significant Ivy *Hedera helix* is present at the rear of the building. A small number of gaps were recorded under the ridge tiles.

- 6.2.1. The proposals for the site are to demolish Building B2 and construct a two-storey extension attached to Building B1c.
- 6.2.2. Owing to the absence of roosting bats within the building, the building can be demolished without the need for a Natural England European Protected Species (EPS) licence.
- 6.2.3. In the unlikely event that any bats are encountered during the demolition, all work will cease immediately, and Ecology Solutions will be contacted for advice.
