# Ecological Technical Note

## Proposed Temporary Car Park, Green Park Village, Reading

August 2021, Revision B

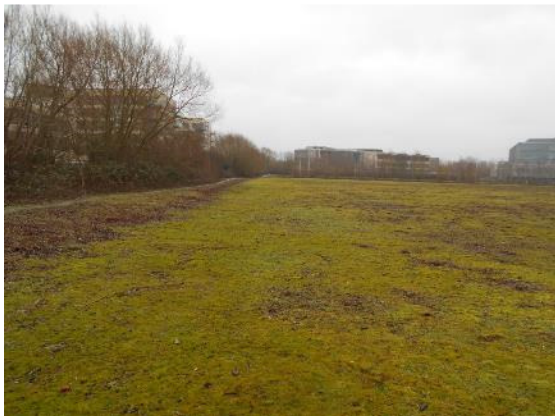
Photograph 1. View east across Site

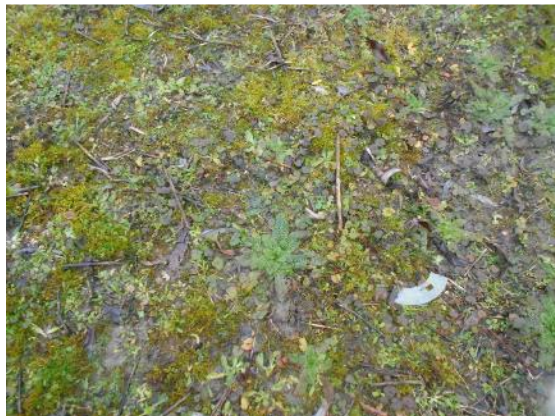
- 3.8 The Site comprises a strip of uncultivated land dominated by low-growing herbs and mosses with compacted stone in parts. The vegetation was primarily short and relatively sparse, typical of colonising ground, with a few ruderal species. Aerial photographs (Google Earth) suggest it may have historically been grassland but was partly cleared in or prior to 2003 before being reinstated. Some areas of standing water were present during the January visit though there was no indication from the vegetation present that these are any more than temporary pools following wet weather. An unsurfaced worn footpath is present along the northern edge of the Site.

Photograph 2. Close-up of colonising ground vegetation

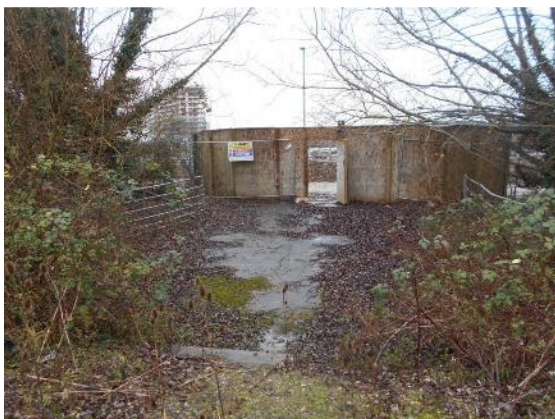
Photograph 3. View north across ditch bridge towards Smallmead Road

- 4.1 Habitats to be impacted by proposed car park are considered to be of low ecological value and do not pose a constraint to the works.
- 4.2 Adjoining boundary habitats are of greater significance, with ditch, scrub and tree habitats providing habitat for a range of wildlife and forming part of the local green/blue infrastructure network, as well as having intrinsic ecological value. There is potential for protected species to occur in association with these habitats, namely bats, otter, nesting birds and grass snake.
- 4.3 It is understood that these habitats are not due to be directly impacted, with the exception of some minor trimming back of overhanging tree branches and immature bramble scrub on the existing bridge (see photo

in Appendix A) and at the proposed access point on the eastern boundary to improve visibility when needed. There will also be clearance of limited area of bramble scrub for construction of the headwall and pipework. The location and arrangement of the car park and drainage features have been designed to minimise impacts of trees and their roots.

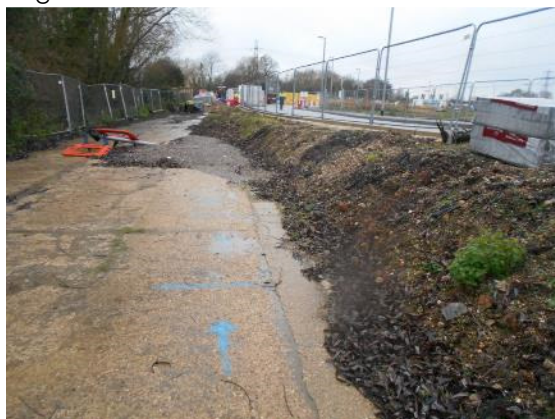
- 3.10 The development proposals also include a small area of hard-standing over a culverted ditch/drain plus some hard-standing, bare and colonising ground along the verge of Flagstaff Road.

Photograph 4. View west along Smallmead Road showing hard-standing and bare ground habitats to be cleared for access route

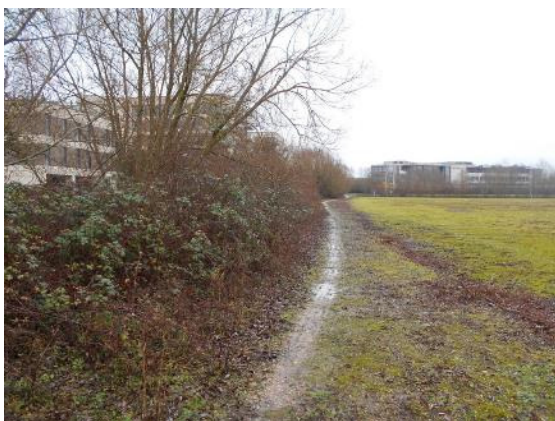
- 3.11 Habitats immediately surrounding the red-line area are also of relevance to the proposals. The Site is part of a larger field bounded by ditches, trees and scrub. The northern boundary of the field comprises a ditch corridor south of Smallmead Road. The watercourse is located within a shallow channel c. 4m in width and the water level was c. 1m deep at the time of the visit. Scattered mature willow *Salix* spp. pollards are present on either side of the bank. Additional trees include mature ash *Fraxinus excelsior*, alder *Alnus glutinosa* and semi-mature silver birch *Betula pendula*, elder *Sambucus nigra* and rose *Rosa* sp. There is a surfaced foot/cyclepath north of the stream which links Kirtons Farm Road with Longwater Avenue. The southern bank is dominated by dense bramble scrub. The drain is culverted in several locations and likely feeds in to the Green Park Flood Relief Channel to the east of Longwater Avenue. It is also connected to ditches along the eastern and western boundaries of the field.

Photograph 5. Northern ditch boundary with mature willows and bramble scrub (view east)

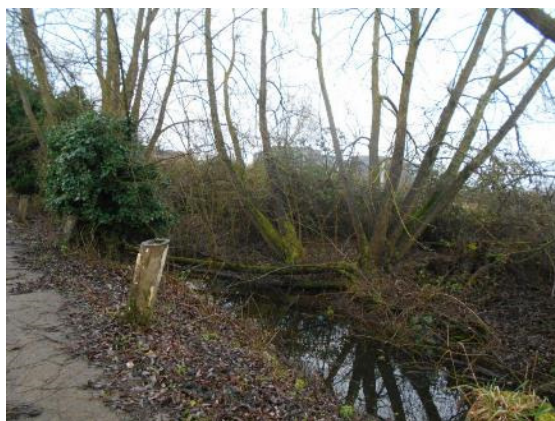
Photograph 6. Northern boundary drain

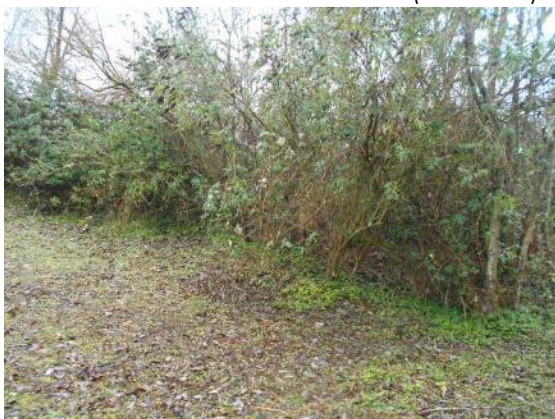
- 3.12 The western boundary of the field comprises another more minor ditch corridor with mature alder and willow trees. Mature *Buddleja* scrub is present along the field edge.

Photograph 7. Mature buddleja scrub along west boundary

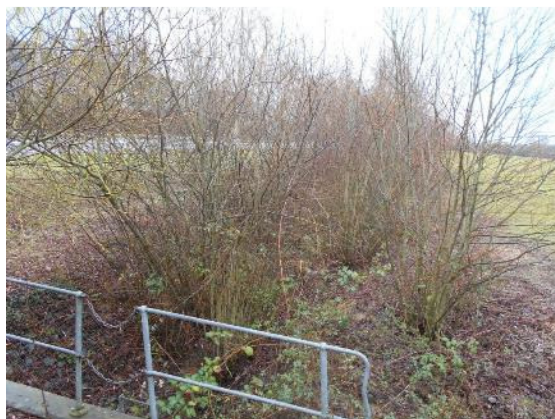
Photograph 8. Ditch with willows along west boundary (view south)
