**SUPPLEMENTARY GROUND INVESTIGATION REPORT**

**READING GOLF CLUB,**

**VISTRY THAMES VALLEY**

| Reference: | GE20079/SGIR/OCT21 |

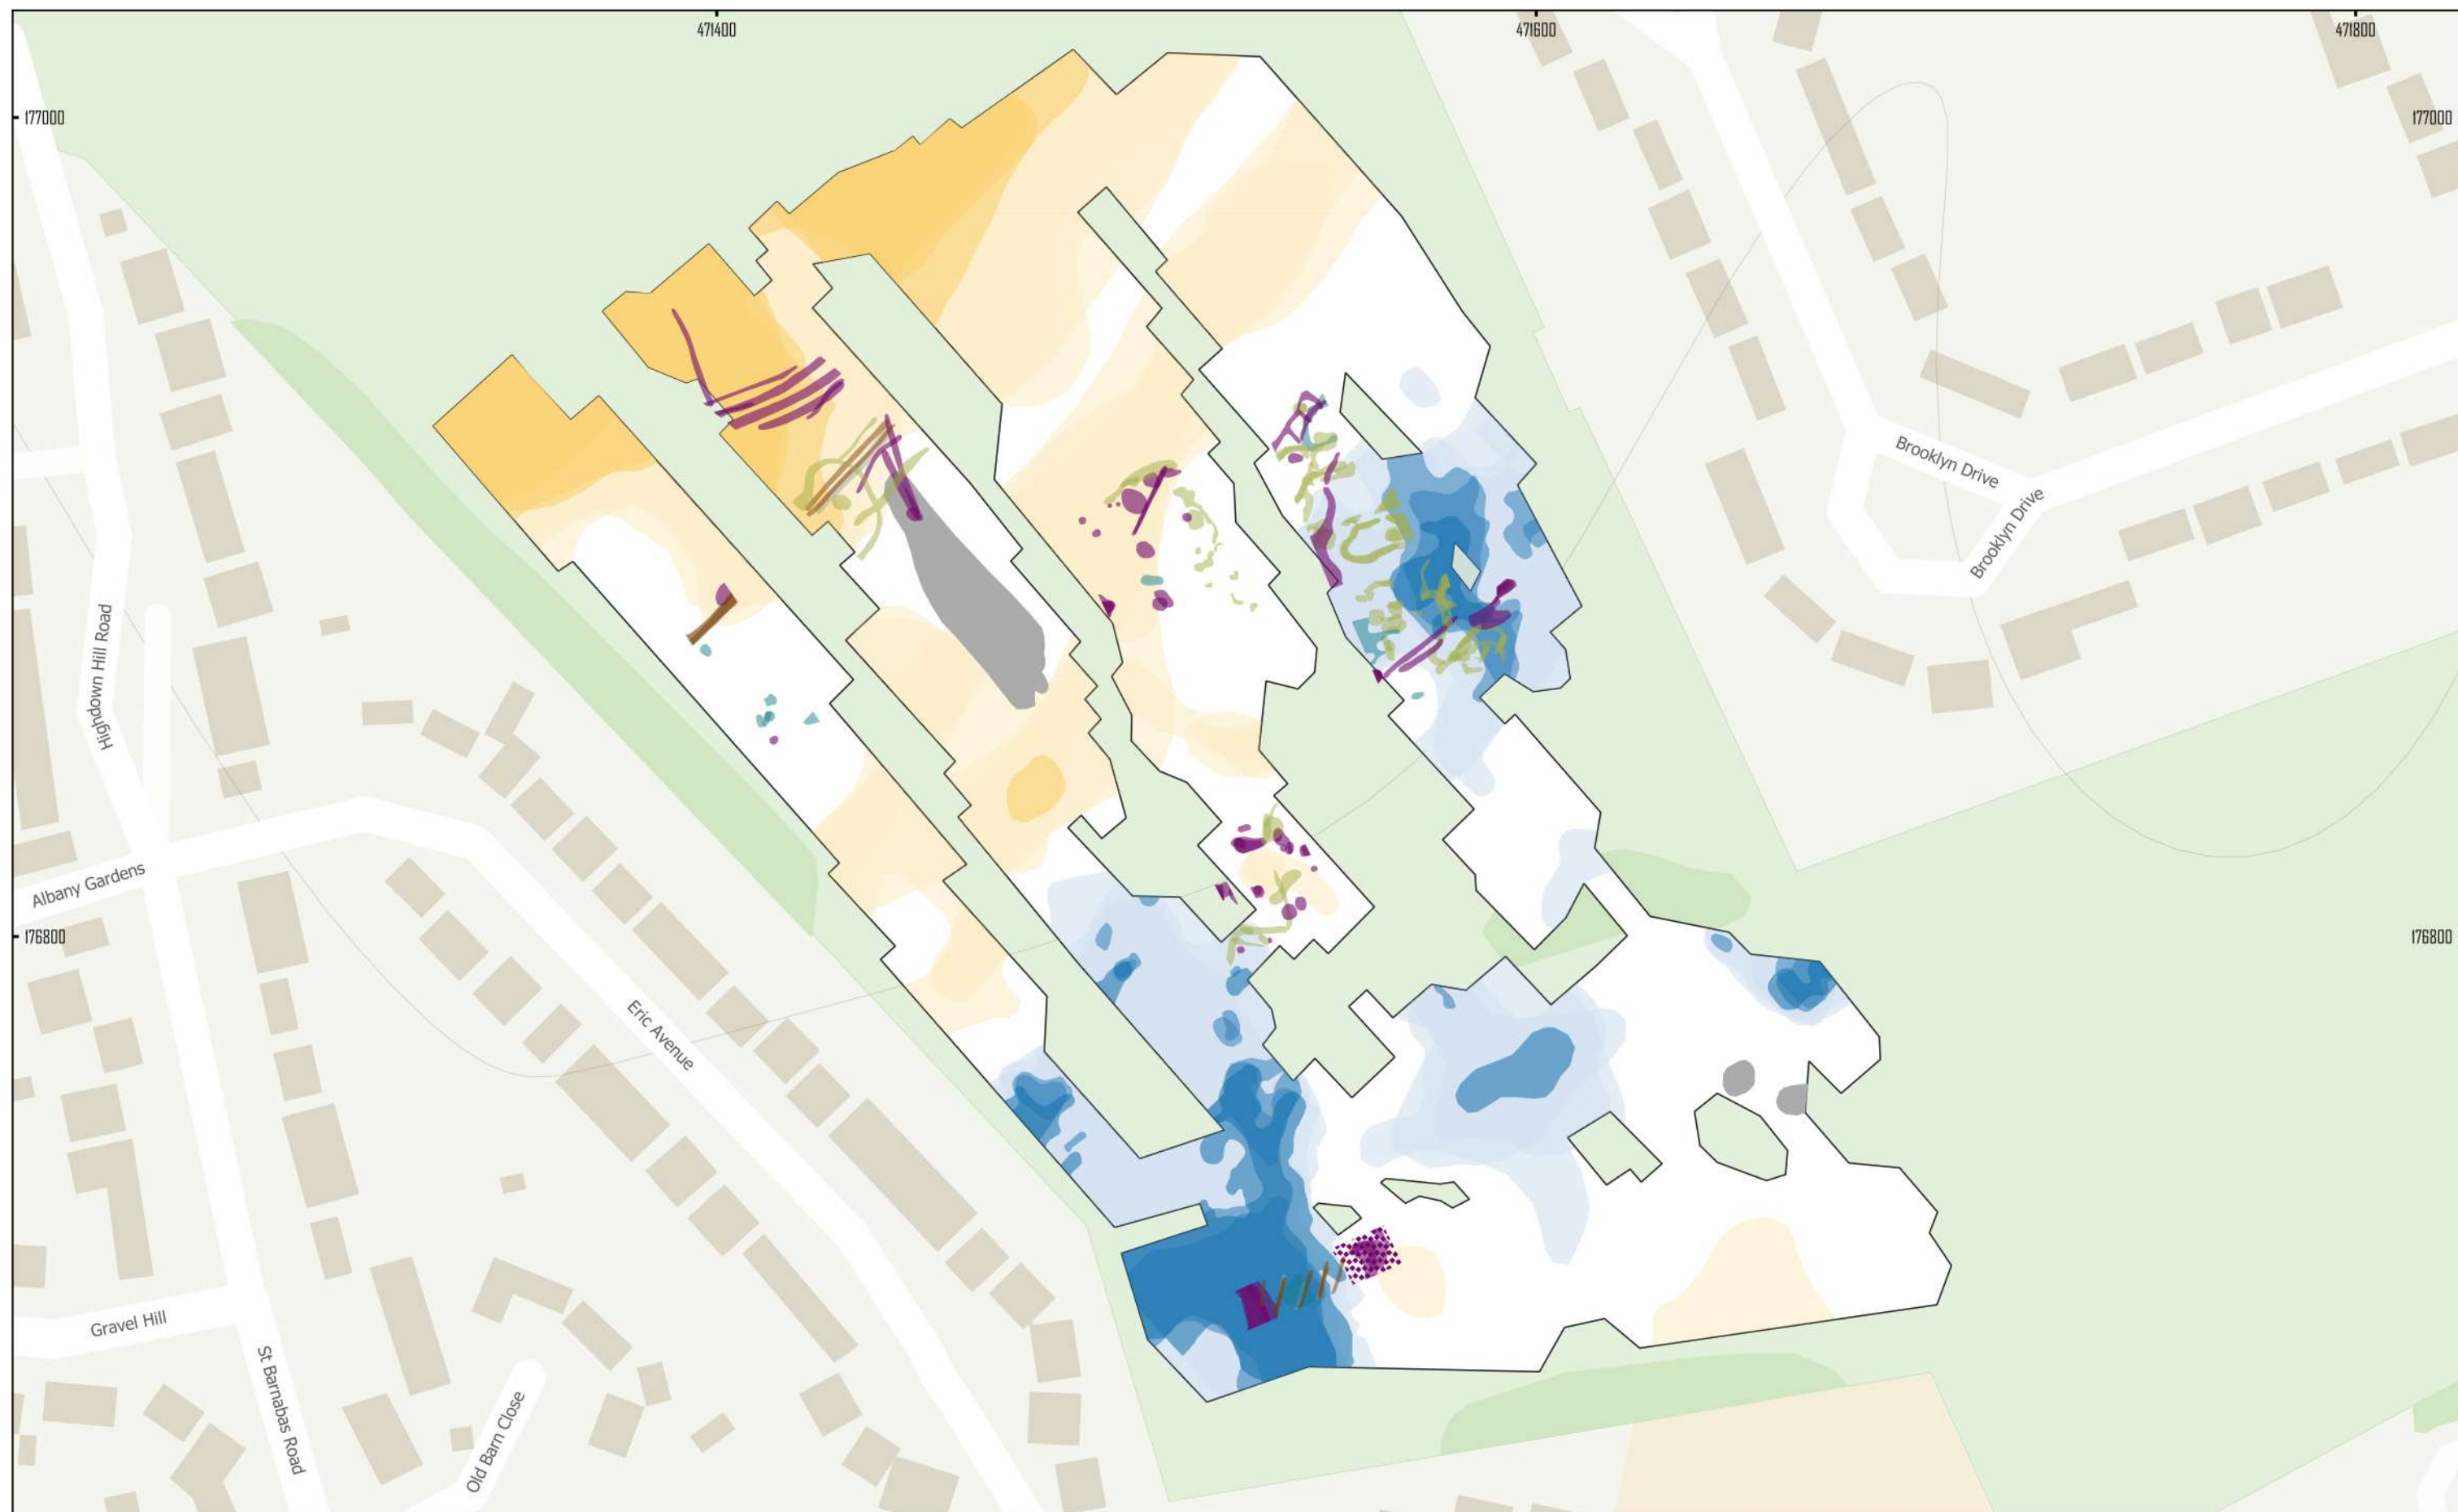
MSSU986 - Reading Golf Club  
 Figure 15 - Composite Interpretation EM & GPR  
 1:1,500 @ A3  
 Copyright Magnitude Surveys Ltd 2021  
 Contains Ordnance Survey data © Crown Copyright and database right 2021

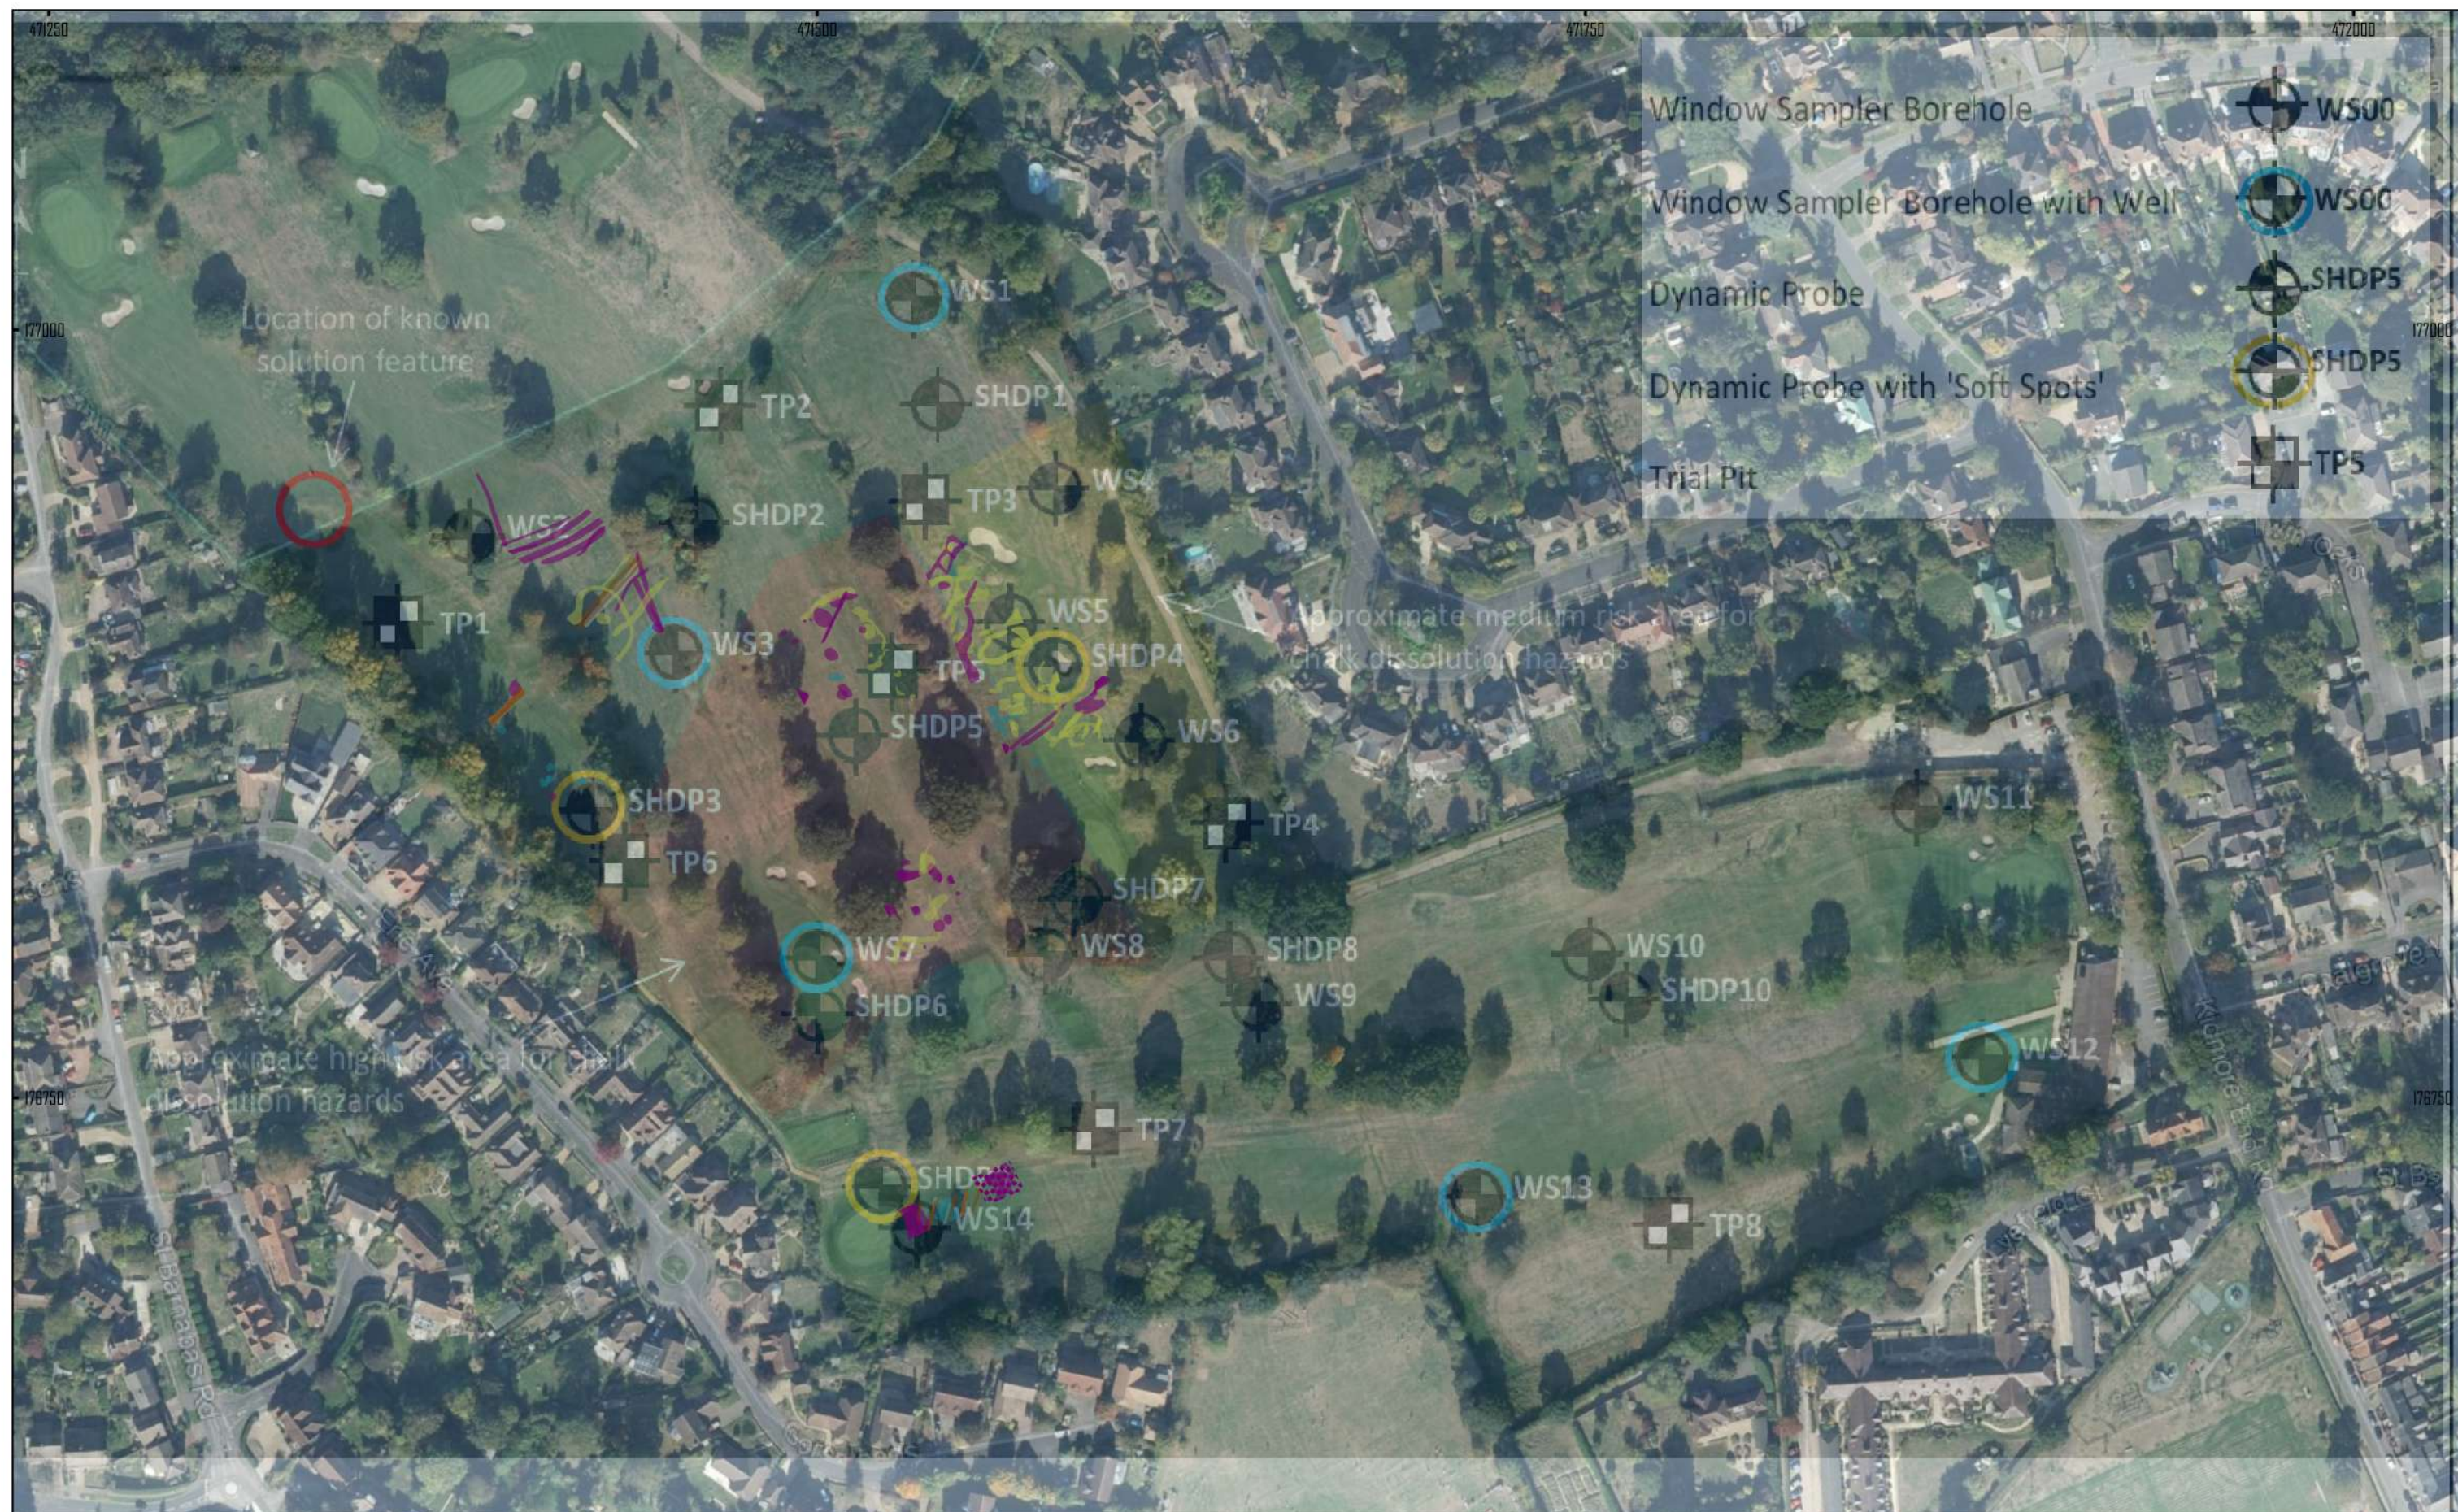
MSSU986 - Reading Golf Club  
 Figure 16 - GPR Composite Interpretation over Exploratory Hole Location Plan  
 1:2,000 @ A3  
 Copyright Magnitude Surveys Ltd 2021  
 Contains Ordnance Survey data © Crown Copyright and database right 2021
