**PHASE 1  
CONTAMINATED LAND &  
GEOTECHNICAL  
DESK STUDY REPORT**  
Proposed Secondary School Development  
Land off Richfield Avenue, Reading

**Prepared for: Hampshire County Council**

**Date: May 2018**

**Report No: 6147/2**

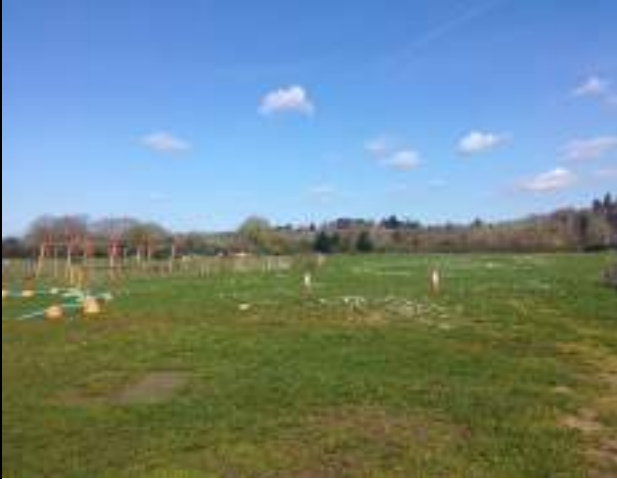
| Table 2.2: Walk-over Survey Photographs | |
|---|---|
| <b>Photo 1:</b> Open land to the north of the site used as a children's activity centre. Photo taken looking north. | <b>Photo 2:</b> Single-storey open-fronted building currently present onsite forming part of the Reload shooting range and Children's activity centre. Photo taken looking west. |

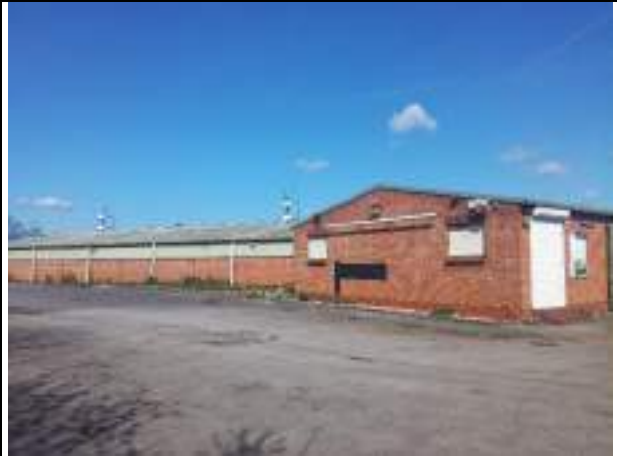
| Table 2.2: Walk-over Survey Photographs | |
|---|---|
| <b>Photo 3:</b> Building currently present on-site. Photo taken looking north-west. | <b>Photo 4:</b> Stockpile present along the eastern site boundary. |

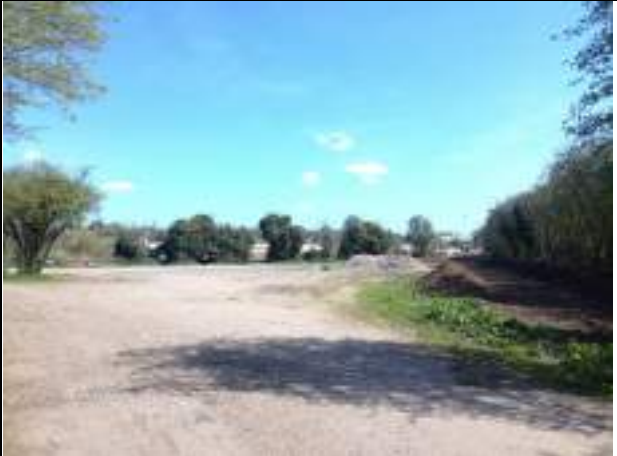
| Table 2.2: Walk-over Survey Photographs | |
|---|---|
| <b>Photo 5:</b> Southern section of the site comprising an open car parking area. Photo taken looking east. | <b>Photo 6:</b> Secondary area to south of site comprising open car parking area. Photo taken looking east. |
