# TEMPLE

Reading Golf Club, Emmer Green  
Flood Risk Assessment and Outline Sustainable Drainage Systems (SuDS) Strategy

P21279R1

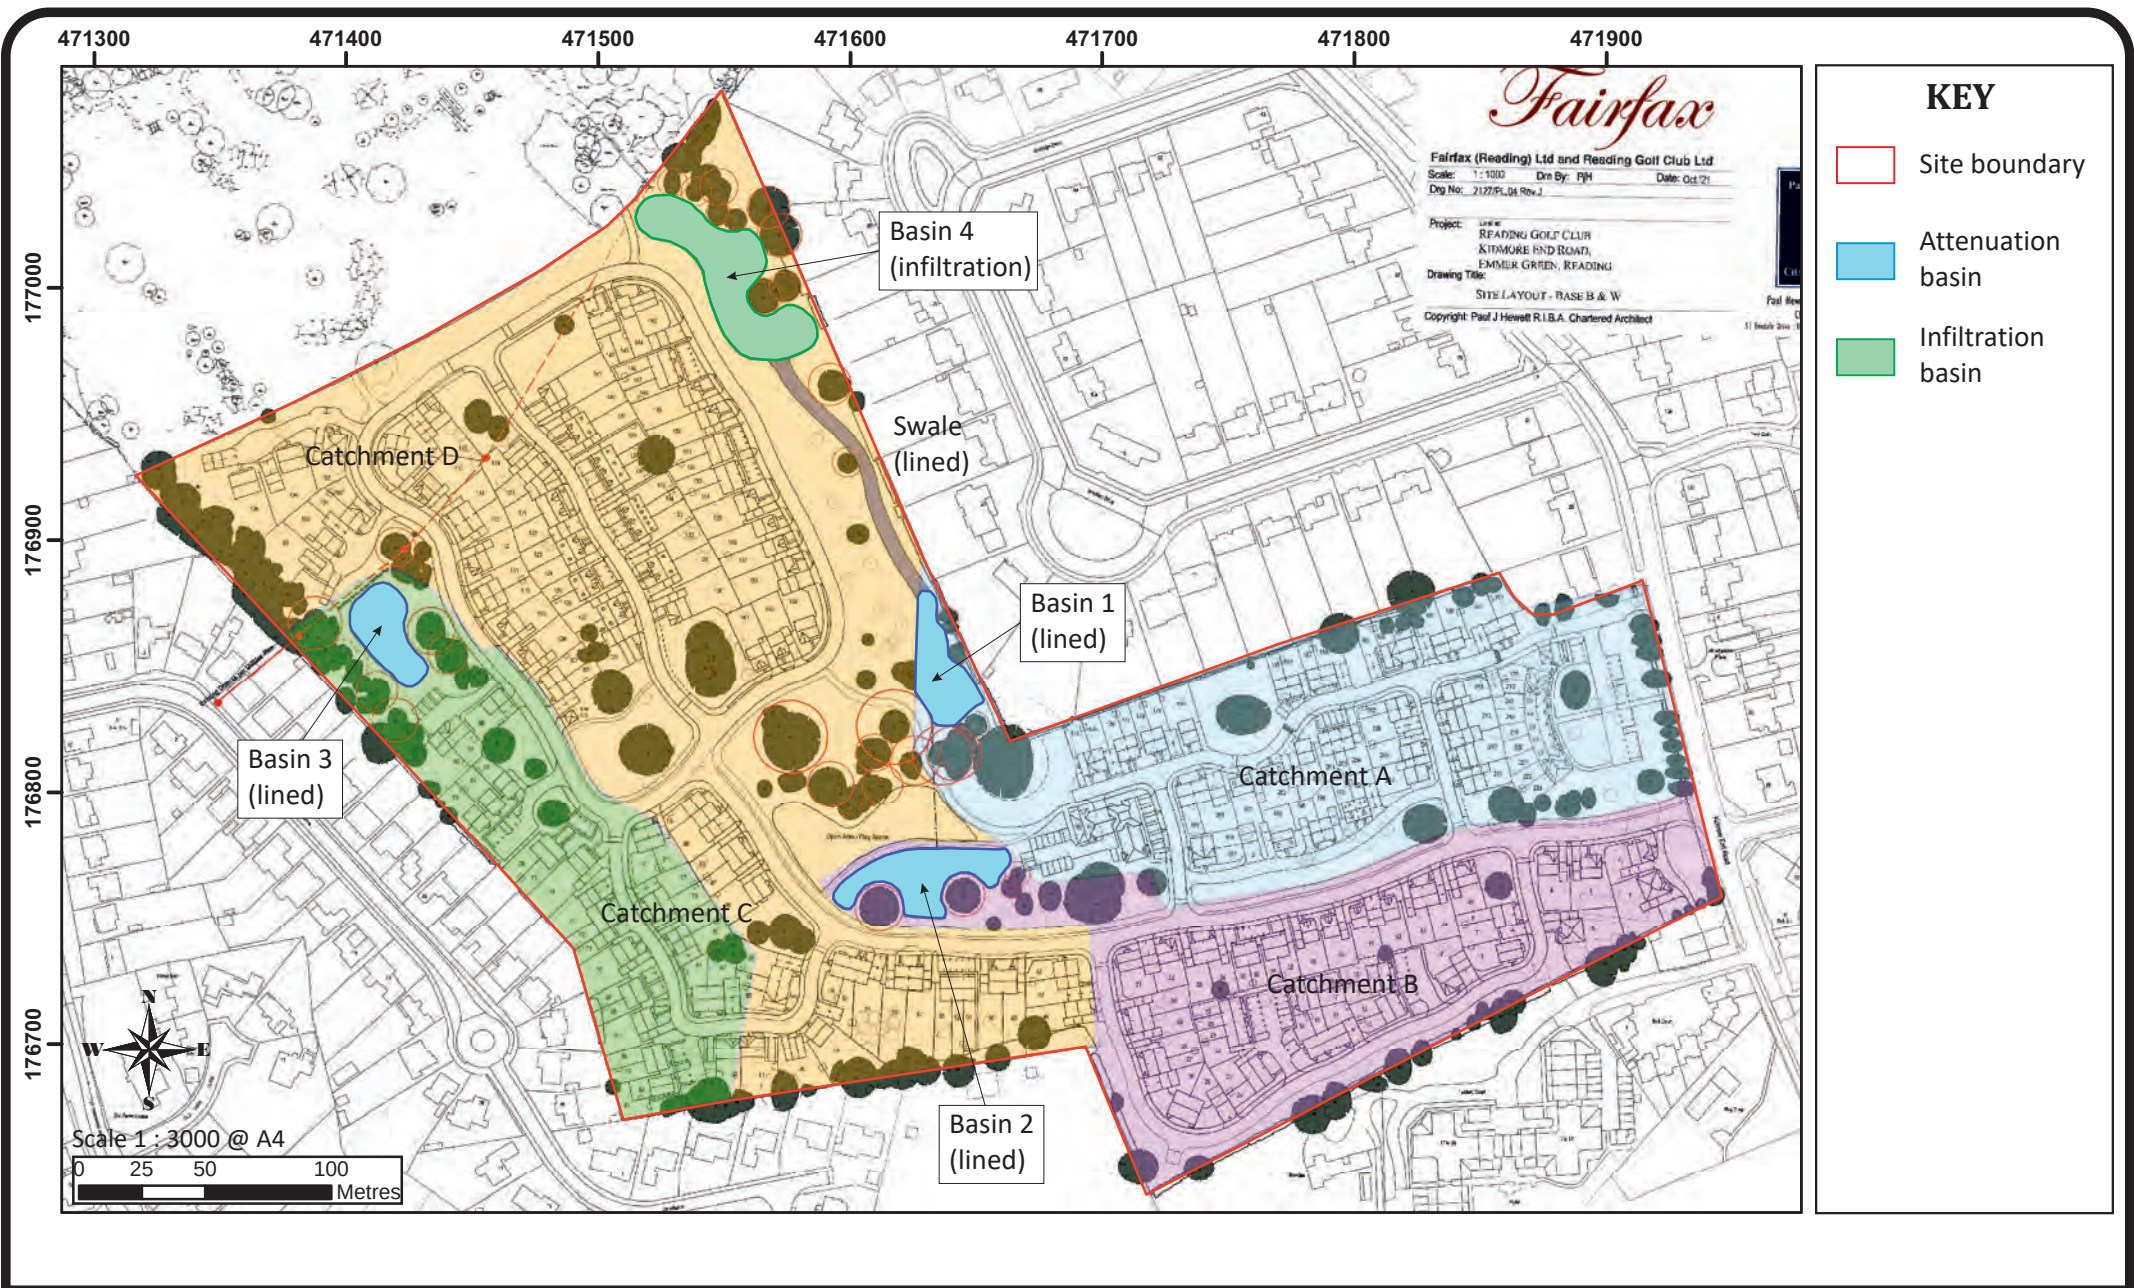
Drainage Catchments

The basins are herein referred to as Basins 1, 2, 3 and 4 respectively (see Figure 7.1 for the location of these basins). The proposed development layout has been sub-divided into four catchments that will each drain via gravity to one of these basins, with a final discharge to the infiltration basin (see Figure 7.1). These sub-catchments have been delineated based on the development layout plan included in Appendix A and LiDAR Digital Terrain Model (DTM) data.

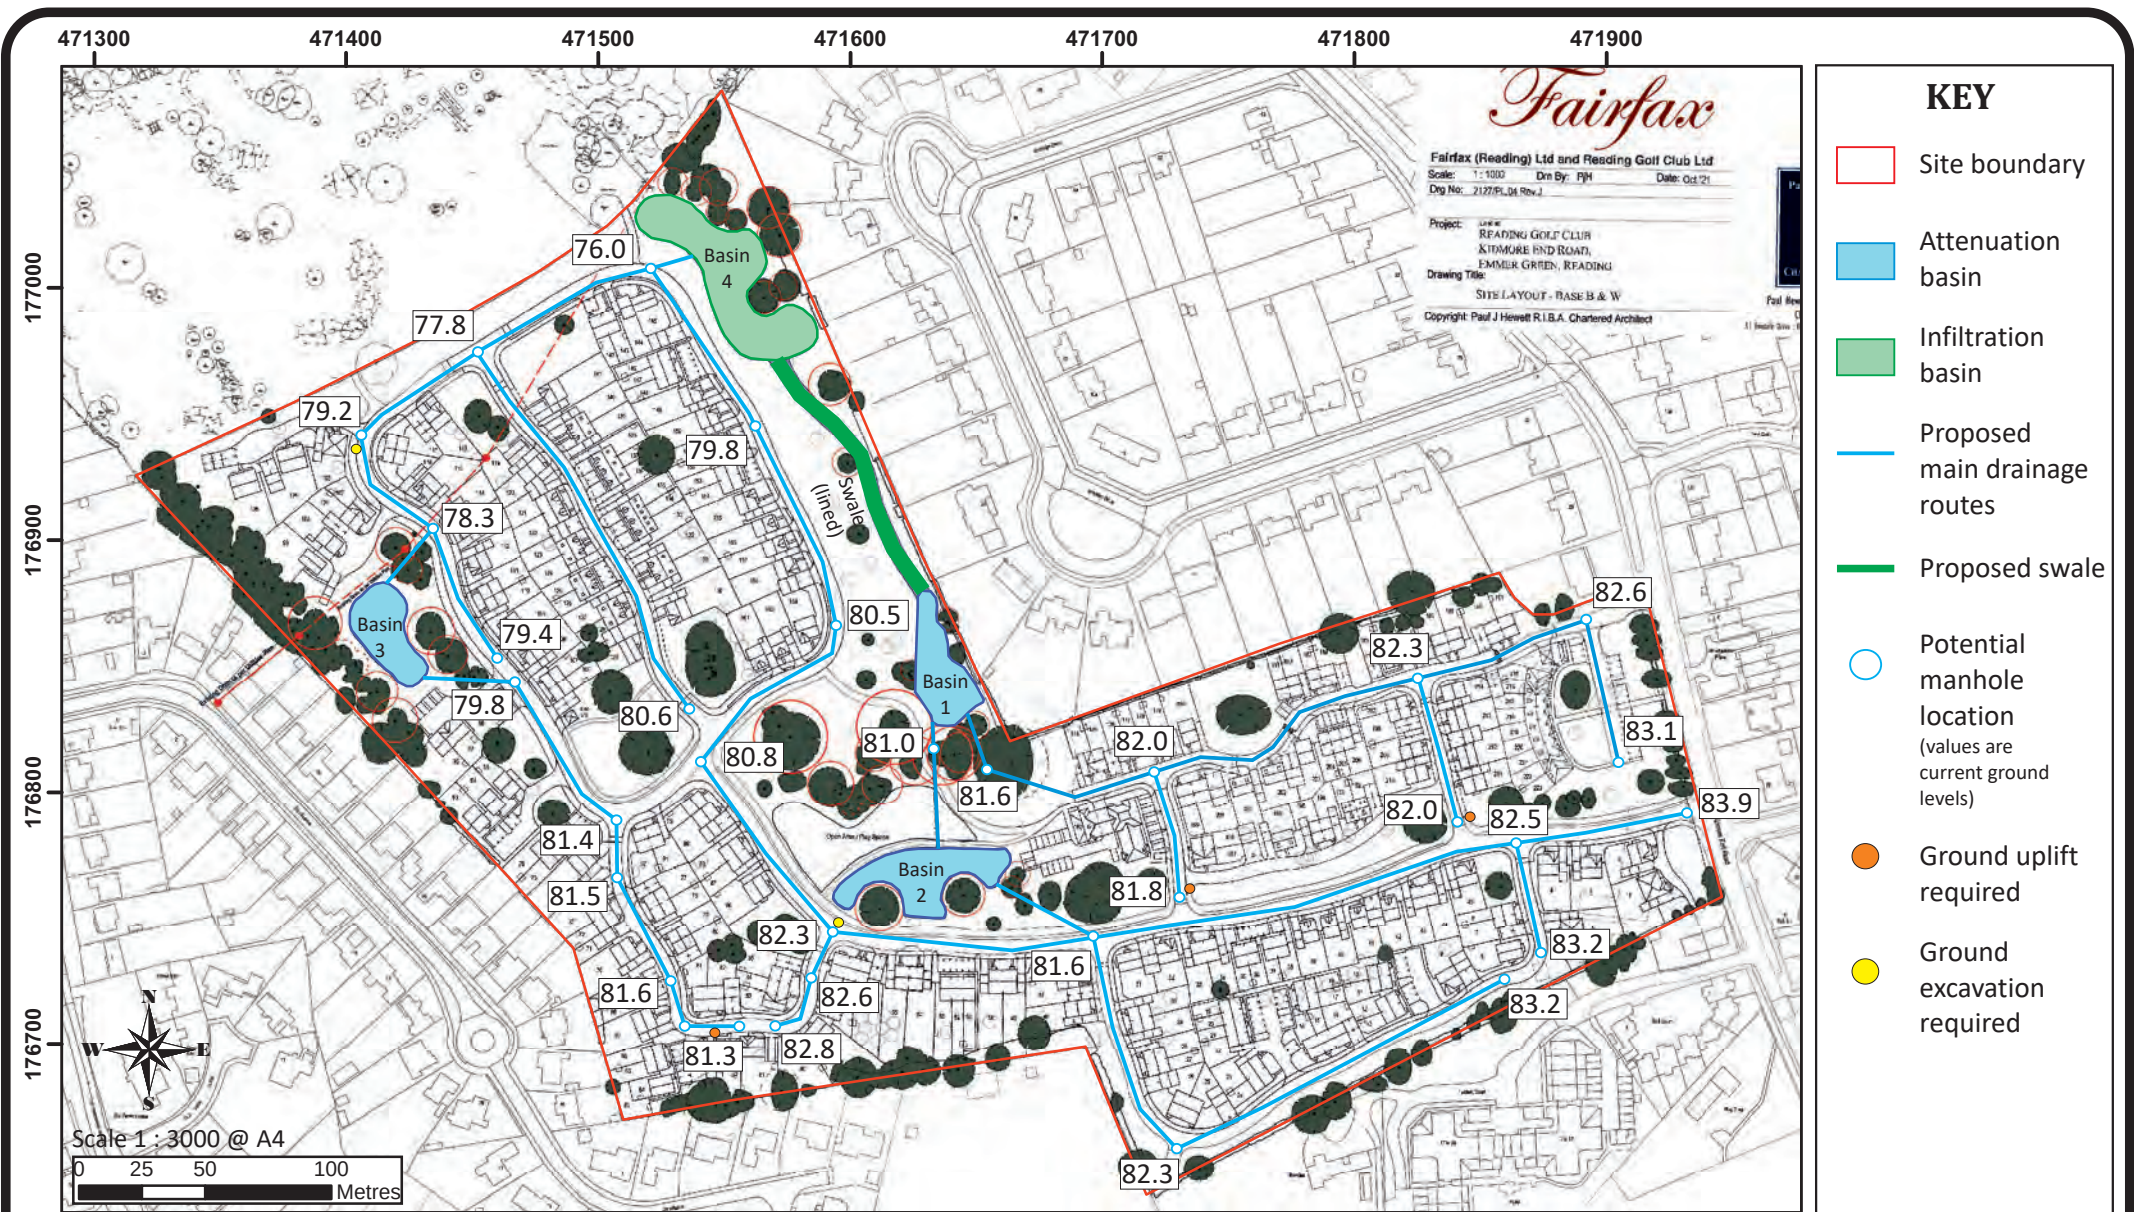
Figure 7.2

Preliminary Outline Drainage Routes

The Site will require some raising and lowering of existing ground levels to achieve the required cover depths and gradients for an adoptable surface water drainage system (locations are shown on Figure 7.2). It is anticipated that in-situ arisings from the excavation of the basins and the construction of house foundations would be used for this purpose, without the requirement to import significant volumes of external fill material.

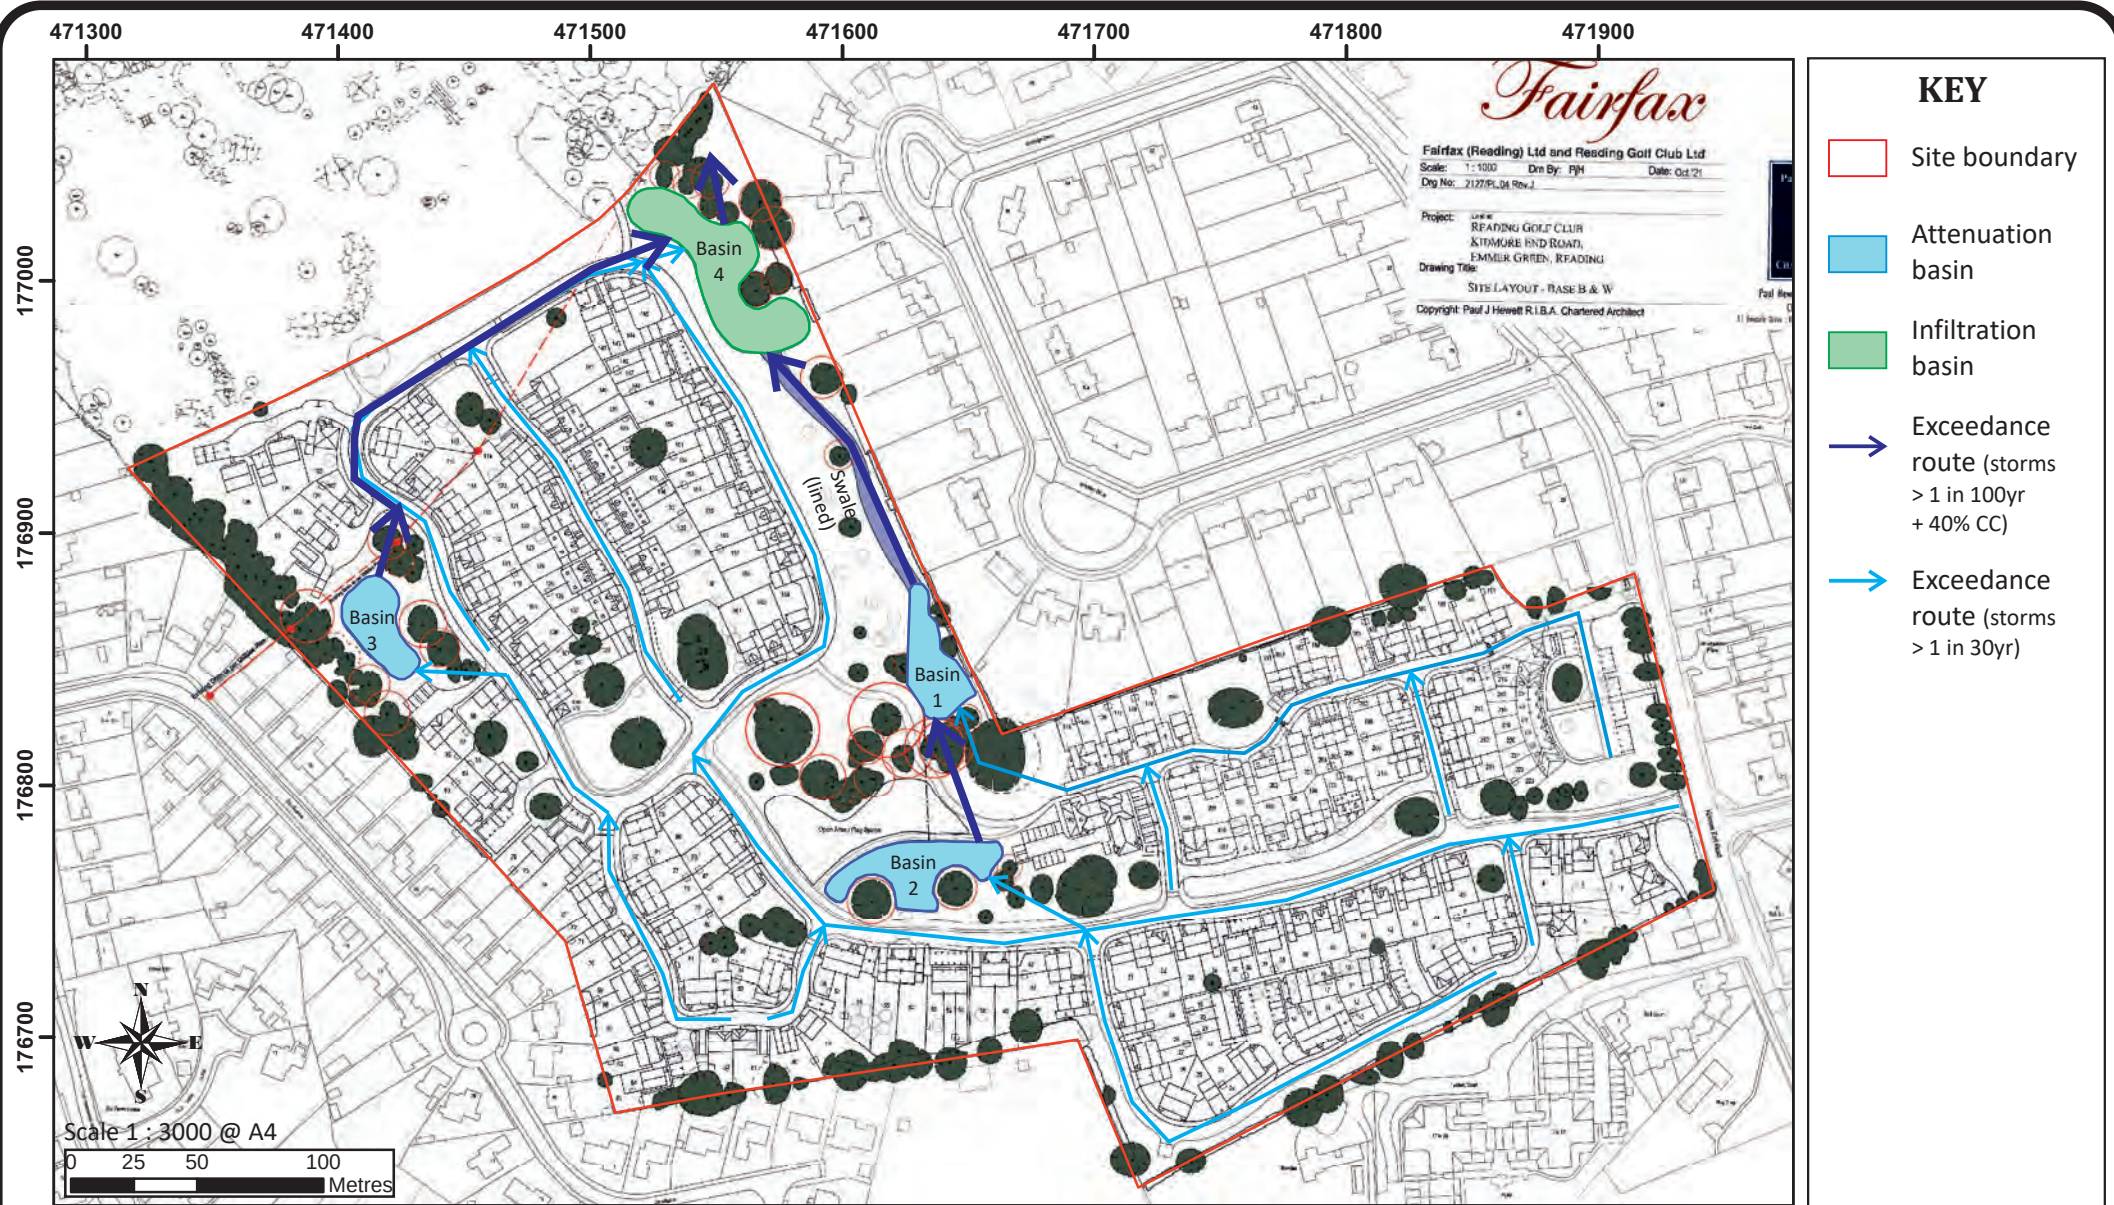
Figure 7.3

### Exceedence Flow Routes

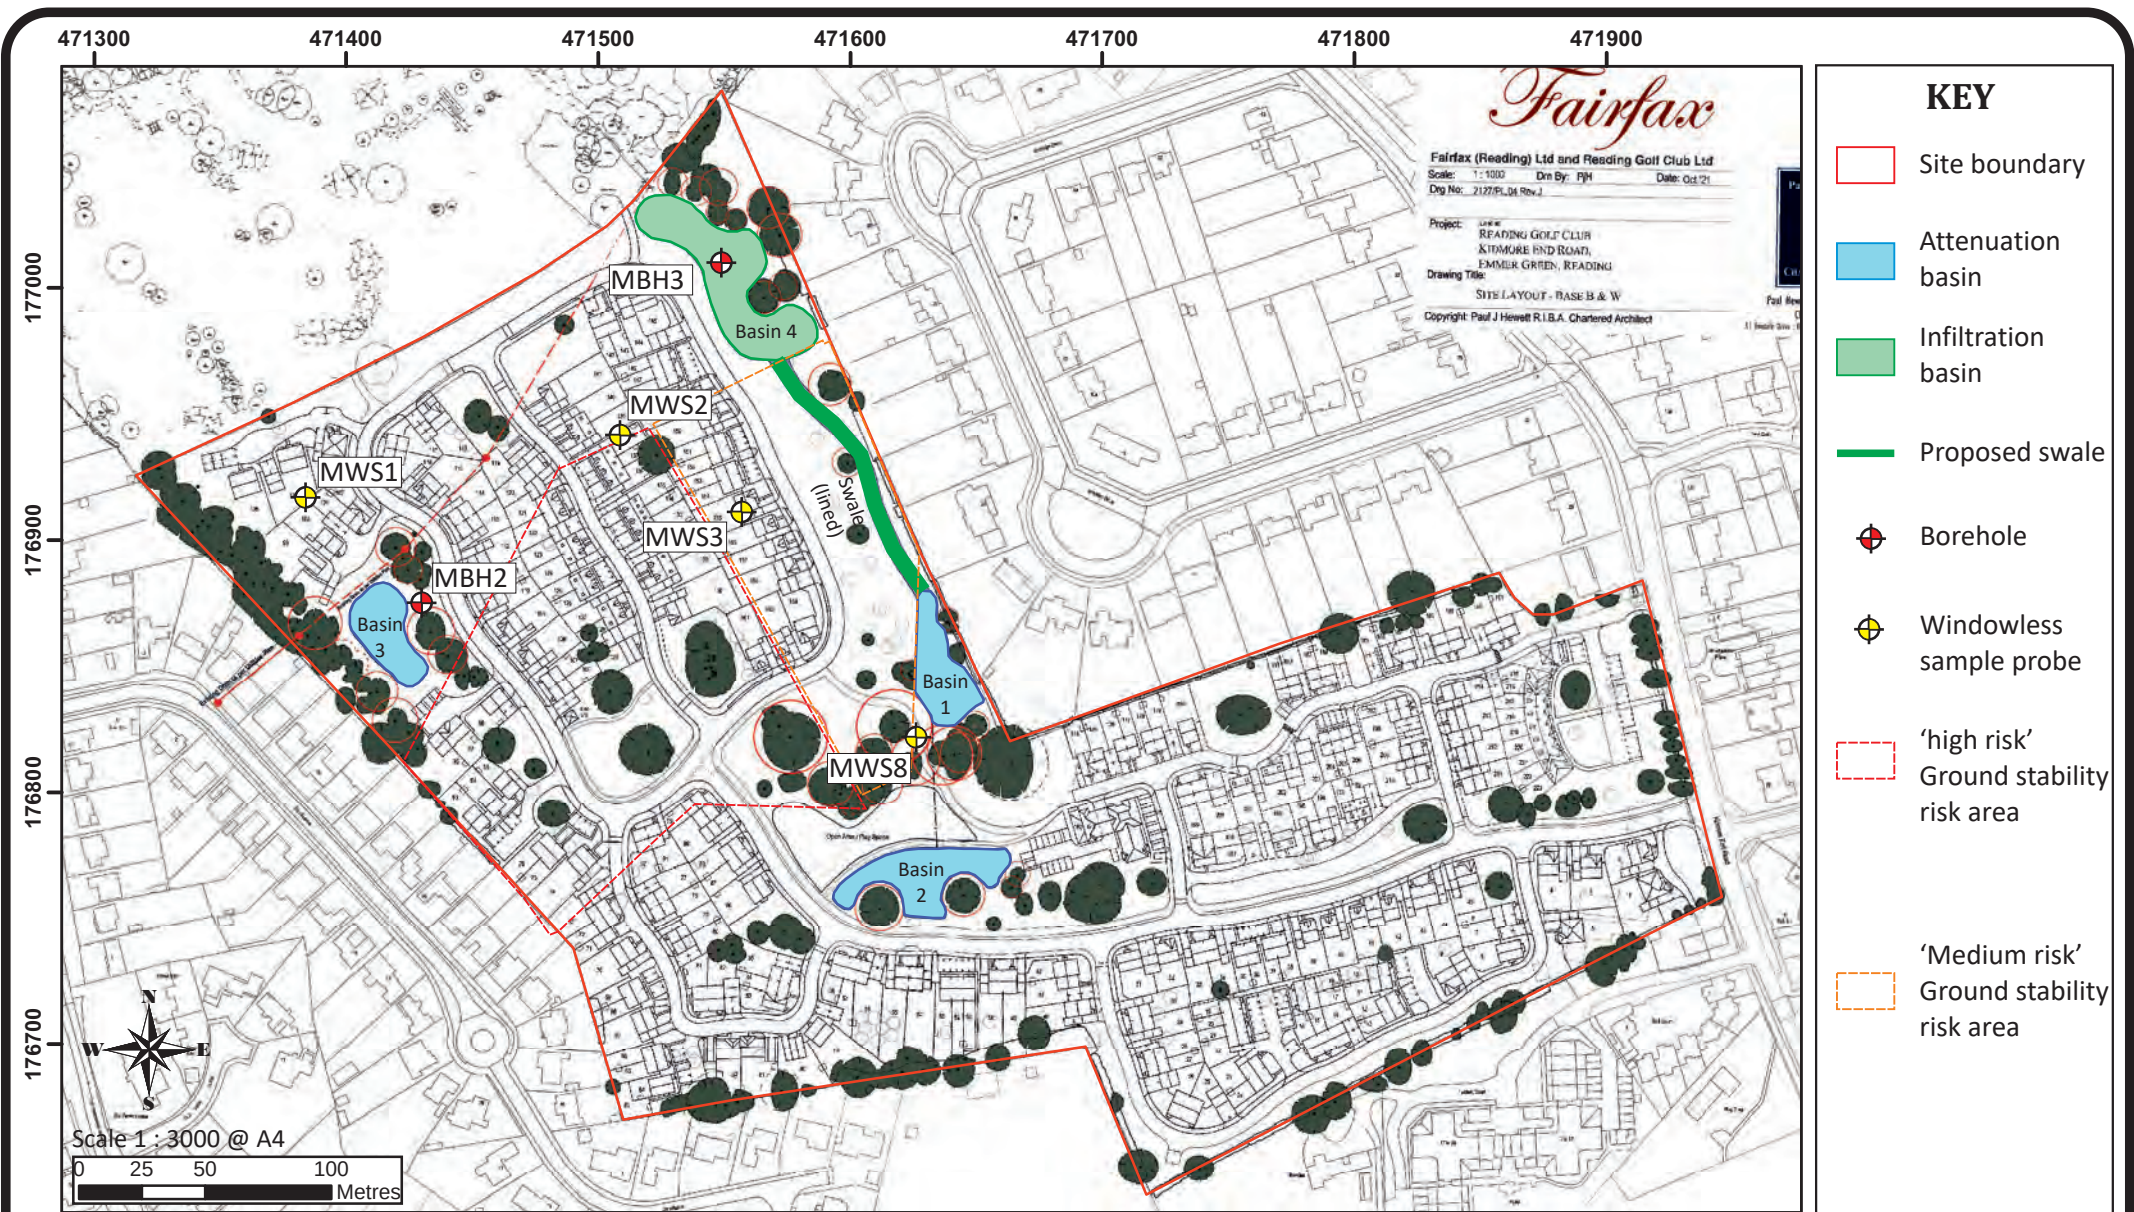
Figure 7.4

Site Investigation Locations

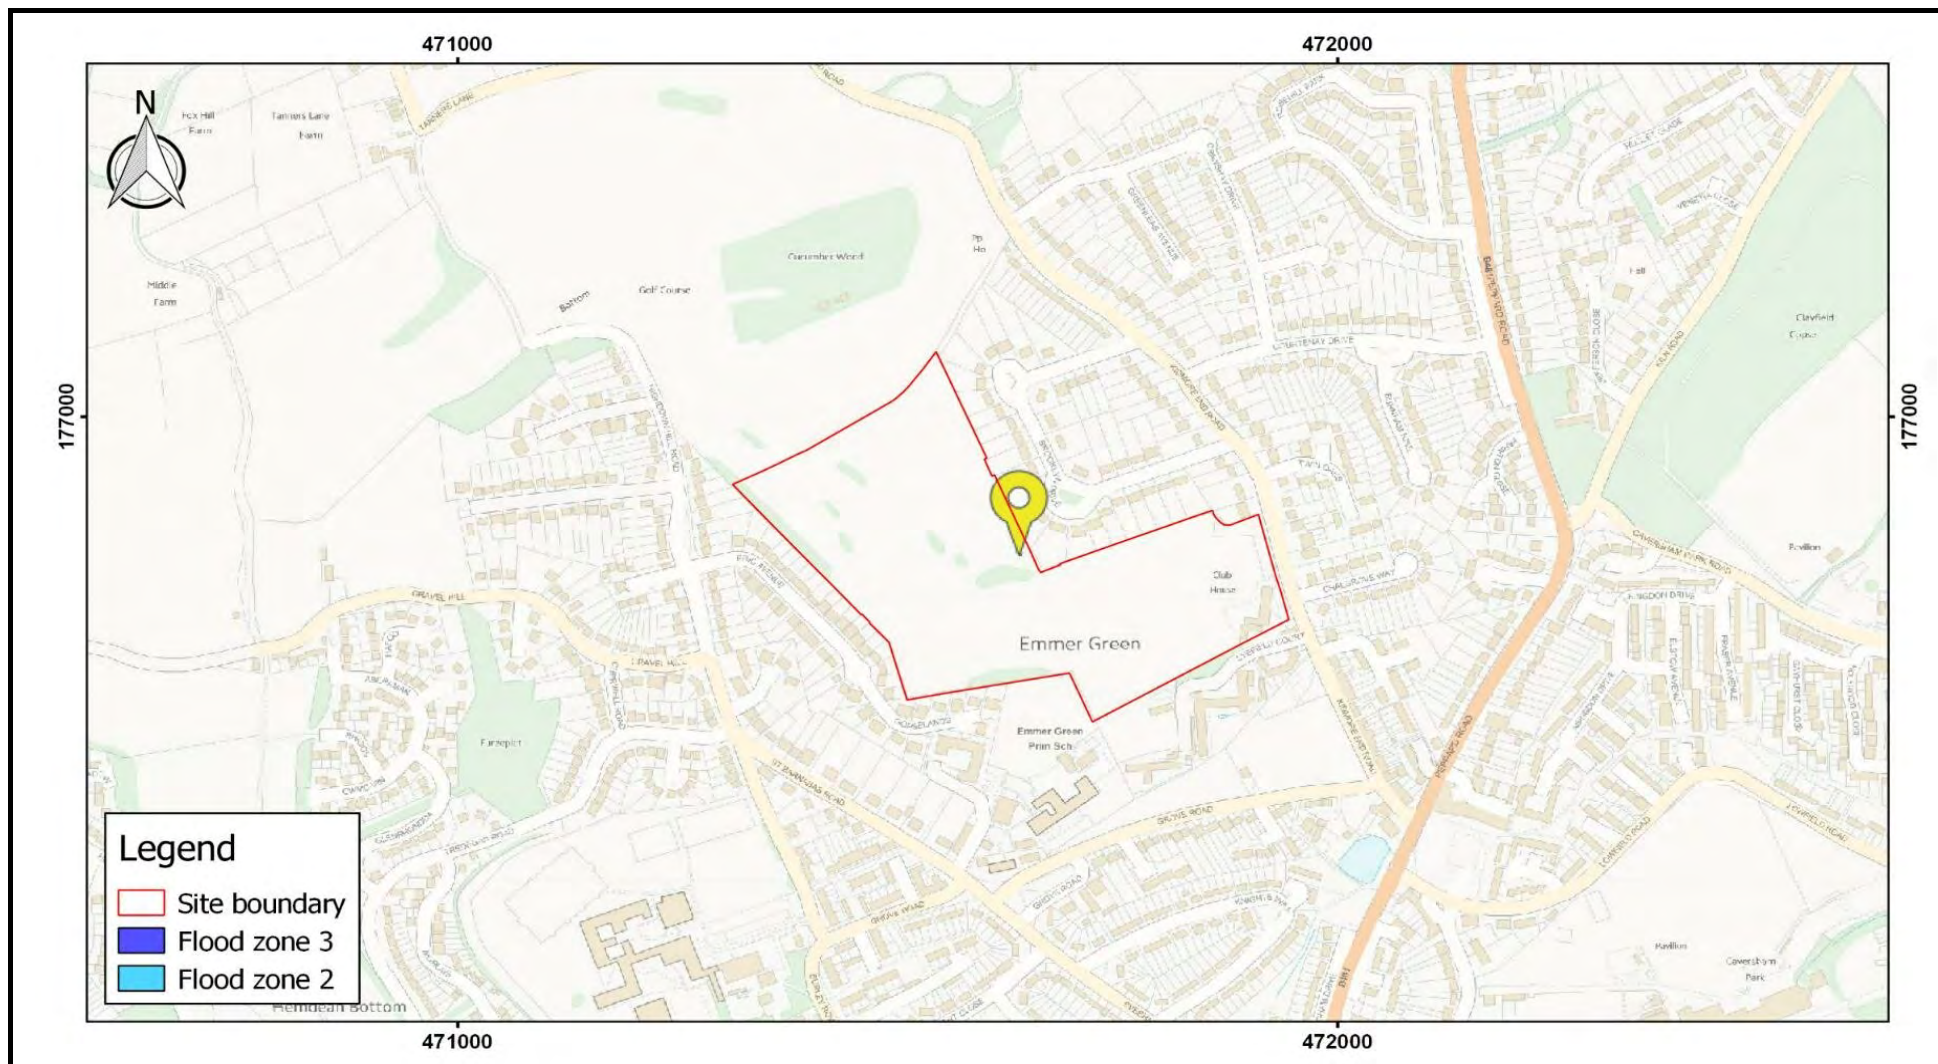
| <p>7 Neptune Court, Vanguard Way,<br/>Cardiff, CF24 5PJ<br/><a href="mailto:helpme@yellowsubgeo.com">helpme@yellowsubgeo.com</a></p> | Drawing Title | EA Fluvial flood risk map | Scale | NTS | |

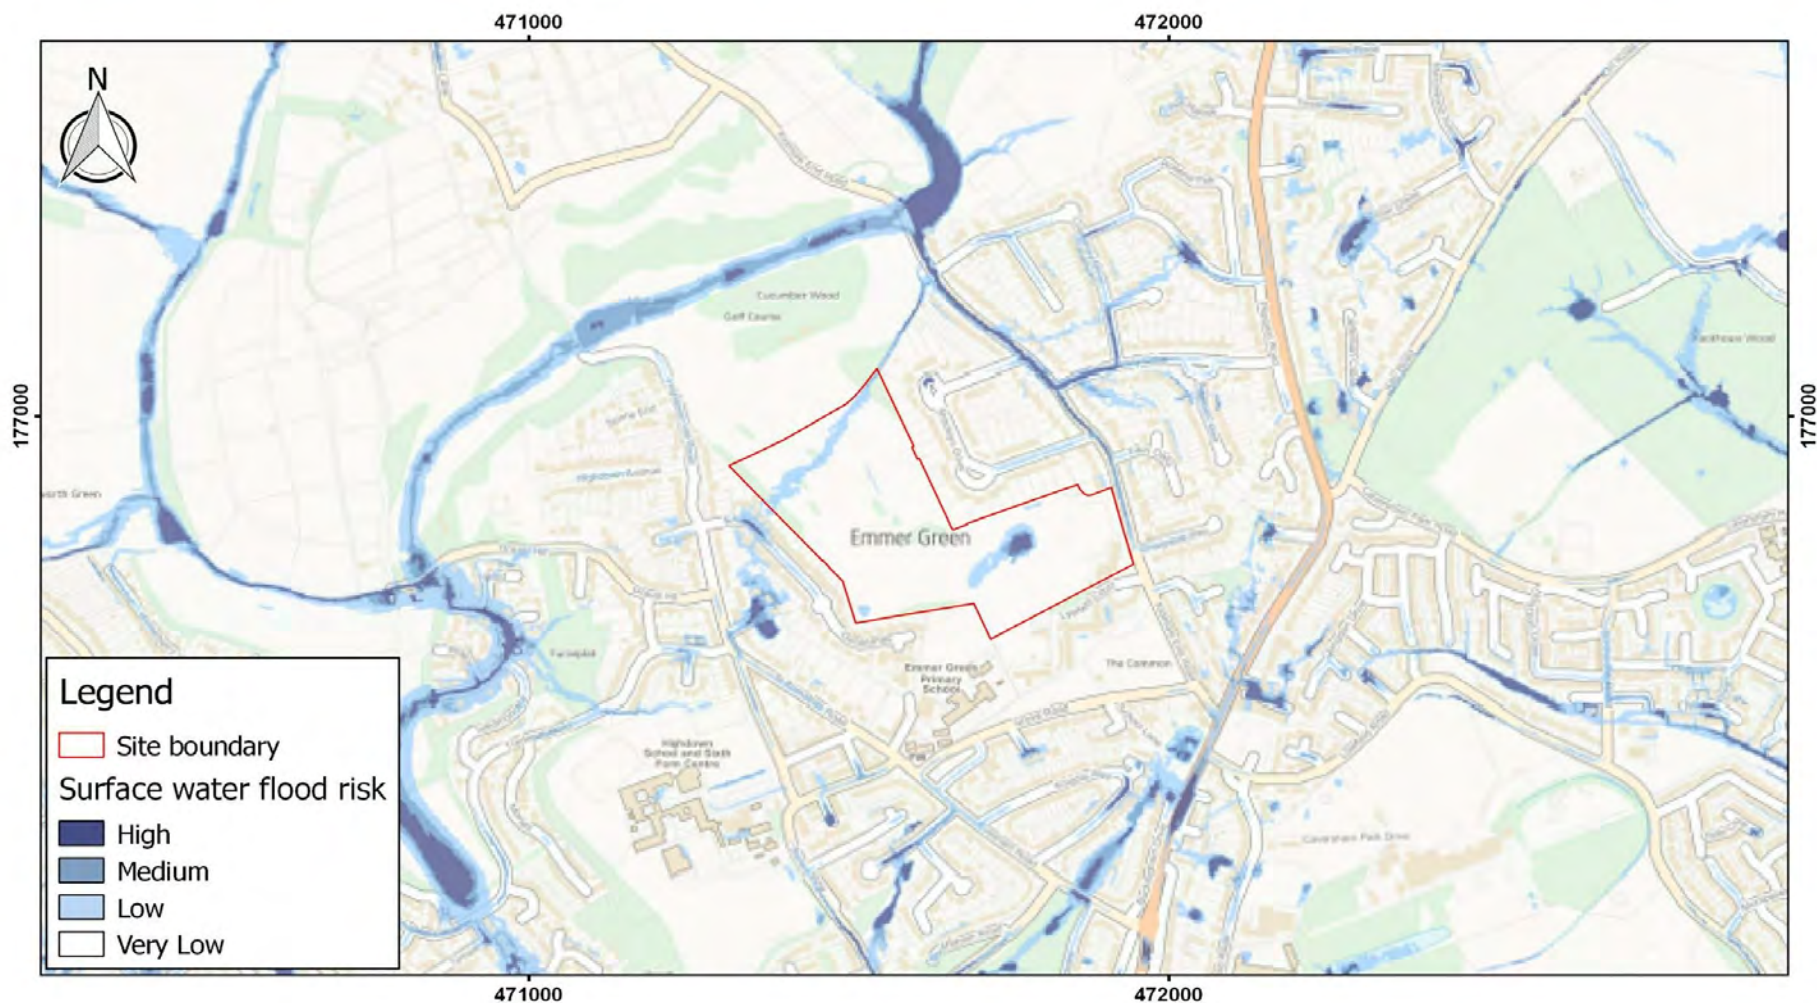
| Drawing Number | <b>App C</b> | Revision | <b>0</b> |

| Drawing Title | <b>EA Surface water flood risk map</b> | Scale | <b>NTS</b> |

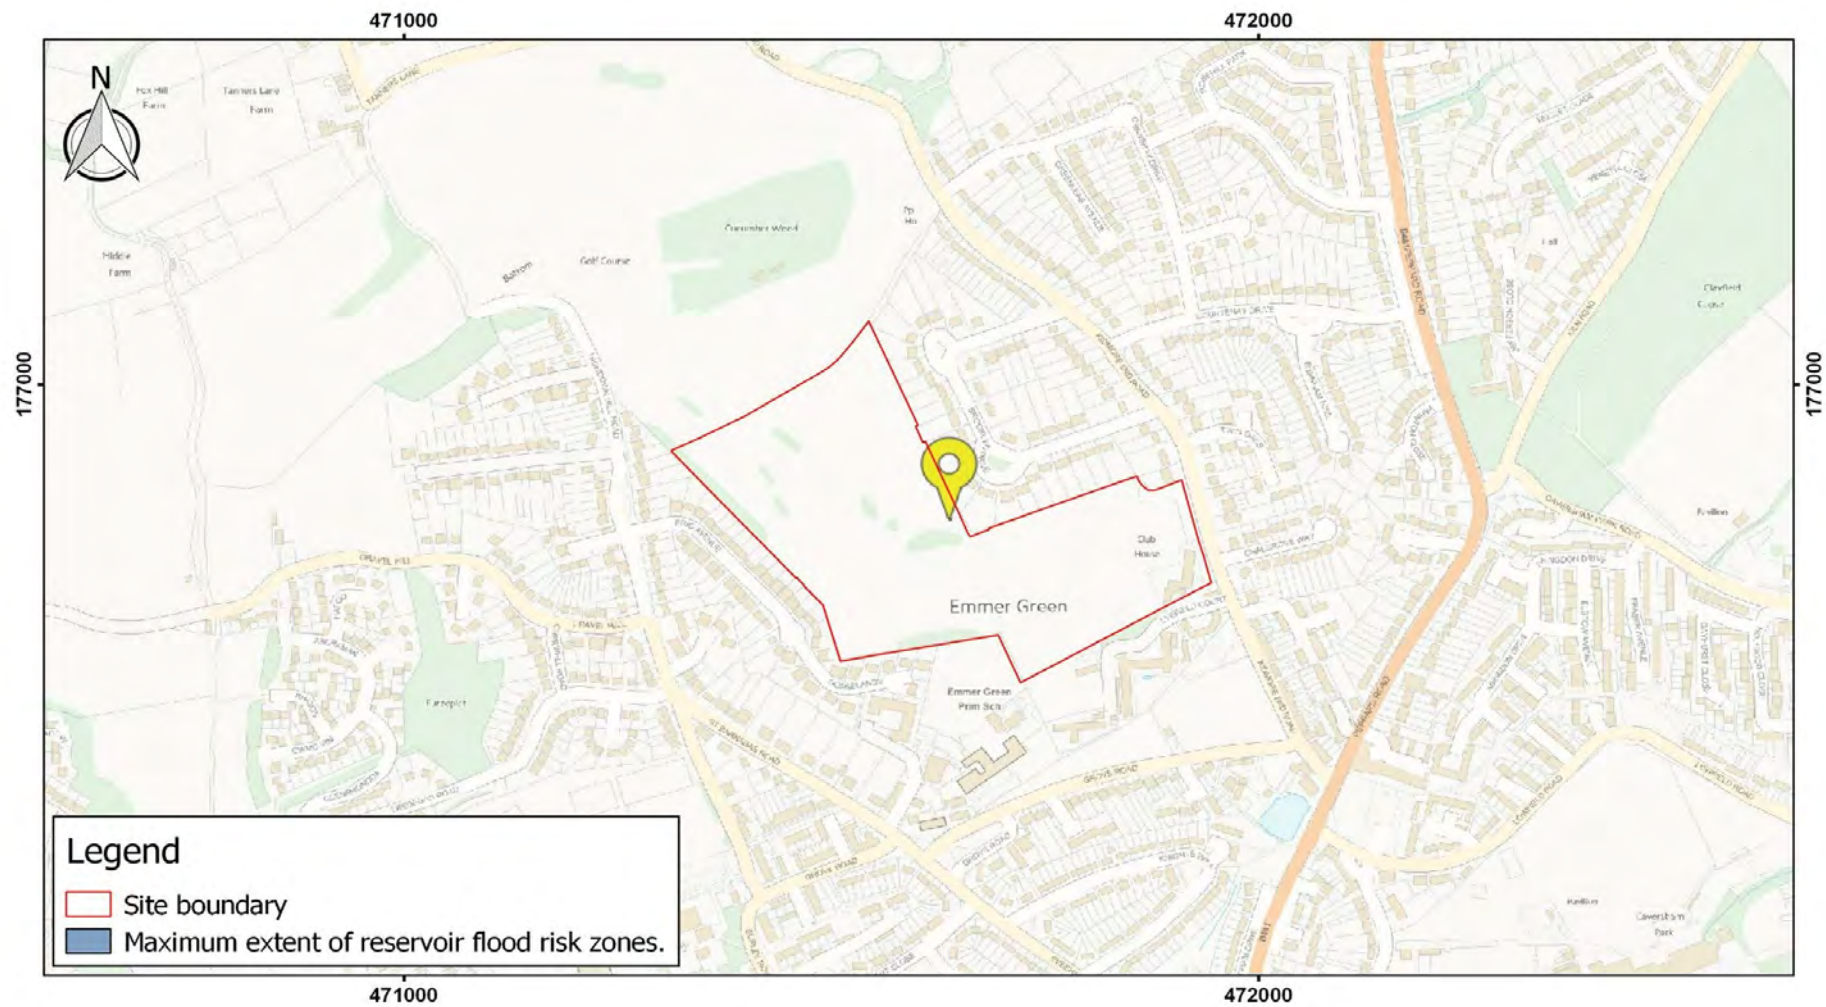
| Drawing Number | <b>App D</b> | Revision | <b>0</b> |

| Drawing Title | <b>EA Reservoir failure flood risk map</b> | Scale | <b>NTS</b> |

There are no historical records of flooding of the Site from reservoir failure, canals or other artificial sources. Reservoir flooding is unlikely to happen, although the EA has produced flood mapping to indicate the worst-case scenario in the event of reservoir failure. The EA's Flood Map for Reservoirs (Appendix D) indicates that the Site would not be at risk of reservoir flooding. Accordingly, these sources of flood risk are not considered further.

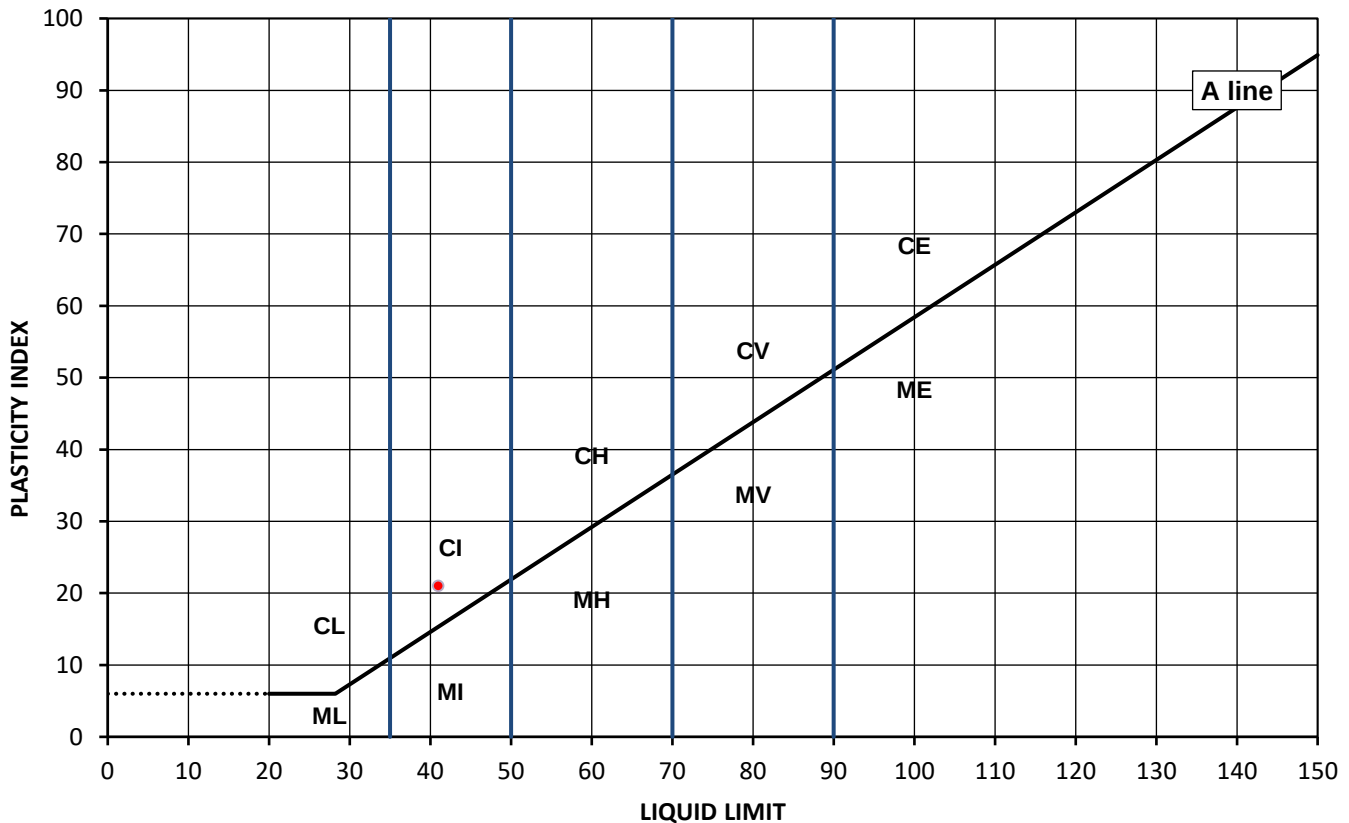
| As Received Moisture Content [%] | Liquid Limit [%] | Plastic Limit [%] | Plasticity Index [%] | % Passing 425µm BS Test Sieve |
| 12 | 41 | 20 | 21 | 73 |

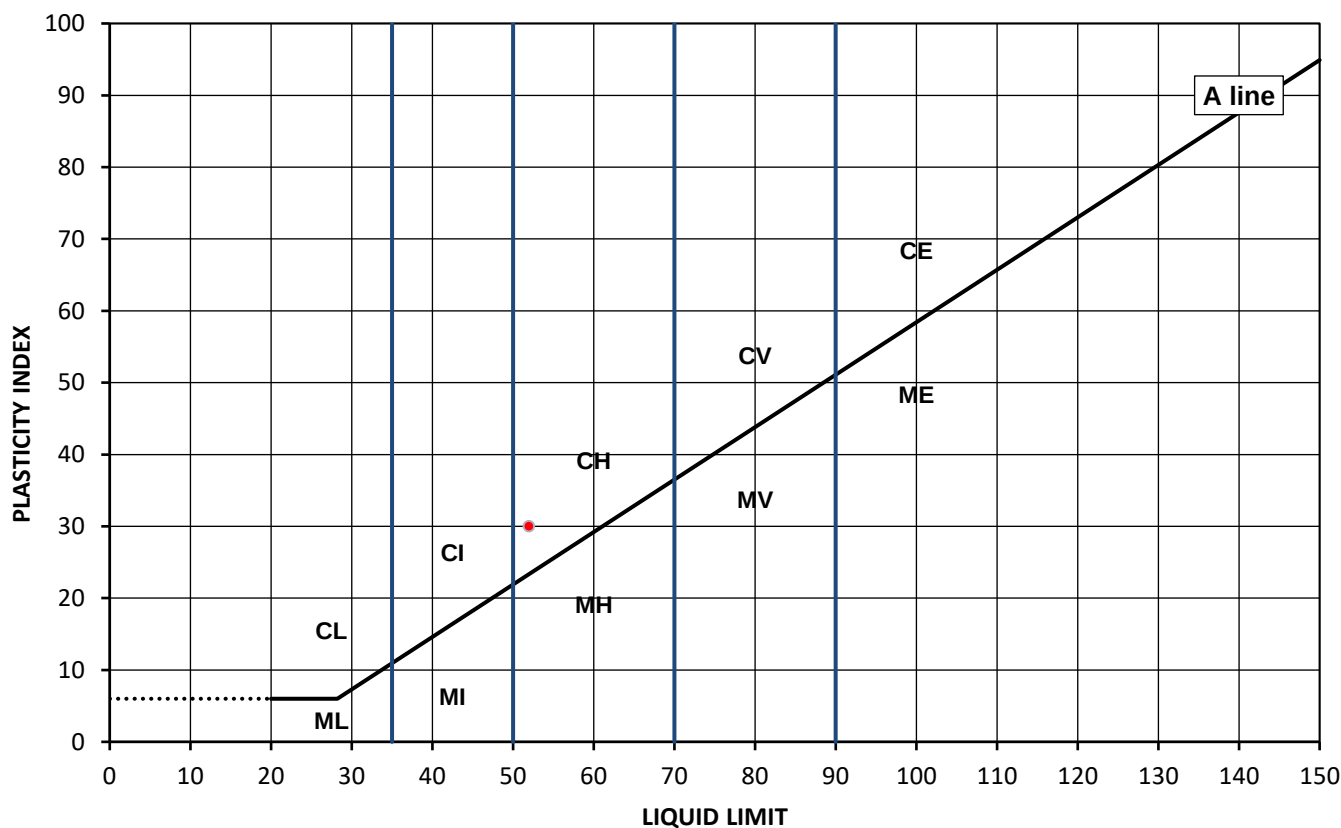
| As Received Moisture Content [%] | Liquid Limit [%] | Plastic Limit [%] | Plasticity Index [%] | % Passing 425µm BS Test Sieve |
| 19 | 52 | 22 | 30 | 97 |

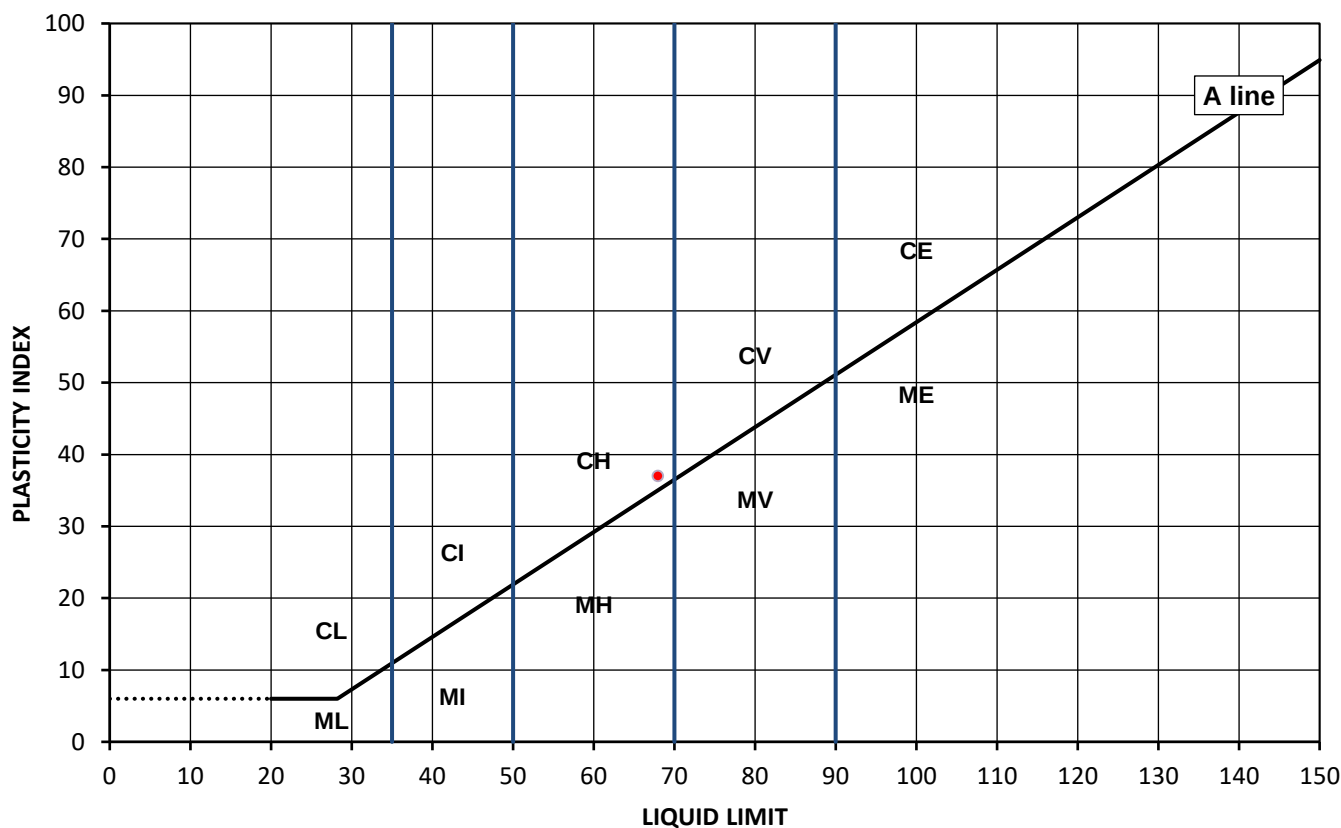
| As Received Moisture Content [%] | Liquid Limit [%] | Plastic Limit [%] | Plasticity Index [%] | % Passing 425um BS Test Sieve |
| 11 | 68 | 31 | 37 | 55 |

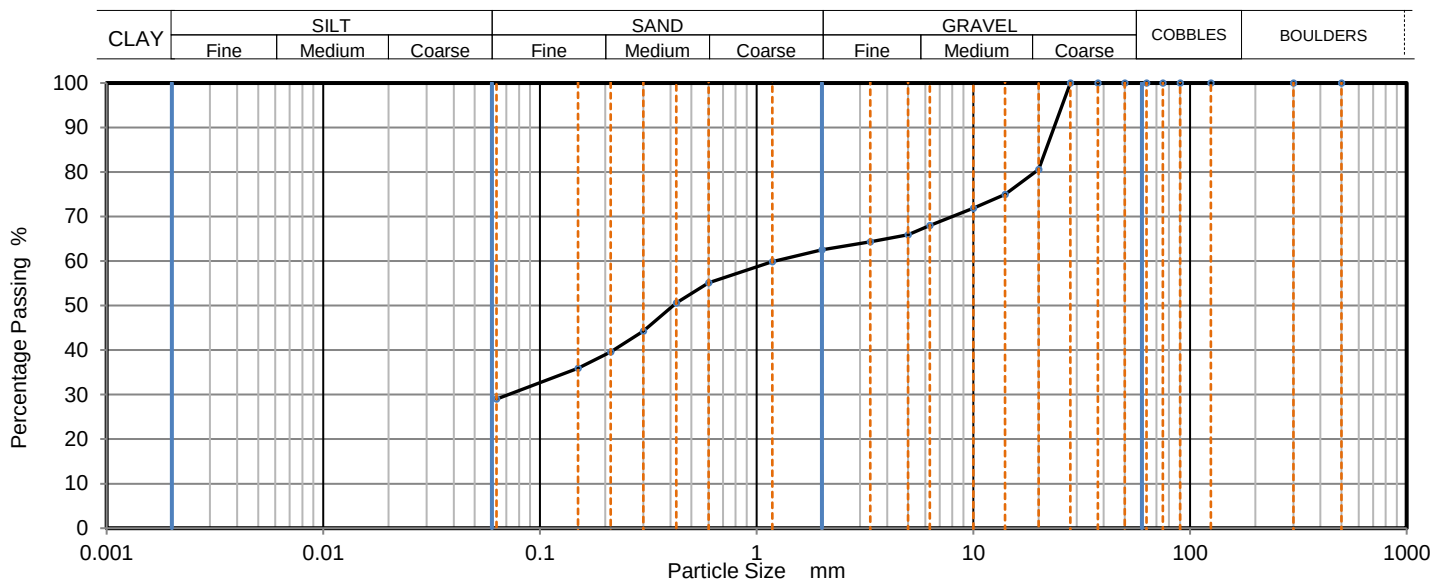
Laboratory Reference: 1339035  
Hole No.: BH1  
Sample Reference: D1  
Sample Description: Brown very clayey very sandy GRAVEL

Depth Top [m]: 1.00  
Depth Base [m]: Not Given  
Sample Type: D

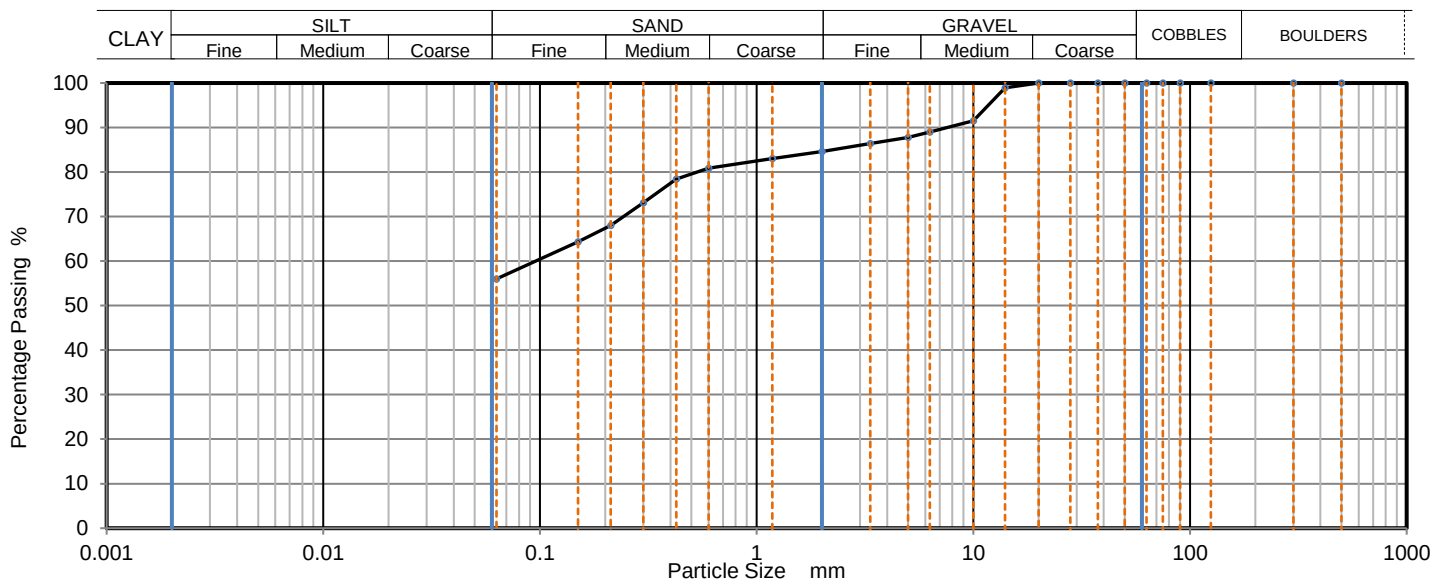
Laboratory Reference: 1339037  
Hole No.: BH2  
Sample Reference: D1  
Sample Description: Brown gravelly sandy CLAY

Depth Top [m]: 1.00  
Depth Base [m]: Not Given  
Sample Type: D
