## **Report on survey findings and structure analysis of the listed chimney at Brock Barracks.**

**TA CENTRE, BROCK BARRACKS**

Oxford Road  
Reading, Berkshire  
RG30 1HW

Evangelos Karkanevatos MEng, MSc  
21/06/2021

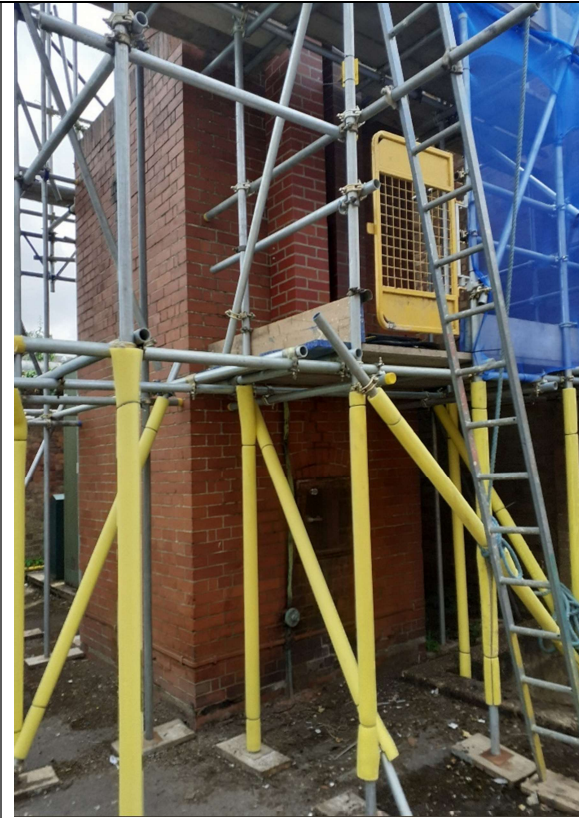
The historical chimney is a stand-alone masonry structure with an adjacent cabinet slab to the east side and a masonry depo building to the south side. The chimney is comprised of two main parts on elevation. A lower rectangular box with a furnace hatch (Fig. 3) and the upper tapered circular part whose top hat is used for the telecoms equipment. The upper circle sits on the lower rectangular part (Fig. 4). After acquiring precise measurements of the tower's dimensions a draft elevation drawing is presented in Appendix C.

Figure 3. View from ground level. Lower rectangular part with access hatch.

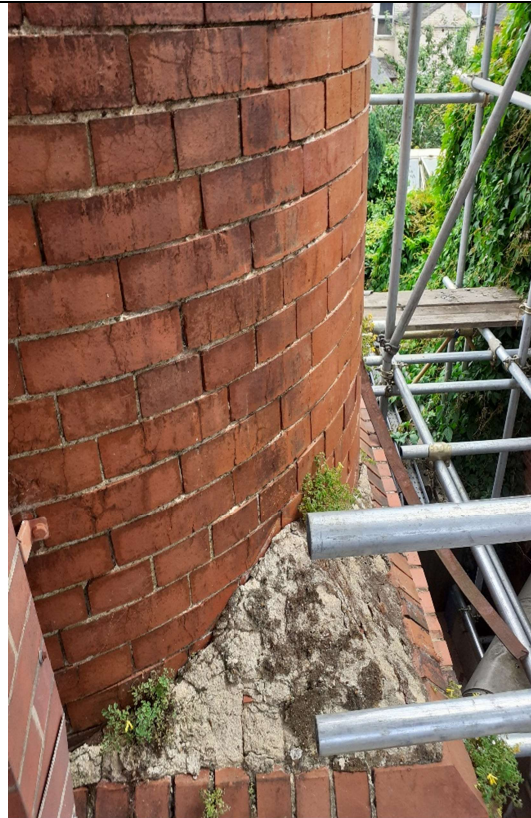
Figure 4. View from first level. Interface detail between upper circle and lower rectangle.

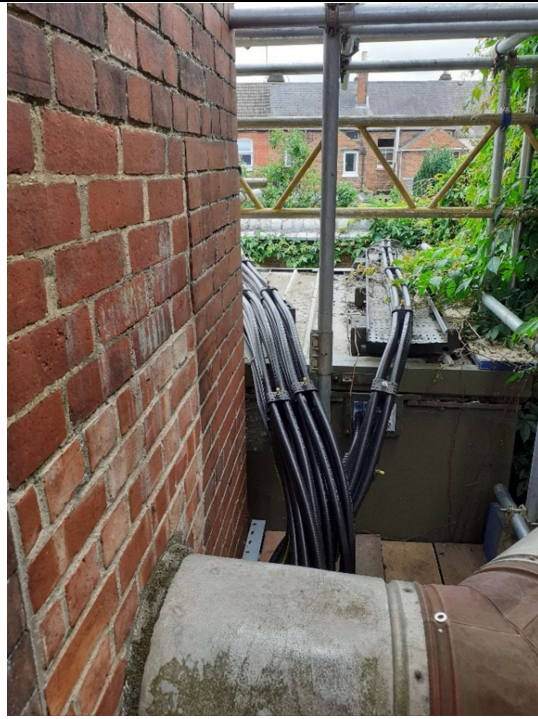
contemporary days of the building (Fig. 7). An existing ventilation pipe just above the lower part of the historical chimney was used to transfer heat from the internal furnace to the adjacent building which remains in place (Fig.6). All telecoms equipment are bolted with resin anchored bolts and steel plates at the top hat appropriately painted to preserve the aesthetics of the listed building (Figures 7,8).

Figure 6. View from first scaffold level. Remaining ventilation pipe (front), cabinet and cable feeders (back)

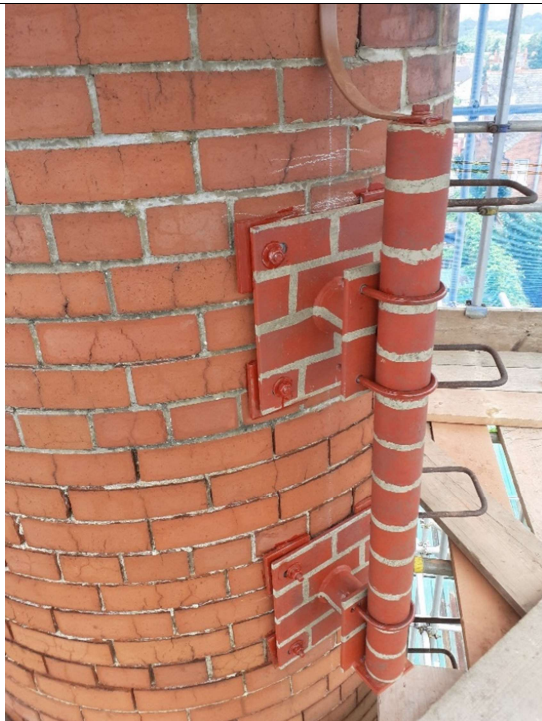
Figure 7. View from scaffolding level 4. Painted wall plates with resin anchors (front), existing U-bars acting as ladder steps (back)

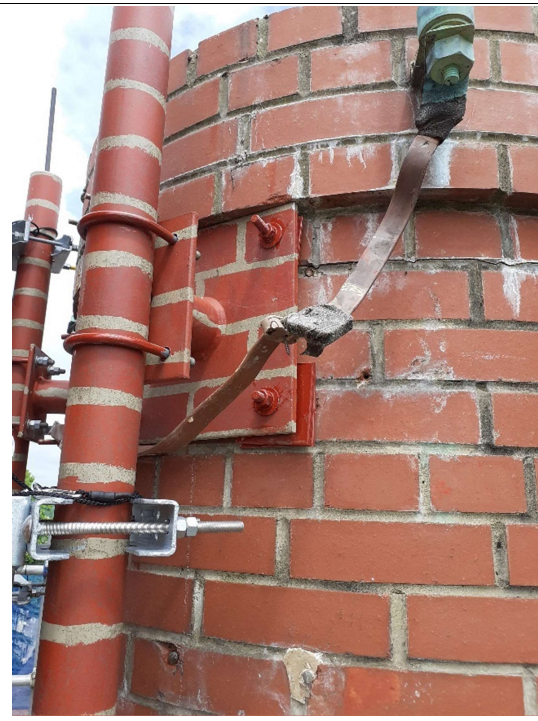
Figure 8. Fixing details for proposed antenna poles at top hat.

- On-site pull-out testing of 3.0 KN for each bolt is well within the expected 0.5 KN tensile and 0.3 KN shear stresses derived from the structural analysis. Therefore, the local wall conditions behind every bolt are adequate.

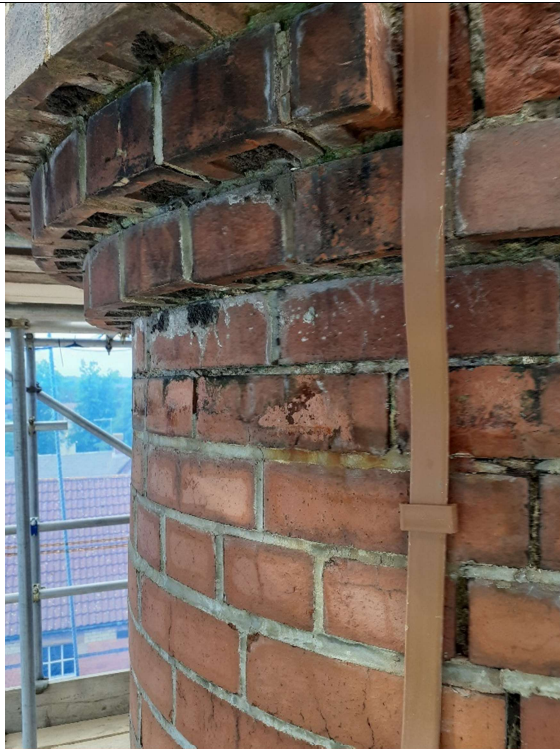
- Structural integrity of the wall is deemed satisfactory with few superficial vertical cracks concentrated mainly at the top of the tower but under the hat where telecoms equipment are located (Fig. 9). This also backs up the assumption that the top hat utilized for the antennas has been regularly retrofitted due to the better condition of the bricks.

Figure 9. Detail of segregating ring between upper parts 2 and 3. Local vertical cracks on upper part 2.

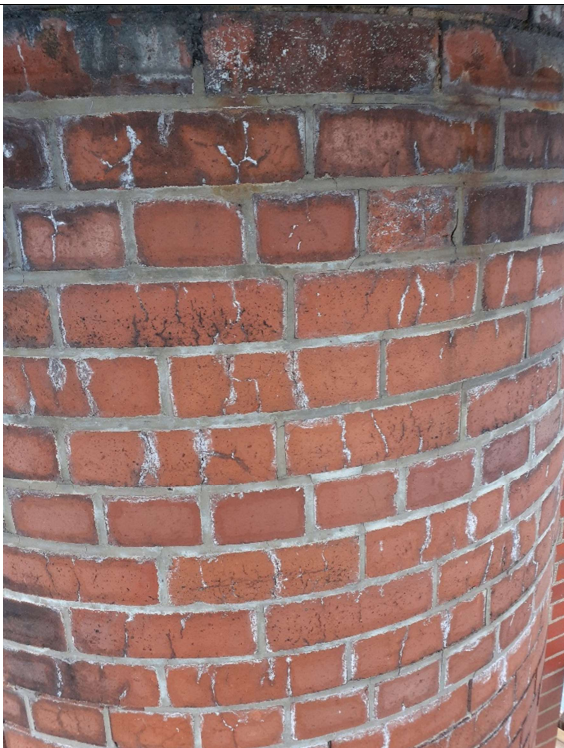
- The lower rectangular part and the first upper part have got stretcher bond type build-up with the upper two tapered parts having English bond with a sequence of 3 long sides -1 short side. Total wall thickness is 215 mm. (Fig. 11,12)

Figure 12. Upper English bond build-up parts.
