# Appendix F

Trial Pit Investigation (Tree Officer)

105, Addington Road,  
Reading,  
Berkshire,  
RG1 5PZ

## **PHOTOGRAPHS OF THREE TRIAL PITS DUG AT:-**

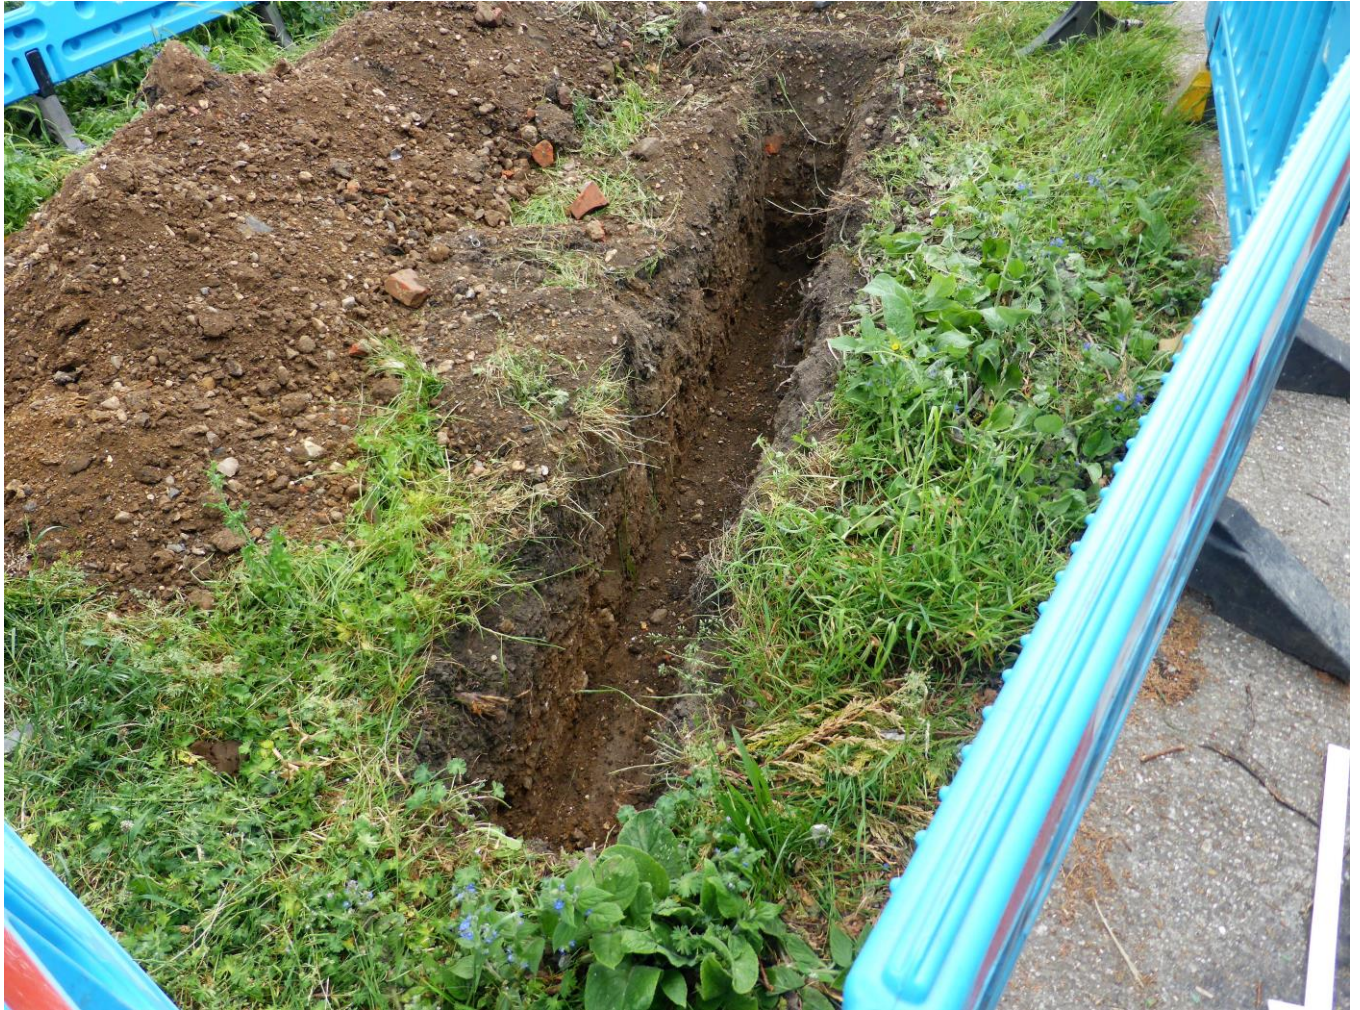
**TRENCH 'A' - ERLEIGH ROAD FRONTAGE**

Trench 'A' was dug further out from the position shown on plan AJT/T at the request of Sarah Hanson (Natural Environment Officer) and bridges the two corners of the proposed building.

There is no evidence of any roots from the adjoining street Lime.

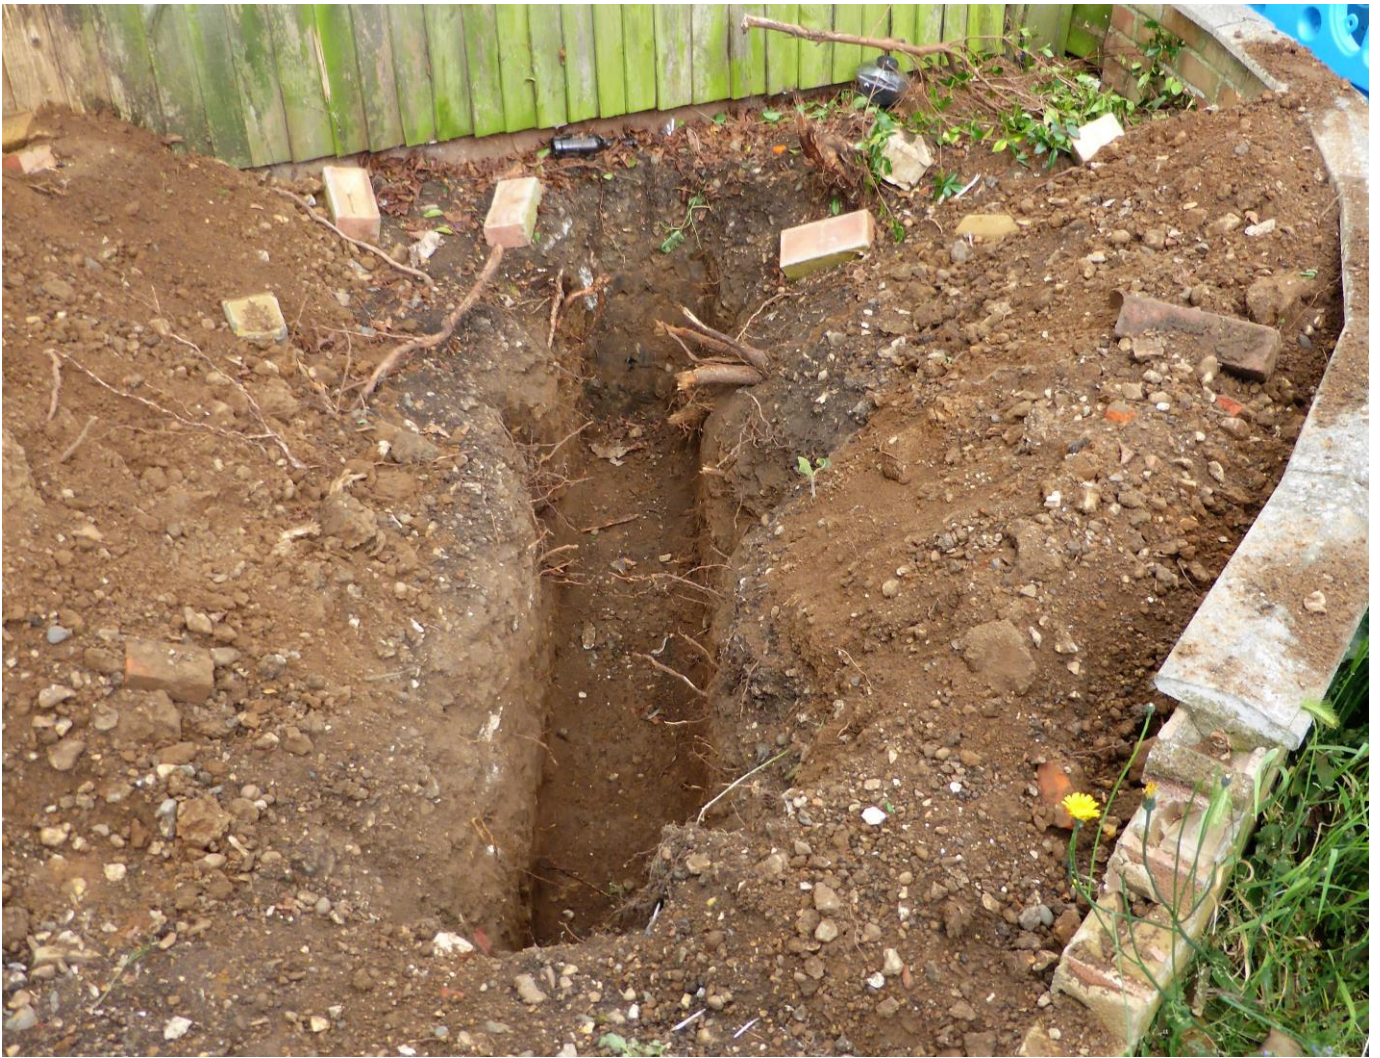
**TRENCH 'B' CORNER OF SITE**

An existing bush (photo below) had to be removed to allow excavation and the remains of its roots are visible on the photograph above.

There is no evidence of any significant roots from the adjoining street Lime.

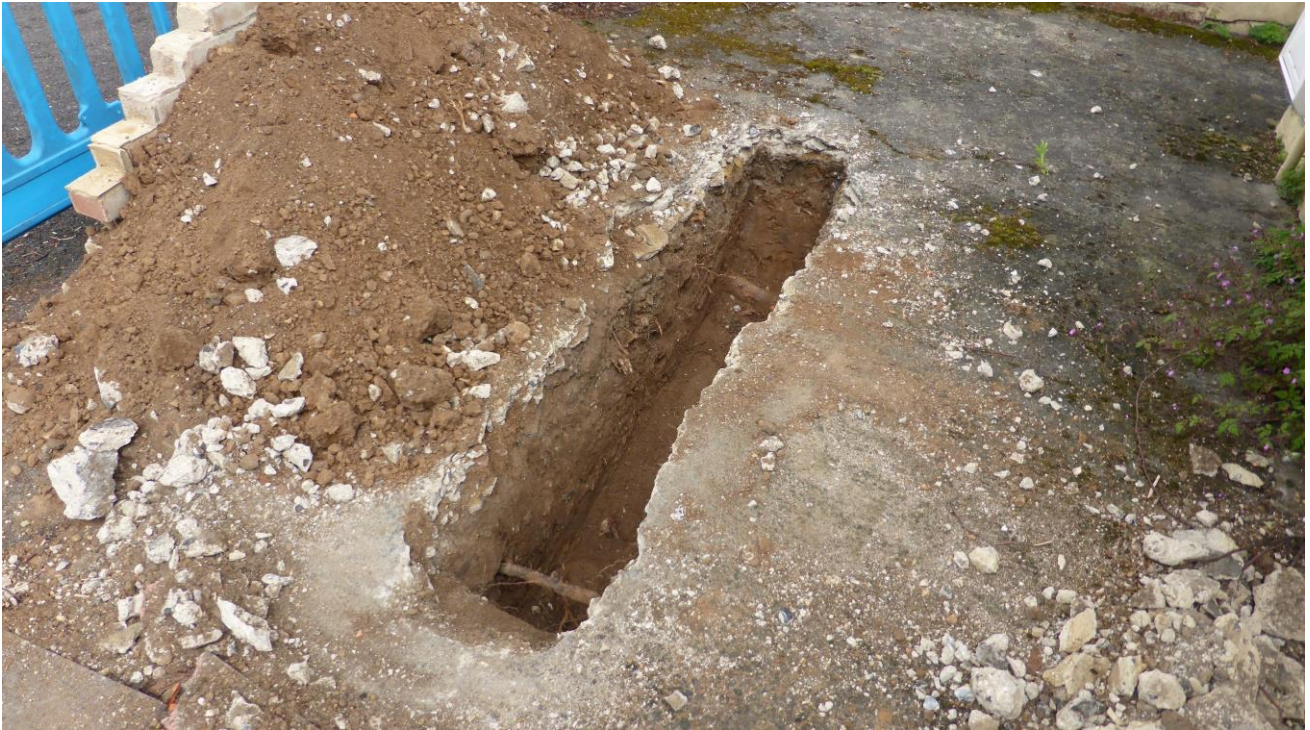
**TRENCH 'C' CONCRETE YARD IN FRONT OF 105 ERLEIGH ROAD.**

The trench revealed two objects crossing the trench. The first (closest to the camera) is an electricity cable. The second (furthest from the camera) is a root from the adjoining street Lime at a depth of 560mm heading towards the basement under the building.
