# PRELIMINARY ROOST ASSESSMENT - REPORT

**SITE:** 55a Armour Road, Tilehurst, Reading, RG31 6HA

**DATE:** 9th December 2021

**REF:** 1426

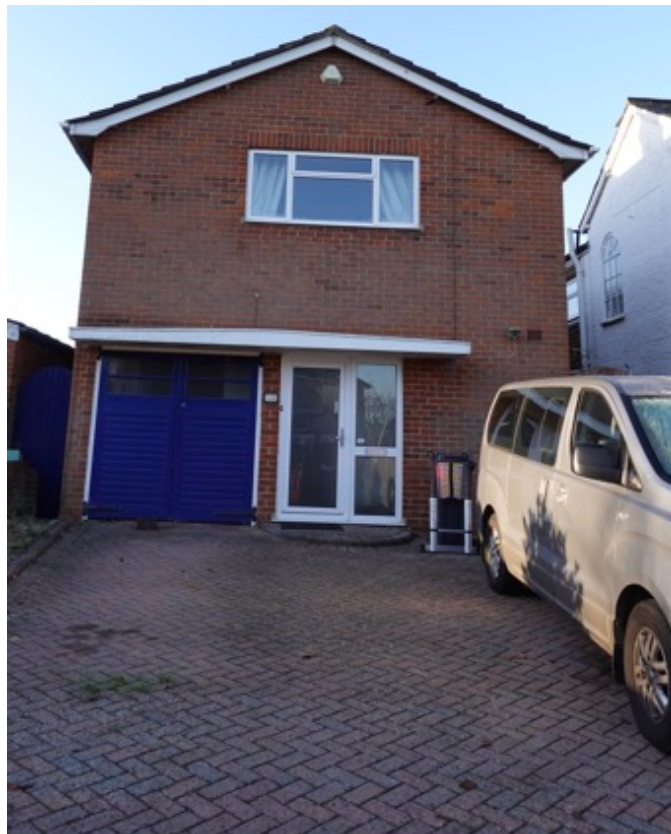
**Plate 1: Overview of the Residential Building (North-Eastern Elevation)**

The main residential building was a two-storey brick built with a pitched clay tiled roof. The building was in a good state of repair and was occupied by the owners.

The roof of the building was made up of clay interlocking roof tiles and clay ridge tiles.

All the tiles were securely fitted and in good condition. No missing mortar, no lifted or broken tiles were recorded. The brickwork was all in good condition and no missing mortar or missing bricks were recorded. Wooden soffits were present along all elevations and were in good condition. No holes or ingress points were recorded within the soffit boxes.

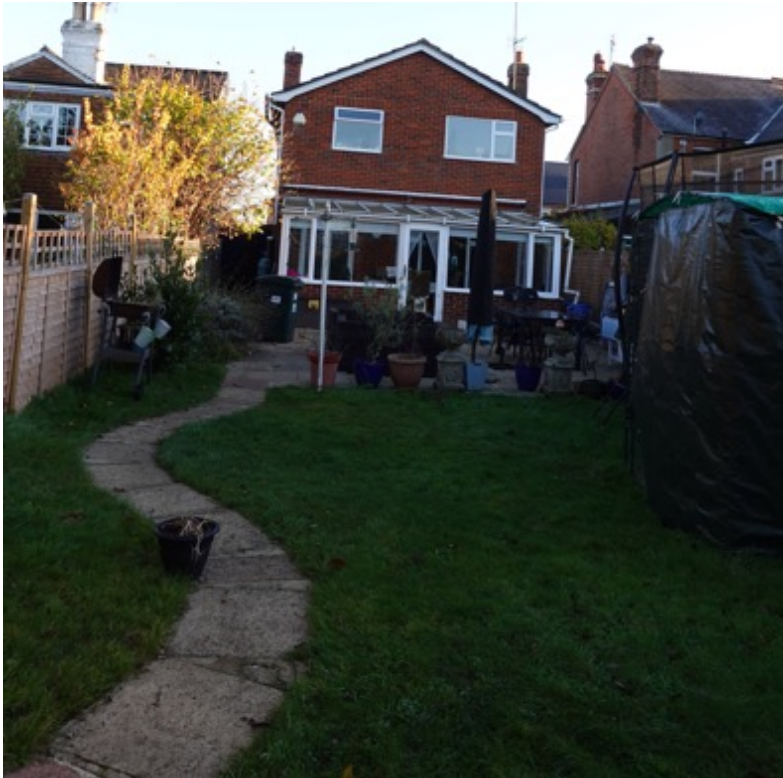
**Plate 2: South-Western Elevation and Portion of Rear Garden**

Further external assessment of the building revealed no further possible ingress points for bats to utilise as the uPVC double glazed windows and door frames were in good condition and were compactly fitted around the brickwork. The single storey conservatory attached to the south-western elevation is considered as negligible to provide bat roosting places and the uPVC structure was firmly fitted to the existing brickwork and shown no crevices that bats could utilise.

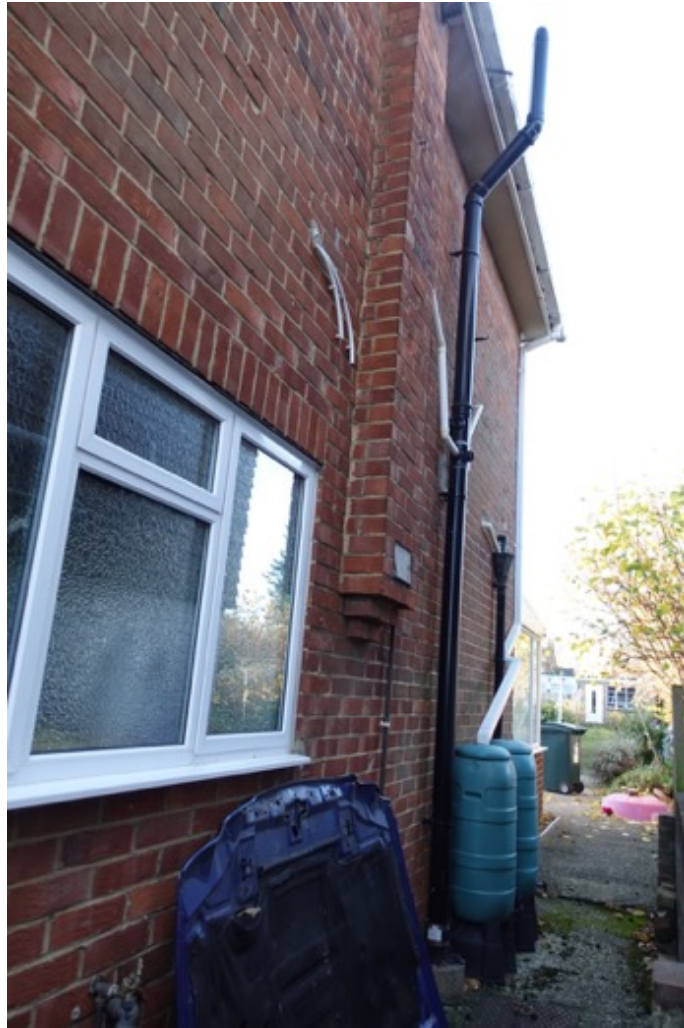
**Plate 4: North-Western Elevation**

No potential roosting features were recorded during the external inspection and therefore no evidence of bats in form of bat droppings, urine staining, feeding remains or scratch marks were recorded.

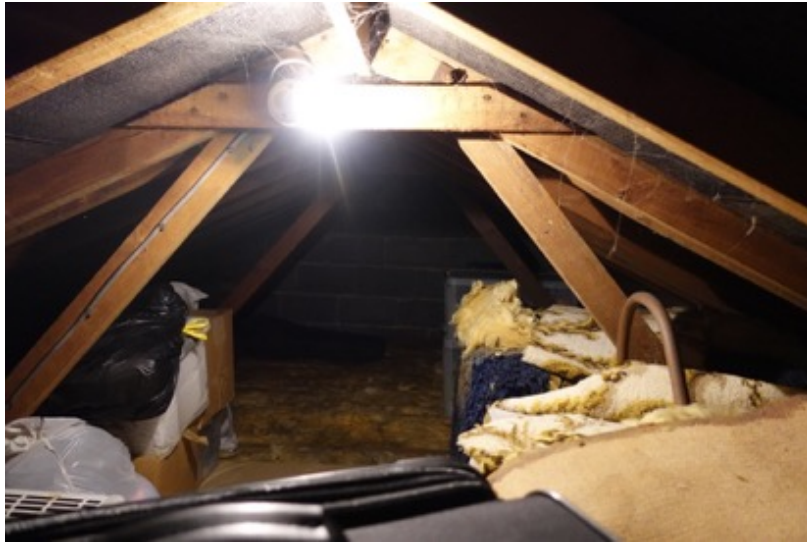
**Plate 5: Inside the Loft Space**

Internally, the loft space could be accessed for inspection. The loft was used to store personal items by current owners. The loft space was at a height of approximately 2.5 meters. The roof was supported by wooden beams and minor cobwebbing was noted along the ridge area. No light was shining through from the outside as all the wooden rafters and trusses were tightly fitted. The block breeze gable ends shown no possible entry points as all the blocks were tightly fitted, in good condition and had no missing mortar. Fibre glass insulation was noted between the wooden floor supporting beams.

No evidence of bats in form of bat droppings, urine staining, feeding remains or scratch marks were recorded within the internal of the building.

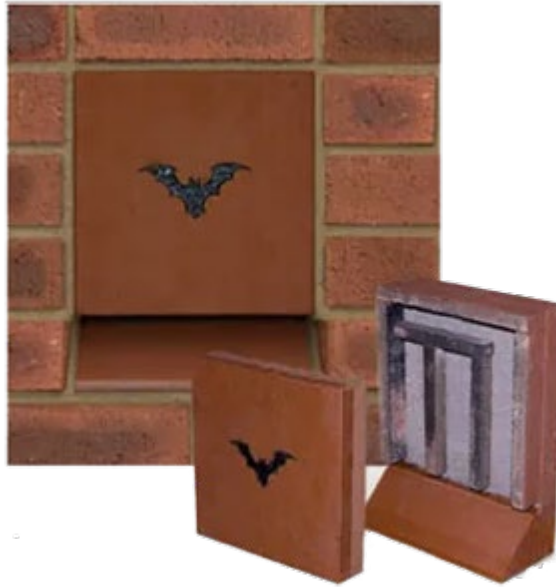
Figure 1: Example of a Bat Roosting Feature (Bat Brick)

In line with the National Planning Policy Framework, the development should aim to enhance the site for bats. Bat boxes should be installed to provide roosting habitat for species such as pipistrelle as shown in Figure 1 and Figure 2 below. In general, bats seek warm places and for this reason boxes should be located where they will receive full/partial sun, although installing boxes in a variety of orientations will provide a range of climatic conditions. Position boxes at least 4 m above ground to prevent disturbance from people and/or predators. The planting of species which attract night flying insects is encouraged as this will be of value to foraging bats, for example: evening primrose *Oenothera biennis*, goldenrod *Solidago virgaurea*, honeysuckle *Lonicera periclymenum* and fleabane *Pulicaria dysenterica*.

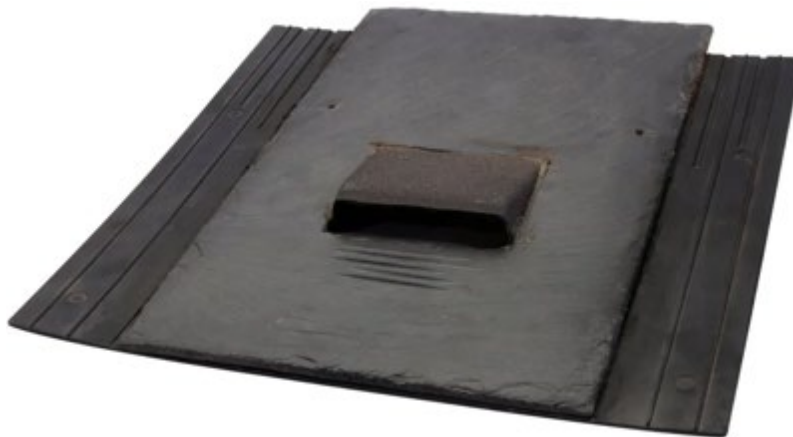
Figure 2: Example of a Bat Roosting Feature (Bat access slate tile)
