## Preliminary Roost Assessment Survey

Charnwood Cottage, Reading, RG4 7EB

Mr & Mrs Hutchins

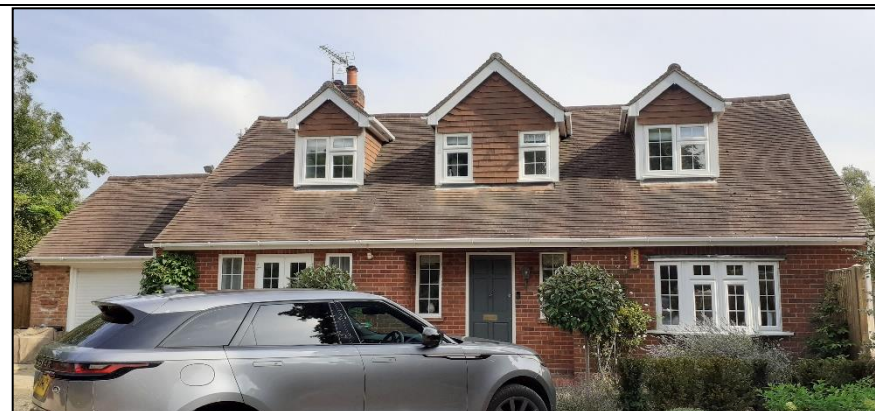
B1- South elevation.

B1 is a detached dwelling. The roof was converted to living space, (bedrooms) during previous development work which included the installation of dormer windows into the front and rear elevations of the roof.

Pictured opposite is the front (south elevation) of B1.

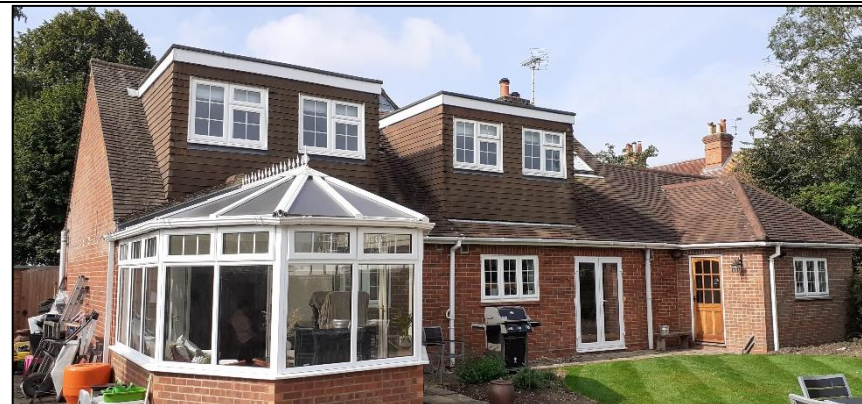
**B1 – northermost elevation, (rear).**

The rear roof pitch contains roof lights and two flat-roofed dormer windows clad in concrete-mix tiles.

The exterior of the building contains a high number of tiles including hanging tiles on the front and rear dormer windows and bats are known to seek out gaps in hanging tiles for day roosting. However, the building appears to have been well maintained. The roof tiles and the hanging tiles are all intact and tight-fitting. There are no missing, loose or raised examples present and there are no gaps between the tiles which bats could exploit.

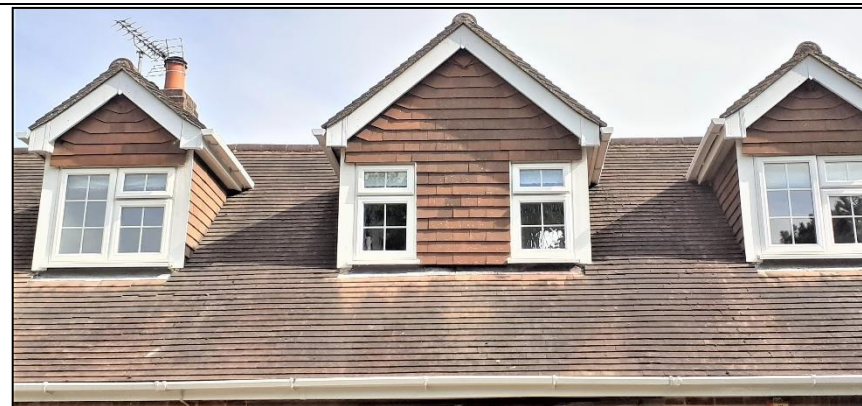
**B1 –Southernmost elevation (front).**

The dormer windows were inspected closely for suitable habitat for roosting bats. The hanging tiles, the apex and the verge tiles on all dormers are well mortared with no gaps. The soffits appear as new and are well sealed to the dormer roofs. The lead flashing at the base of all dormer windows is tightly addressed to the roof tiles. There were no suitable gaps for roosting bats within the tiles.

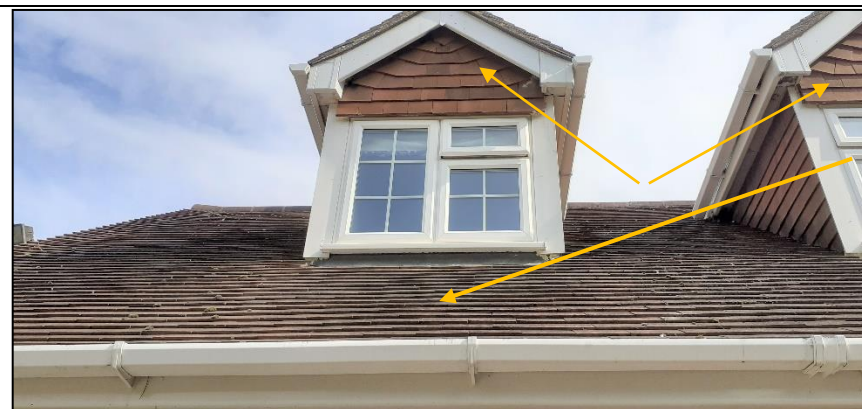
**B1 – south elevations (front).**

Showing the gapless condition of the roof tiles, and the hanging tiles on the dormer windows.

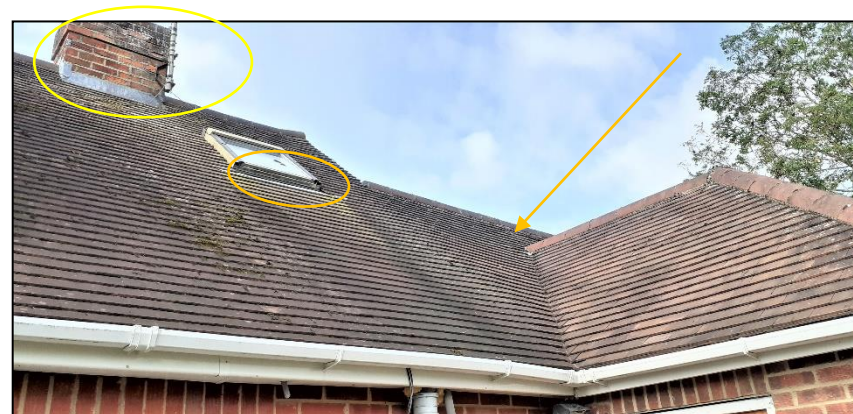
**B1 - northernmost elevations (rear).**

Showing an example of the intact roof tiles on the north elevation. The lead flashing at the base of the chimney is well sealed to the chimney and to the roof. The flashing around the roof-light has no gaps which bats could utilize.

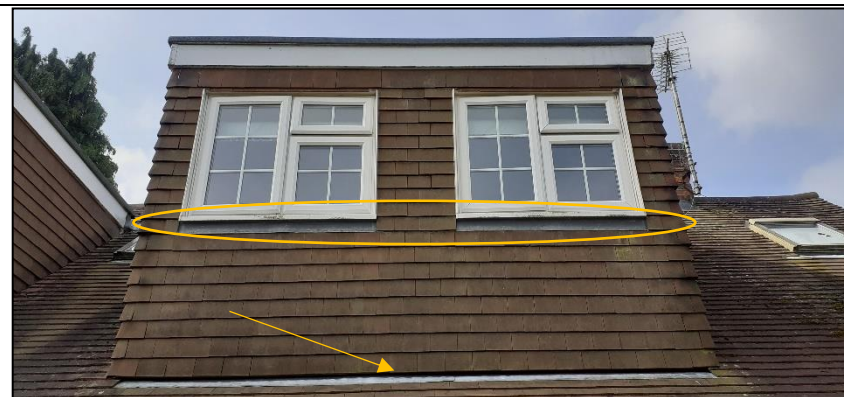
**B1 – northwest elevations**

Showing the hanging tiles and the lead flashing on the westernmost dormer window with an absence of gaps for roosting bats.

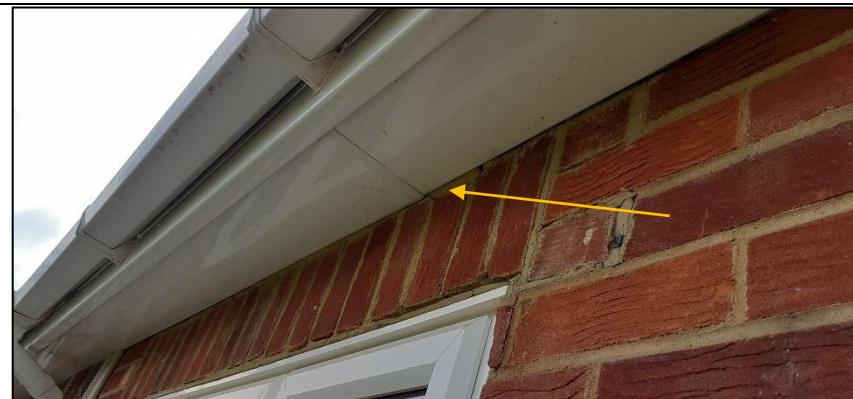
**B1 – north (rear) elevation.**

Showing an example of the tight-fitting soffits on the north (rear) of the building. The picture opposite is representative of the condition of the soffits on all elevations. The soffits appear as new with no linear gaps between the soffits and the brickwork noted and no points of entry for roosting bats identified.

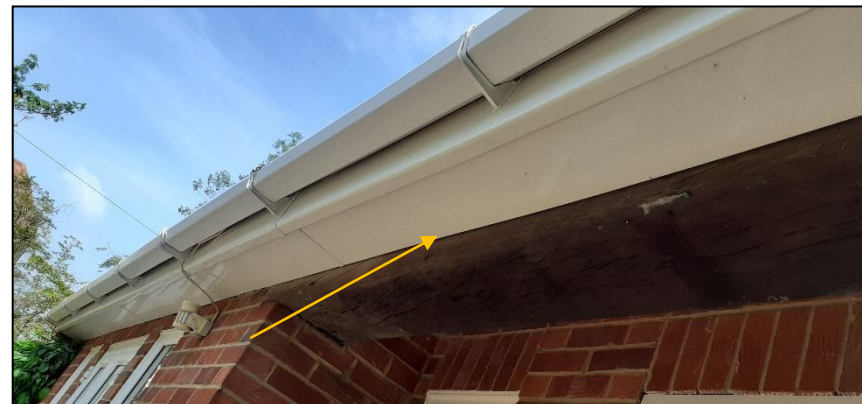
**B1 – south, (front) elevation.**

Showing an example of the tight-fitting soffits on the south elevation.

The walls and the floors below the soffits on all elevations were inspected for evidence of recent bat use, e.g. bat droppings, (bat droppings can persist short-term in favourable weather conditions). No evidence of bat use was seen.

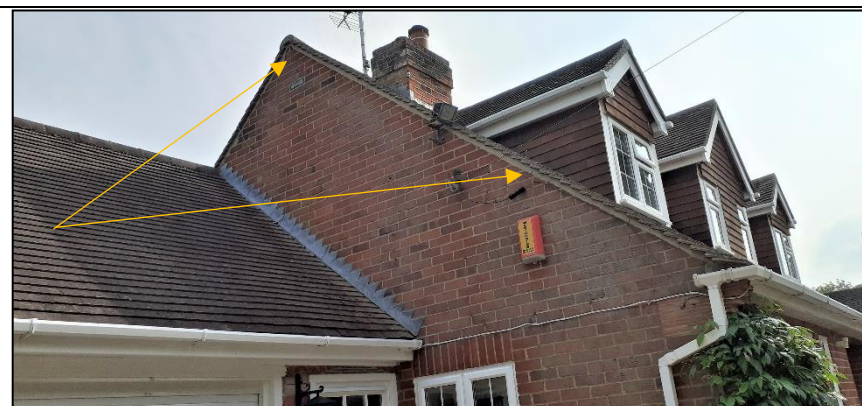
**B1- west gable wall.**

The west gable is equally well sealed with no points of entry for bats identified.

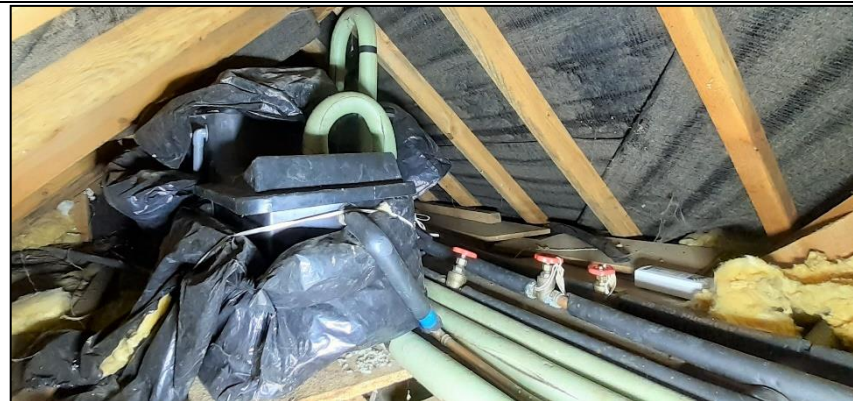
**B1 – internal**

A small void space, large enough to house a water tank is present inside the roof. The void space is lined with bitumen of excellent repair with no tears and no gaps noted.

No daylight enters the roof-space from any angle.

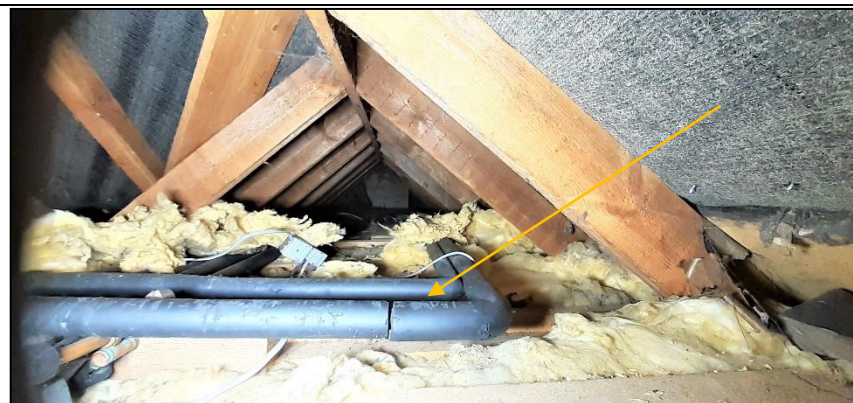
**B1 – internal**

There are bedrooms either side of this void; however, a narrow gap is retained above the bedrooms (below the ridge- pictured opposite). The gap is less than 0.25m height and width. (max). It was not possible to enter the space; however, a high powered lamp was used to inspect the space from the loft hatch.

The roof timbers, the loft insulation and the eaves within reach, were inspected for evidence of bats. The floor and the water tank were all inspected for bat droppings. No evidence of bats was seen.

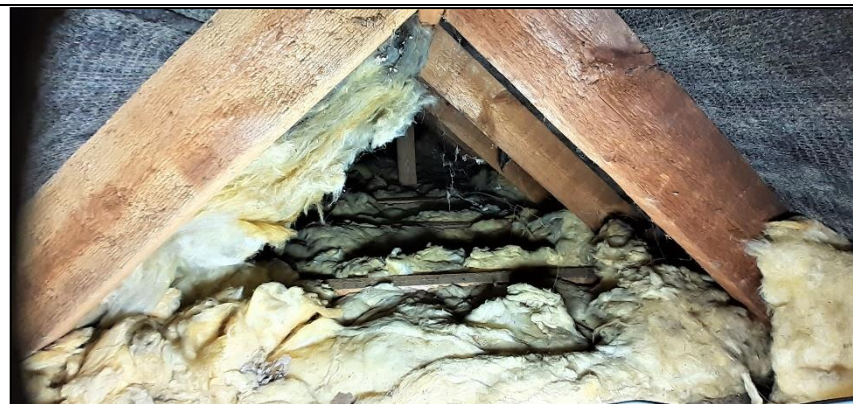
**B1 – internal.**

Looking into the narrow void below the ridge.

There were no points of entry for bats on the outer surfaces and no evidence of bat use was found during the survey.
