# **Preliminary Bat Roost Assessment & Nesting Bird Survey Report**

19 Conisboro Avenue, Reading,  
Berkshire, RG4 7XJ

| Reference | 2021-081 |

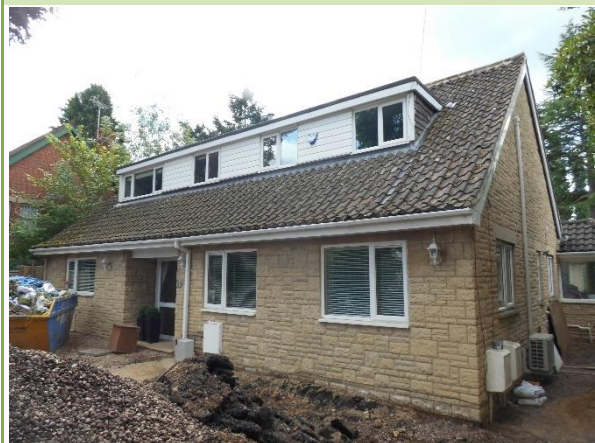
| General Photographs | | |
|---|---|---|
| | Eastern and northern elevations | Western elevation |

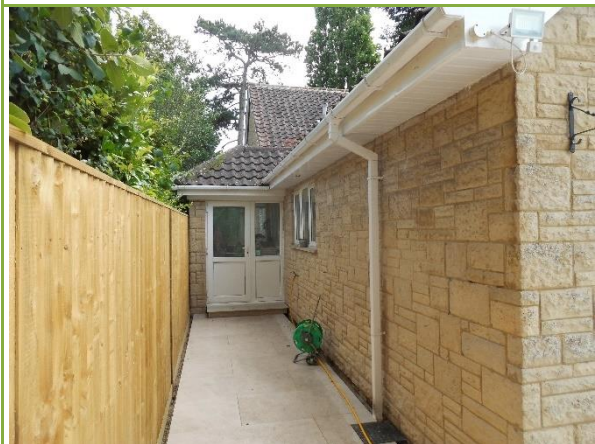
| General Photographs | | |
|---|---|---|
| | North and western elevations | West and southern elevations |

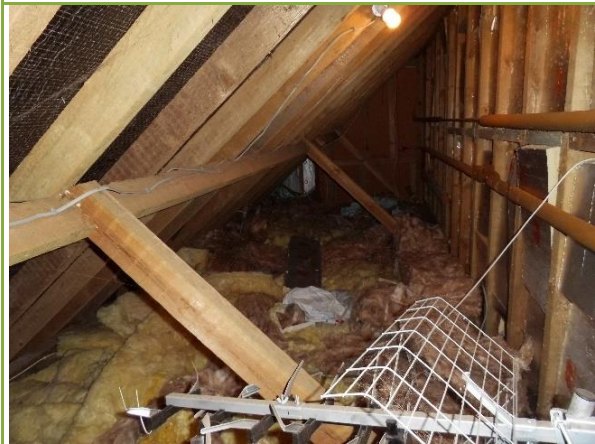
| General Photographs | | |
|---|---|---|
| | Roof space A | Roof space B |

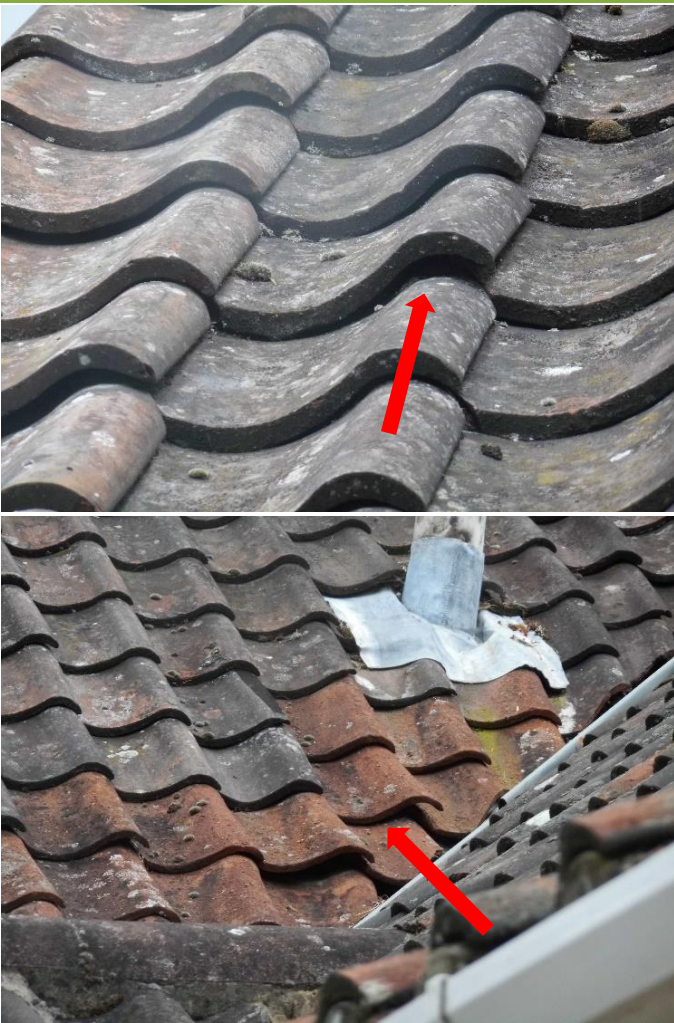
| <b>External Potential Roost Features</b><br>(See Appendix 1 for photographs) | <ul style="list-style-type: none"> <li>• Several gaps between tiles on the north, east and western elevations (P1).</li> <li>• Gaps at the end of tiles providing access to roost between tiles and felt lining (P2).</li> <li>• Gap around the flat roof of the dormer window on the eastern elevation (P3)</li> <li>• Approximate 6 cm gap under the bargeboard, this was fully inspected in the active period with no evidence of bats (P4).</li> </ul> | |

| Number | Description | Photograph |
|---|---|---|
| P1 | Example of gaps between roof tiles. | |

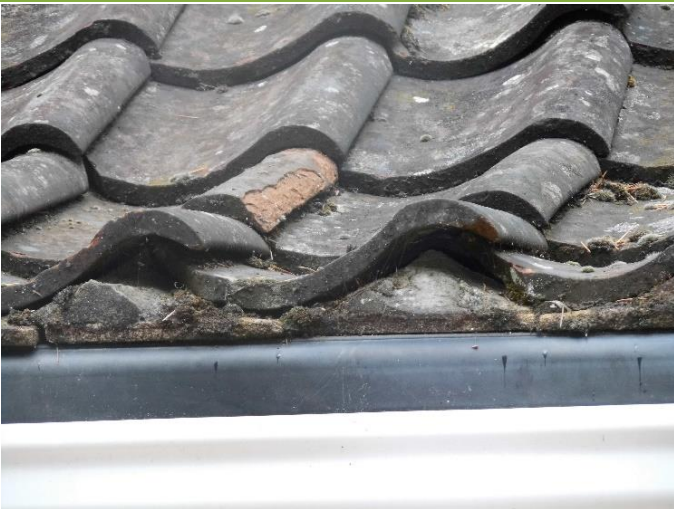
| Number | Description | Photograph |
|---|---|---|
| P2 | Examples of gaps at the end of tiles providing access to roost between tiles and lining. | |

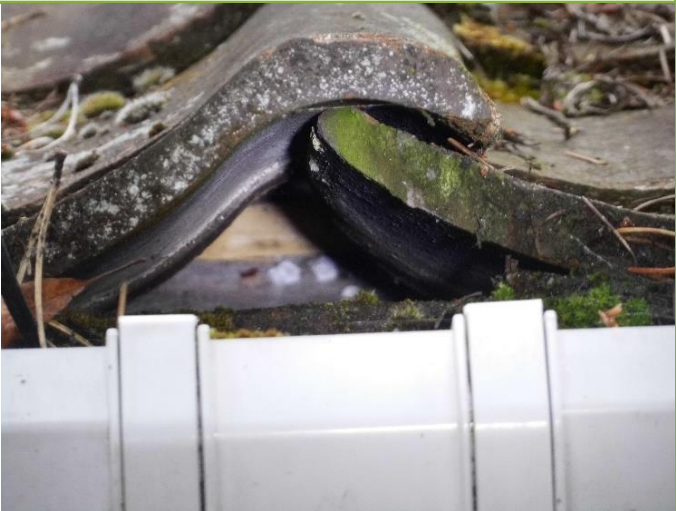
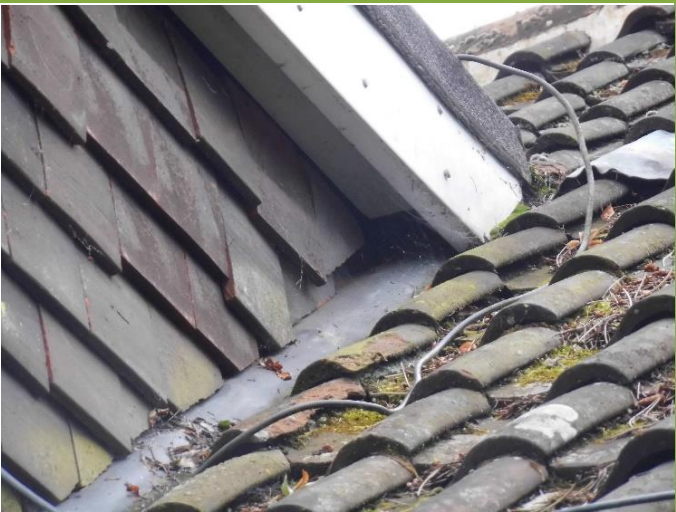
| Number | Description | Photograph |
|---|---|---|
| P3 | Gap around the flat roof of the dormer window on the eastern elevation | |

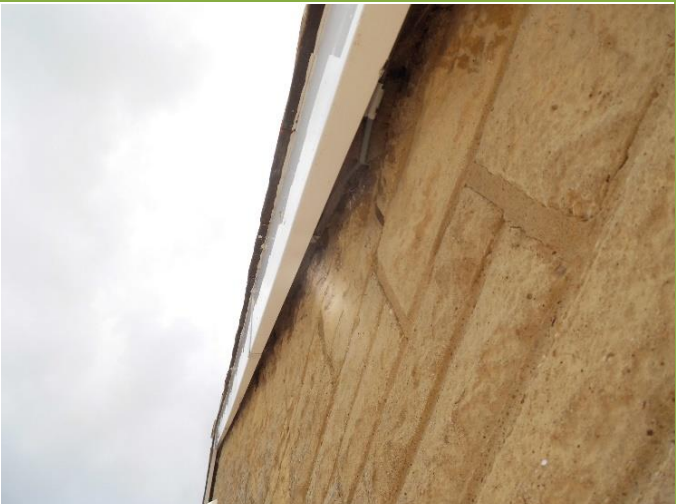
| Number | Description | Photograph |
|---|---|---|
| P4 | Gap under bargeboard. Fully inspected during active period with no signs of use by bats. | |

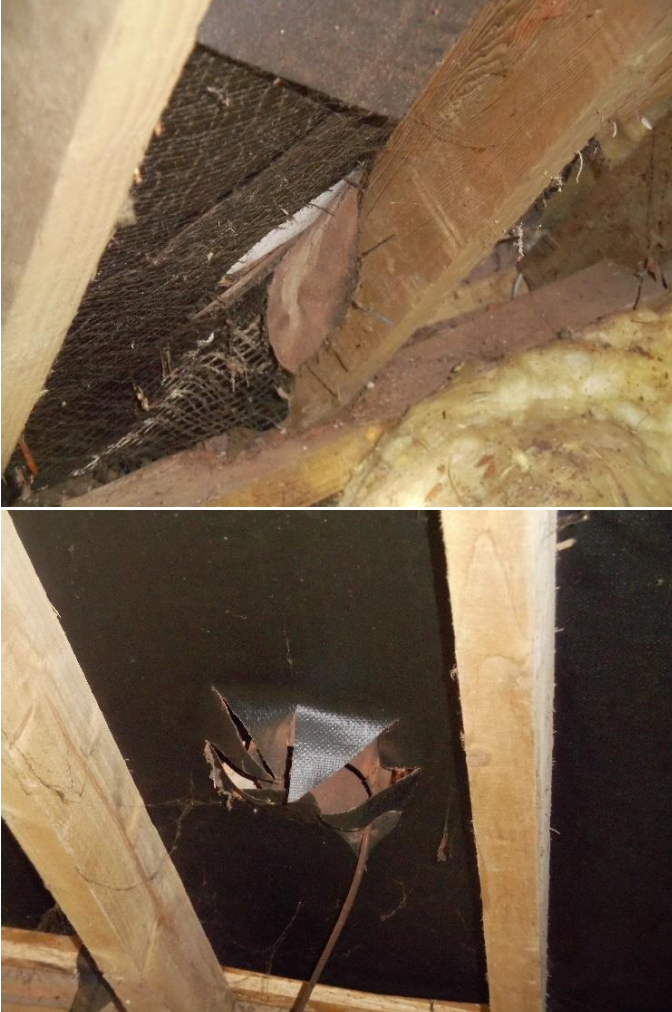
| <b>Internal Potential Roost Features</b><br>(See Appendix 1 for photographs) | <ul style="list-style-type: none"> <li>• On timber rafters throughout all roof spaces, although no evidence of roosting noted below rafters.</li> <li>• Tears and overlapping felt in roof space A (P5).</li> <li>• Tears and overlapping felt in roof space B (P6).</li> </ul> | |

| Number | Description | Photograph |
|---|---|---|
| P5 | Examples of tears in the felt lining in roof space A. | |

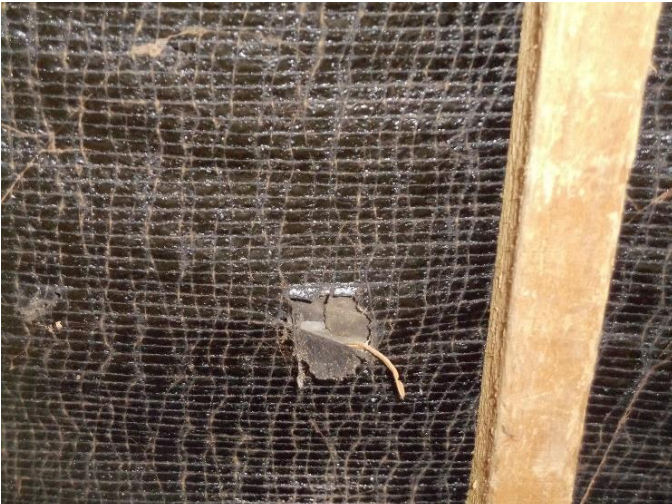
| Number | Description | Photograph |
|---|---|---|
| P6 | Examples of tears in the felt lining in roof space B. | |
